## MEMORANDUM REPORT

NO. WAL 739/87

THE METALLURGICAL EXAMINATION OF A JAPANESE SAMURAI SWORD

25 September 1946

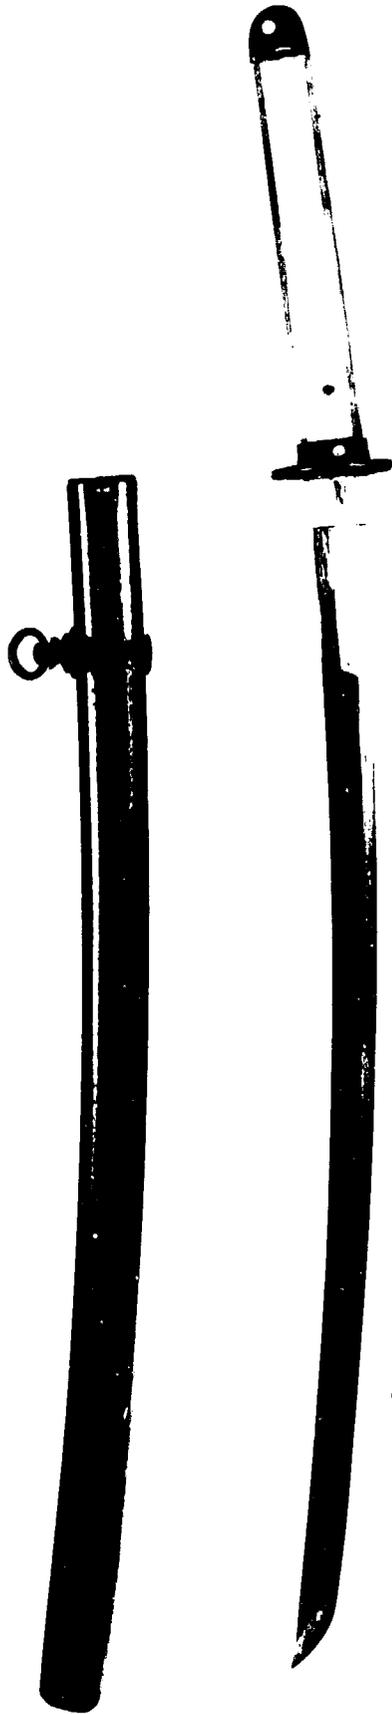
FIGURE 1

SWORD, SAMURI, 36" INCLUDING SCABBARD

After photographing the assembled sword and scabbard, (Fig. 1), the hilt covering was removed and the inscriptions found were photographed, (Fig. 2). A series of Rockwell "C" hardness readings were taken at approximately three (3) inch intervals near the back edge of the blade. Four half inch transverse sections were cut from the sword at Stations\* 4, 13, 22 and 34.5 and examined microscopically. When micro-examination had been completed, the specimens were repolished and transverse Vickers hardness surveys were made on the polished faces. An additional specimen taken from the back edge of Station 22 was polished on a plane parallel to the longitudinal axis in order to examine the inclusion shape, size and distribution. Two Longitudinal sections of the blade taken from Station 0-3.5 and 8-12.5 were macro-etched and photographed. Chemical analyses were made of samples of the steel taken from the handle and the cutting edge of Station 13-16. For comparative purposes, the cutting angle of the blade of Stations 4, 13 and 22 were measured. A simple protractor was used for this purpose. Two longitudinal tensile specimens were machined from the back edge of the sword near Station 22 and tested.

The general appearance of the sword is shown in Figure 1. The blade was highly polished and had a sharp cutting edge (to the touch). In this connection, it is interesting to note that Japanese technical literature makes reference to swords having a cutting angle of 14 degrees whereas this particular sword had a corresponding included angle of 22 to 40 degrees as shown in Figure 3B for Station 4. The cutting power of the subject sword

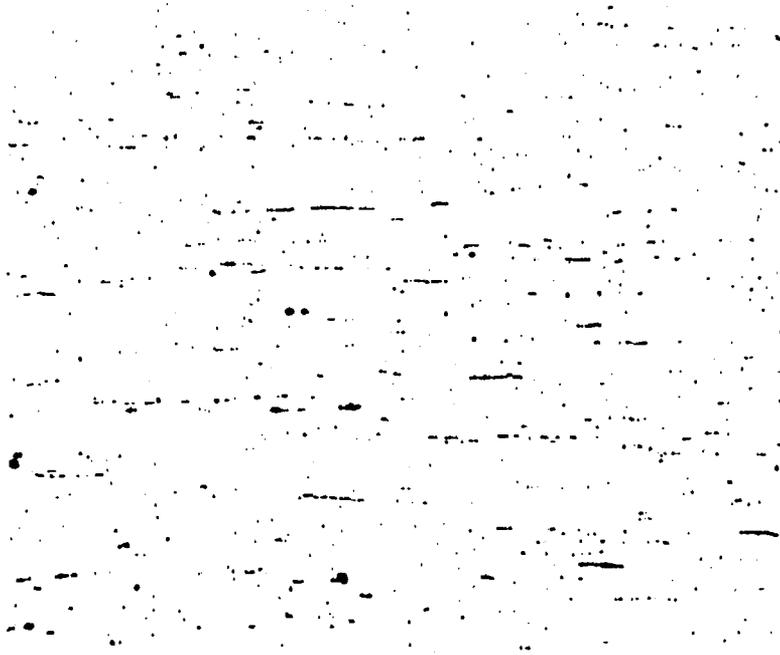
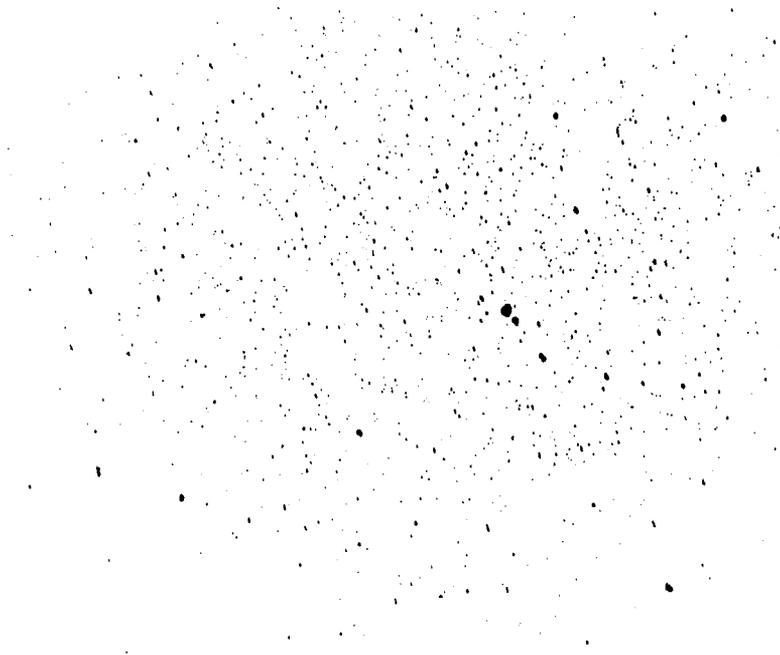
FIGURE 5

X100 - A -  
Longitudinal Section - Sta 22.

X100 - B -  
Transverse Section - Sta 22.

PHOTOMICROGRAPHS OF JAPANESE SAMURAI SWORD  
SHOWING SHAPE & DISTRIBUTION OF NON-METALLIC INCLUSIONS

The unetched structures of a typical section indicate that the steel is very "dirty", containing numerous small non-metallic inclusions. Figures 5A and 5B a transverse and longitudinal section, clearly show the size and distribution of these inclusions.
