**ALTITUDE TESTING OF HERCULES POWDER  
COMPANY BE-3 ROCKET MOTORS**  
(Phase II—Qualification and Acceptance Testing)

A. L. Cannell and C. F. Nokes, Jr.  
Rocket Test Facility  
ARO, Inc.

TECHNICAL DOCUMENTARY REPORT NO. AEDC-TDR-62-63

April 1962

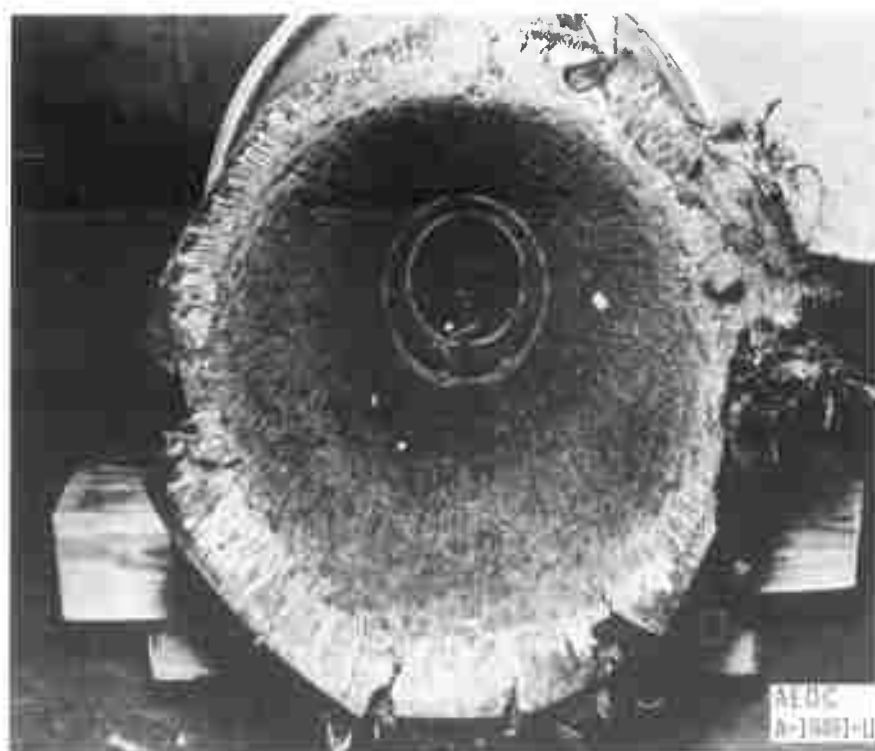
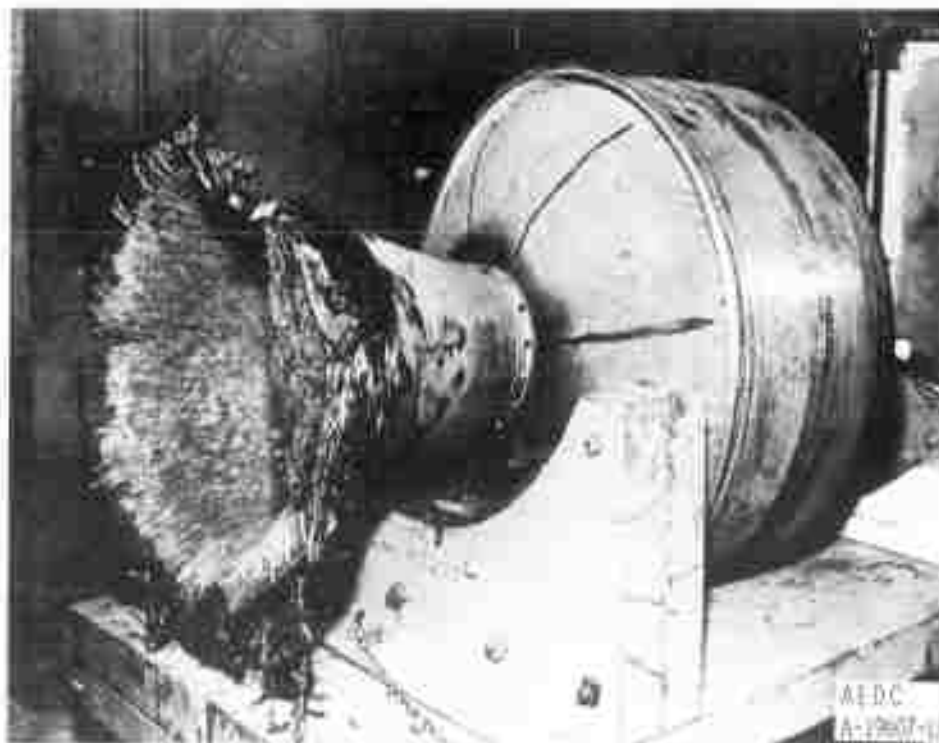
a. Run T3-41-03; Motor S/N 37

b. Run T3-41-04; Motor S/N 38

c. Run T3-41-05; Motor S/N 39

Film sequences of three firings considered typical are presented in Fig. 8. Post firing photographs of all motors are presented in Fig. 9. As can be seen, extensive nozzle deterioration was experienced during the first four firings. During the fifth firing a 2-in. strip of reflective aluminum tape was placed on the nozzle exit cone. No improvement in nozzle condition was noted. After the fifth firing the 42-in. uncooled diffuser was removed and replaced with a 48-in. water-cooled diffuser. This was done to determine if nozzle deterioration was being caused by radiation from the diffuser walls. During the first firing using this diffuser, the chamber pressure adapter failed; however, the nozzle deterioration still occurred during this firing which verified the existence of a nozzle problem rather than a testing environment problem.

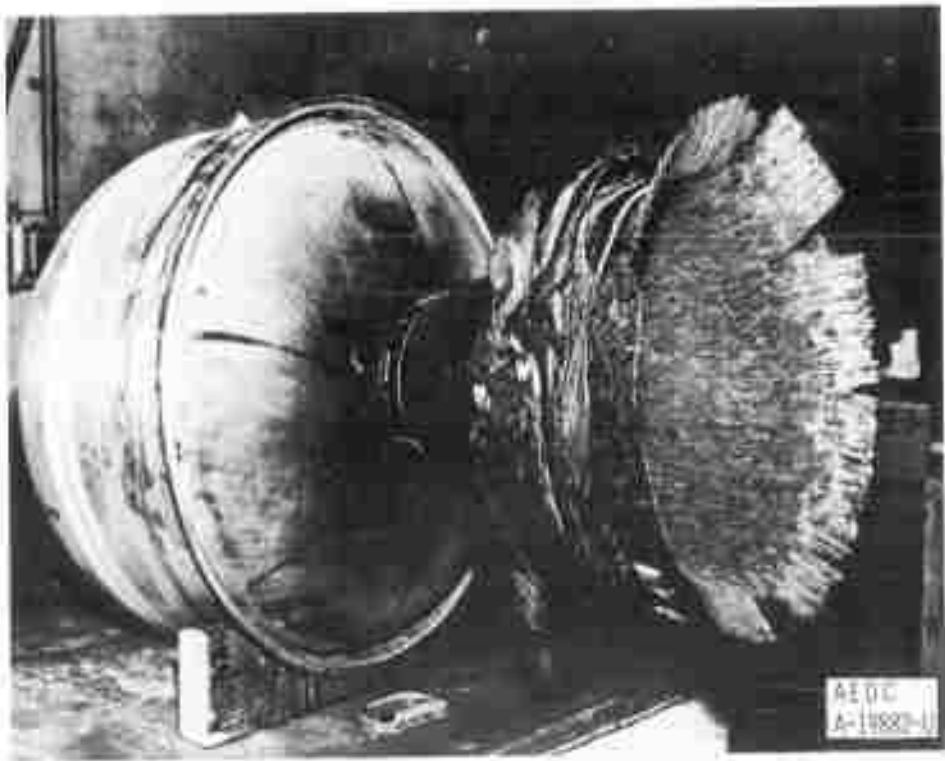
h. Run T3-41-10; Motor S/N 43

Fig. 9 Concluded

The last two units were fired with an aluminum stiffening ring incorporated on the nozzle exit cone (Fig. 1f) as explained in Apparatus Section. This ring worked well on the first attempt (Fig. 9g) even though it became partially unbonded. On the second trial it became completely unbonded from the nozzle during firing and extensive deterioration was again experienced (Fig. 9h). It is believed that this ring would be sufficient as a fix if a sufficiently strong bonding agent is used and provided the weight penalty involved is not prohibitive.
