UNITED STATES ARMY CONCEPT TEAM IN VIETNAM
APO 143, San Francisco, California

ACTIV-AM

② 31 January 1963,

Monthly Test Report Number 3 -- Armed Helicopters

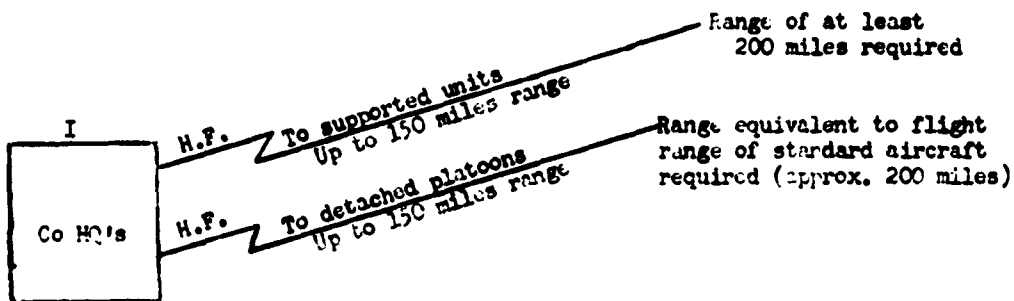
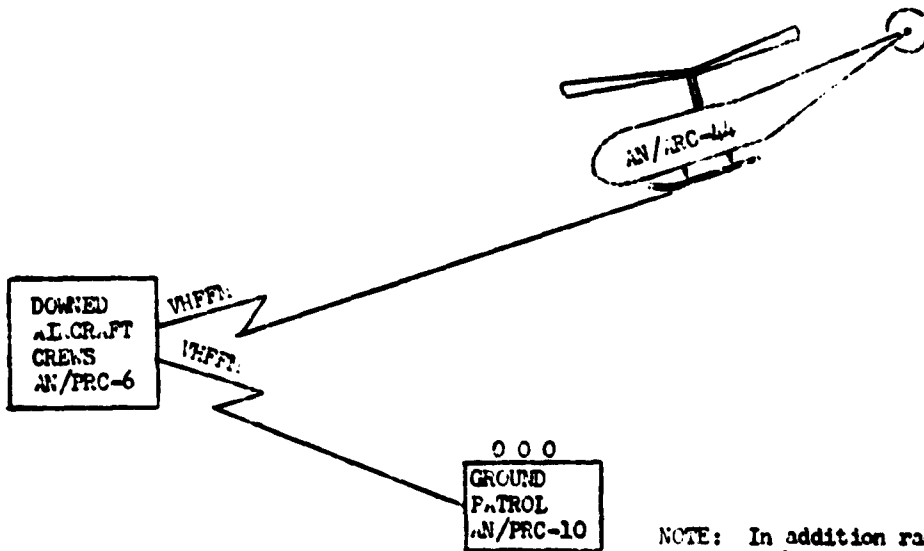
Incl 2
ANNEX C

Inclosure 2 to ANNEX C -- Diagram of radio nets required but not now provided

NOTE: In addition radio set AN/PRC-6 has capability of functioning as a homing beacon for search army aircraft.

b. Under conditions outlined in 2a above, the UTICO has demonstrated a need for voice communications facilities between (see Inclosures 1 and 2):
