GDC-63-197

DEVELOPMENT OF A HIGH-TEMPERATURE
NUCLEAR-RADIATION-RESISTANT
PNEUMATIC POWER SYSTEM
FOR FLIGHT VEHICLES

QUARTERLY REPORT

24 September 1963

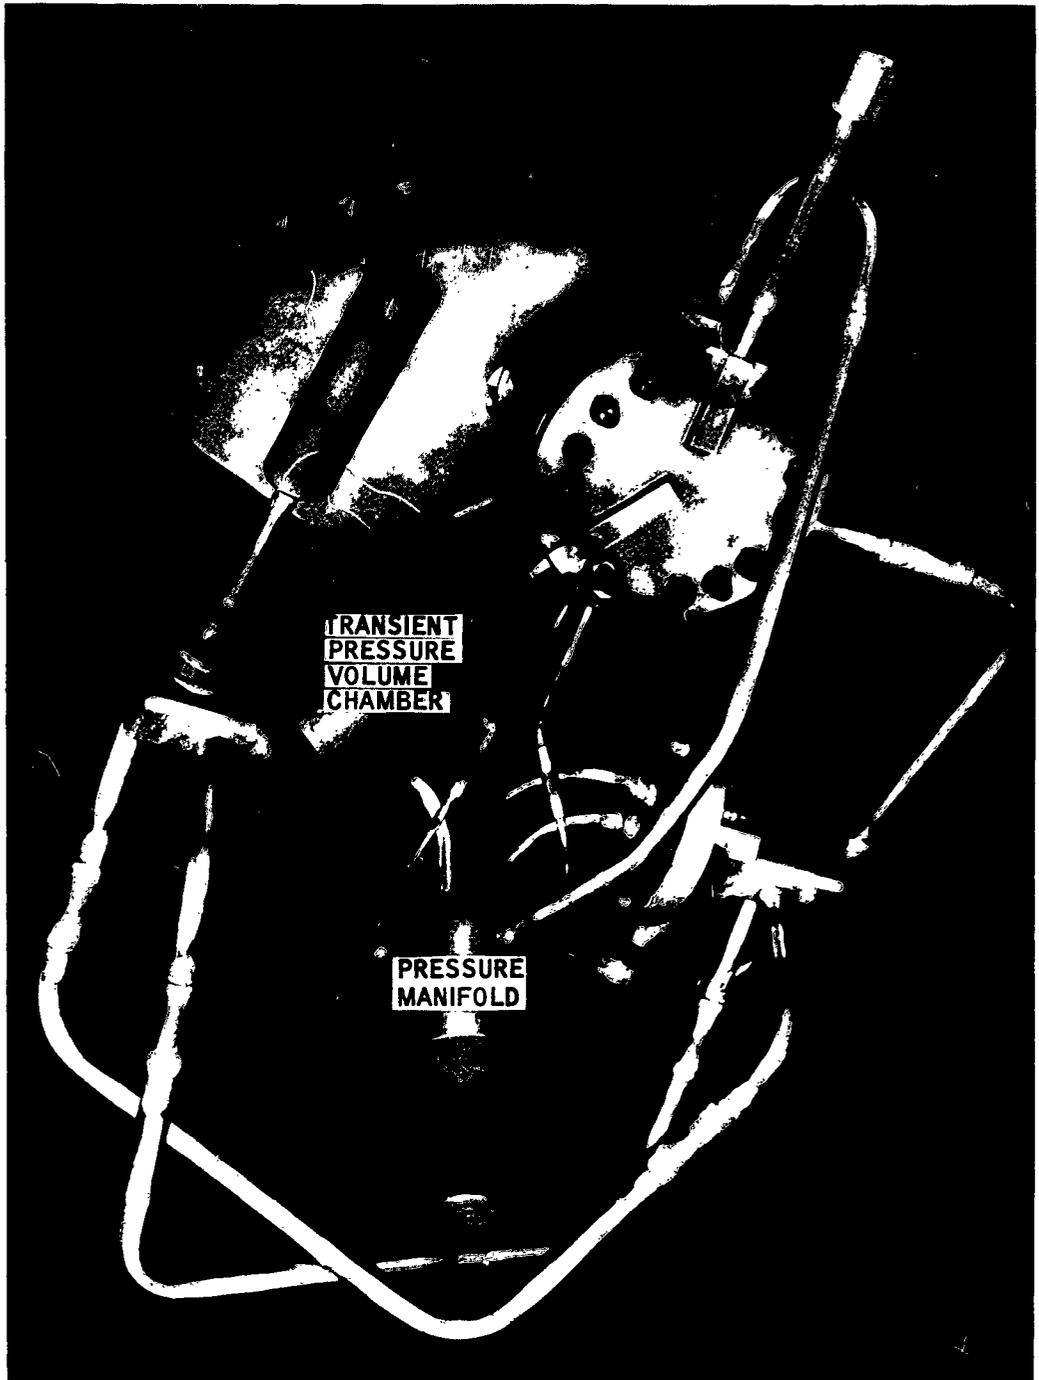
Figure 8 is a photograph of the RASP, in the as-received condition, showing the location of the pressure manifold and transient pressure volume chamber. The RASP was installed in the actuator loading mechanism followed by calibration of instrumentation (see Figures 9 and 10 for two views of the actuator loading mechanism). Proof-pressure testing was then initiated. While a servo signal pressure of 1,000 psig (null pressure) was maintained, both the inlet and return pressures were slowly increased. A failure of the pressure manifold occurred between 800 and 900 psig inlet pressure. Figure 11 is a general view of the installed RASP subsequent to this failure while Figure 12 is a closeup of the pressure manifold. Examination of the cylinder and end cap revealed that little penetration had occurred during the brazing process.

Figure 8. Rotary Actuator and Servo Package (As Received)
