OPERATIONAL TEST AND EVALUATION

CAMOUFLAGE AND CORROSION CONTROL (RF-101)

TAC-TR-63-8
October 1963

Operational Test and Evaluation
Camouflage and Corrosion Control (RF-101)

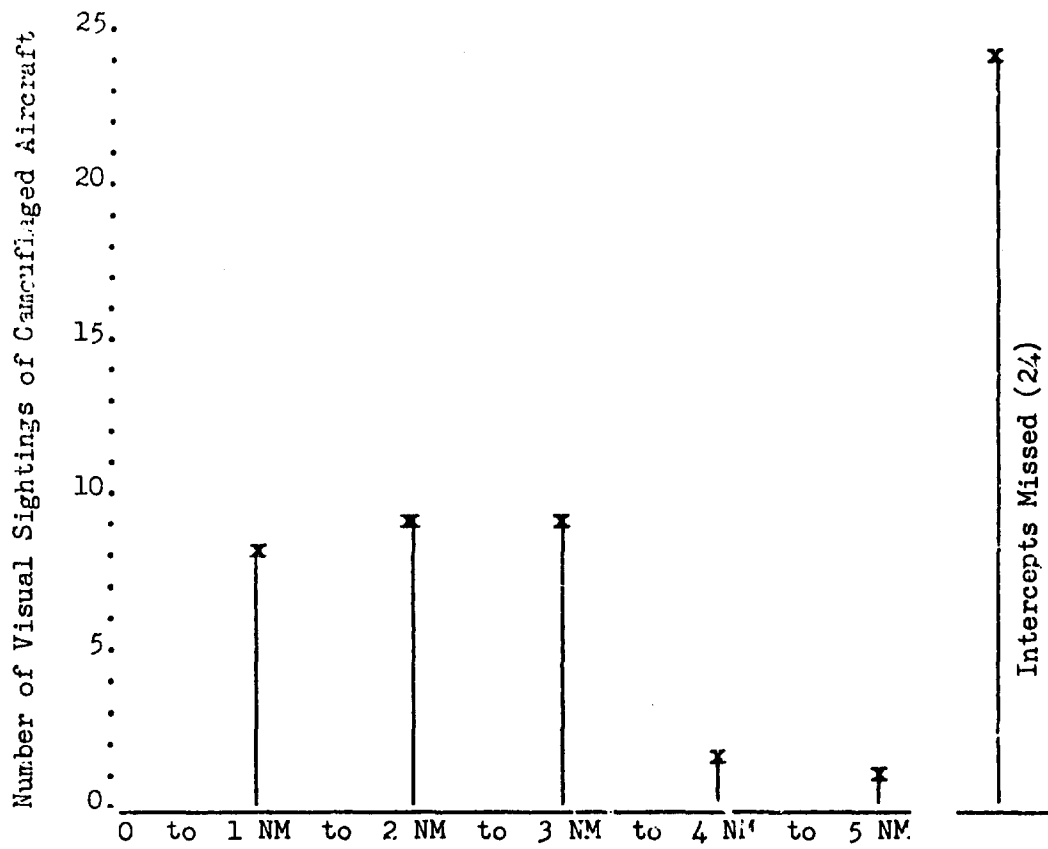
FIGURE 1. Results of Attempted Visual Interceptions of Camouflaged Aircraft (RF-101)

Total Intercepts Attempted - 54
 Total Effective Intercepts - 30
 Total Ineffective Intercepts - 24
 Percent Ineffective - 44.5%

c. Following are the results of the intercepts. Figure 1 shows the results of those intercepts in which only dull aircraft were targets; figure 2 is for those intercepts in which a bright aircraft was included as a target.

d. As shown by the graphic results, when sightings were effected the intercept distances of the dull and bright aircraft were approximately the same. However, that the dull aircraft was not seen on 44.5 percent of the attempted intercepts is considered to be the significant fact. This becomes more significant when compared to the bright target, which was missed on only 11.3 percent of the intercepts attempted. This degree of reduced detectability, attributed to the camouflage, was realized during interceptions on which the interceptor was constantly receiving azimuth and range information directly from the target aircraft pilot. This type of guidance is inherently more descriptive and timely than that which could be obtained from an intermediate source, such as a radar controller. In all cases, the interceptors were RF-101 aircraft and the intercept techniques were identical.

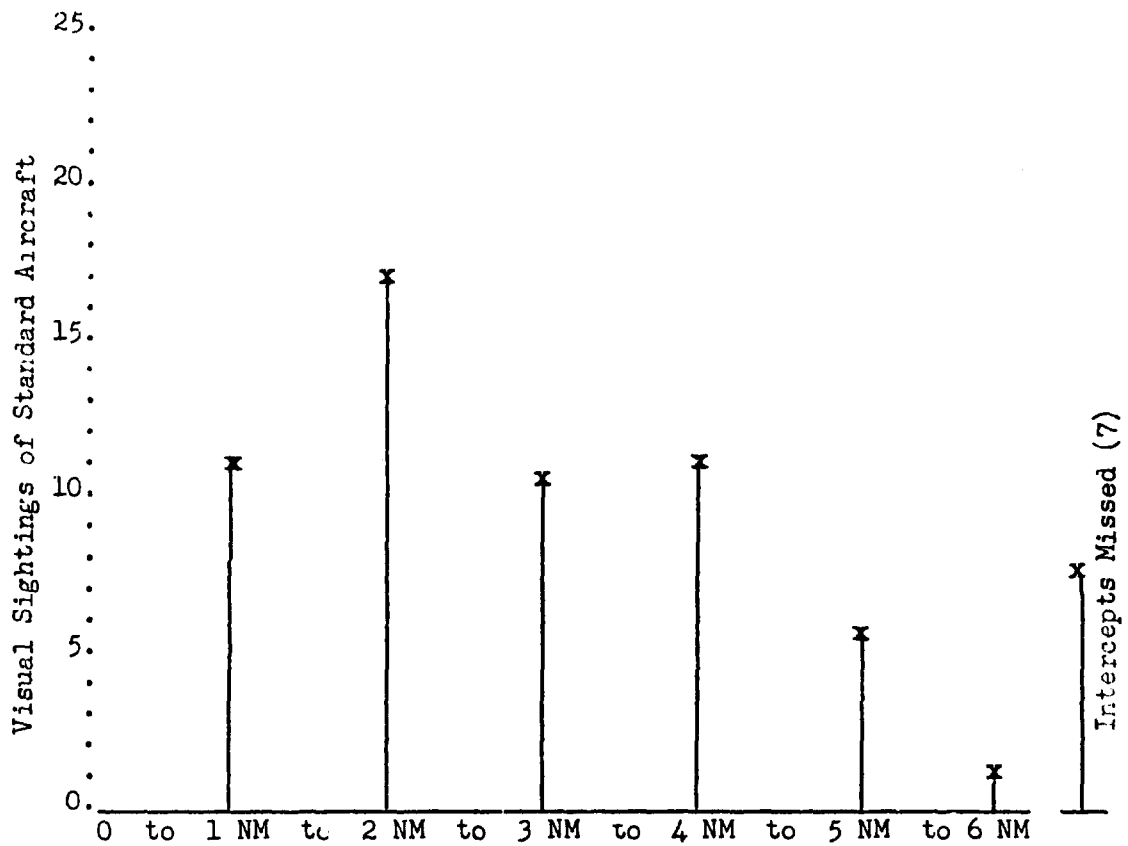
FIGURE 2. Results of Attempted Visual Interceptions of
 Standard Painted Aircraft (RF-101)

Total Number Interceptions Attempted-62
 Total Intercepts Effective - 55
 Total Intercepts Ineffective - 7
 Percentage of Ineffective Intercepts-
 11.3%
