Second Quarterly Progress Report
September, October, November, 1962

FACTORS AFFECTING THE COMPATIBILITY OF
LIQUID CESIUM WITH CONTAINMENT METALS

MSA Research Corporation

Contract No. AF 33(657)-9168

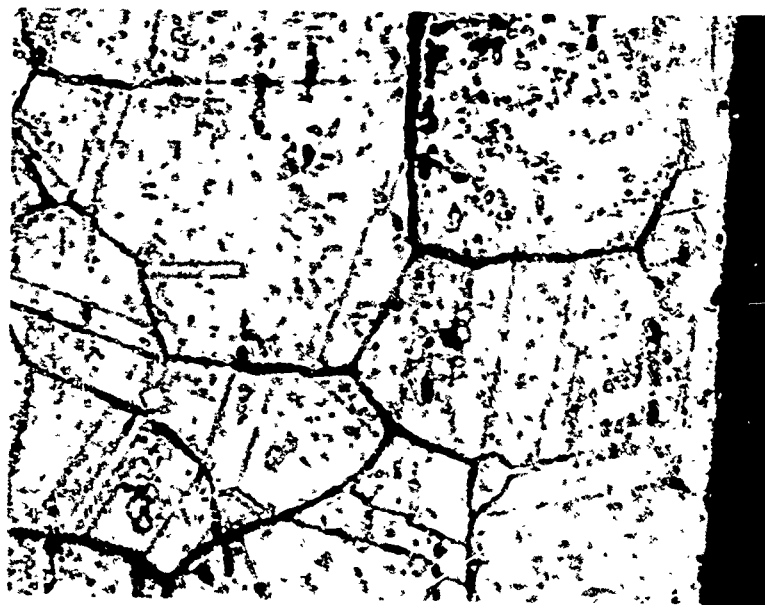
Fig. 2 Haynes Alloy Aged 25 Hours in Air
Etchant: HCl - H₂O₂ 266x

Table 3 summarizes Haynes-25 capsule tests performed to date. As a control study on the Haynes alloy-25, one capsule (#1) was fabricated and exposed to "as-produced" cesium at 1800°F (982°C) for 104 hours. The capsule showed no extensive corrosion effects (Fig. 3), but increased precipitation at the surface as compared to an air aged specimen (Fig. 2). No attempts was made for a complete analysis of the metals dissolved in cesium.
