BL-221 70 Gc MAGNETRON
PRODUCTION ENGINEERING
MEASURES PROGRAM
FINAL REPORT
Section 1 and 3 - Volume 1
6 August 1961 through 6 May 1964

CONTRACT NO: DA-36-039-SC-85974

OBJECT: To investigate minor constructional modifications in the present design, evaluate a pre-production run of thirty (30) tubes and determine manufacturing facilities capable of producing fifty (50) tubes per month.

PREPARED BY: Robert C. Sibley
Manager, Power Tube Product Development

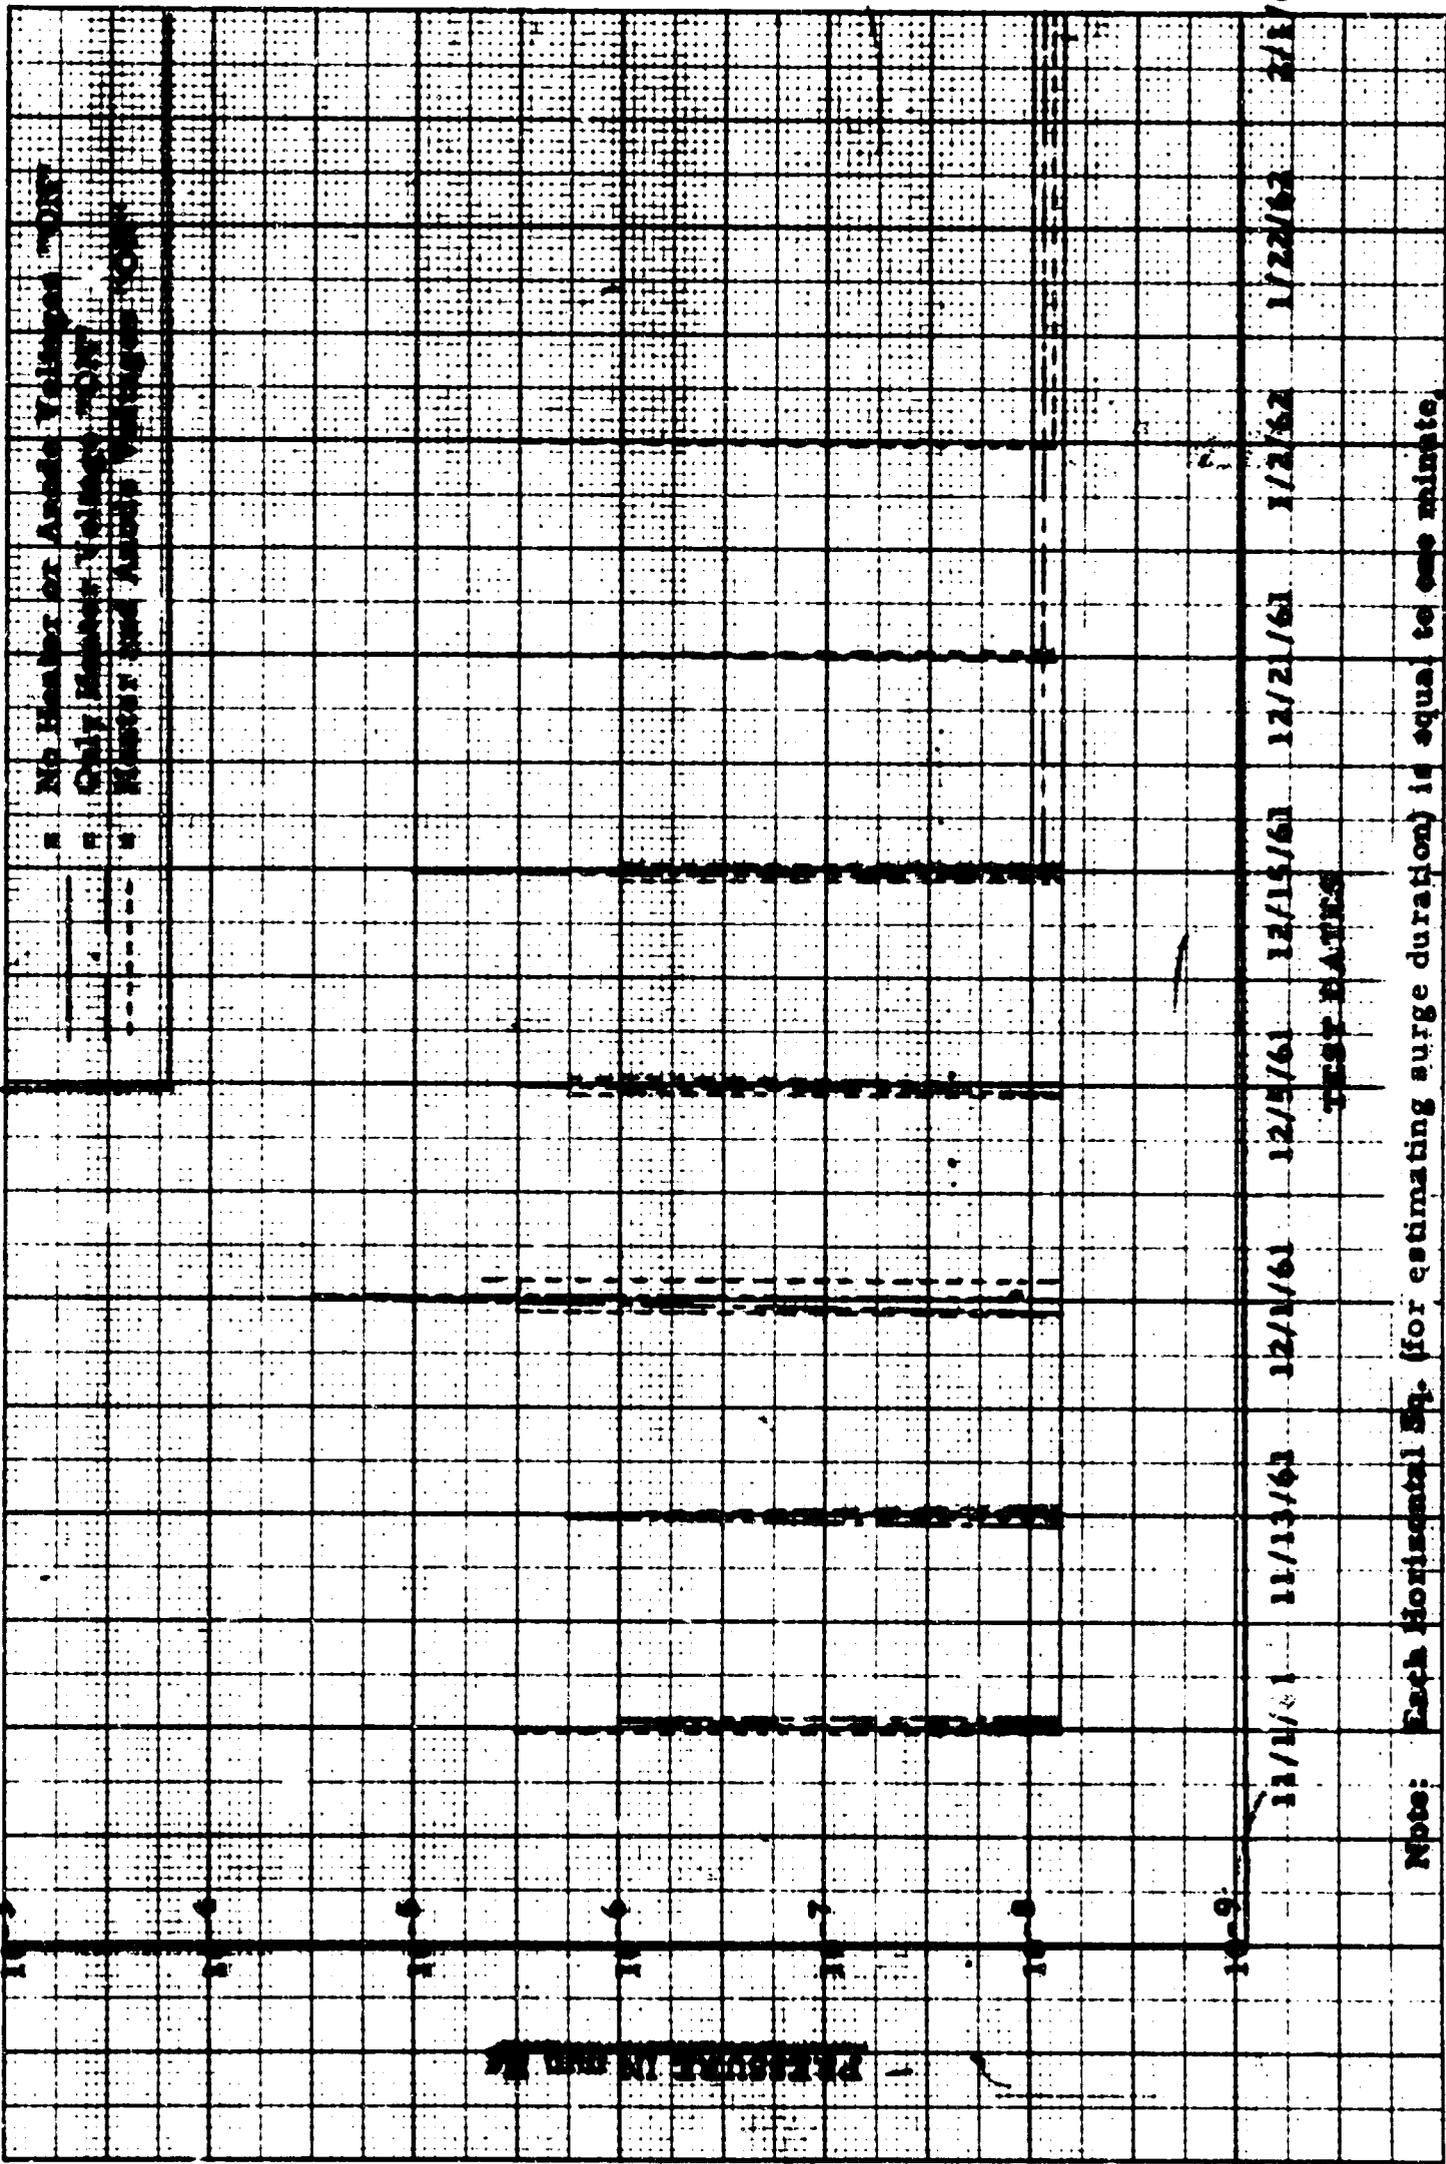
Figure 2

All tubes were held for 1/1-2 months shelf storage and then initiated on life test. Internal tube pressure and test readings were monitored periodically throughout the sequence. Representative data is presented in Figures 2 through 5. The data shows no significant difference between the control tubes and the vac-ion appendage tubes. It is apparent that continuous pumping is not categorically helpful in prolonging the serviceability of the tube as it was designed and processed prior to this PEM Program. A more extensive investigation applied on the present state of design might demonstrate some significant results, but it seems more logical to conclude when taking other facts into consideration that operating life is limited by something other than vacuum degradation.

PERIODIC INTERNAL TUBE PRESSURE TESTS

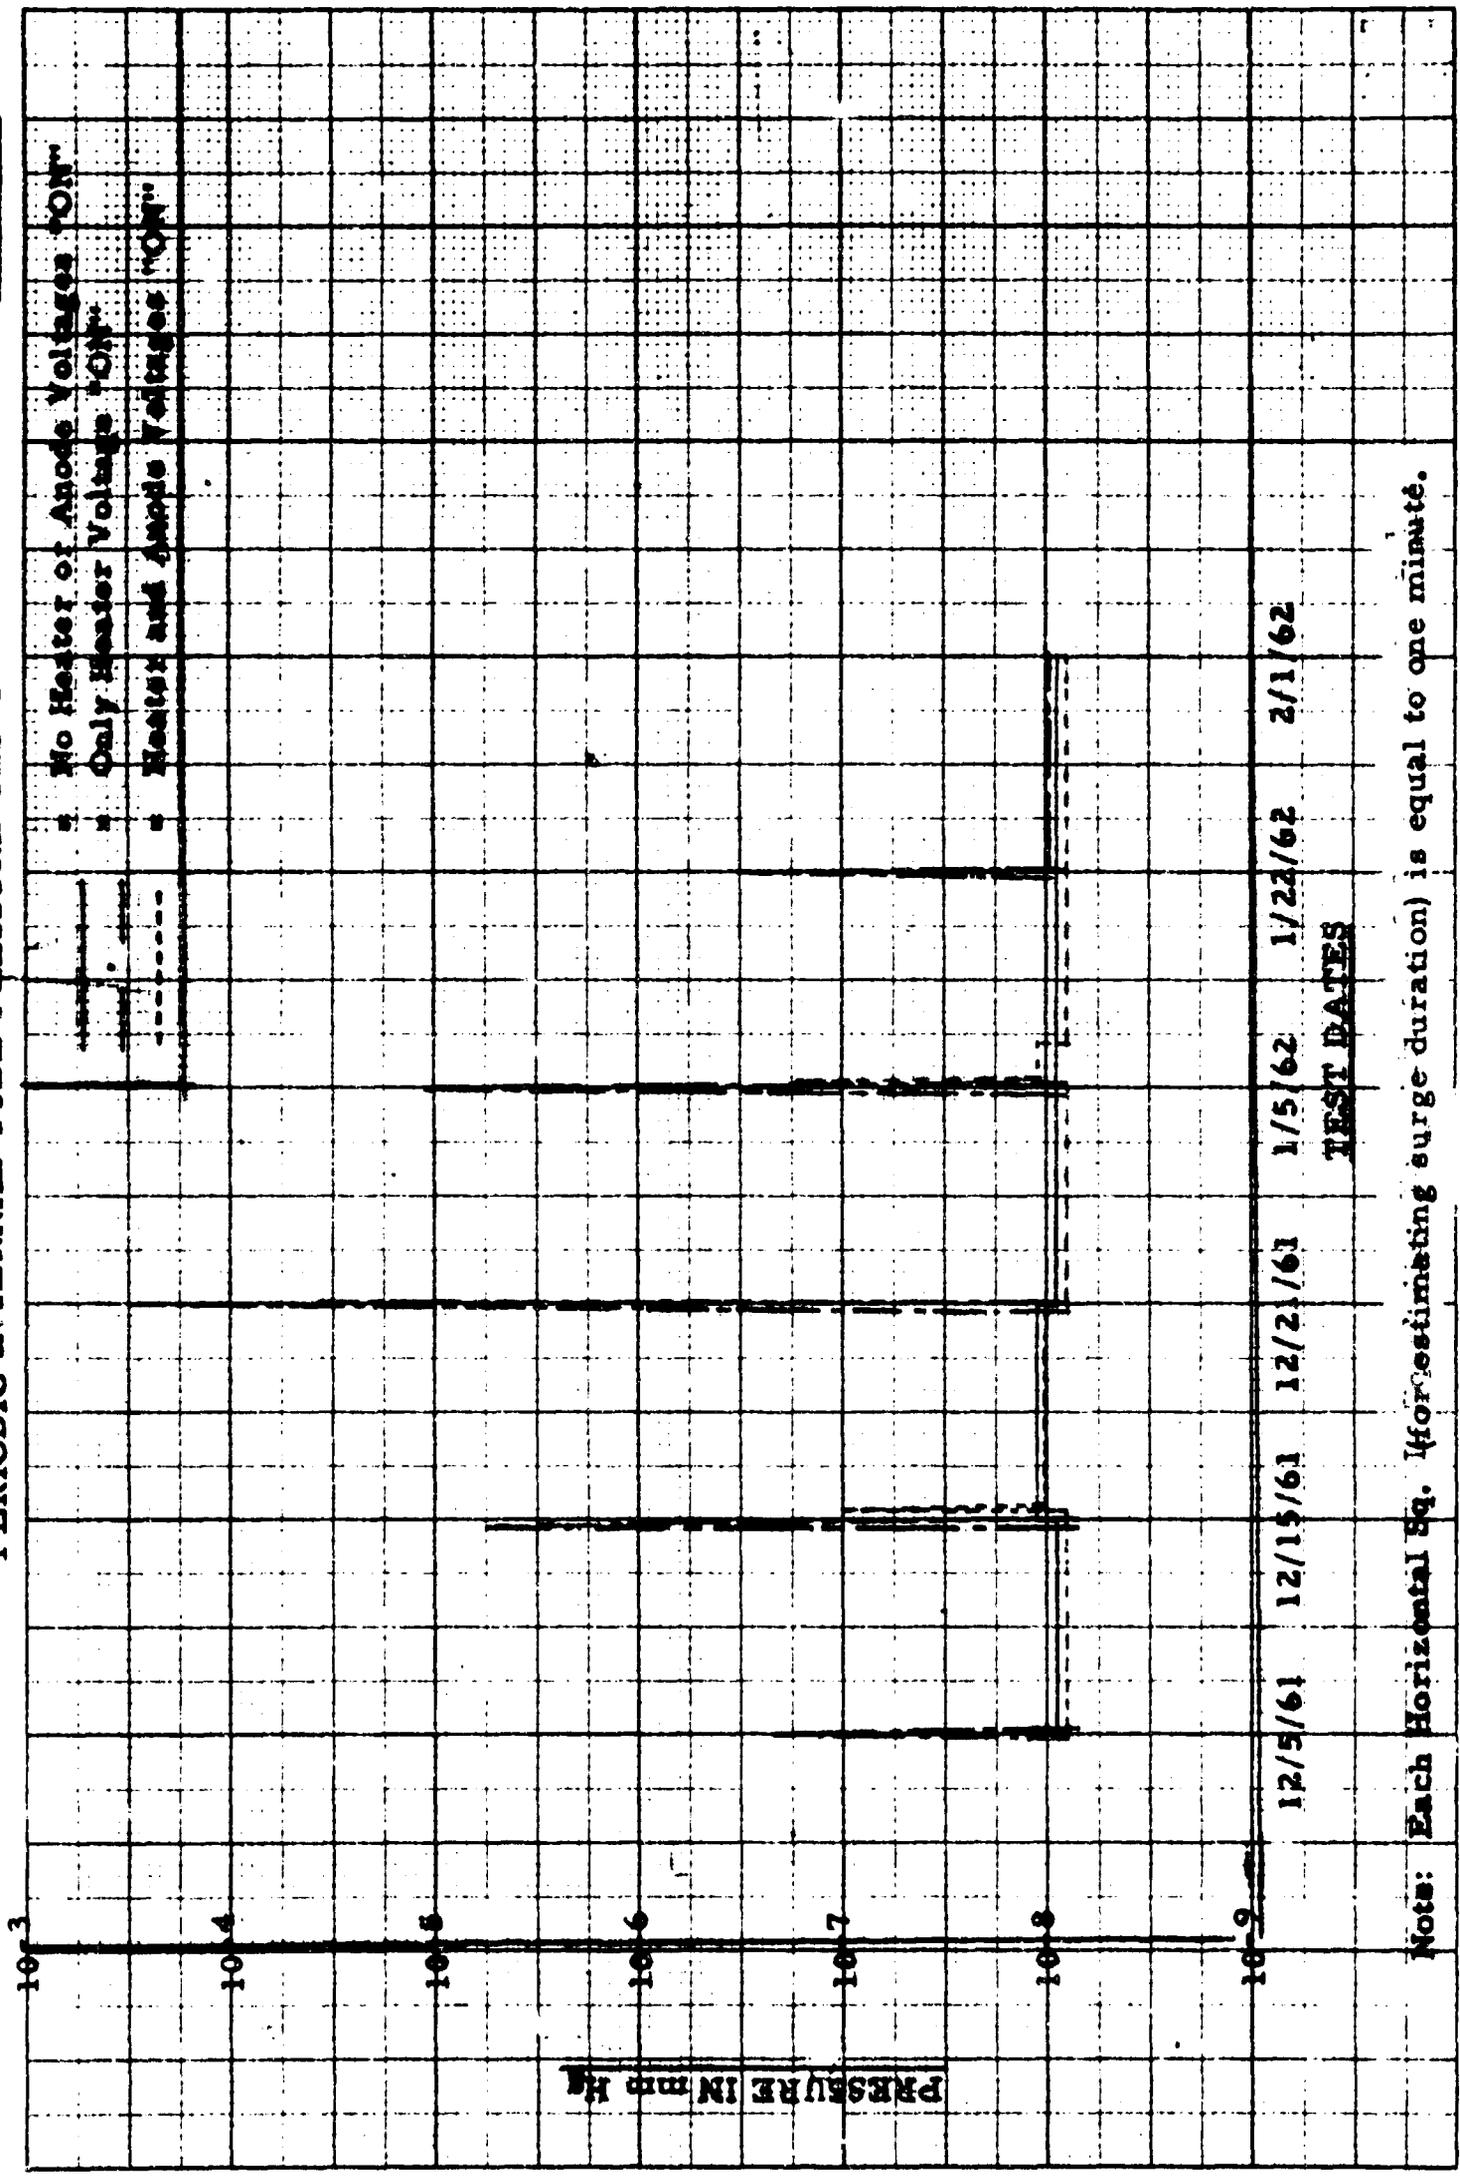
Figure 3

PERIODIC INTERNAL TUBE PRESSURE TESTS

Note: Each Horizontal Sq. (for estimating surge duration) is equal to one minute.

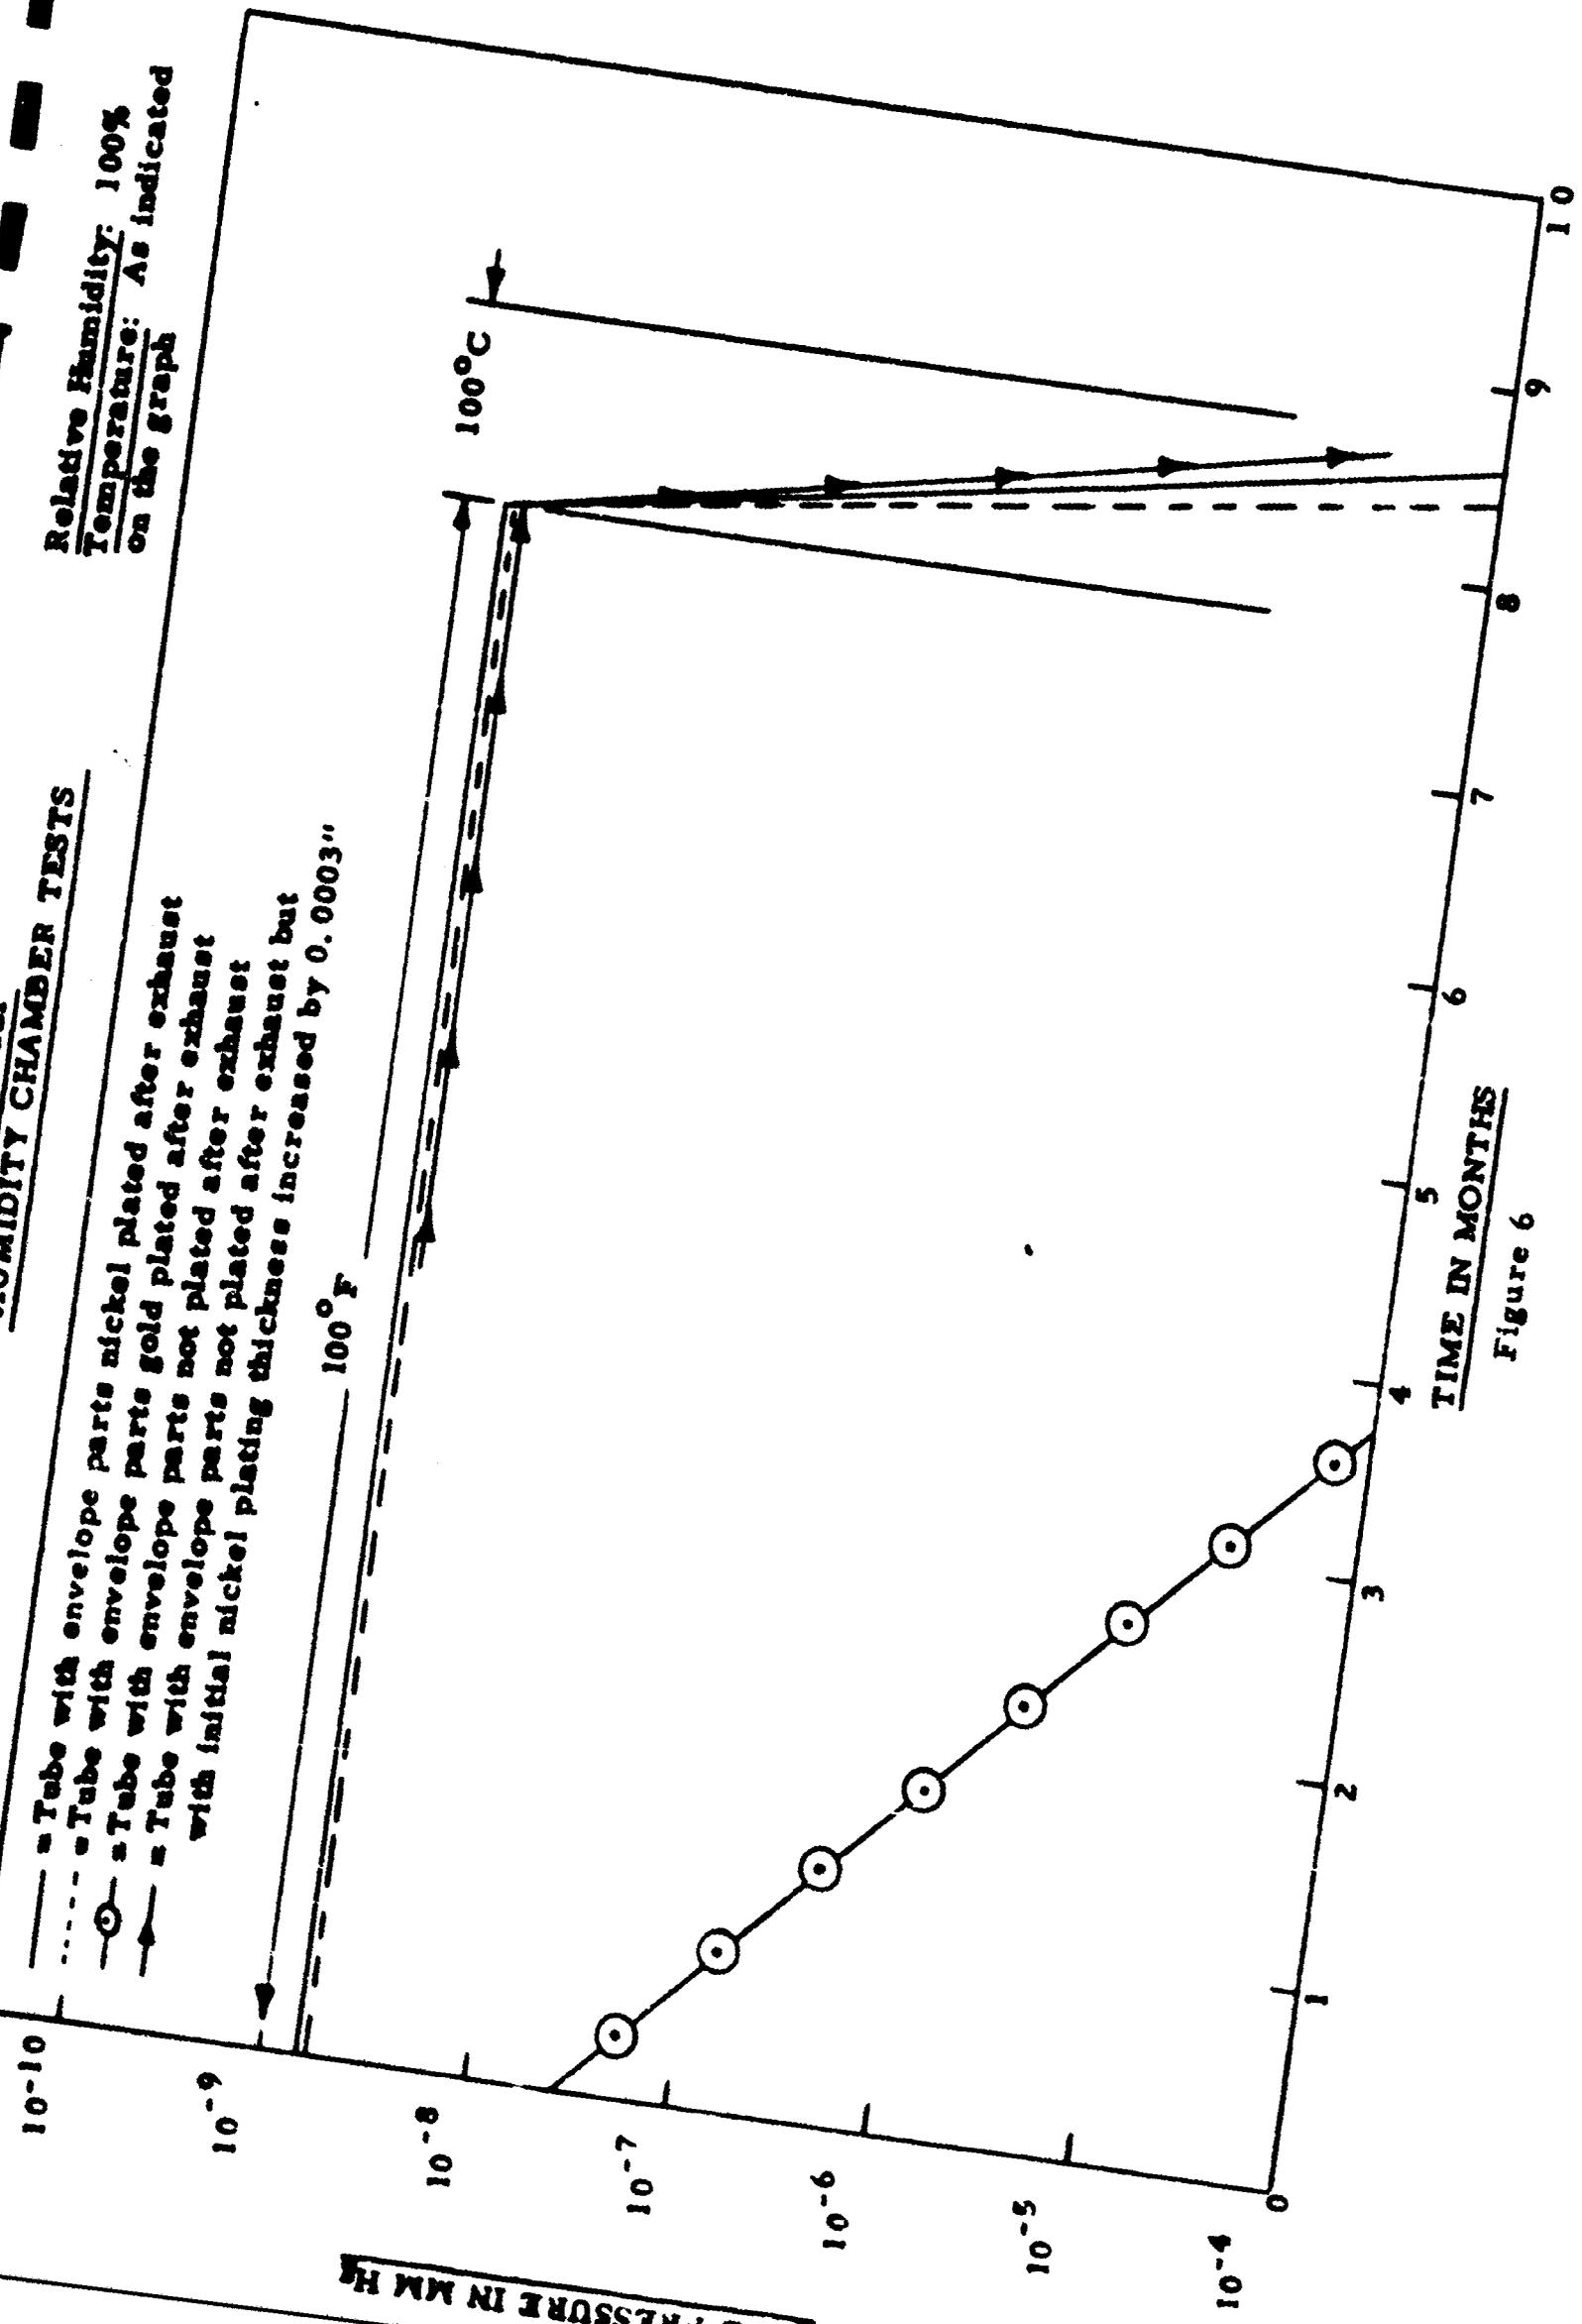
TIME IN MONTHS
Figure 6

The graph Figure 6, and the picture Figure 7, illustrate the effect of temperature and humidity exposure on tubes processed in four different ways.

BL-221
HUMIDITY CHAMBER TESTS

Relative Humidity: 100%
Temperature: As indicated
on the graph

The method originally used to prevent corrosion during storage was to nickel plate all exposed ferric materials prior to final assembly and before exhaust and bakeout. Pressure readings taken on a control tube stored at 100°F and 95% humidity along with the poor storage life experienced in the field indicate that this plating is insufficient.

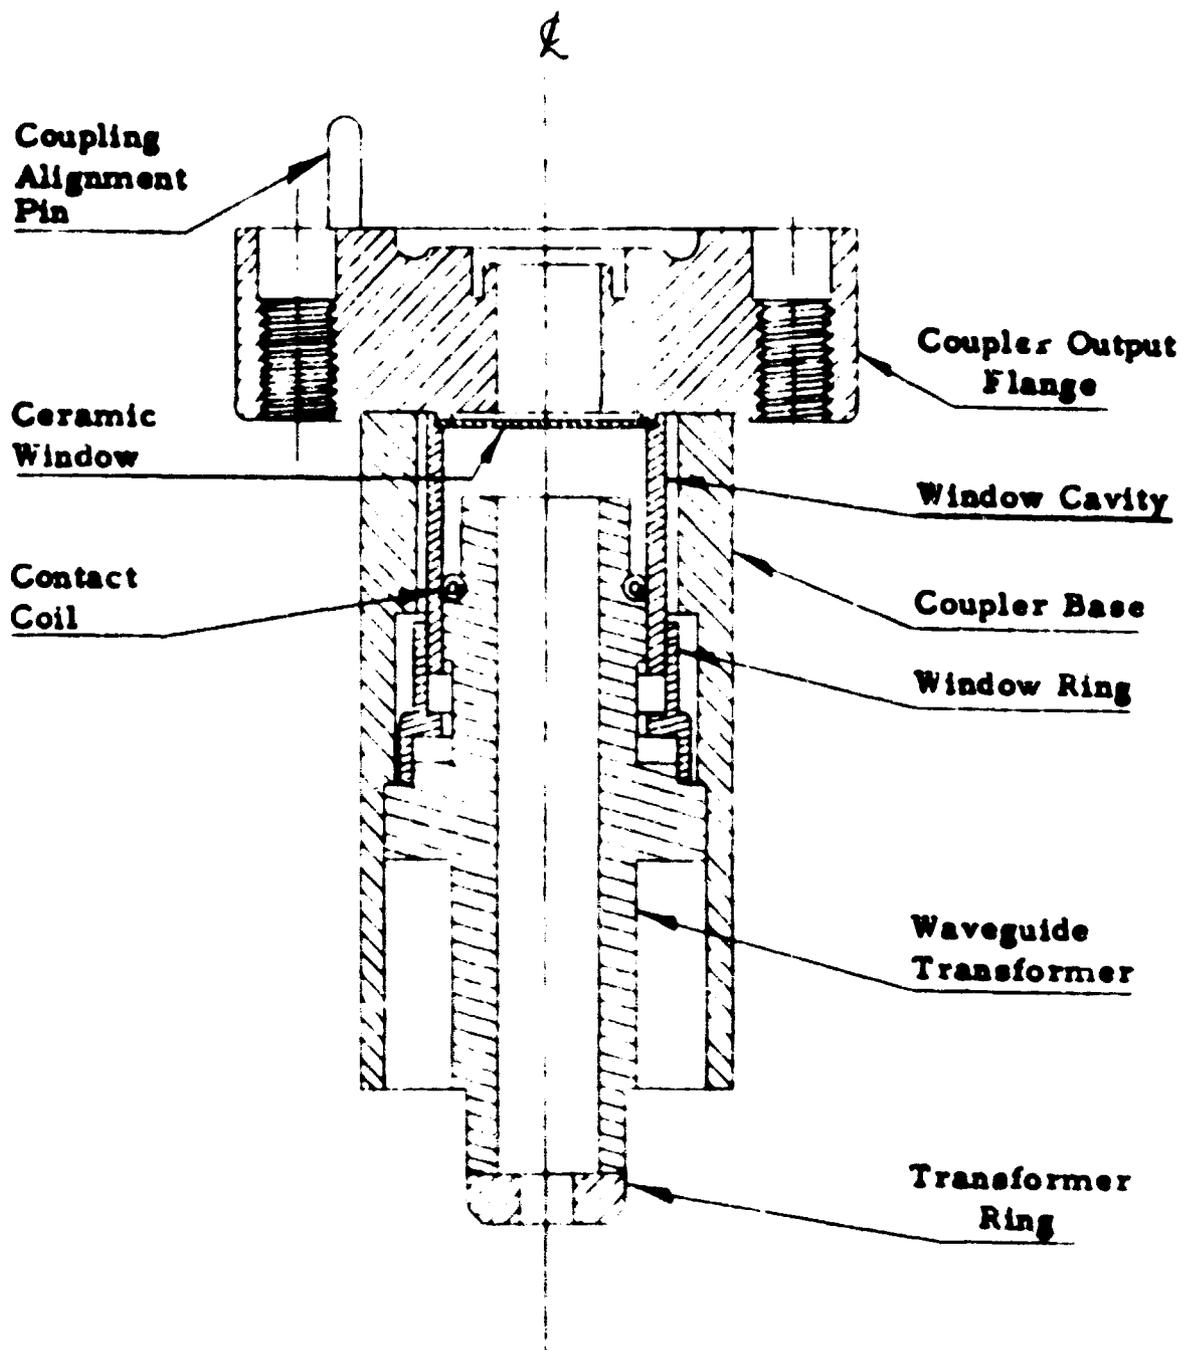
A high Q design shown in Figure 8 was tested and quickly discarded because of the inability to match anode frequency to the window pass band. A broadband design shown in Figure 9 was developed and found satisfactory.

TENTATIVE	SPECIFICATION SHEET	BONAC LABORATORIES INC. SALEM ROAD BEVERLY MASSACHUSETTS
	Ceramic Output Window Assembly	3-19-62

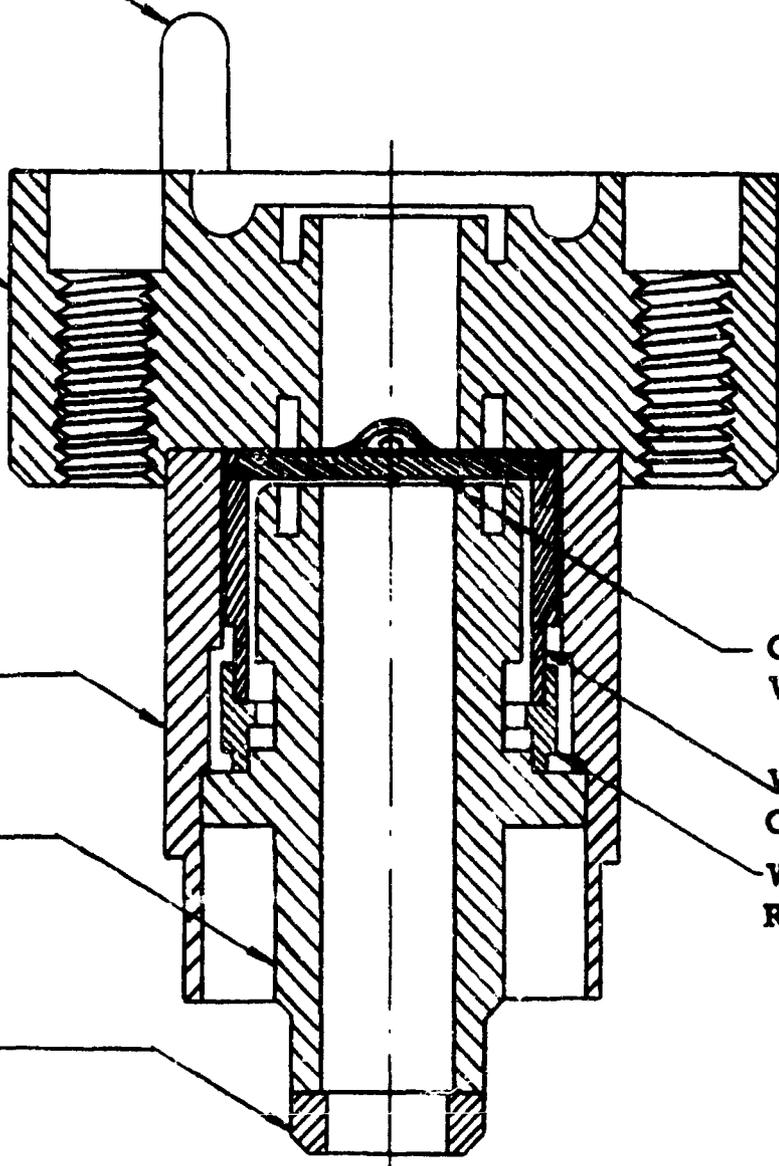
Figure 9
- 17 -

TENTATIVE Model No. 2	SPECIFICATION SHEET	BOMAC LABORATORIES INC. SALEM ROAD BEVERLY, MASSACHUSETTS
	Ceramic Output Window Assembly	4/17/62

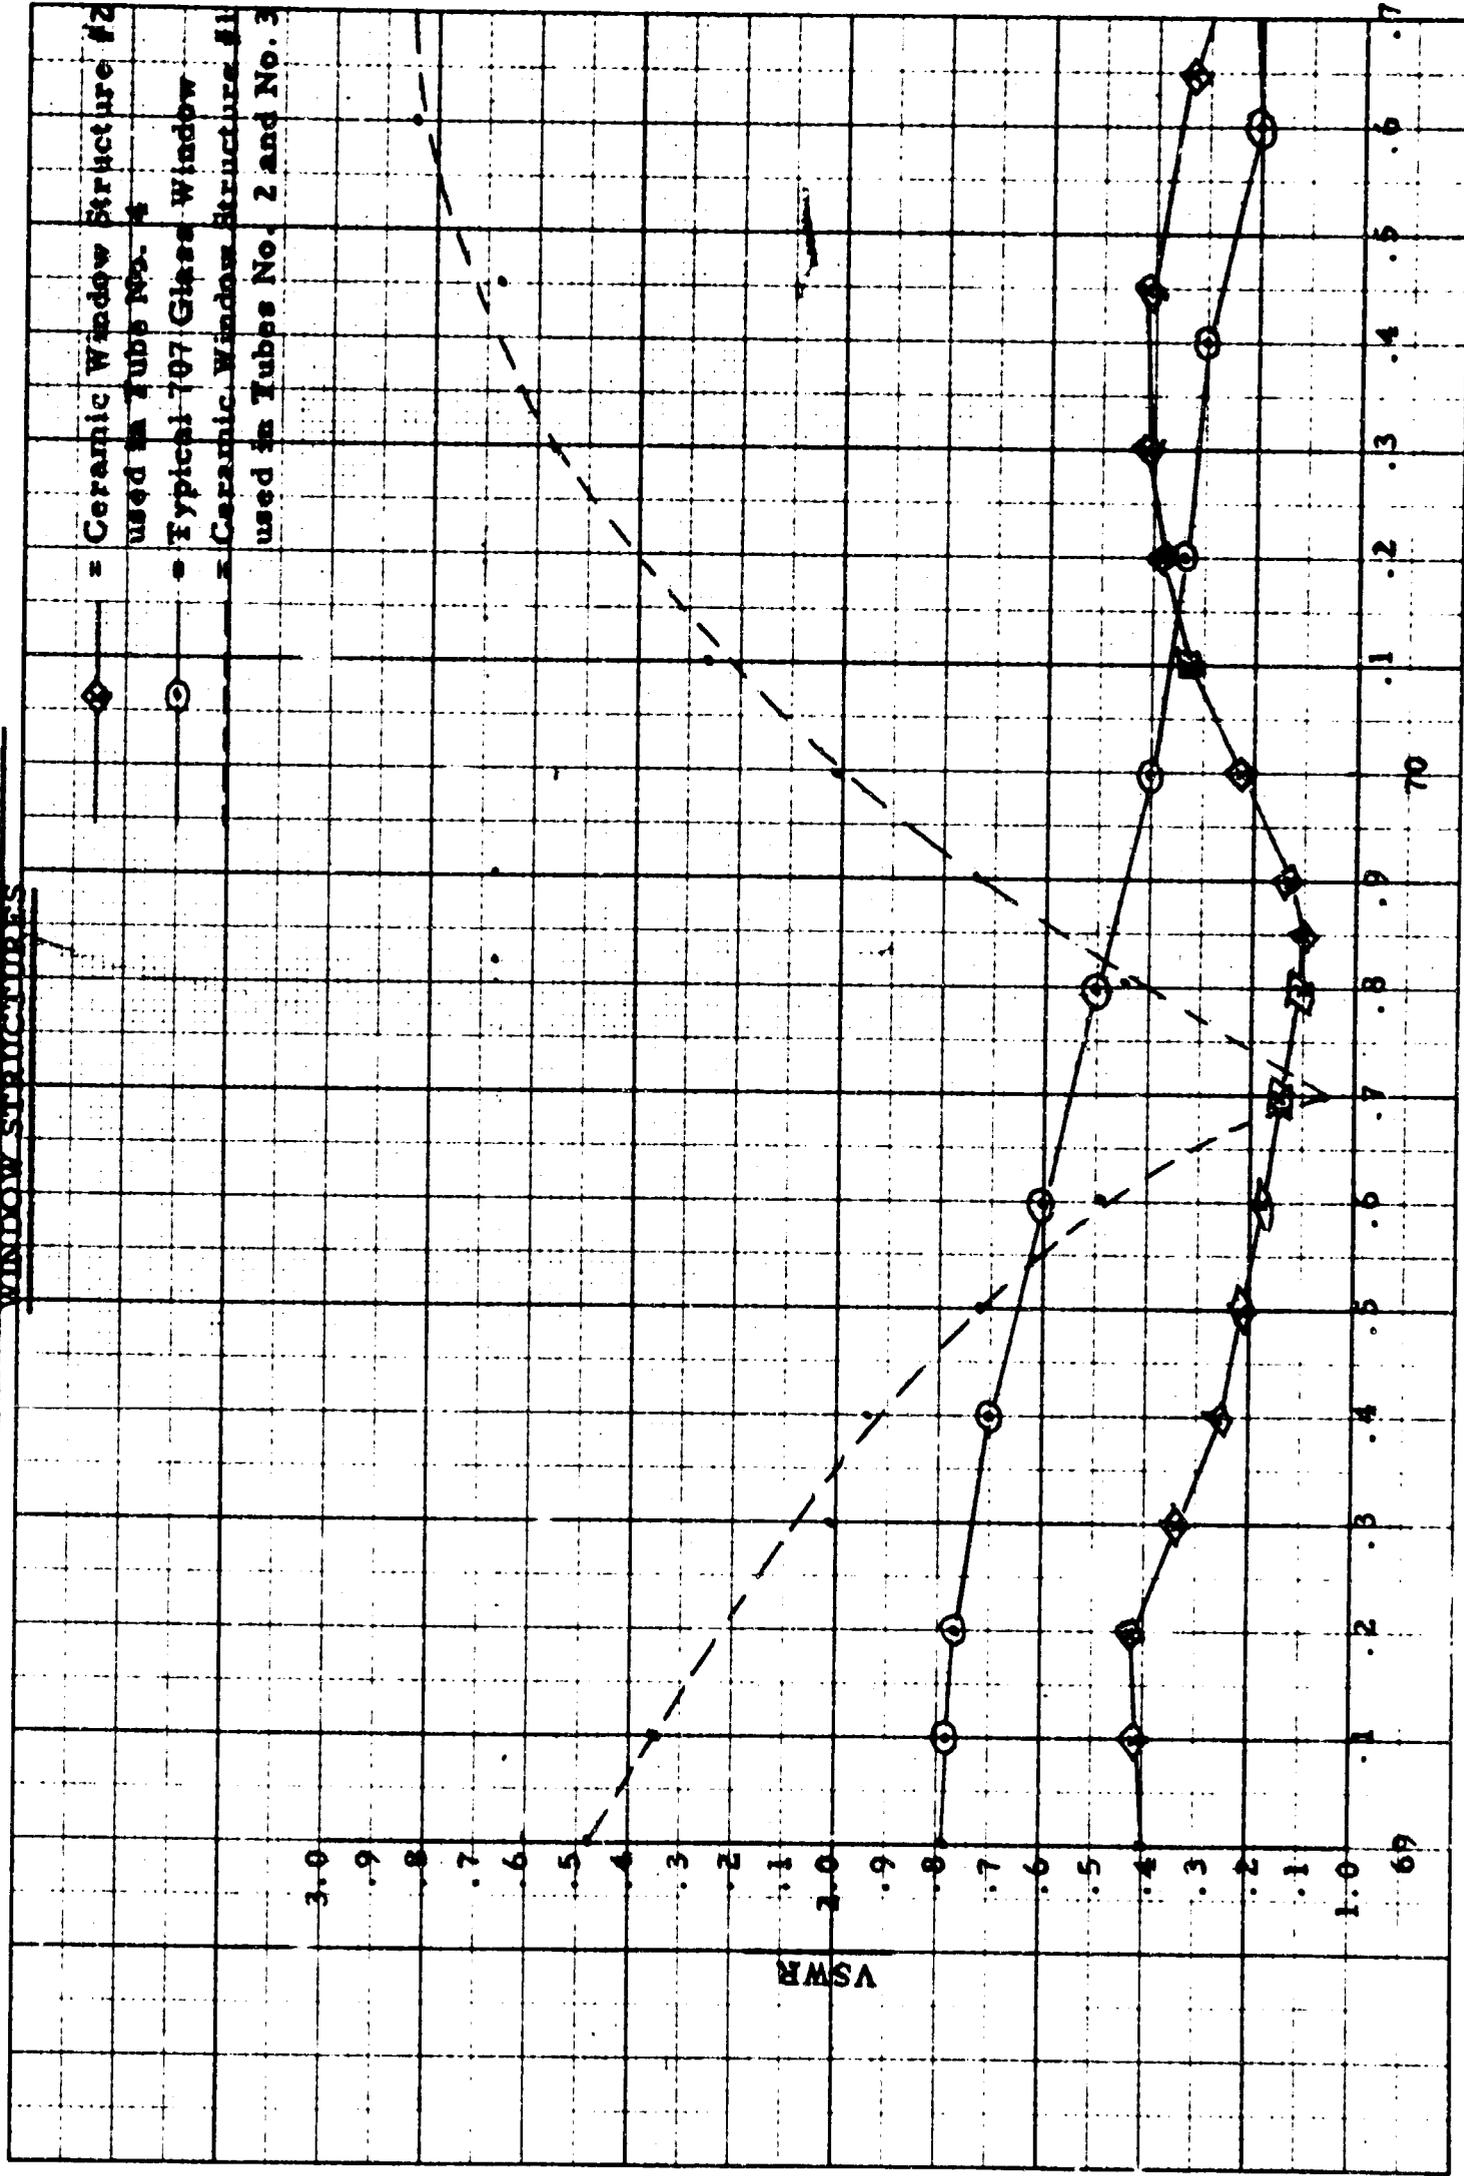
Frequency in Gc
Figure 10

It may be noted by reference to Figure 10 that a low value (1.1 or better) of VSWR was not achieved. The result of this is that output coupler position and exact waterfall configuration critically affect power output at test. An adjustment and/or selection process during first test must therefore be retained.

**FREQUENCY vs VOLTAGE STANDING
WAVE RATIOS FOR VARIOUS OUTPUT
WINDOW STRUCTURES**

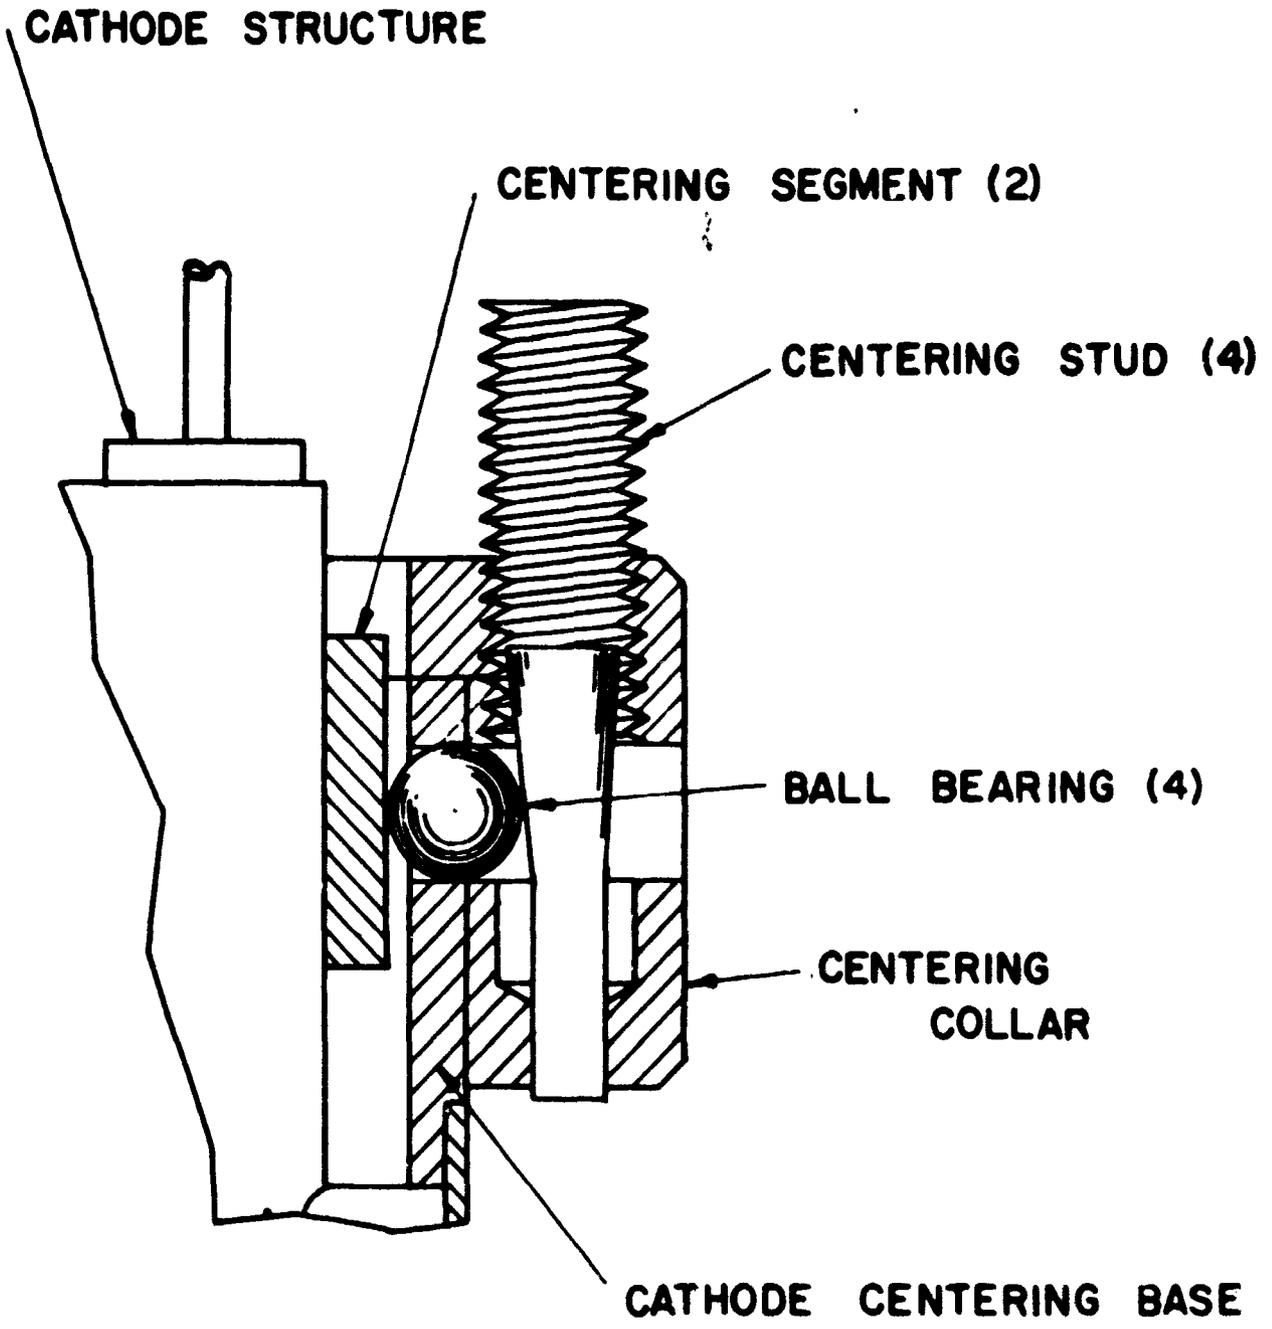
The BL-221 contains a cathode centering assembly permanently affixed to the magnetron. Radial centering changes of less than .002" will change a tube from complete acceptability to complete mode behavior. Because of this, the device must be smooth in its operation and stable in storage. The original design, shown in Figure 13, used 4 centering studs pushing on 4 ball bearings on point contacts and these in turn pushed on 2 centering segments. In use the centering studs became scribed and the adjustment became discontinuous. Further, 2 centering studs could not uniquely conform to the diameter of the cathode structure and hence a small amount of backlash existed between the centering segments and the cathode. The new structure, as can be seen in Figure 14, corrects both of these defects.

SPECIFICATION SHEET	BORAC LABORATORIES INC. SALEM ROAD BEVERLY, MASSACHUSETTS
	(OLD)	
	CATHODE CENTERING ASSEMBLY	10/18/62

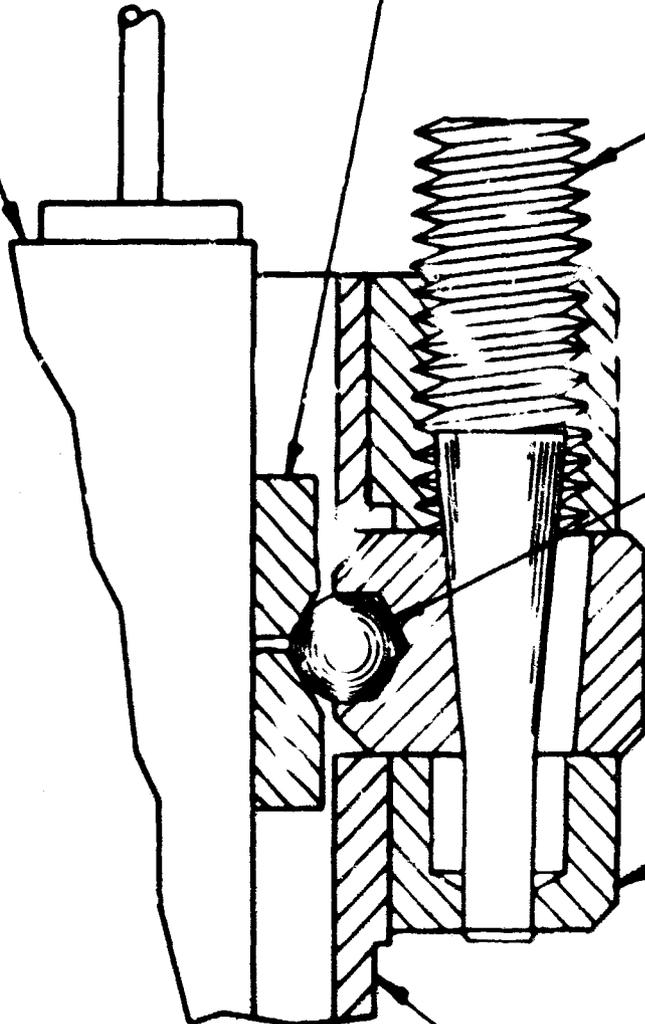
FIGURE 14

The centering segments, ball bearings, and centering pins are all hard materials and have exhibited essentially zero plastic flow during the tube life. Thus the position achieved during testing should be stable for an adequate amount of time.

SPECIFICATION SHEET	BONAC LABORATORIES INC.
	(NEW)	SALEM ROAD
	CATHODE CENTERING ASSEMBLY	BEVERLY, MASSACHUSETTS
		10/18/62

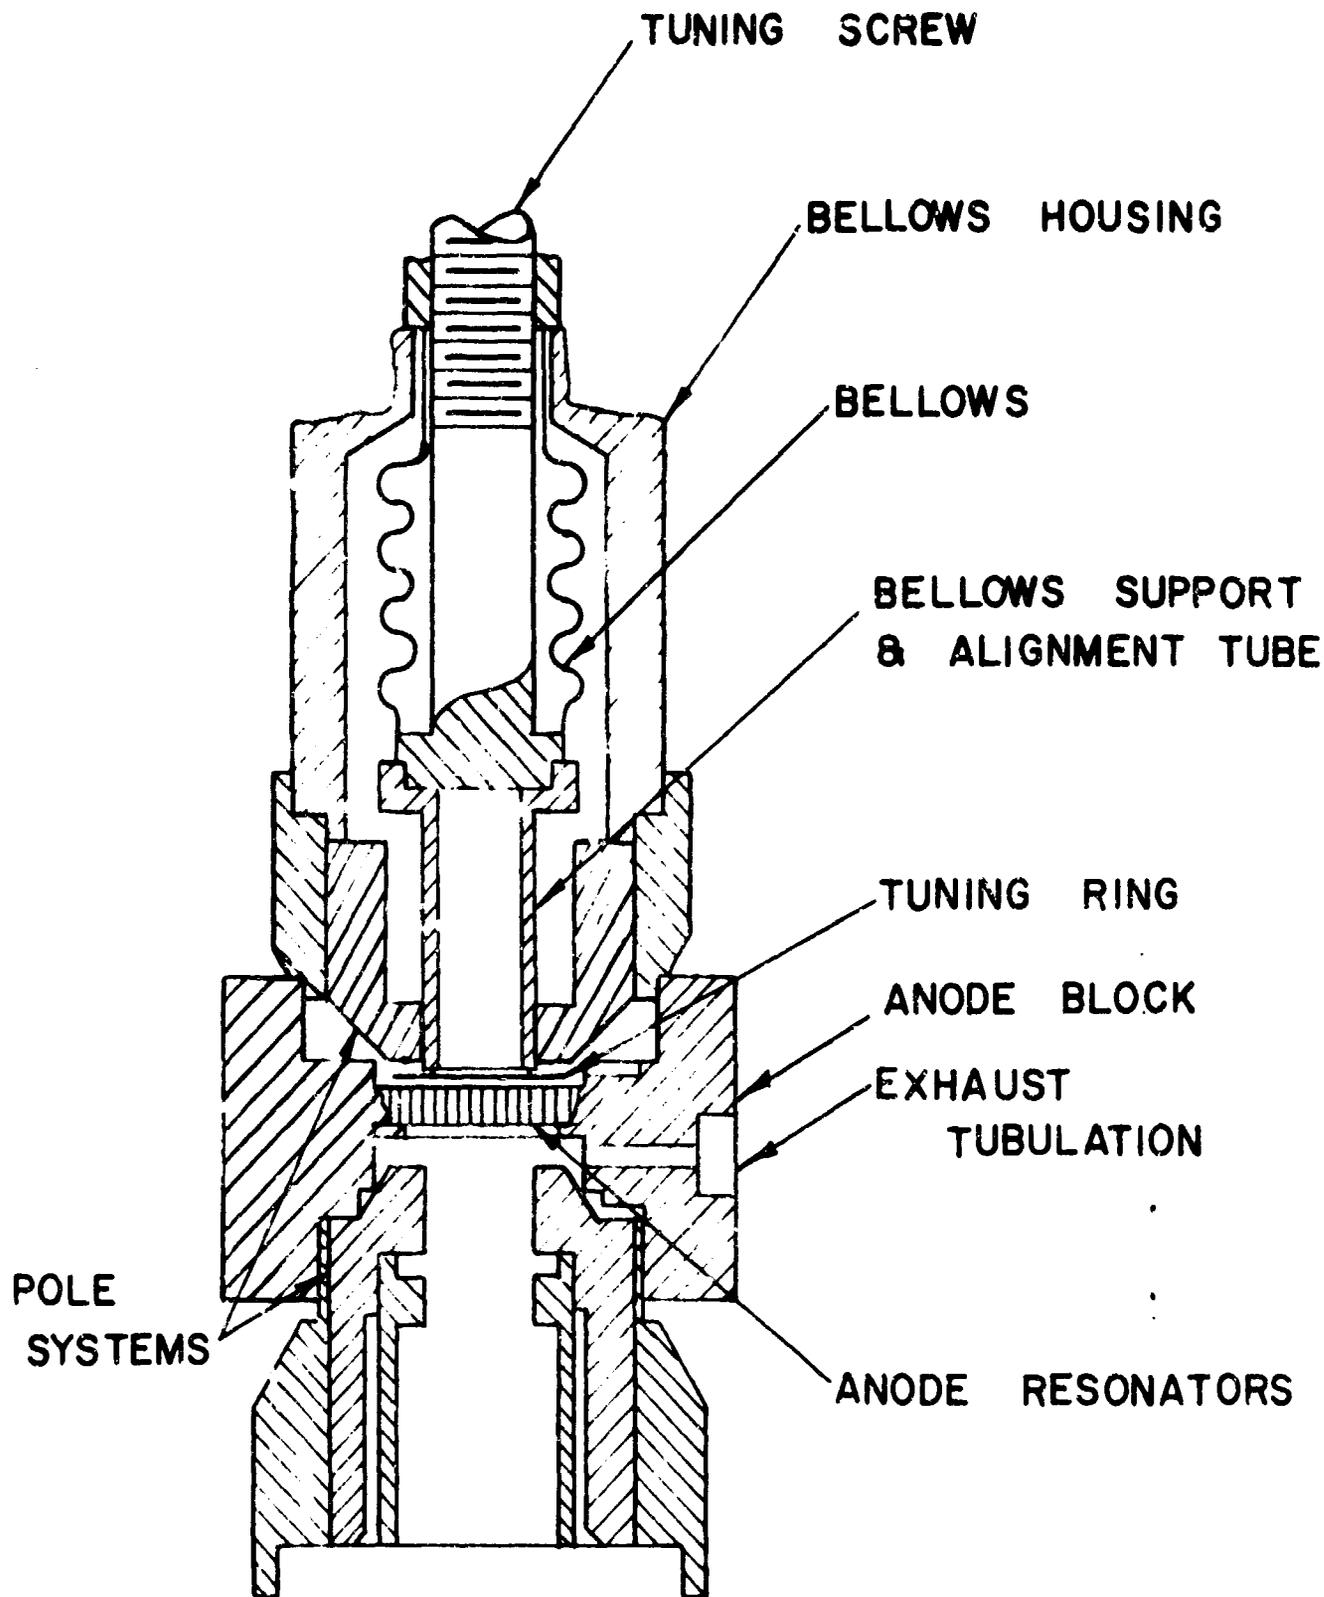
FIGURE 15

SPECIFICATION SHEET	BOMAC LABORATORIES INC. SALEM ROAD
	TUNER MODEL NO. 2	BEVERLY, MASSACHUSETTS
