BL-221 70 Gc MAGNETRON
PRODUCTION ENGINEERING
MEASURES PROGRAM
FINAL REPORT
Section 1 and 3 - Volume 1
6 August 1961 through 6 May 1964

CONTRACT NO: DA-36-039-SC-85974

OBJECT: To investigate minor constructional modifications in the present design, evaluate a pre-production run of thirty (30) tubes and determine manufacturing facilities capable of producing fifty (50) tubes per month.

PREPARED BY: Robert C. Sibley
Manager, Power Tube Product Development

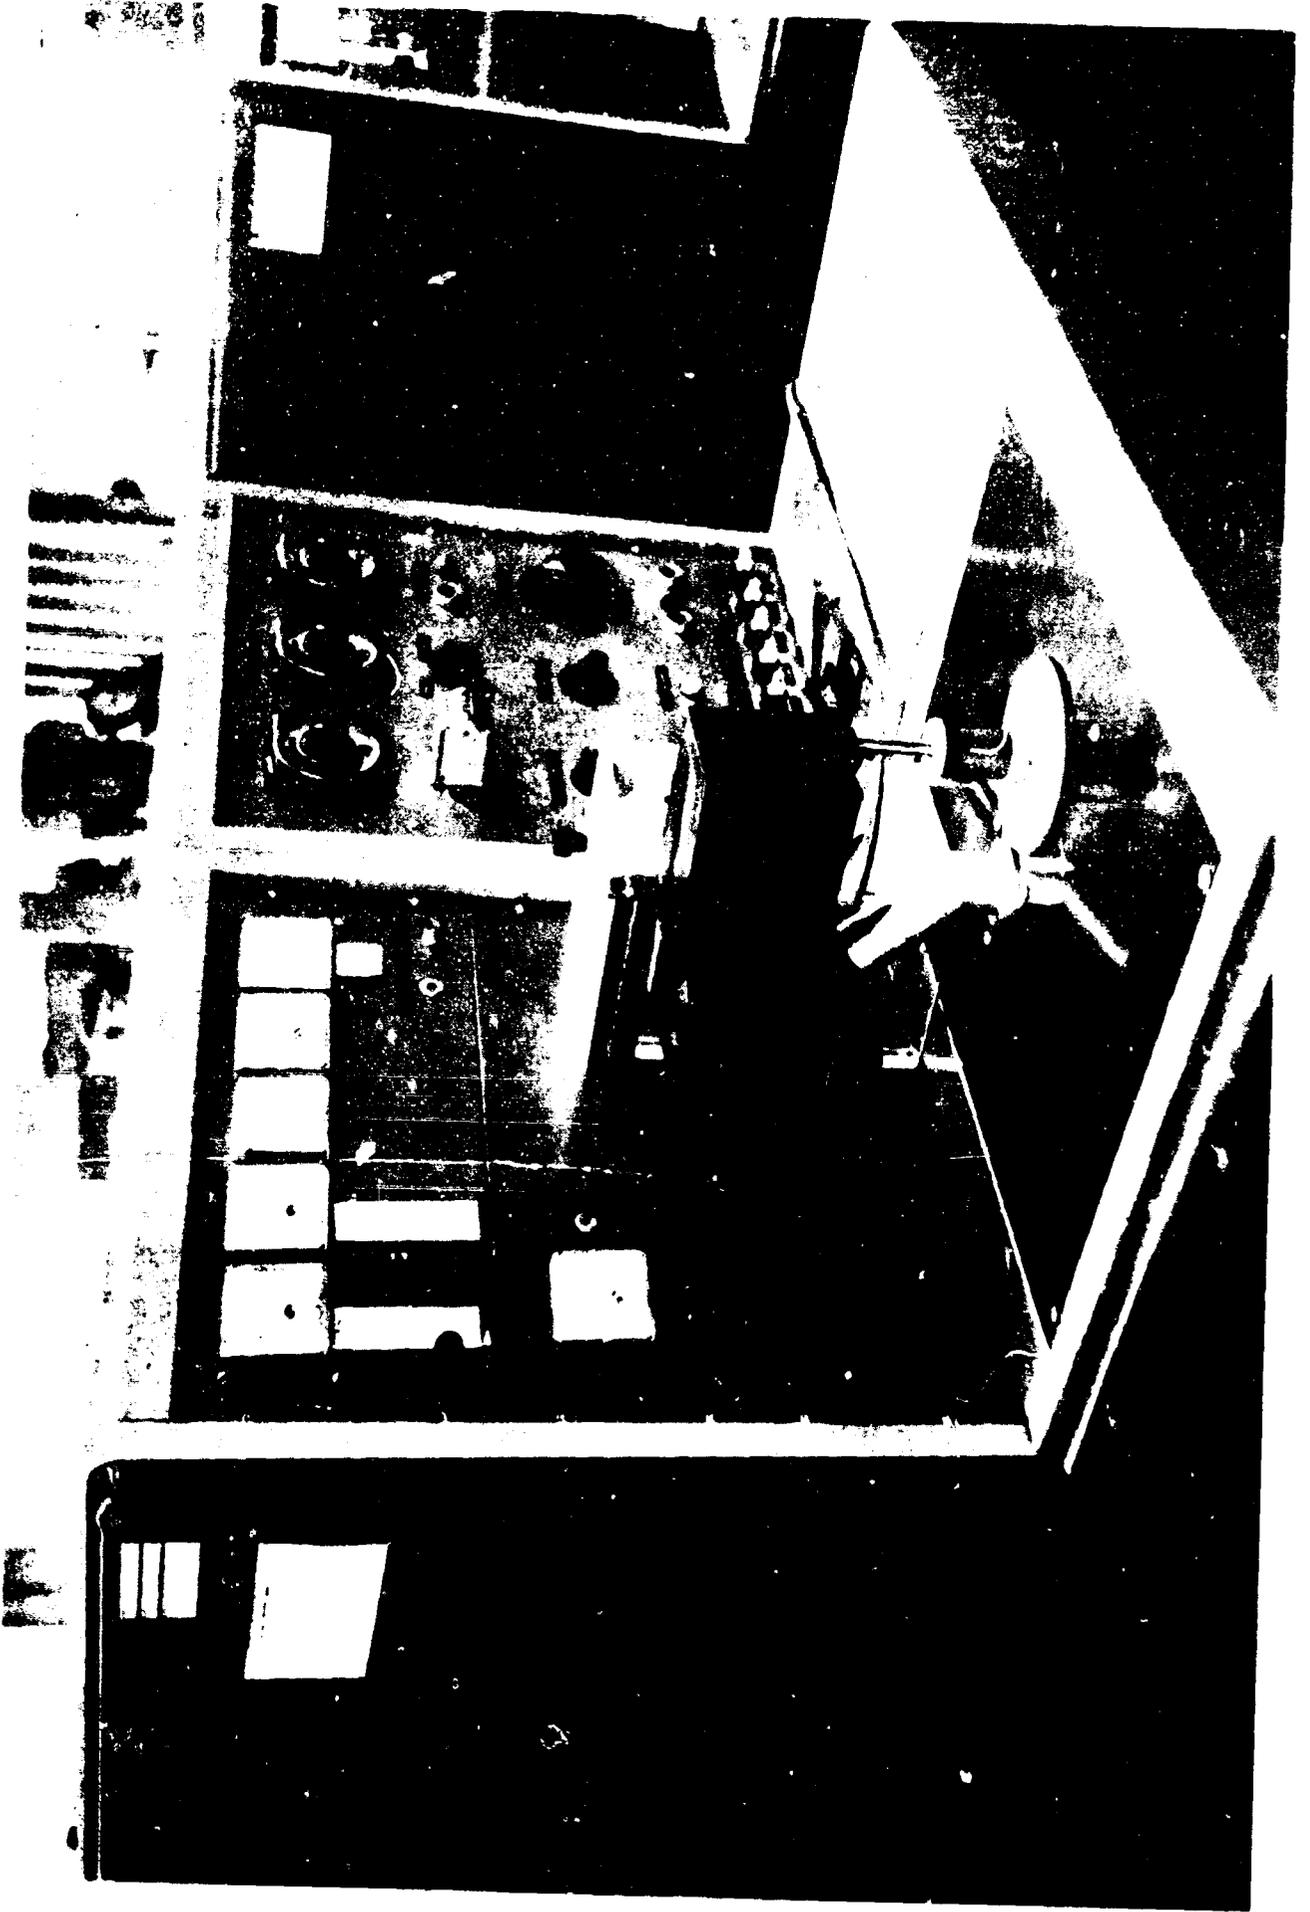
FIGURE 19

This modulator was also built by Bomac. It however, was built under the existing PEM Contract DA-36-039-SC-85974. It was used during Life Testing of Tube No. 73 and is shown in Figure 19. This modulator supplies the following pulse conditions:

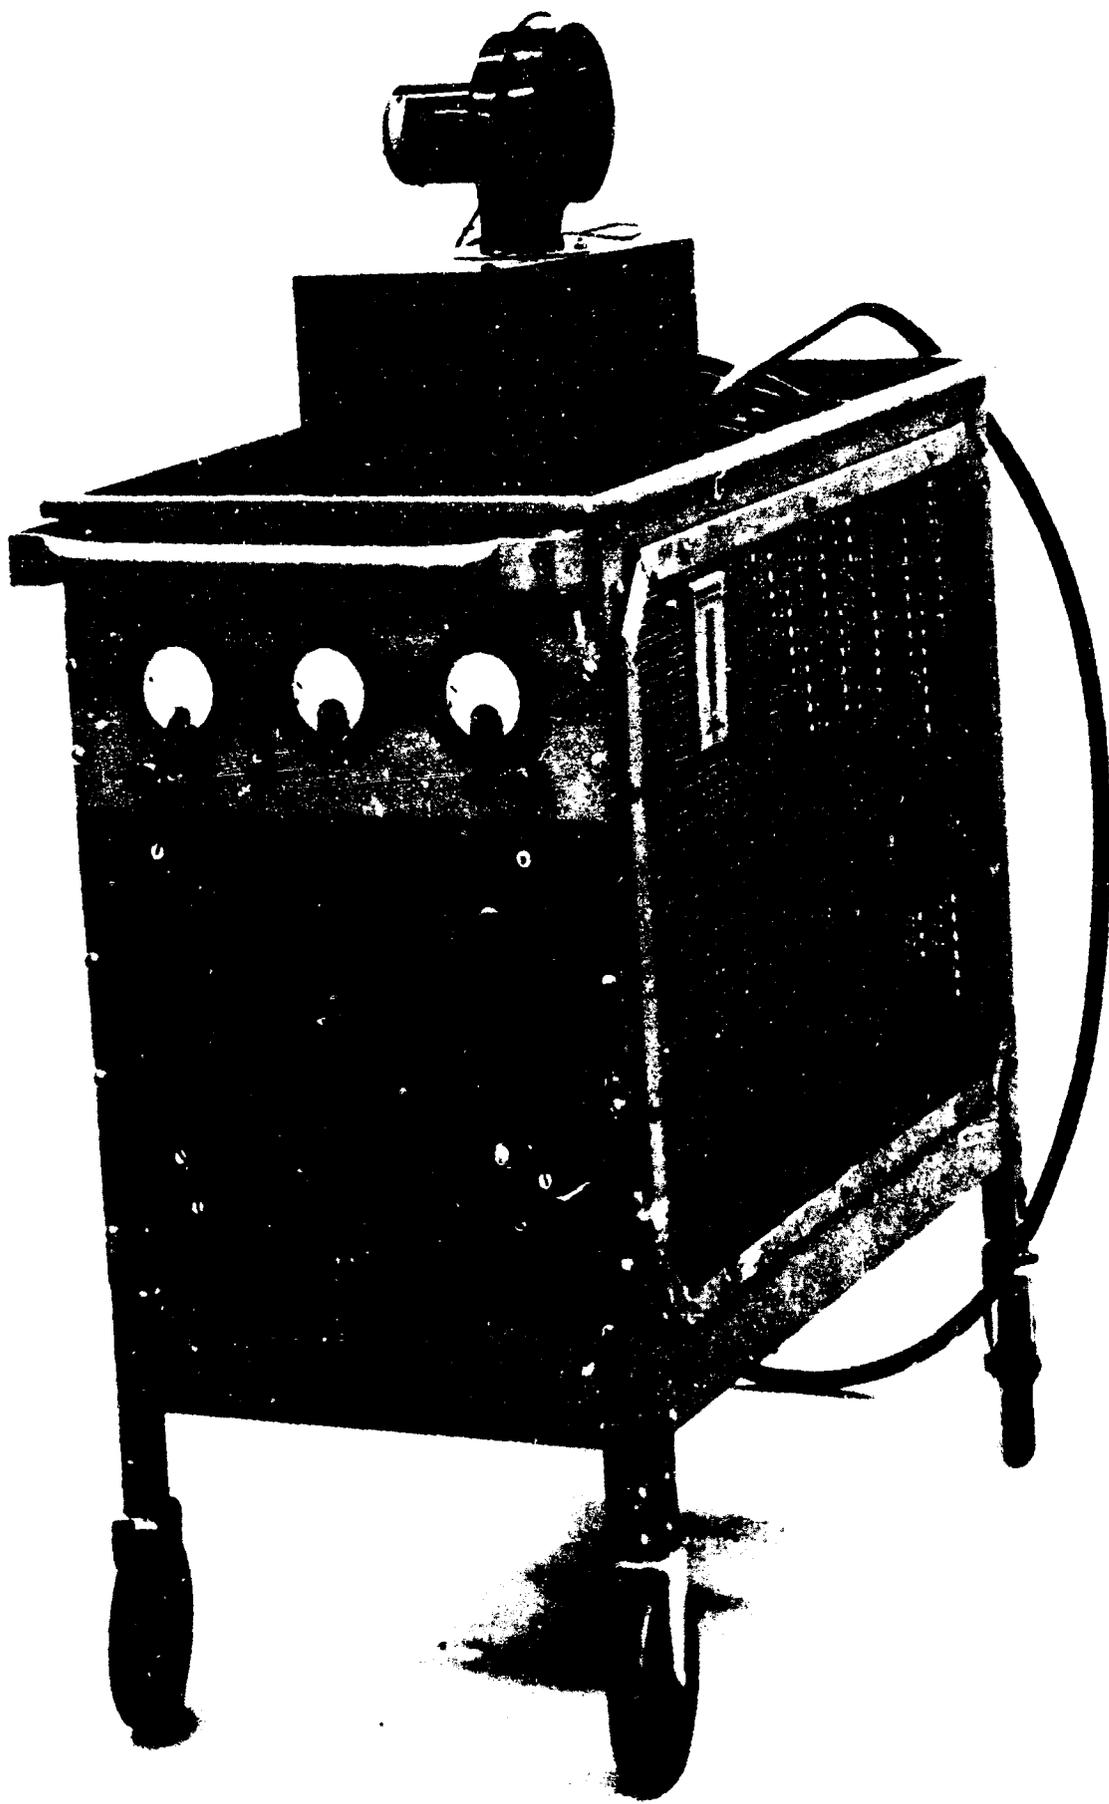
FIGURE 20

This modulator is of Bomac construction, having been built under Contract DA-36-039-SC-73285. It was used for tests during shock and vibration and is shown in Figure 20. It supplies the following pulse conditions:

- 5.2.2 Mount the tube on the jig in such a position that vibration will be along the X_1 axis.
- 5.2.3 Connect the portable modulator, shown in Figure 20 to the tube and preheat for 90 seconds.
- 5.2.4 Apply pulse voltage and operate tube under Oscillation 2 conditions as outlined under Test Procedure Paragraph 12.0 with a waveguide horn as a load.
- 5.2.5 Detect the R. F. energy with the spectrum analyzer with another waveguide horn as a pick up device.
- 5.2.6 Monitor the spectrum, and measure and record the bandwidth during vibration with the assistance of the marker pip of the analyzer.
- 5.2.7 Repeat 5.2.2 through 5.2.6 with vibration applied along the Y axis.
- 5.2.8 Repeat 5.2.2 through 5.2.6 with vibration applied along the X_2 axis.
- 5.2.9 Make pre-shelf tests as outlined in Paragraphs 11.0, 12.0 and 13.0 which follow.

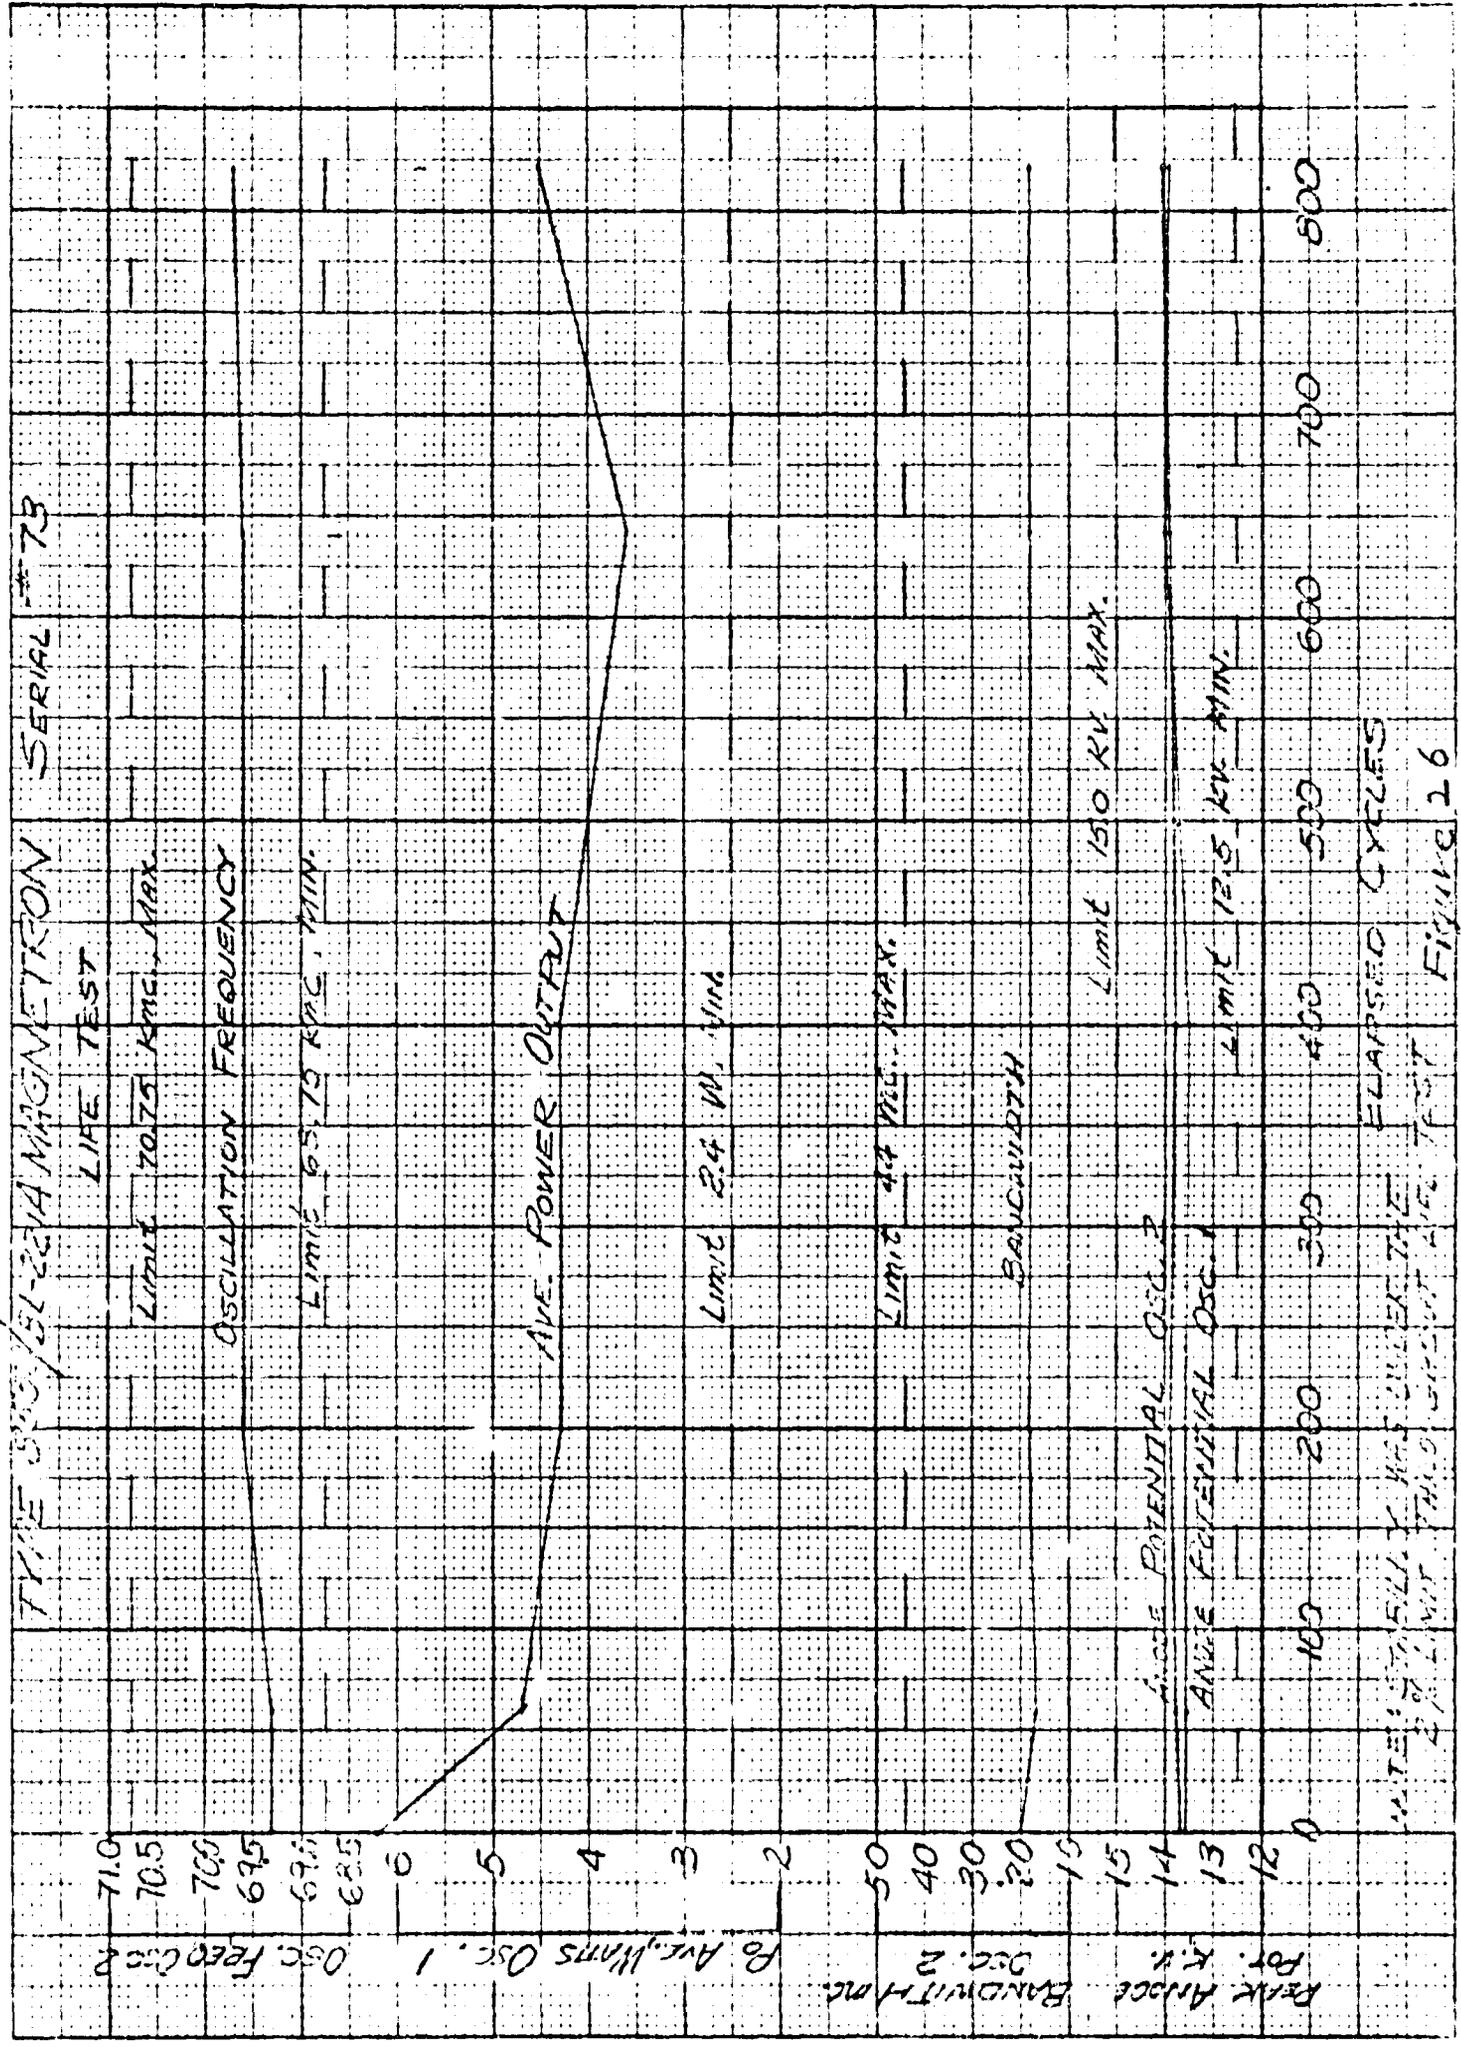
14.4.1 The measurements on the selected tube, #73 under Cycled Life Tests End Point conditions at the end of 640 cycles, shown in the Data Section indicate satisfactory compliance with the requirements of the TSS. The results are shown graphically in Figure 26.

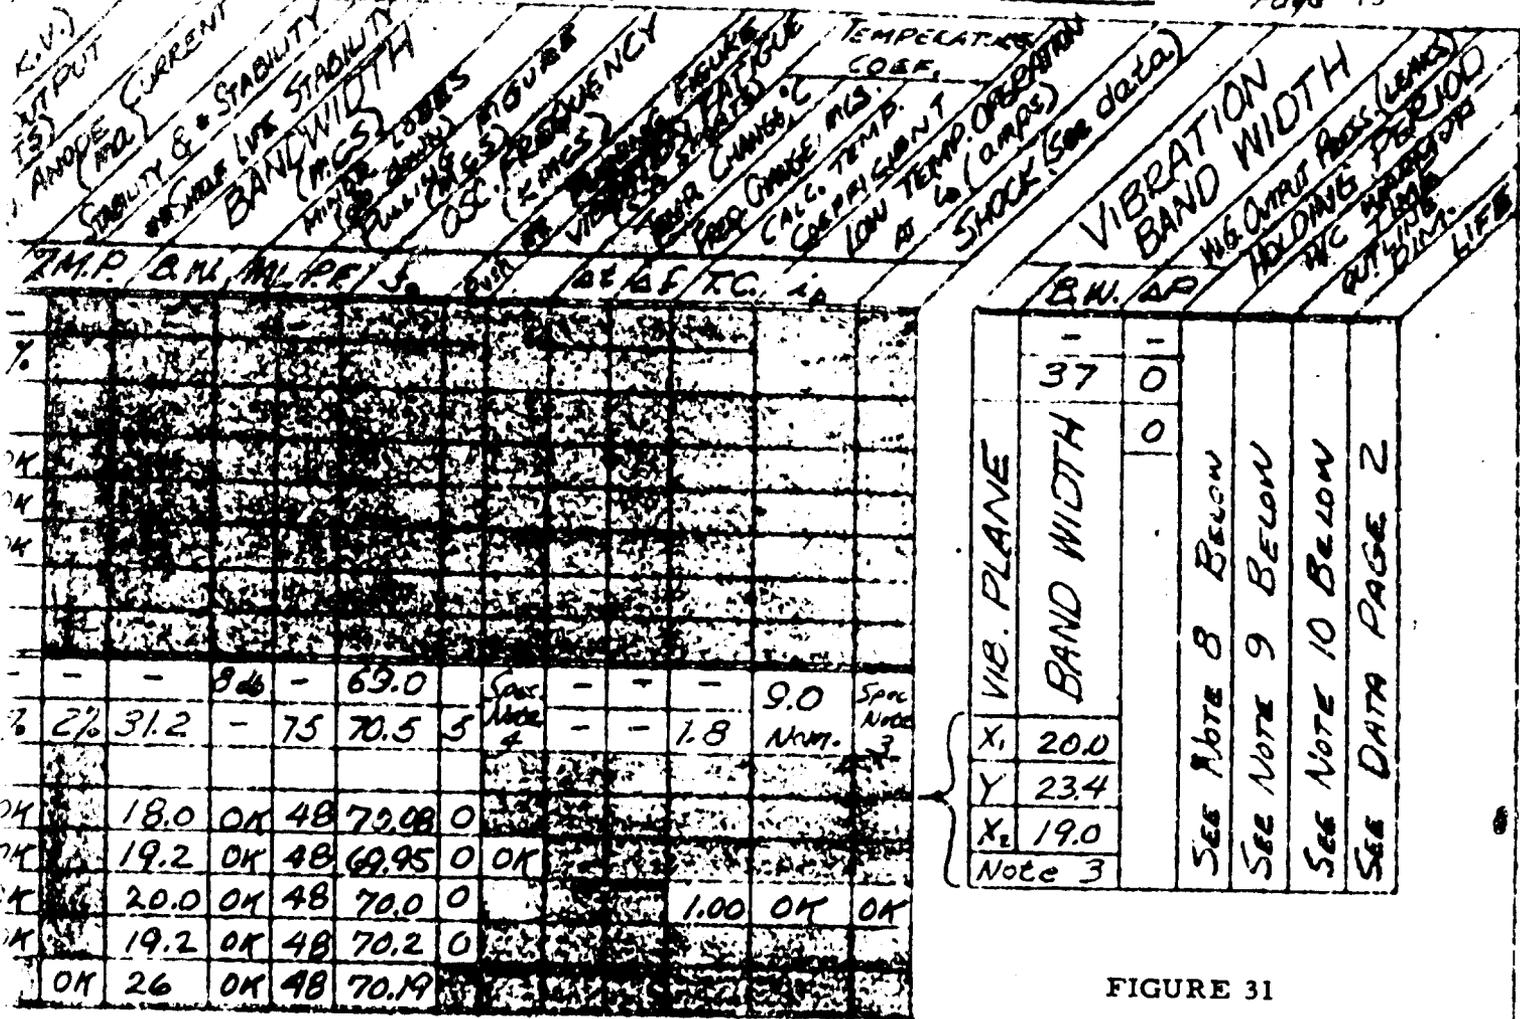
FIGURE 31

- Plane X1 is perpendicular to cathode axis and parallel to output. Plane X2 is perpendicular to cathode axis and perpendicular to output. Plane Y is parallel to cathode axis and perpendicular to output.

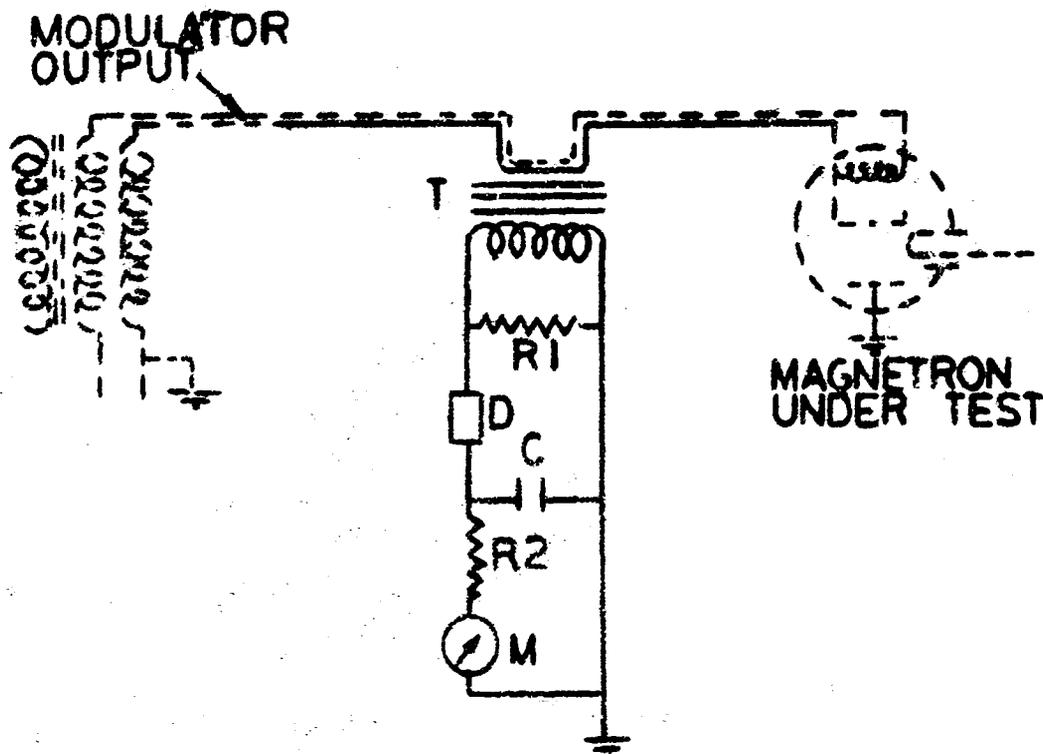
Peak Current Indicating Circuit

- T = Special pulse current transformer
- a. Primary = 1 turn, bifilar for this application
 - b. Secondary = 5 turns #14 magnet wire
 - c. Core = Special Ferrite, Ferroxcube #203F250-3C or equivalent
- R₁ = Non-inductive resistor network,
10-240 ohm composition resistors in parallel resulting in 24 ohms total. Resistors = MS35043-71-RC20GF241J
- D = Ultra-High Conductance Diode, IN3730
- C = Low inductance capacitor, .25 μ fd Sprague Hypass #48P12 or equivalent
- R₂ = Resistor, 1 megohm, 1 watt, MS35044-173-RC32GF105J. Note 1
- M = Indicating meter, 0-50 μ a, MR-36W-050-DC-UAR
- Note 1: Use of a 10 megohm resistor and a 0-5 μ a meter will provide reduced inherent error

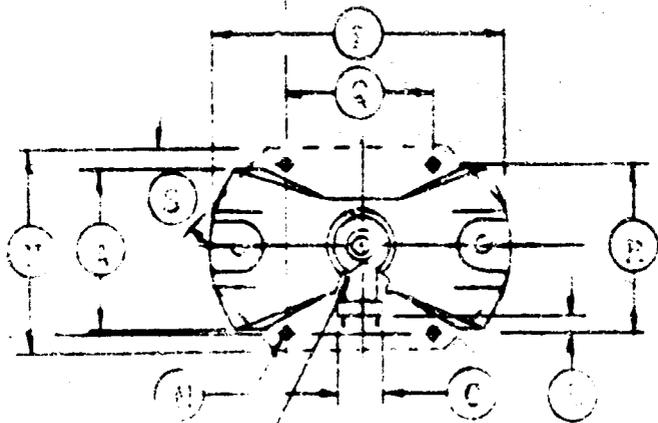
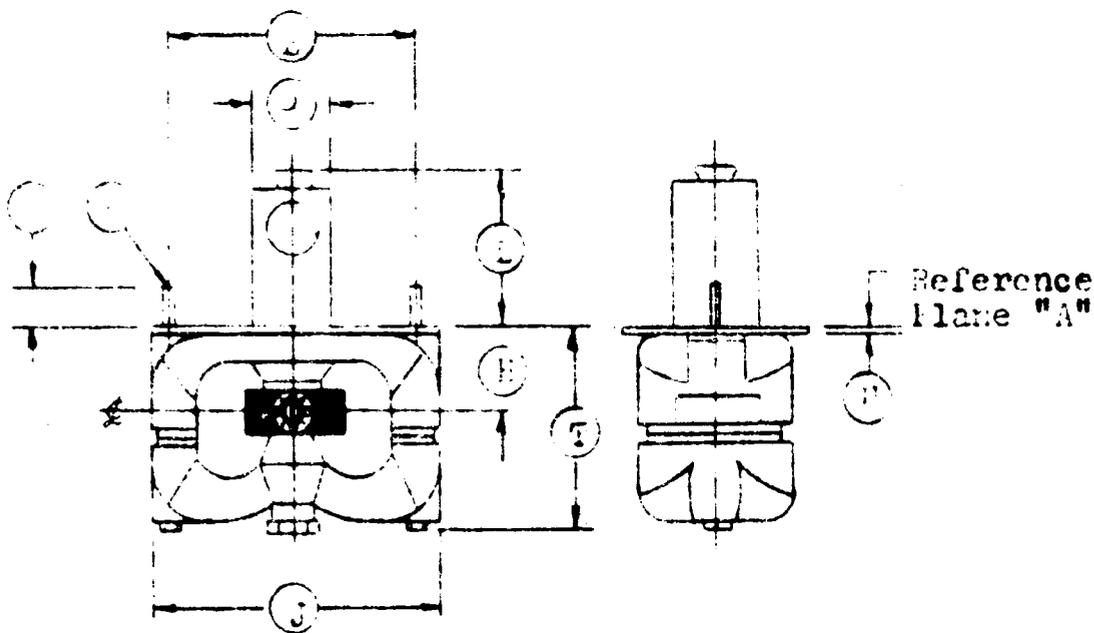
Figure 1

Ref.	Dimension in Inches
A**	3.037 Max
B	0.454 ±.030
C**	0.750 ±.005 Dia
D**	1.750 ±.010 Dia
E	4.603 ±.030
G**	0.007 Min
H	1.634 ±.030
J**	5.732 Max
K	5/16-18NC
L**	2.375 Max
M	0.266 Dia Drill 4 Holes
N**	4.000 ±.020
P**	5.500 ±.020
Q	3.000 ±.010
R	3.000 ±.010
S**	4:0
T**	4.032 Max
U**	0.250 ±.010

"T" Anode Temperature test point (on anode body adjacent to output flange).

Note:- Axis of waveguide flange must lie parallel within ±.010 to Planes A and B.

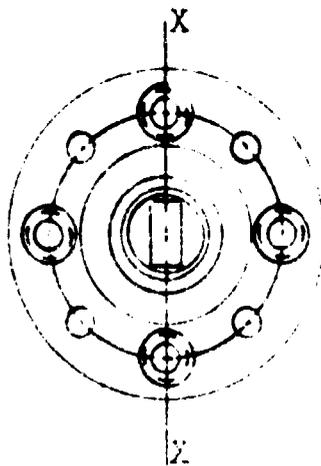
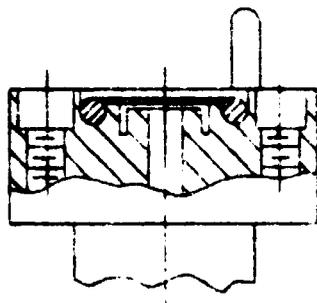
Outline include: Terminal Connection, Output Flange #1, and Mating Waveguide Flange #1

Note 1:- Centerline X-Z must lie parallel to plane within $\pm 1/2^\circ$. Refer to page 1 of Outline.

Note 2:- This flange must mate with modified mating bayonet flange #1, Type 11-11/15.

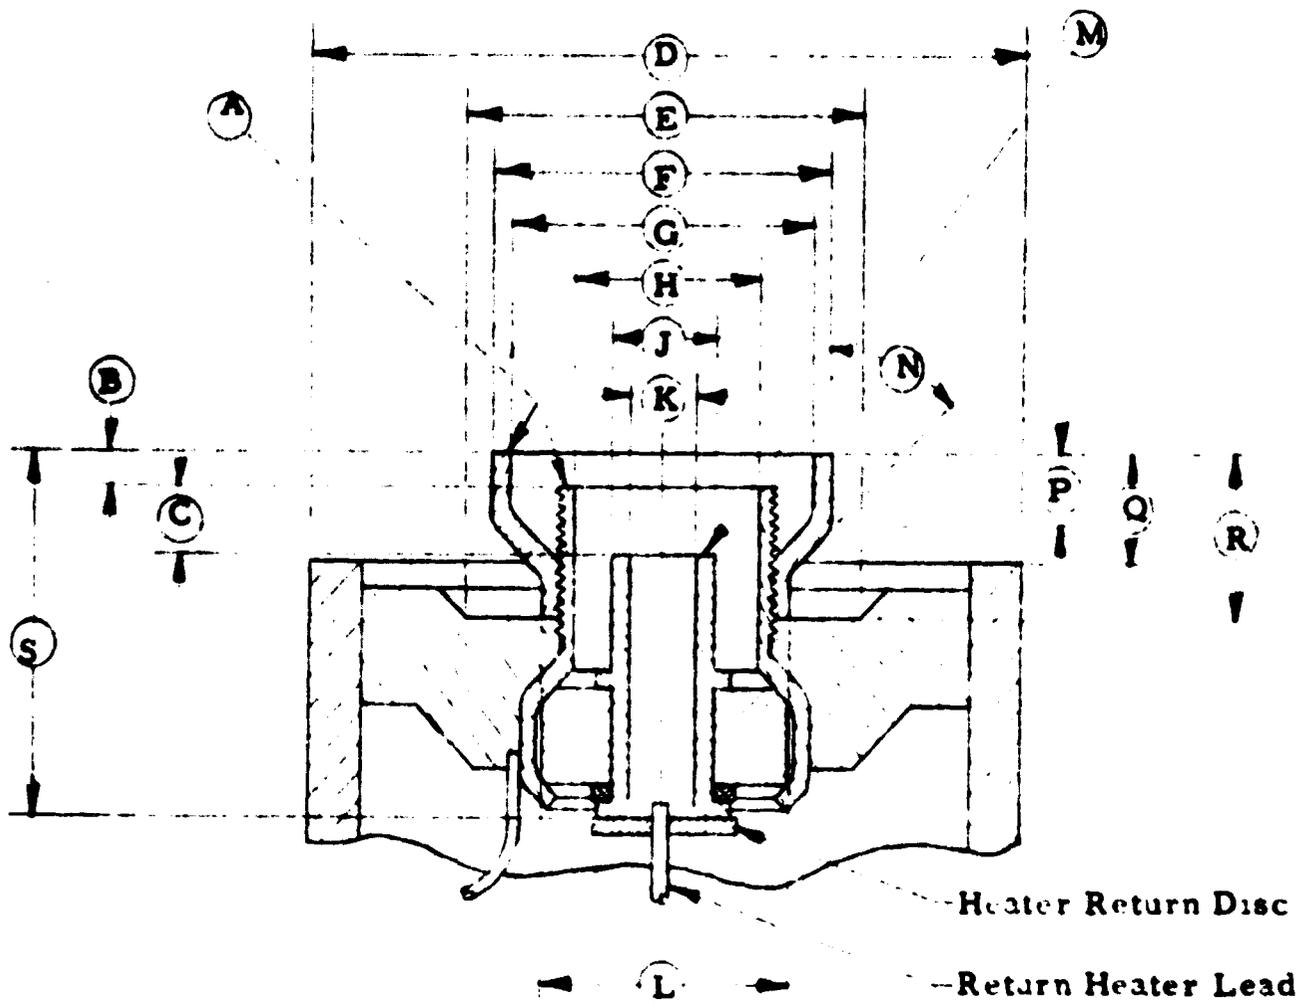
Ref.	Dimension in Inches
A	Heater - Cathode Common
B**	0.075 Min.
C**	0.150 ±.005
D**	1.750 ±.005 Dia.
E**	1.000 ±.010 Dia.
F**	0.847 Max. Dia.
G**	0.735 ±.010-.005 Dia.
H**	0.531 ±.003 Dia.
J**	0.250 ±.005 Dia.
K**	0.169 ±.005 Dia.
L**	0.700 Max. Dia.
M	Heater Return
N**	45° Approx.
P**	0.150 ±.005
Q**	0.180 ±.020
R**	0.360 ±.020
S**	0.670 Min.
