# ULTRASONIC WELDING PROCESS AND EQUIPMENT FOR CONSTRUCTION OF ELECTRON-TUBE MOUNTS

Thirteenth Quarterly Progress Report  
For the Period  
July 1 through September 30, 1965

AEROPROJECTS INCORPORATED  
West Chester, Pennsylvania

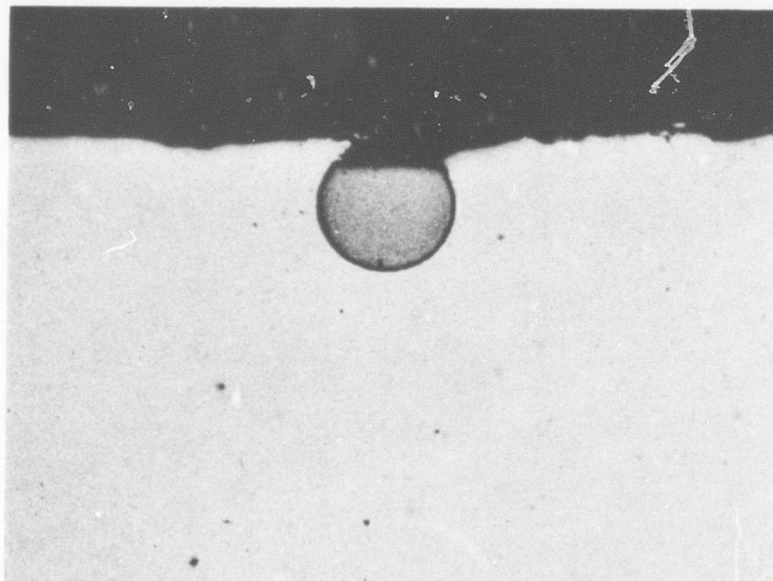
Figure 4

PHOTOMICROGRAPH OF 0.003-INCH DIAMETER W-3Re WIRE  
ULTRASONICALLY WELDED TO 0.060-INCH NICKEL PLATE

Transverse Section

Magnification: 200X

Etch:  $\text{KOH} + \text{K}_3\text{Fe}(\text{CN})_6 + \text{H}_2\text{O}$

These data indicate that satisfactory bond strength can be obtained using the magnetostrictive-transducer 600-watt welder to join tungsten-rhenium wire to nickel and molybdenum sheets. Joint strength obtainable with the tungsten sheet is limited because of splitting and fragmentation of the wire. The appearance of the welded joints is shown in the samples of Figures 1-3. Photomicrographs of the joints between the wire and the nickel sheet and between the wire and the molybdenum sheet are shown in Figures 4 and 5.

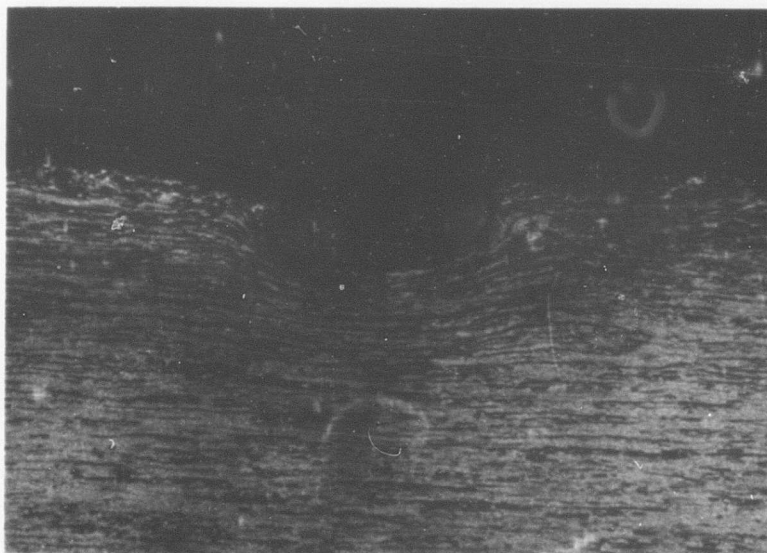
Figure 5

PHOTOMICROGRAPH OF 0.003-INCH DIAMETER W-3Re WIRE  
ULTRASONICALLY WELDED TO 0.060-INCH MOLYBDENUM PLATE

Transverse Section

Magnification: 200X

Etch:  $\text{KOH} + \text{K}_3\text{Fe}(\text{CN})_6 + \text{H}_2\text{O}$
