**AIRCRAFT FABRICATION,
ASSEMBLY, AND INSPECTION**

XV-5A Lift Fan
Flight Research Aircraft
Contract No. DA 44-177-TC-715

ADVANCED ENGINE AND TECHNOLOGY DEPARTMENT
GENERAL ELECTRIC COMPANY
CINCINNATI, OHIO 45215

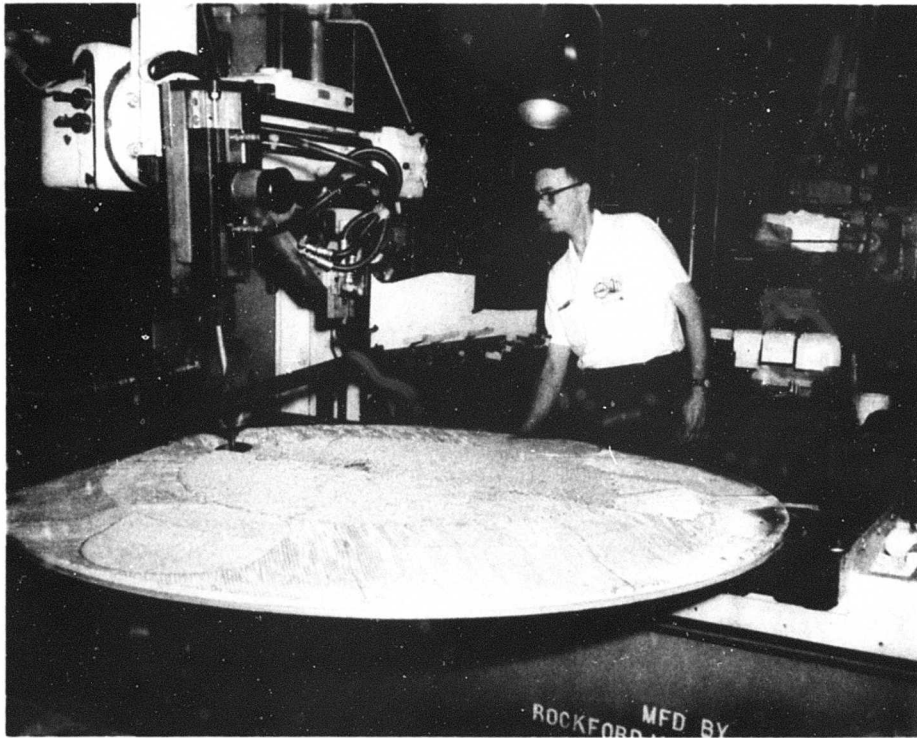
Figure 4 Honeycomb Core - Wing Fan Door

were separated. Figure 4 shows the honeycomb core being machined to the proper contour, Figure 5 shows the core after machining was complete. The outer skin was applied and bonded as in Figure 6. A vacuum process was utilized to maintain exact bonding between the skins and core, (Figure 7). The inside skin was then applied, (Figure 8) and the entire assembly cured in a medium temperature oven. The lower skin was fabricated with high temperature phenolic resins to resist the temperature environment of the fan cavity. The door was then trimmed and hinge and latch points installed (Figure 9). Figure 10 shows the completed door being installed on the aircraft.

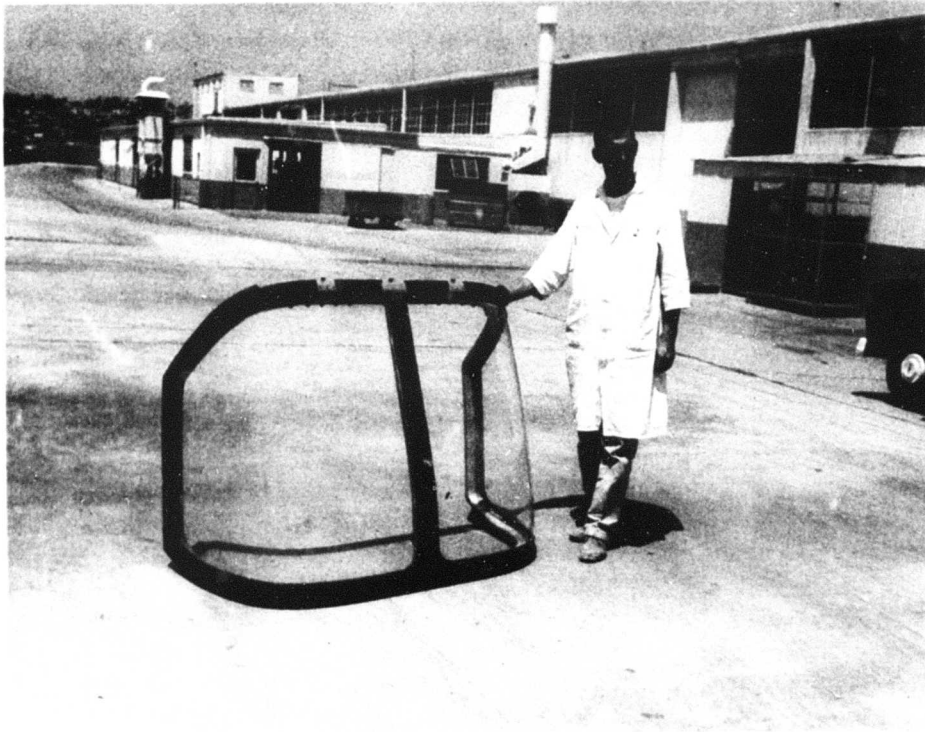
Figure 18 Cockpit Canopy

Another significant use of reinforced Fiberglas laminates is the cockpit canopy shown in Figure 18. The frame of the canopy utilizes U-shaped channels filled with low density plastic foam.
