AM 66-18

# Evaluation of Head and Face Injury Potential of Current Airline Seats During Crash Decelerations

OFFICE OF AVIATION MEDICINE  
FEDERAL AVIATION AGENCY

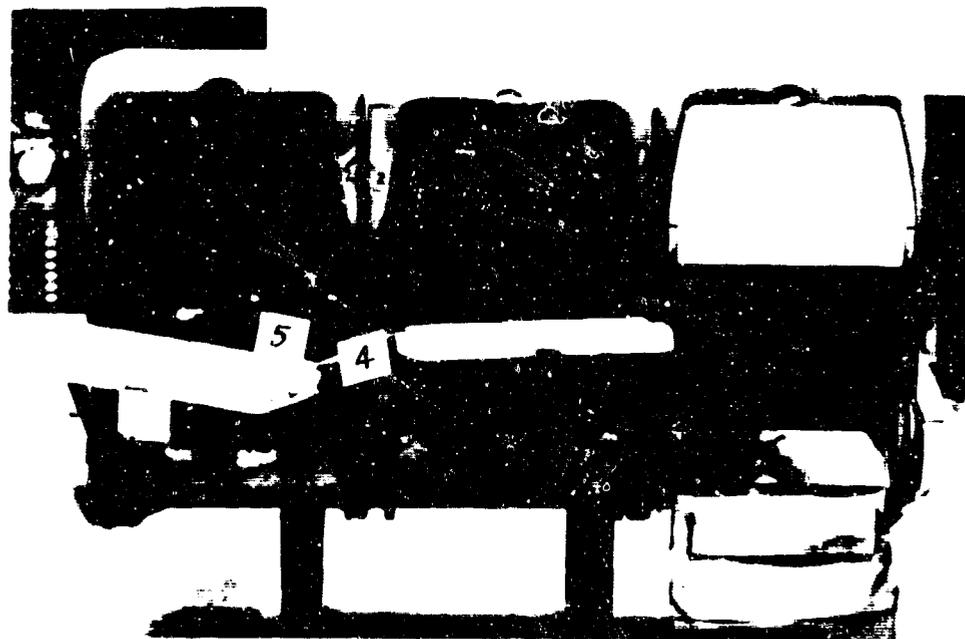
FIGURE 12 - Seat A.

Since the arms supporting the folding serving trays have broken off in some airline crashes and caused serious injury, two impacts were made on the unfolded trays of Seat A (Figure A2). Impact #4 was centered in an area between the left and center trays, whereas impact #5 was against the right edge of the left seat tray. The tray support arms in both cases bent several inches but did not fracture. The impacts produced long duration forces of about 40g or less.

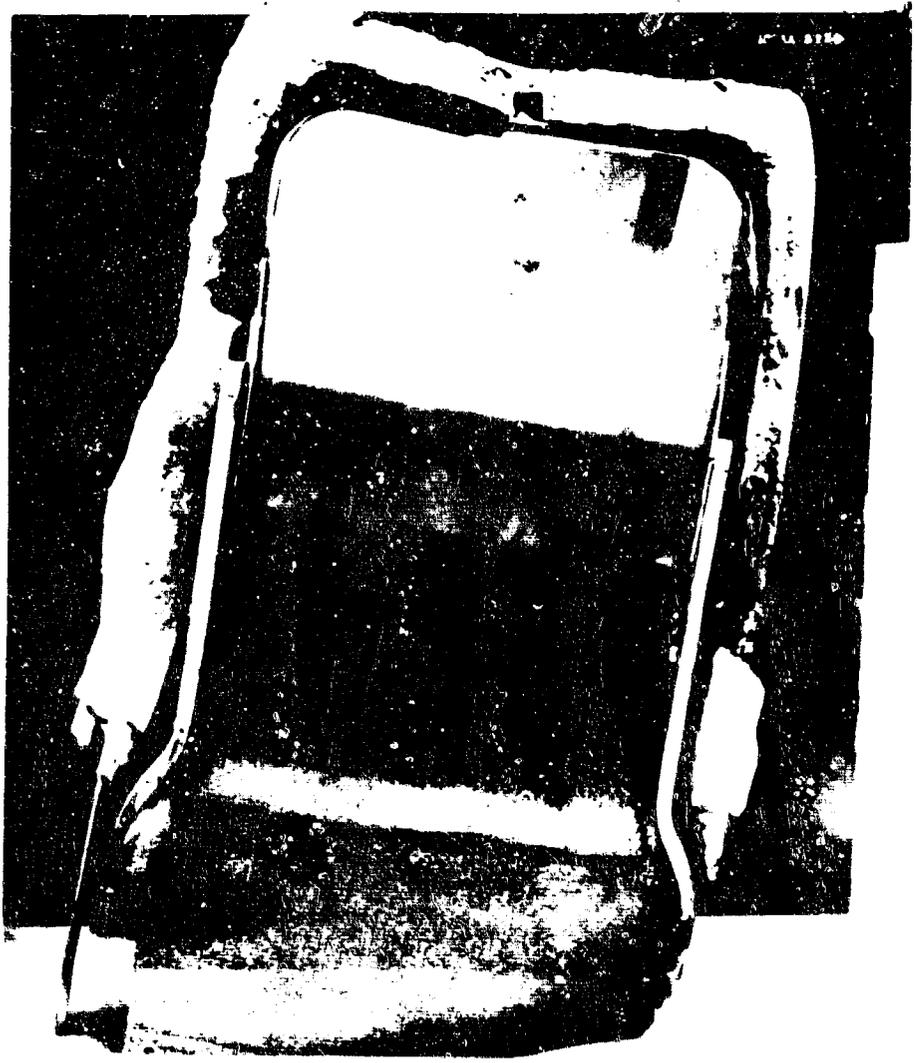
FIGURE A1 - SEAT C

Impact #9 against the top edge of Seat C produced a somewhat larger dent (Figure A4). The g-force curve looks almost as severe as the one in Figure A3; however, there is one important difference. Since the metal did deform and contour to the curvatures of the head, the pressure in pounds per square inch on the head would be much less than in the previous figure and the danger of injuries reduced accordingly.
