FINAL REPORT
TO
NATIONAL SONIC BOOM EVALUATION OFFICE

RESPONSE OF STRUCTURES TO
SONIC BOOMS

PRODUCED BY XB-70, B-58 AND F-104 AIRCRAFT

BASED ON SONIC BOOM EXPERIMENTS
AT
EDWARDS AIR FORCE BASE

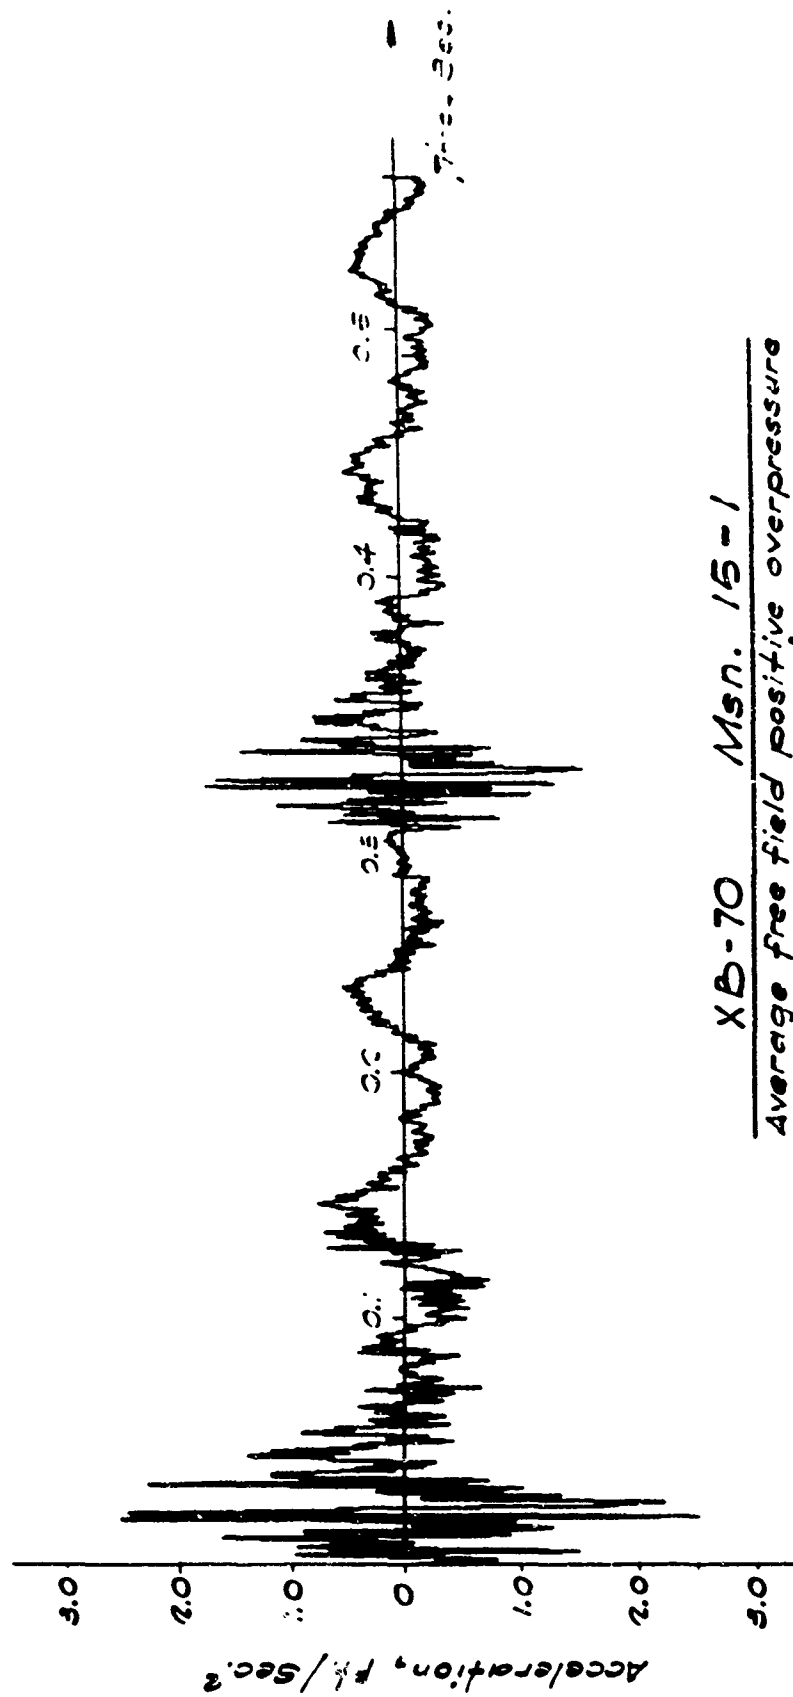
XB-70 Msn. 15-1
 Average free field positive overpressure
 = 2.15 p.s.f.

FIG. 8-2	<u>EAST - WEST RACKING ACCELERATION</u> <u>AT ROOF LINE OF N.E. CORNER OF HOUSE E-1</u> <u>(CHANNEL 201)</u>	FIG. 8-2
-------------	--	-------------
