A/RIA SYSTEM
CATEGORY II FINAL TEST REPORT

AEROSPACE INSTRUMENTATION PROGRAM OFFICE
ELECTRONIC SYSTEMS DIVISION
AIR FORCE SYSTEMS COMMAND
UNITED STATES AIR FORCE
L. G. Hanscom Field, Bedford, Massachusetts

(Prepared under Contract No. AF 19(628)-4888 by Douglas Aircraft Modification Division, 2000 N. Memorial Drive, Tulsa, Okla. 74115.)

This report presents the results of the Category II test and evaluation of the A/RIA system, accomplished by the Douglas Aircraft Company, 2000 North Memorial Drive, Tulsa, Oklahoma 74115. The test program was authorized under Contract No. AF 19(628)-4888, with the Electronic Systems Division, Air Force Systems Command. The ESD cognizant office was the Aerospace Instrumentation Program Office (ESSIA). Tests were conducted over the period from 28 October 1966 to 25 May 1967, in accordance with the procedures established by "Category II Flight Test Procedures for A/RIA System," Douglas Aircraft Company Report No. DAC 56171, dated 15 September 1966.

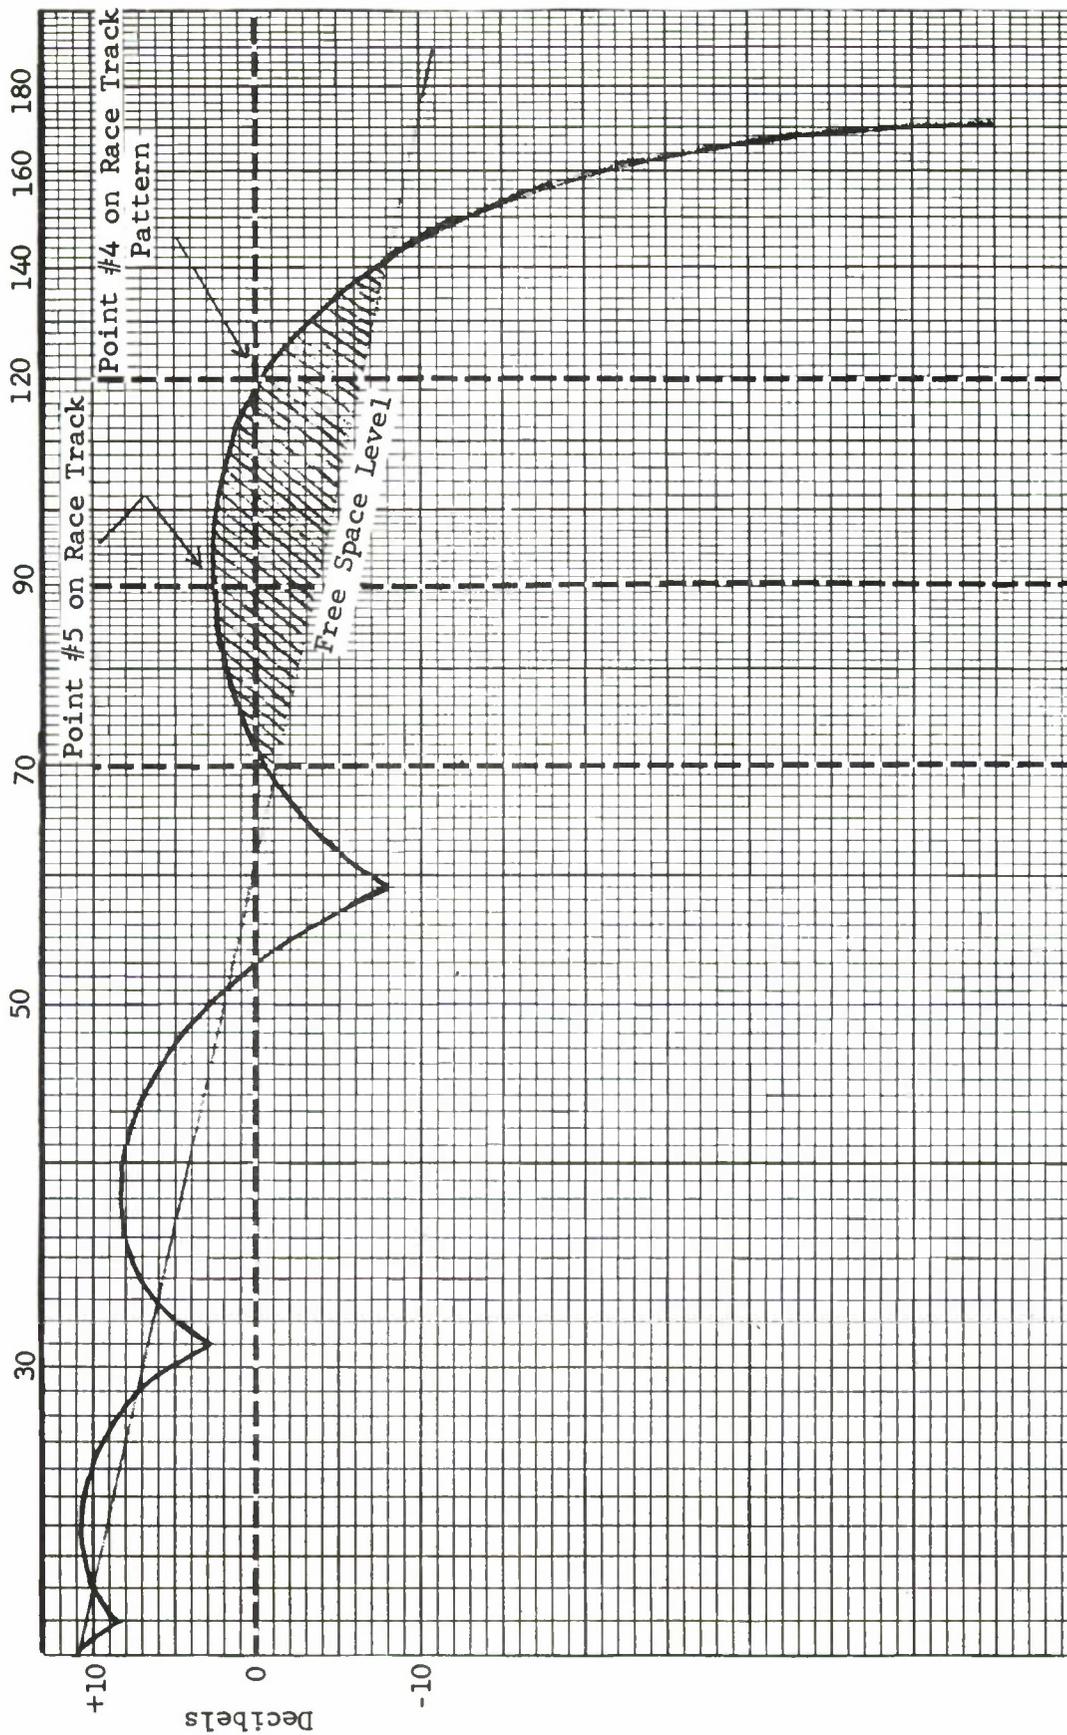
FIGURE 10. TULSA GROUND STATION PROPAGATION PATTERN

A radiation pattern test run was made at the beginning and end of each ground station test flight to insure that all tests were performed within the main lobe structures of the VHF and UHF ground station antennas (see Figure 10). The ground station VHF and UHF antennas were set to a height that would position the first radiation pattern null at 59-nm from the ground station with the A/RIA aircraft at an altitude of 35,700 feet MSL. Since changes in temperature, weather conditions and atmospheric conditions will affect the antenna lobe structures causing the null positions to shift, the first radiation pattern check was made with the antennas set to the calculated heights of 5.5 wavelengths.

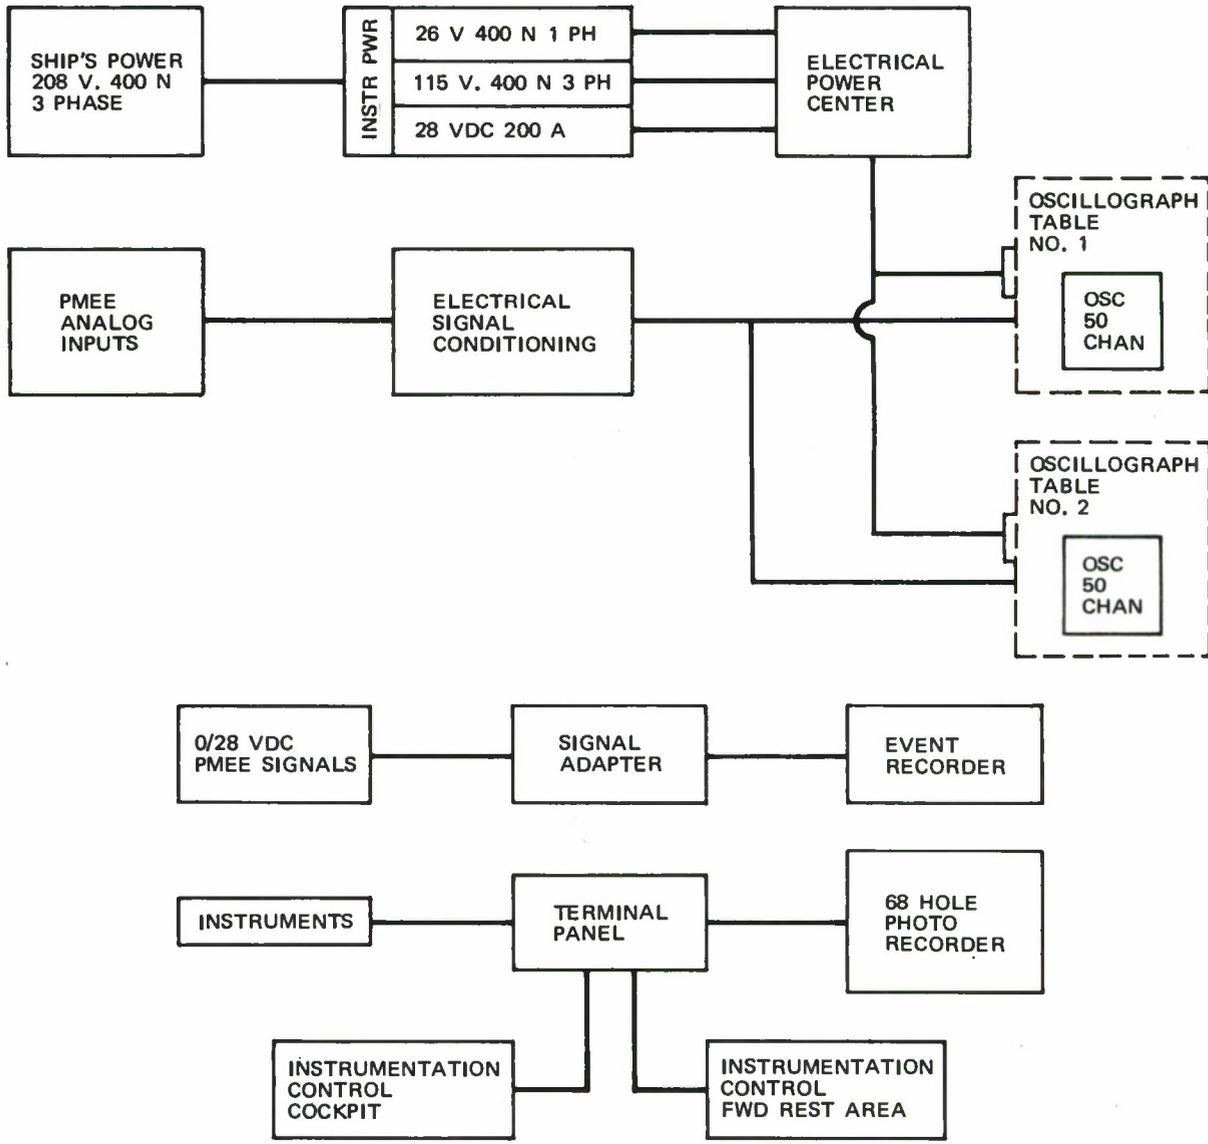
FIGURE 22. A/R IA 372 INSTRUMENTATION BLOCK DIAGRAM

Two 50-channel oscillographs - CEC Type 50-119P3-50, located in the aft rest area, were used to record all dynamic PMEE parameters where a continuous time-history was required. Analog signals routed to the oscillographs included AGC, frequency deviation, carrier deviation, and azimuth and elevation errors.

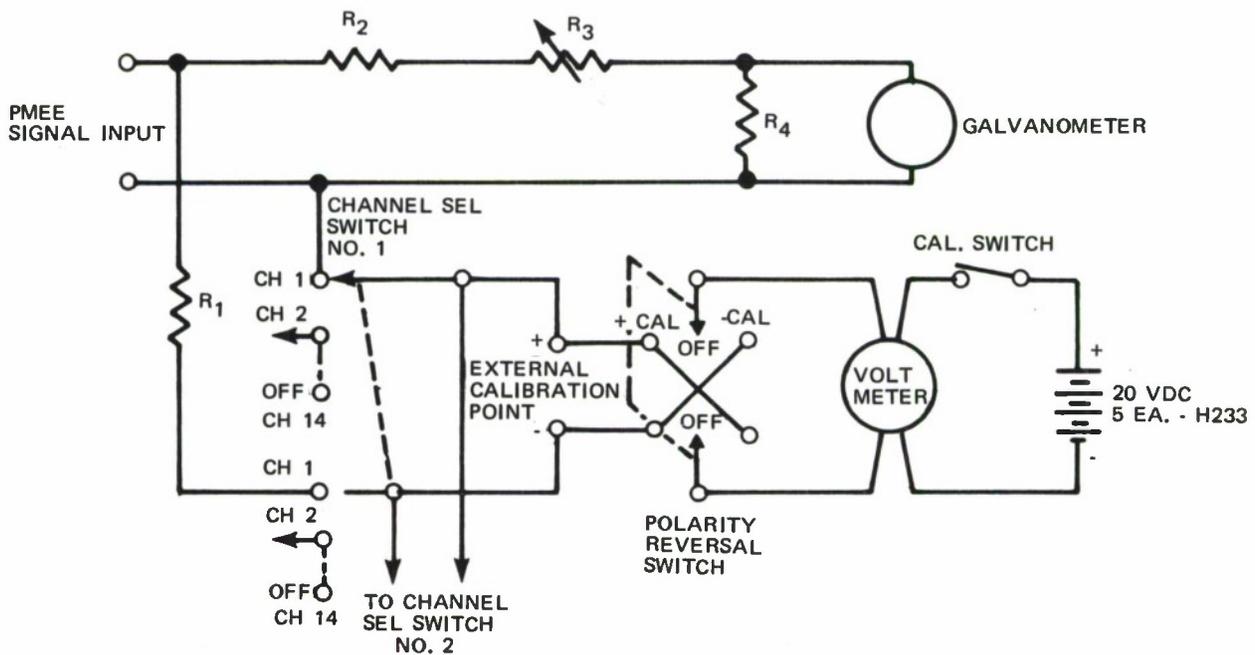
FIGURE 23. OSCILLOGRAPH SIGNAL CONDITIONING UNITS

All PMEE inputs were fed into their respective units through a signal connector. When the calibration circuits were energized, the connectors were removed to prevent any feedback of the calibration signal into the PMEE equipment.

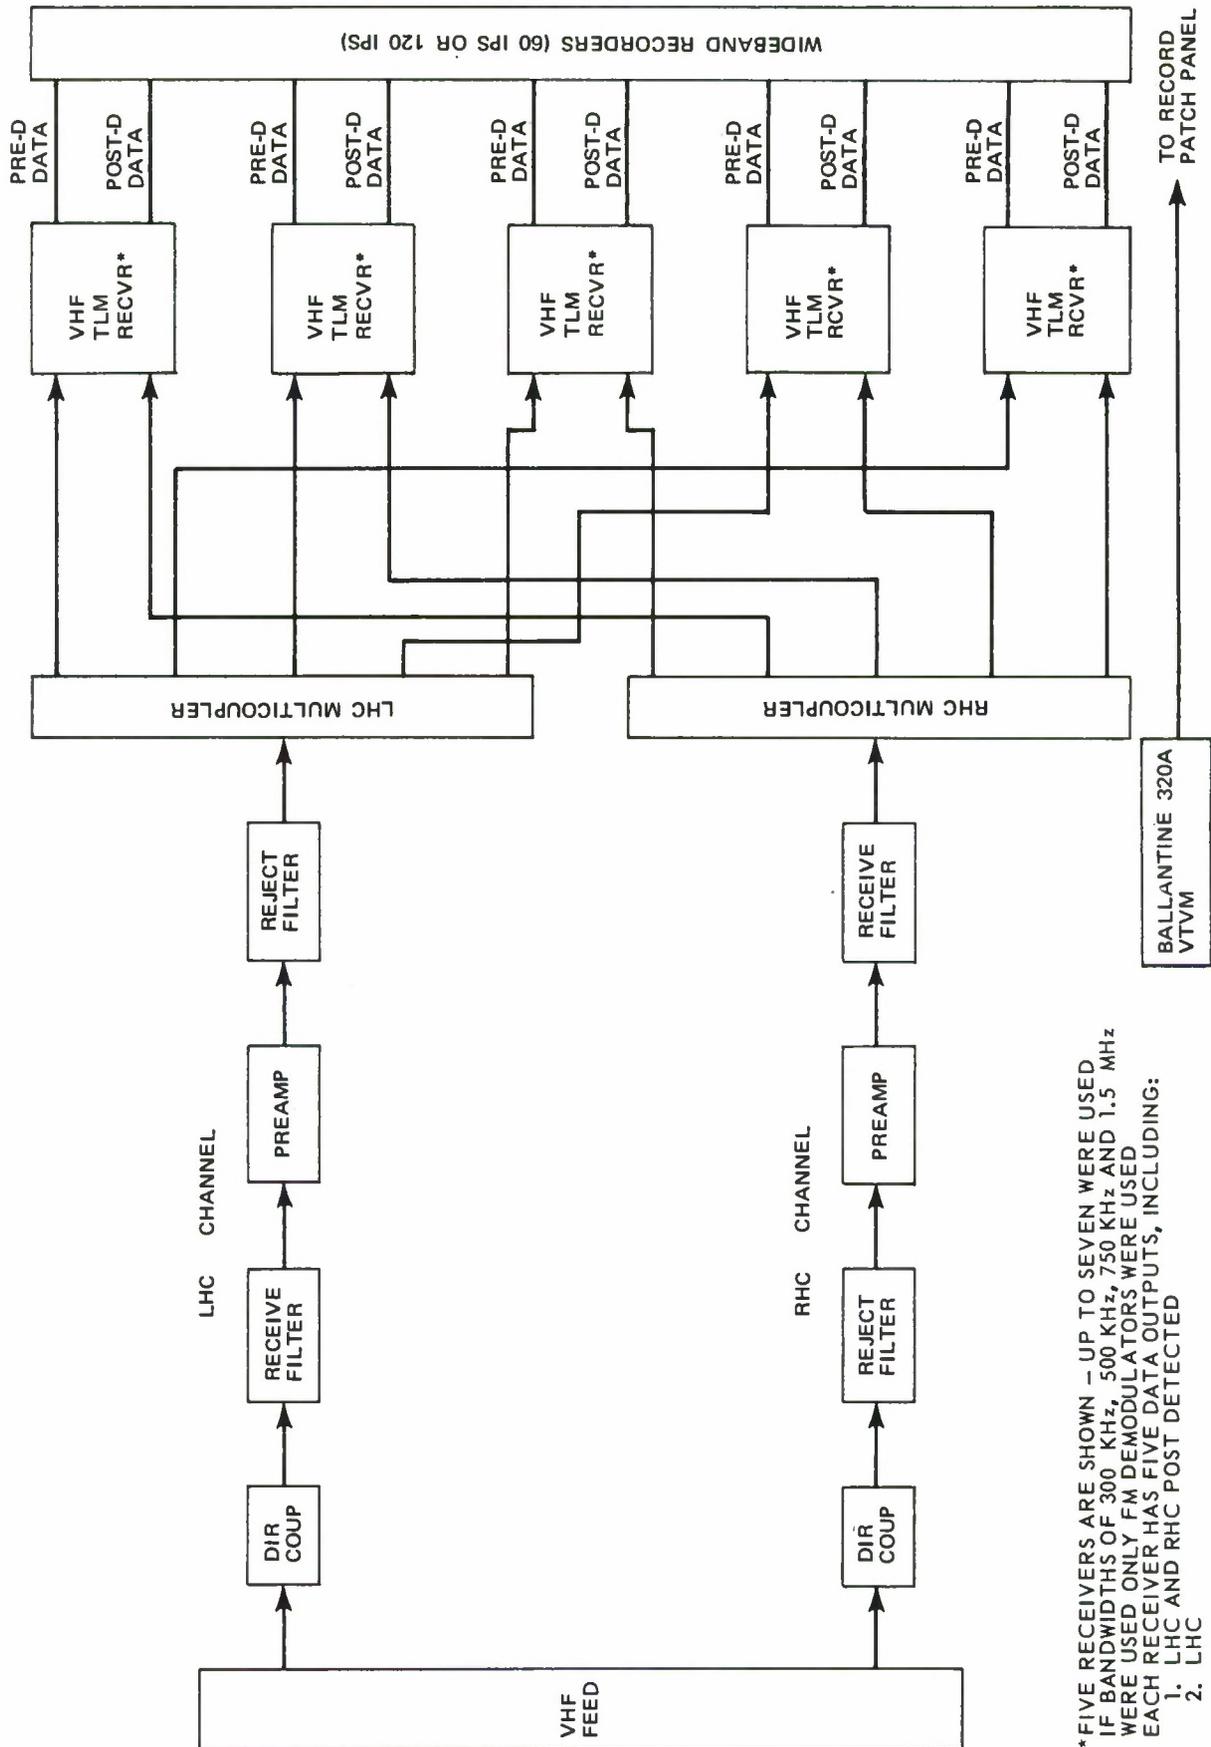
FIGURE 57. VHF DATA, RECORD SYSTEM CONFIGURATION

* FIVE RECEIVERS ARE SHOWN - UP TO SEVEN WERE USED IF BANDWIDTHS OF 300 KHz, 500 KHz, 750 KHz AND 1.5 MHz WERE USED ONLY FM DEMODULATORS WERE USED EACH RECEIVER HAS FIVE DATA OUTPUTS, INCLUDING:
 1. LHC AND RHC POST DETECTED
 2. LHC

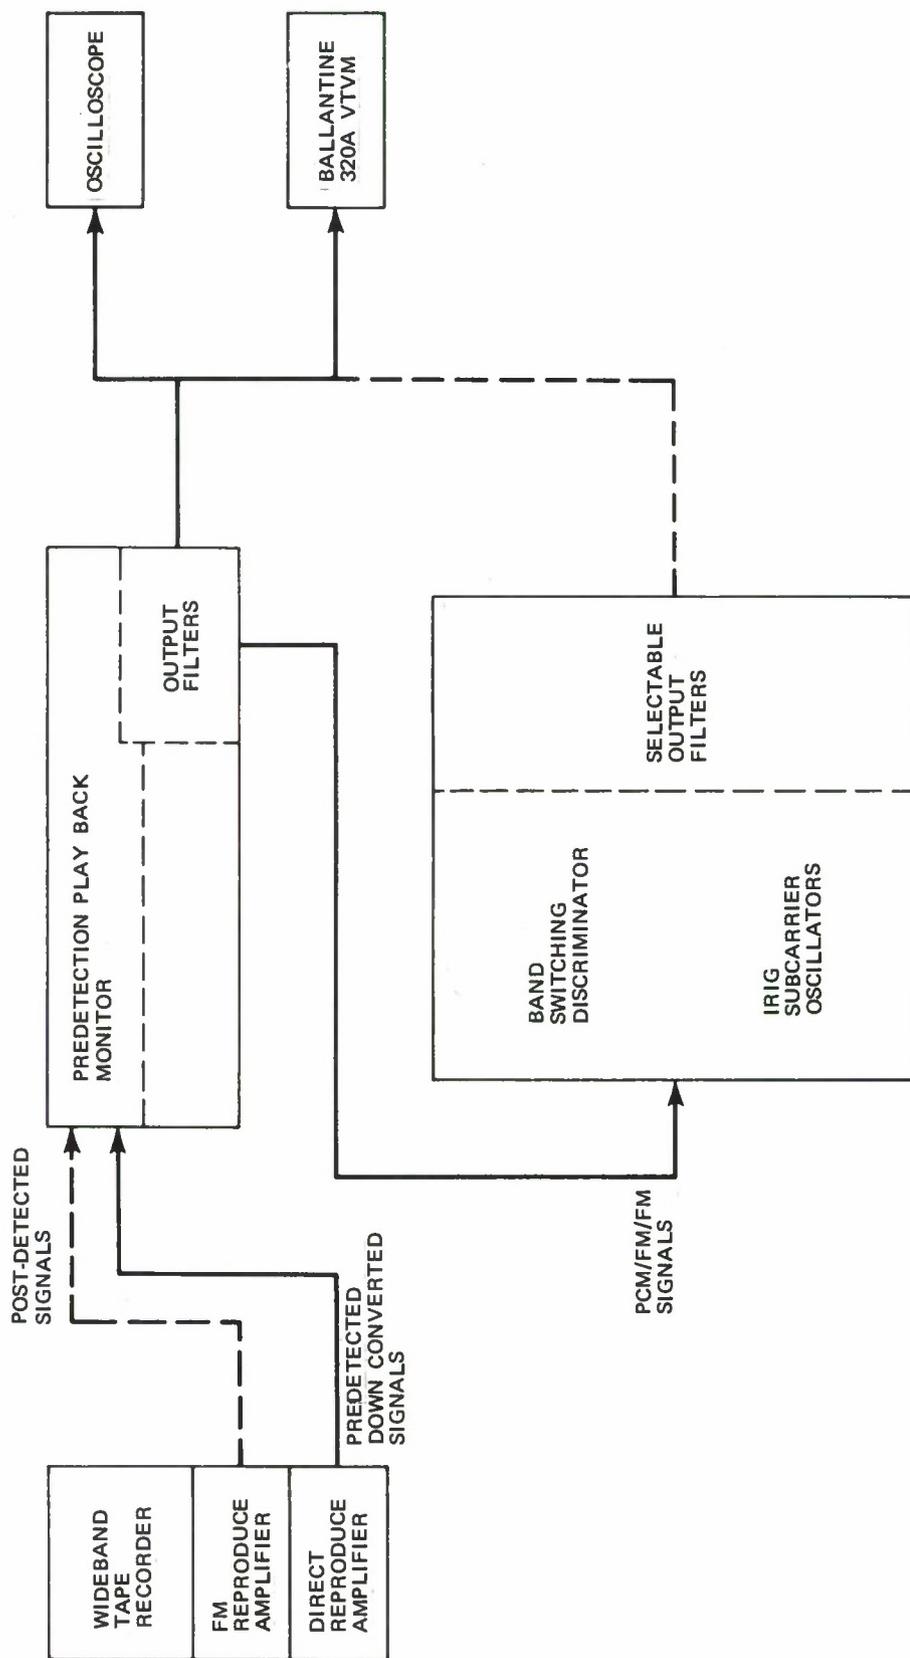
FIGURE 58. WIDEBAND MAGNETIC TAPE REDUCTION SET-UP

Signal plus noise-to-noise measurements were also taken from the magnetic tapes recorded during the data runs. Readings of both predetection and post detection were accomplished, using the configuration shown in Figure 58.

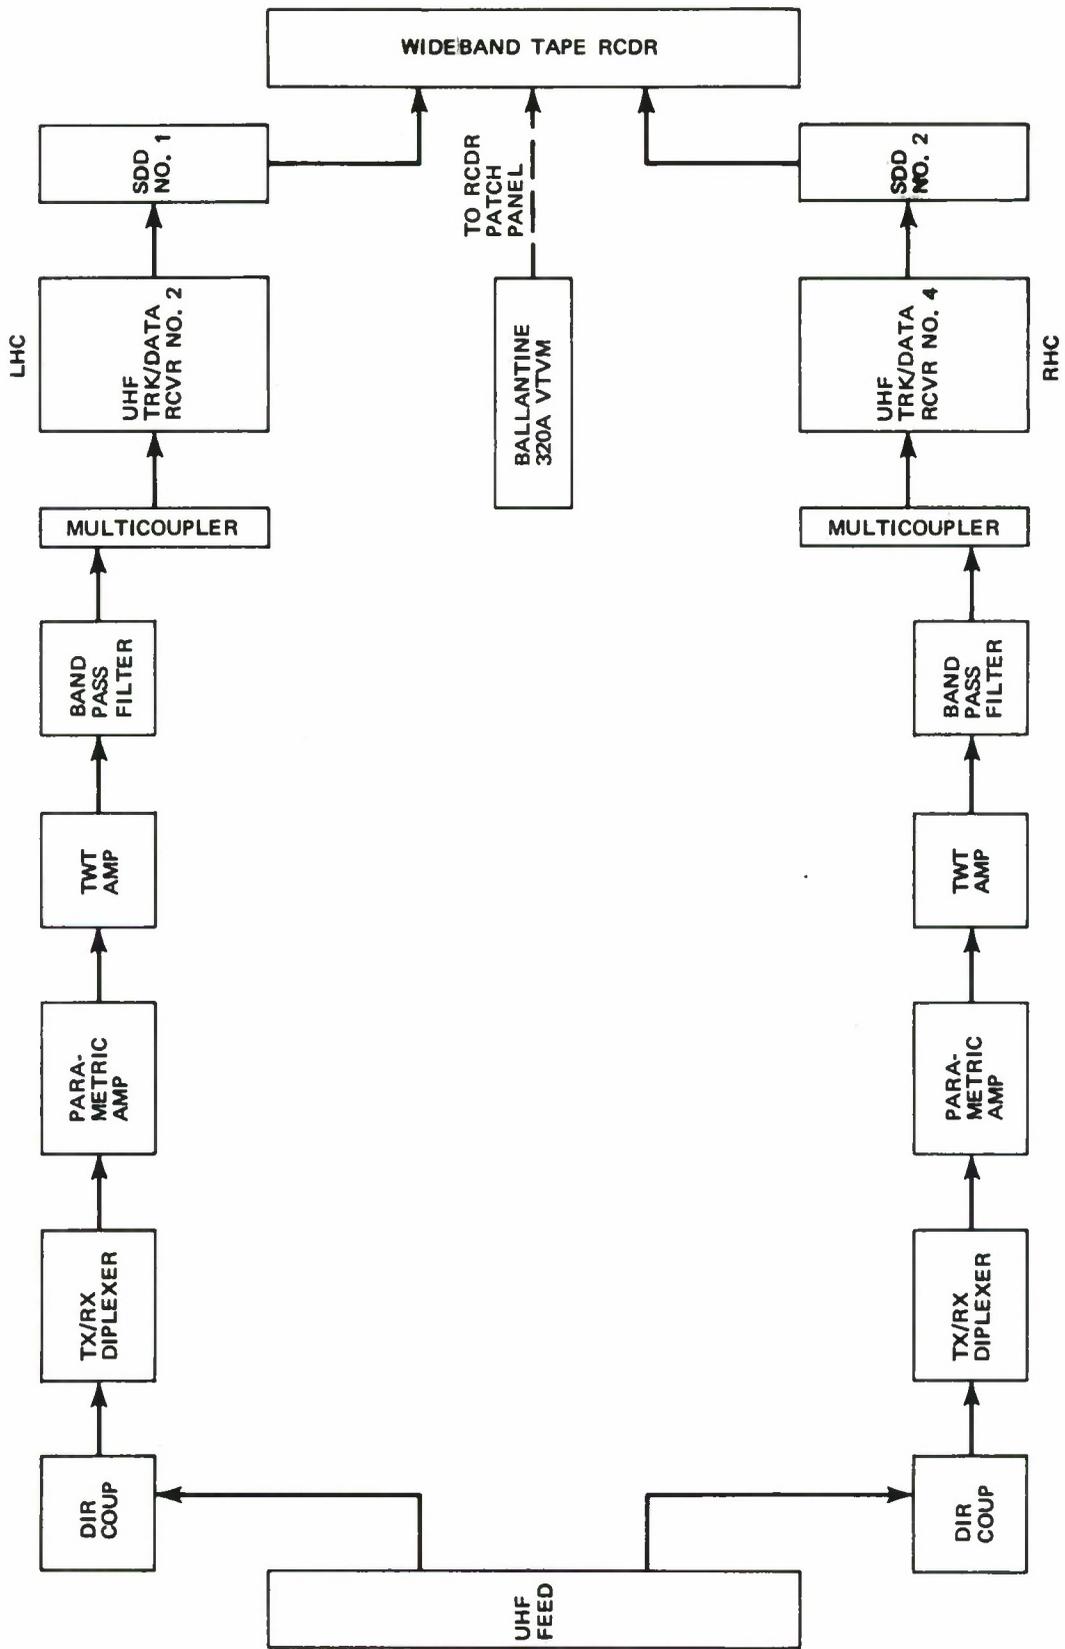
FIGURE 63. UNIFIED S-BAND SYSTEM CONFIGURATION

The A/RIA PMEE configuration used to receive and record Unified S-Band telemetry data is shown in Figure 63. The signals received by the UHF antenna are amplified by the parametric and TWT amplifiers in the LHC and RHC sum channels and fed to the UHF multicouplers. The LHC multicoupler output is fed to UHF track receiver 2 and the RHC multicoupler output fed to track receiver 4. The receiver IF bandwidth filters used were 3.3 MHz. The 1.024-MHz data subcarriers were patched to the data demodulators. The post-detected PCM pulse train was recorded FM to the recorder.

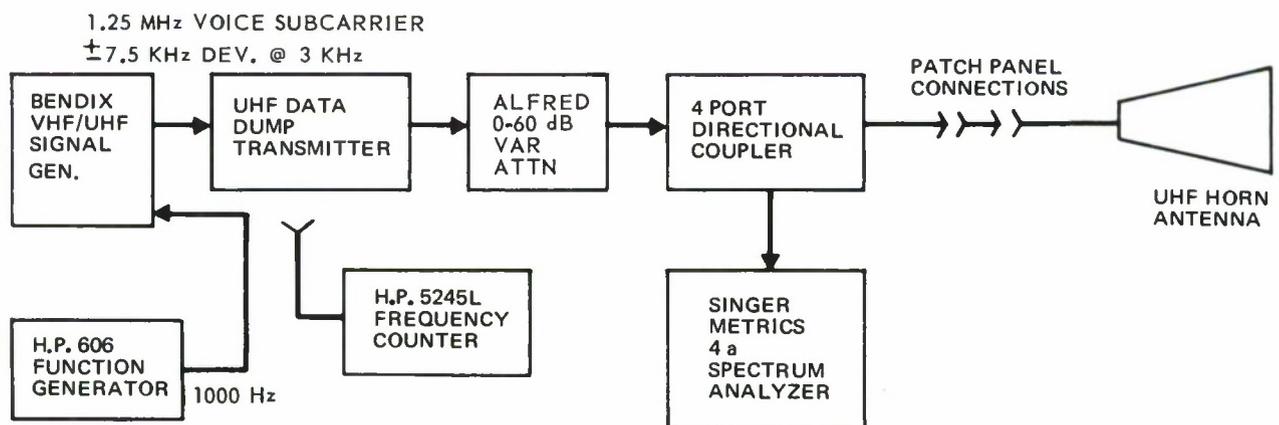
FIGURE 69. USB VOICE TESTS USING DATA DUMP TRANSMITTER

The USB voice tests accomplished with the ground station were conducted under controlled conditions. Figures 69, 70, and 71 show the configurations used to accomplish all USB voice tests.

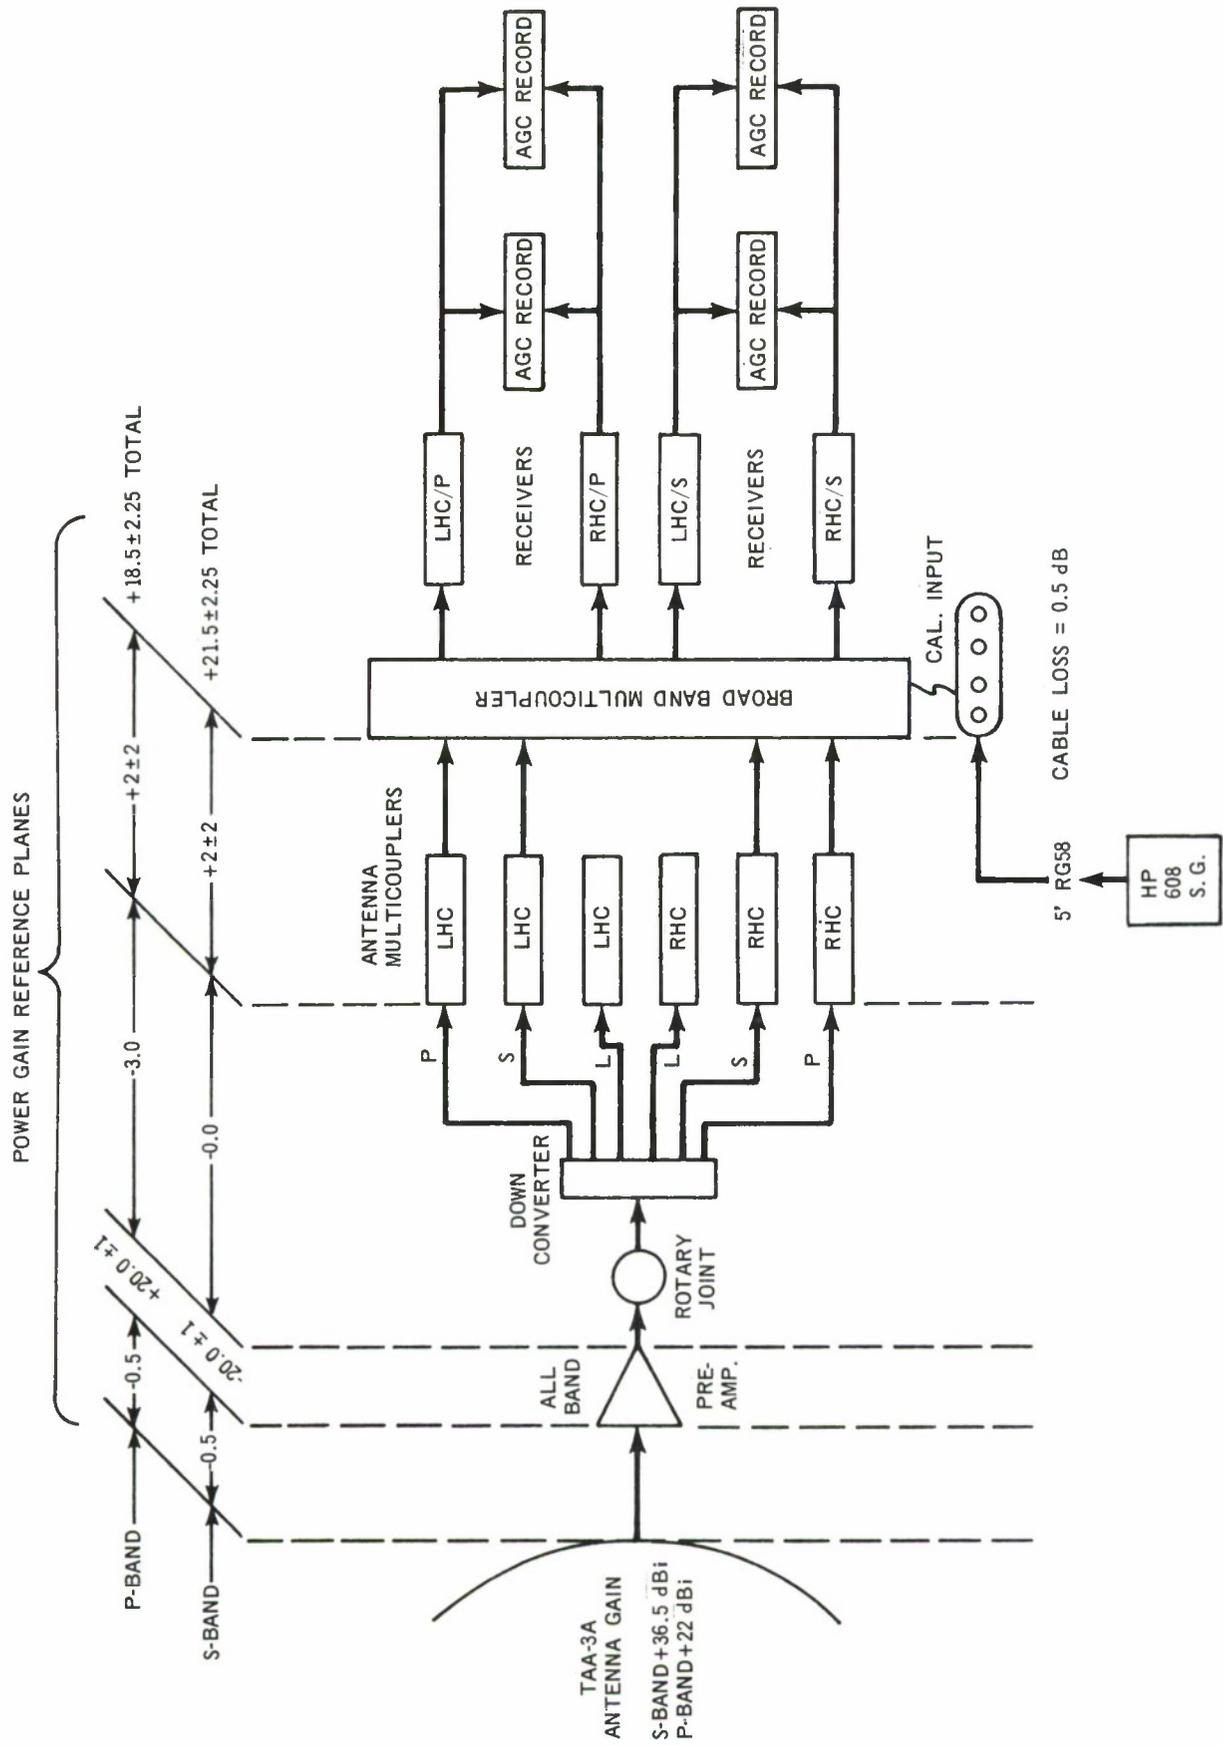
FIGURE 85. TEL-IV SIMPLIFIED BLOCK DIAGRAM

A simplified block diagram of the TEL IV ground station is shown in Figure 85. Signal strength recordings were made from both the RHC and LHC receivers on VHF and from the LHC on UHF. Bit error counts were derived from each frequency. All

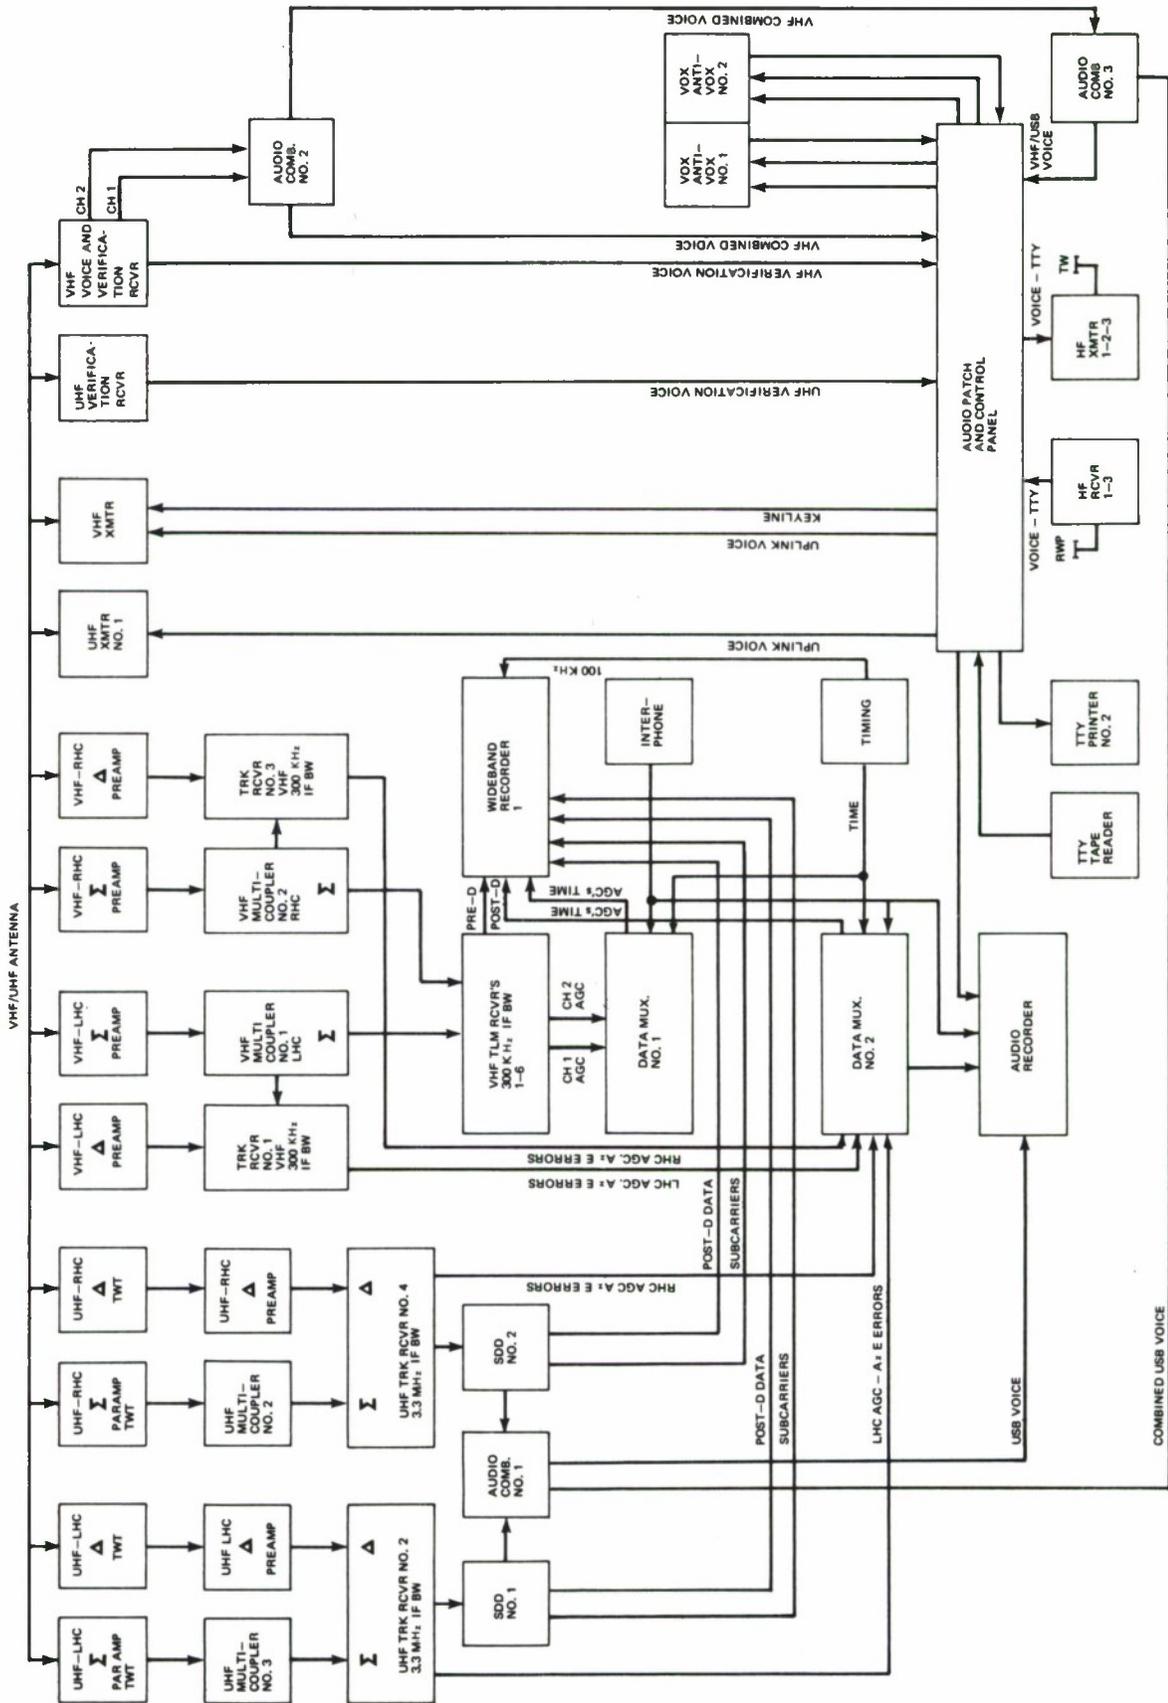
FIGURE 98. INTEGRATED SYSTEM BLOCK DIAGRAM

As shown on the diagram, the A/RIA was configured to acquire and track on UHF (Unified S-Band), with the VHF tracking receivers serving as back-up. The UHF track receivers were patched to receive USB data, while the six VHF telemetry receivers were set to receive PCM/FM data. The spacecraft voice links were configured to receive and transmit VHF and USB voice, while the HF subsystem was patched to receive and transmit voice and teletype. The system was patched for voice relay. The timing subsystem was synchronized to WWV. The wideband and audio recorders were patched as follows:
