Report 1928

**EXPERIMENTAL MODEL,
MARGINAL-TERRAIN ASSAULT BRIDGE AND ARMORED
PERSONNEL CARRIER TRANSPORTER AND LAUNCHER**

April 1968

**U. S. ARMY MOBILITY EQUIPMENT RESEARCH AND DEVELOPMENT CENTER
FORT BELVOIR, VIRGINIA**

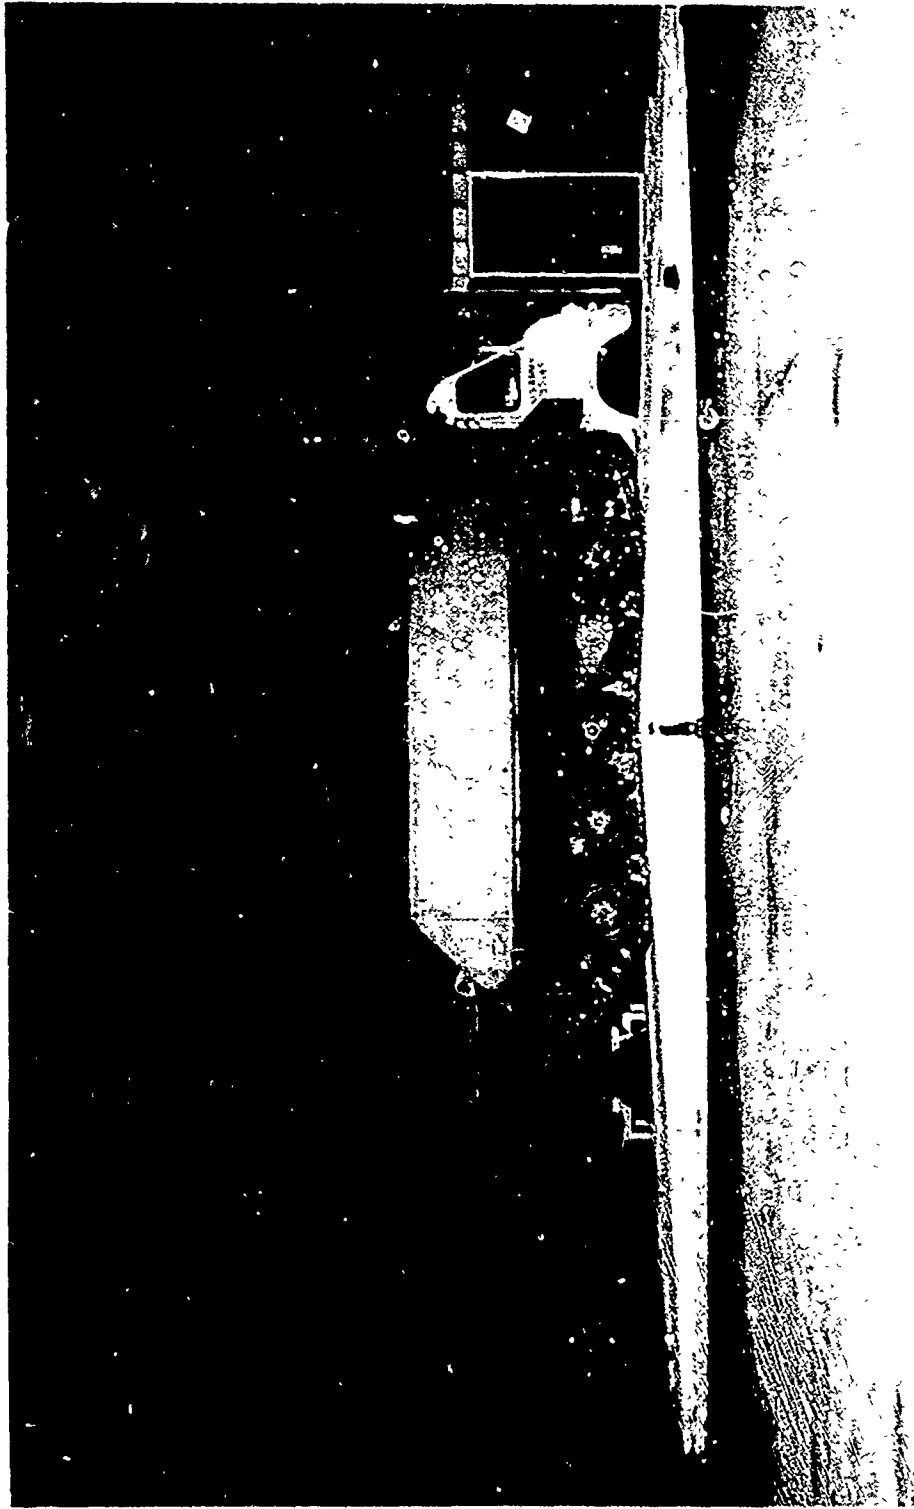
N8911

Fig. 9. Bridge under dynamic loading.

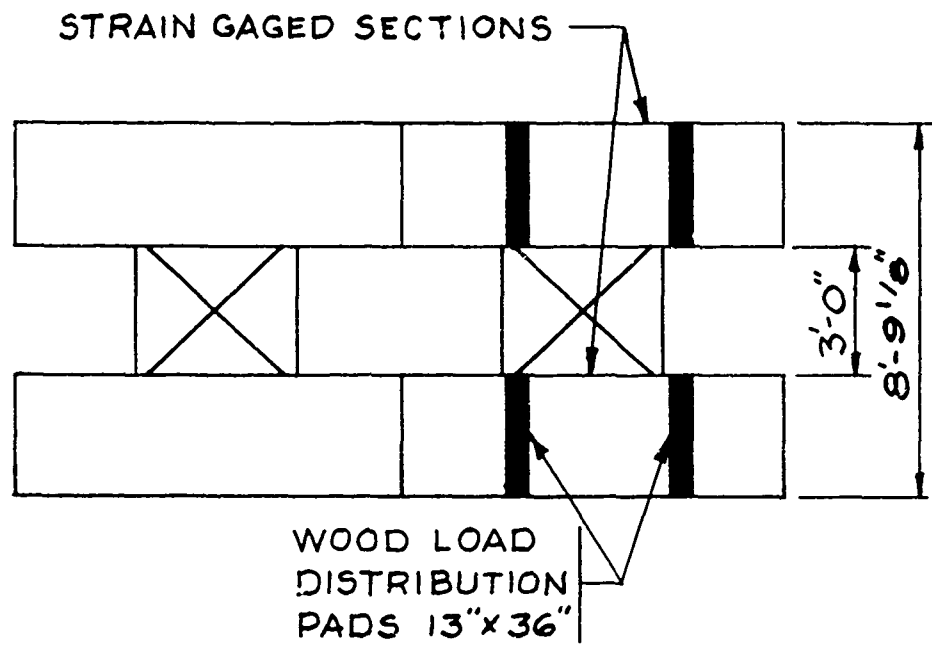
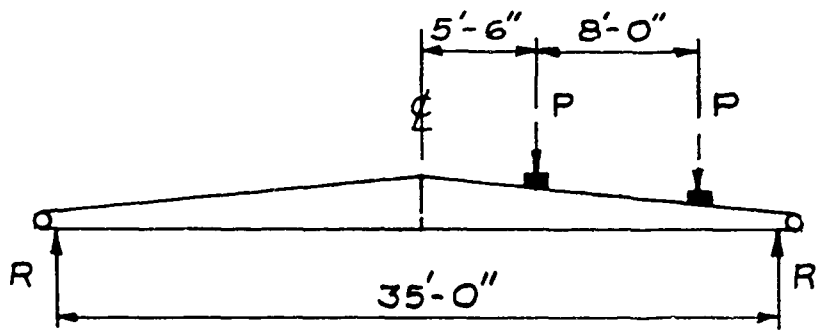
Fig. 12. Load Position 3.

Strain gage readings were taken for five different loading conditions. Figures 10 through 14 show the positions of the loads.

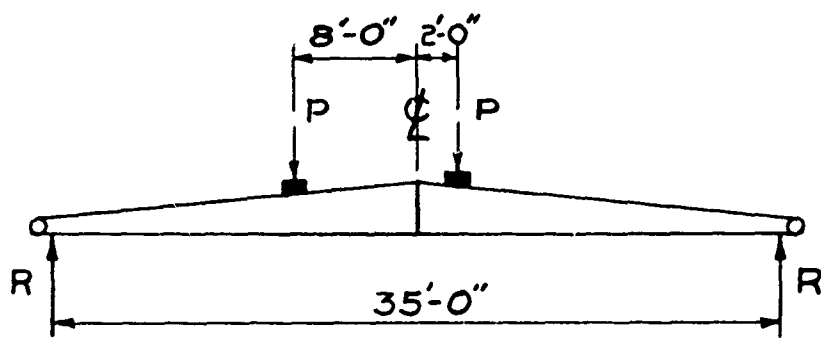
Fig. 13. Load Position 4A.

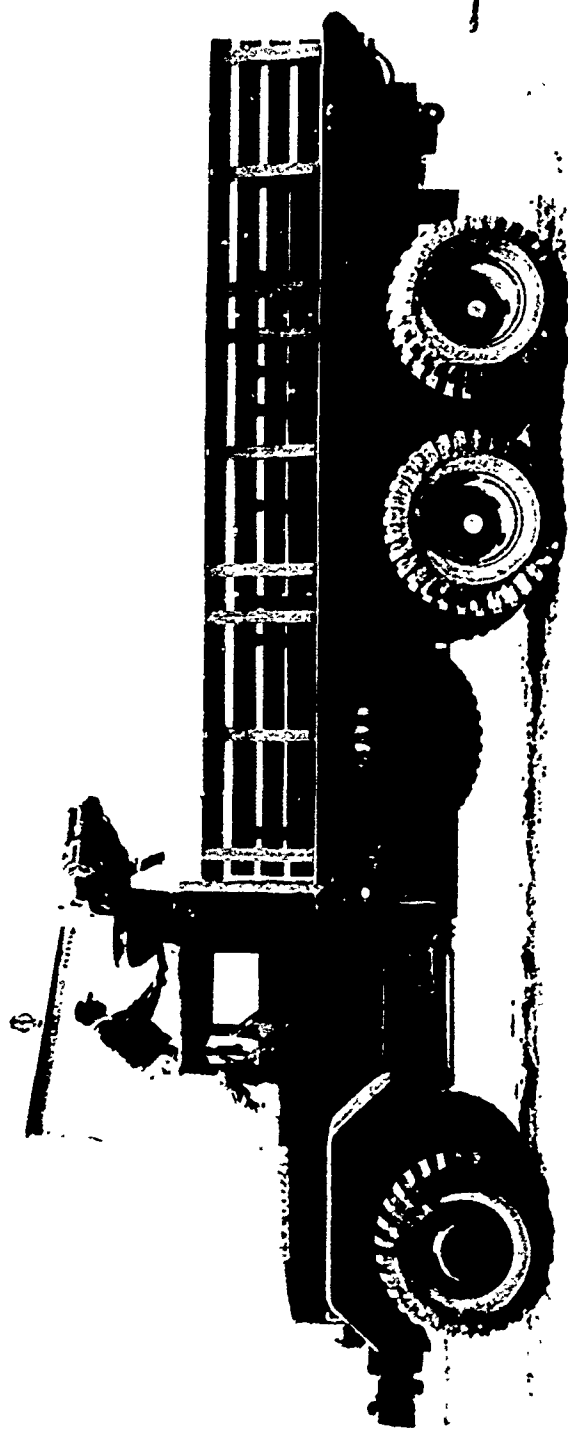
C3197

Fig. 16. Five-ton bridge truck, class 22.

The wheeled vehicle was an M-139 bridge truck loaded to a gross weight of 44,000 pounds (Fig. 16). Crossing speeds were limited to a crawl because only the inside, dual wheels of each rear axle were on the bridge. This created an extreme condition of weight (Class 22) and eccentricity, but the stresses show no areas of concern and the stress levels were well within the limits of proportionality (Table VII). Runs 1 and 2 show variations in different crossings, while run 3 shows the static stresses with the center of gravity (C.G.) of the vehicle at the centerline of the bridge.

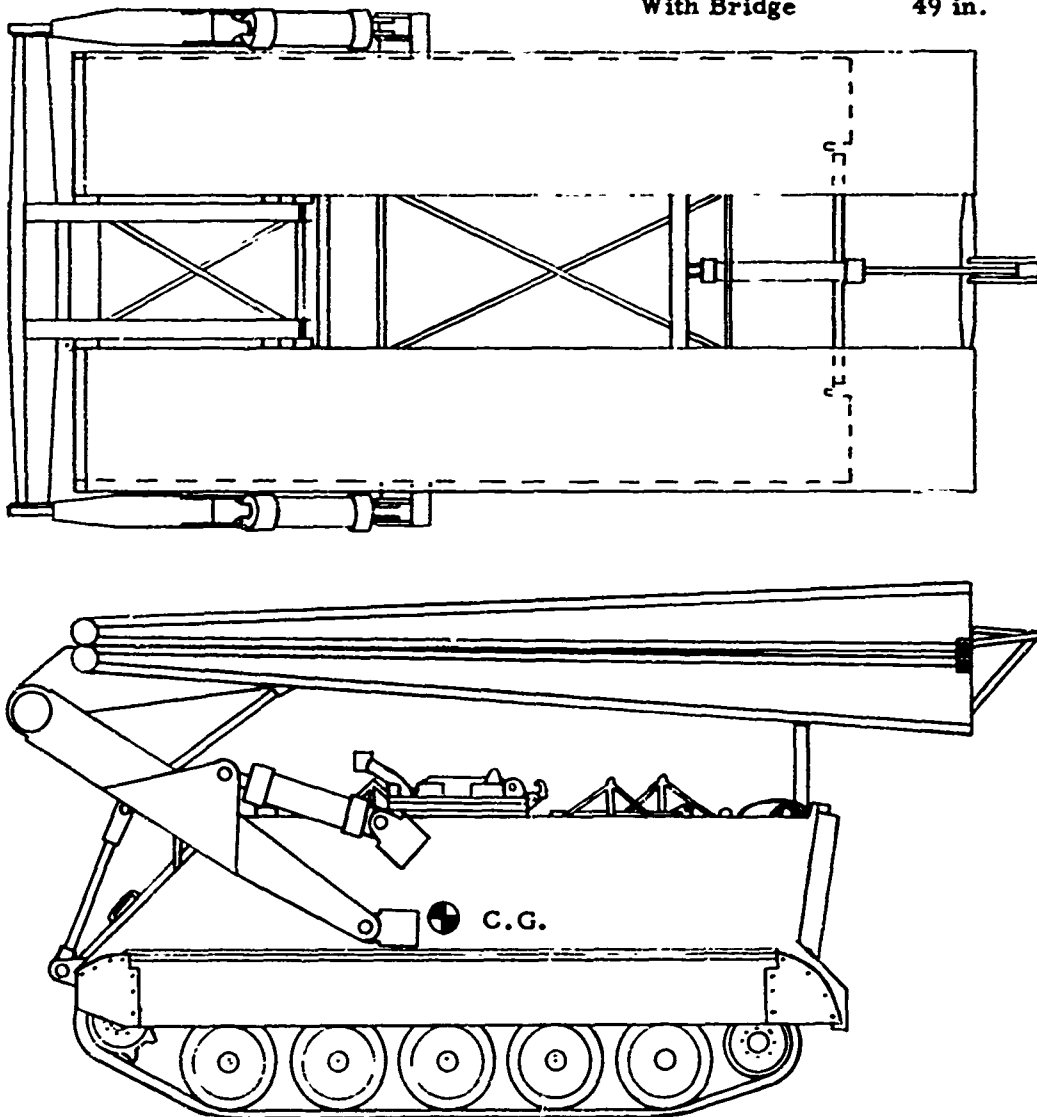
Crew	2	Height	
Weight		Without Bridge	109-1/4 in.
Without Bridge	20,250 lb.	With Bridge	136-1/2 in.
With Bridge	23,000 lb.	Center of Gravity	
Width	123-1/2 in.	(from noseline)	
Length		Horizontal	
Without Bridge	209-1/2 in.	Without Bridge	83-1/2 in.
With Bridge	249 in.	With Bridge	90 in.
		Vertical	
		Without Bridge	38 in.
		With Bridge	49 in.

Fig. 27. General data.

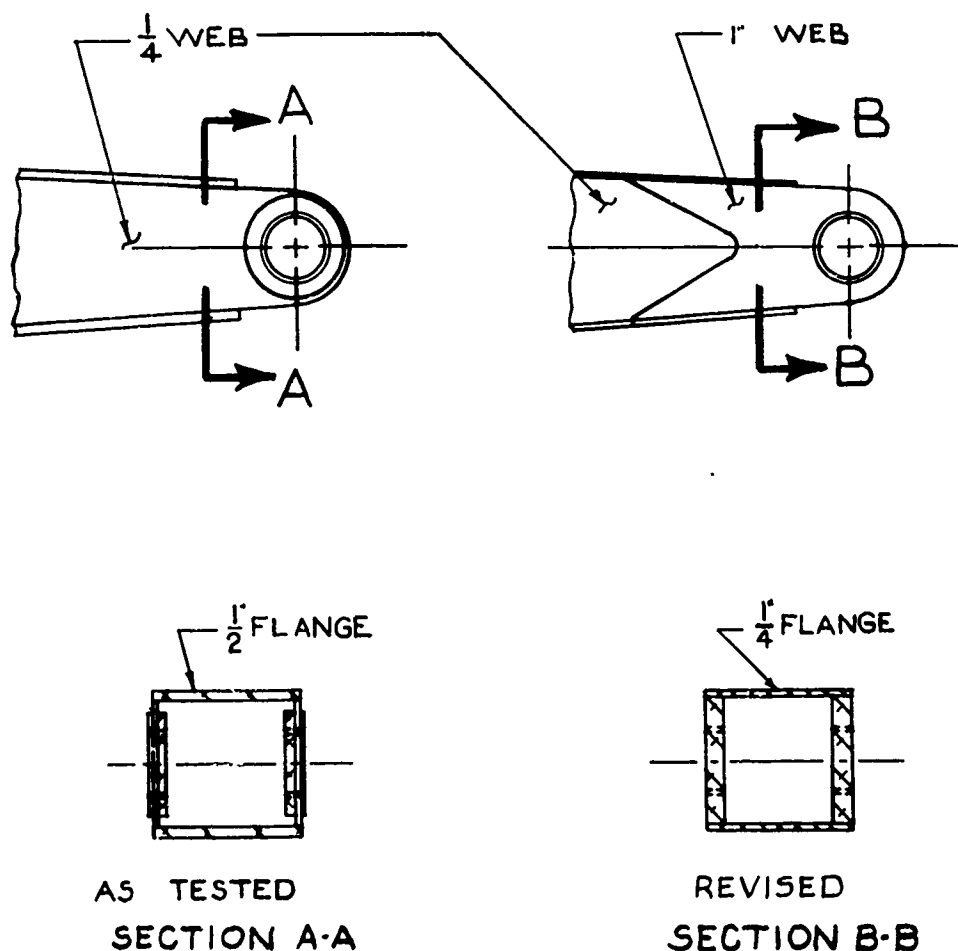
This limited data and the nonavailability of complete characteristics of the alloy did not allow a conclusive failure theory. There was speculation that the fracture was the result of flexural fatigue aggravated by a stress concentration at the end of the flange (Fig. 30).

Fig. 30. Revised launching beam.

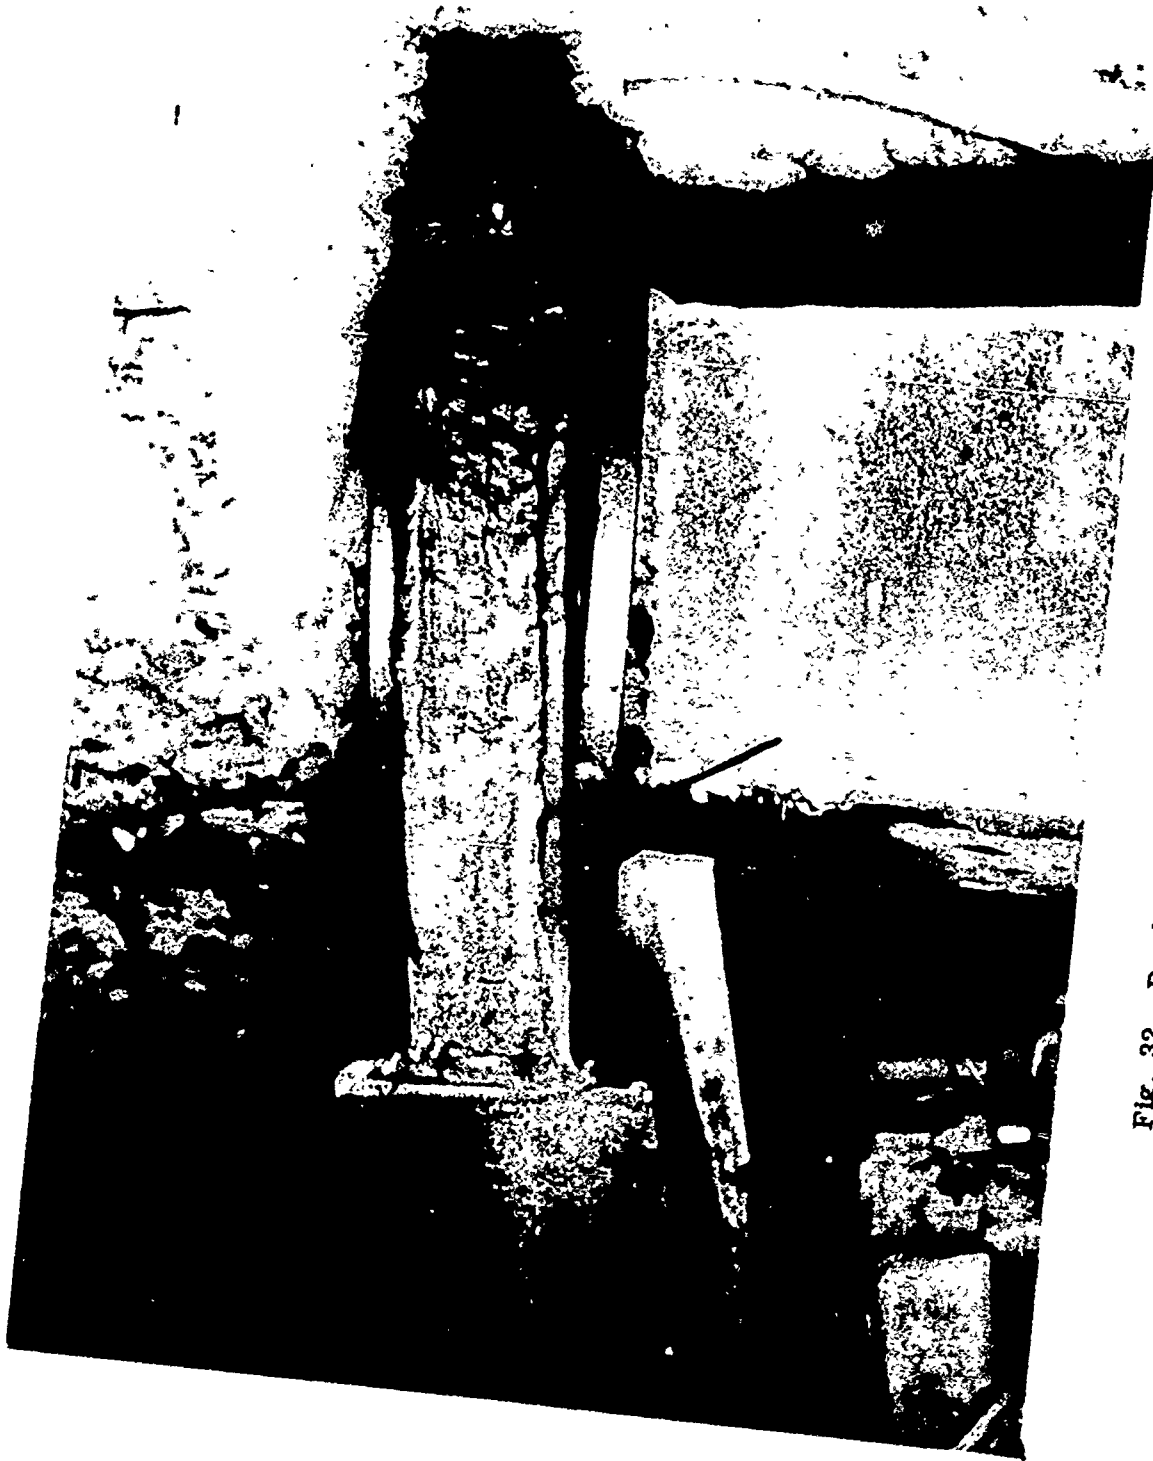
The failure caused racking of the mechanism (Fig. 31) and bent the end plate and trunnion mount on the left end of the tongue-frame crossbeam (Fig. 32). The racking action gave a permanent set in torsion to the rotating link. The link was cold straightened by a press, and the end plate and trunnion were cold straightened by driving. The crushed end of the launching beam was replaced with 1/2-inch web plates; the unfailed, left-side, launching-beam webs were stiffened with 1/4-inch plates. This arrangement still required the use of 1/2-inch-thick bearing plates to be welded on at the pinhole. For cost reduction and ease of fabrication, the web plates on a production model would be 1 inch thick (Fig. 30). The 1/2 inch webs were strain gaged during subsequent testing (Gage No. 48, Table X).

Fig. 32. Bending of crossbeam end plate and trunnion pin. P5778

After 945 cycles, the left end plate of the crossbeam sheared (see arrow, Fig. 32). No other damage was sustained, and the plate was rewelded with a larger weld. The right end plate was also rewelded as insurance against a similar failure. No other action was taken since the failure was precipitated by bending caused during the launching-beam failure and subsequent straightening during repair.

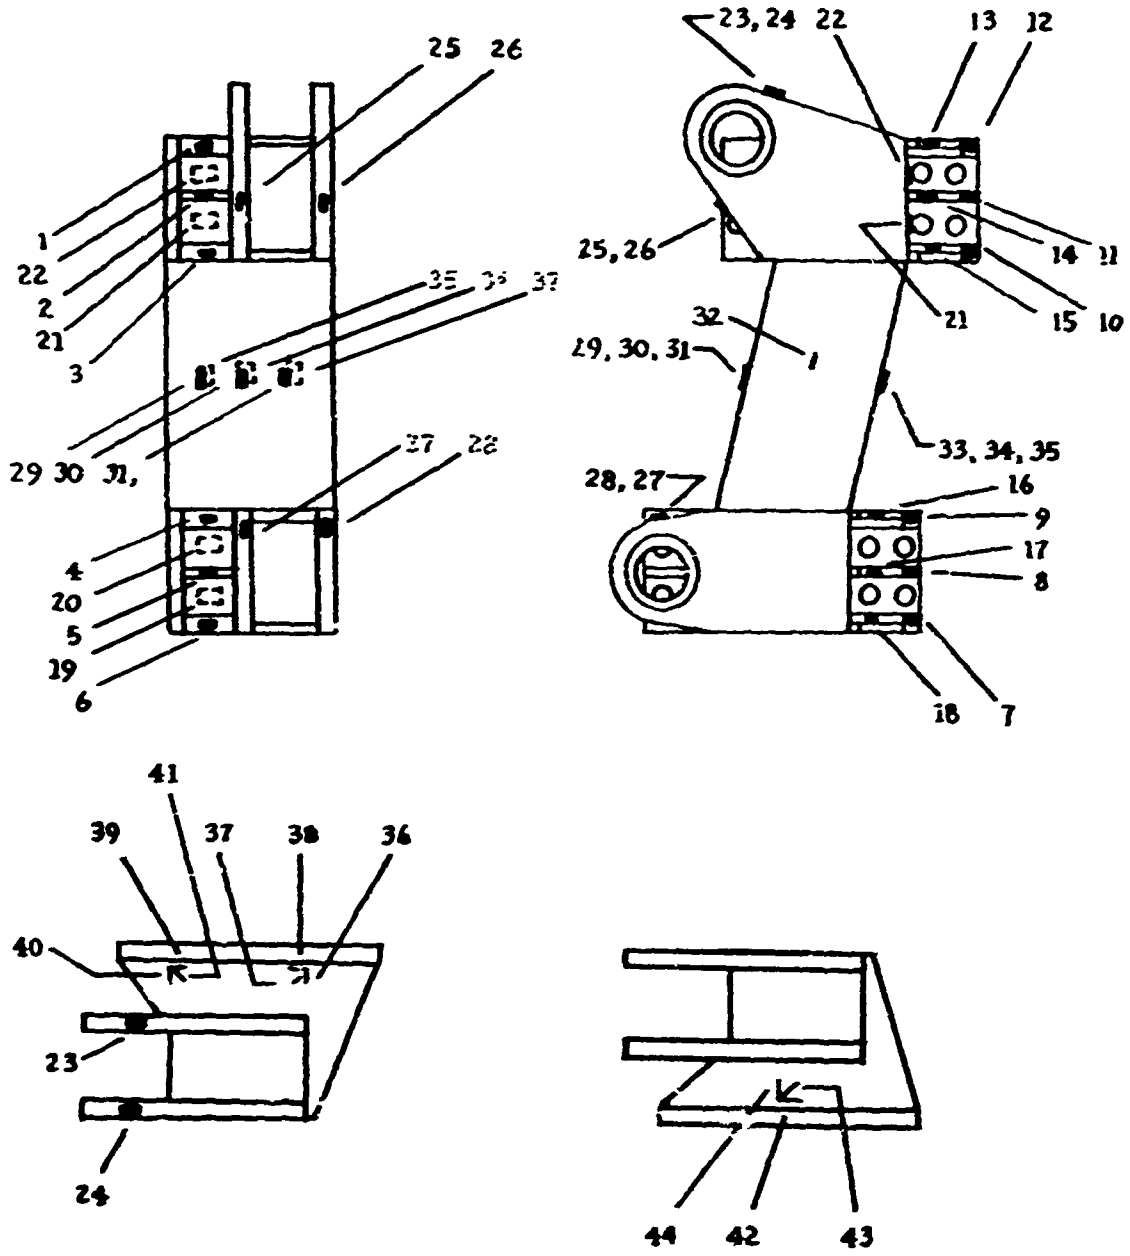
Fig. 35. Strain gage locations.

Dynamic stress recordings were made for the same non-shock, shock, and sideslope shock conditions as before; results of these tests appear in Table X (Strain gage locations are shown in Fig. 35). A rosette placed on the welded mount was gage numbers 45, 46, and 47. The rosette was located on the bottom of the lower mount adjacent to the connecting weld and approximately 3 inches behind the forward edge. Gage number 48 was placed on the centerline of the launching beam in front of the mount pin. This was the area that previously failed under compression. The recorded stresses for the 1/2-inch webs gave no further insight to failure in the 1/4-inch webs.
