U. S. ARMY ENGINEER RESEARCH AND DEVELOPMENT LABORATORIES
FORT BELVOIR, VIRGINIA

Division Report

HUMAN WASTE STUDIES
IN AN
OCCUPIED CIVIL DEFENSE SHELTER

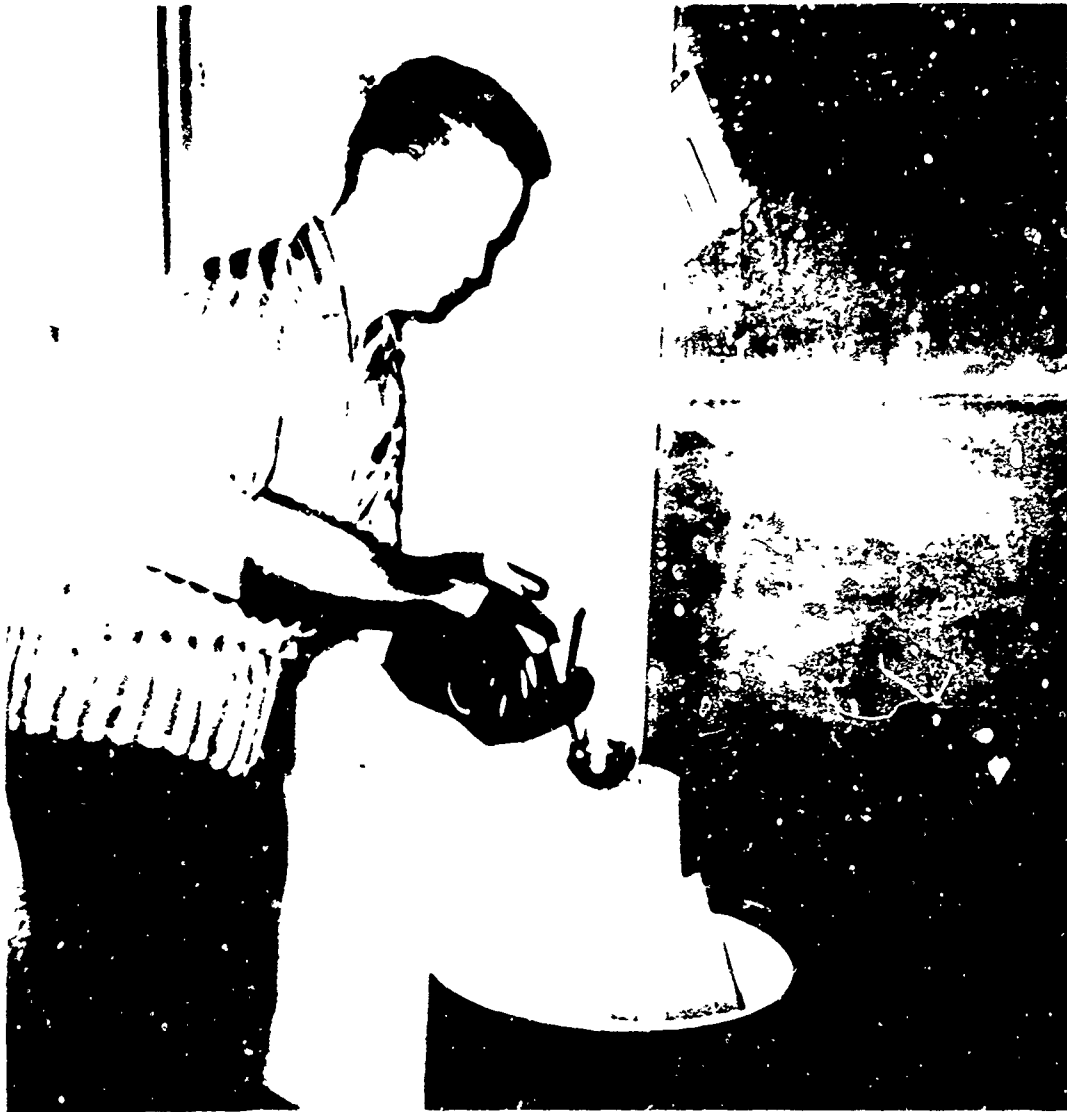
Figure 12. Technician Removing Waste Sample from Dual-Purpose Drum with Ladle.

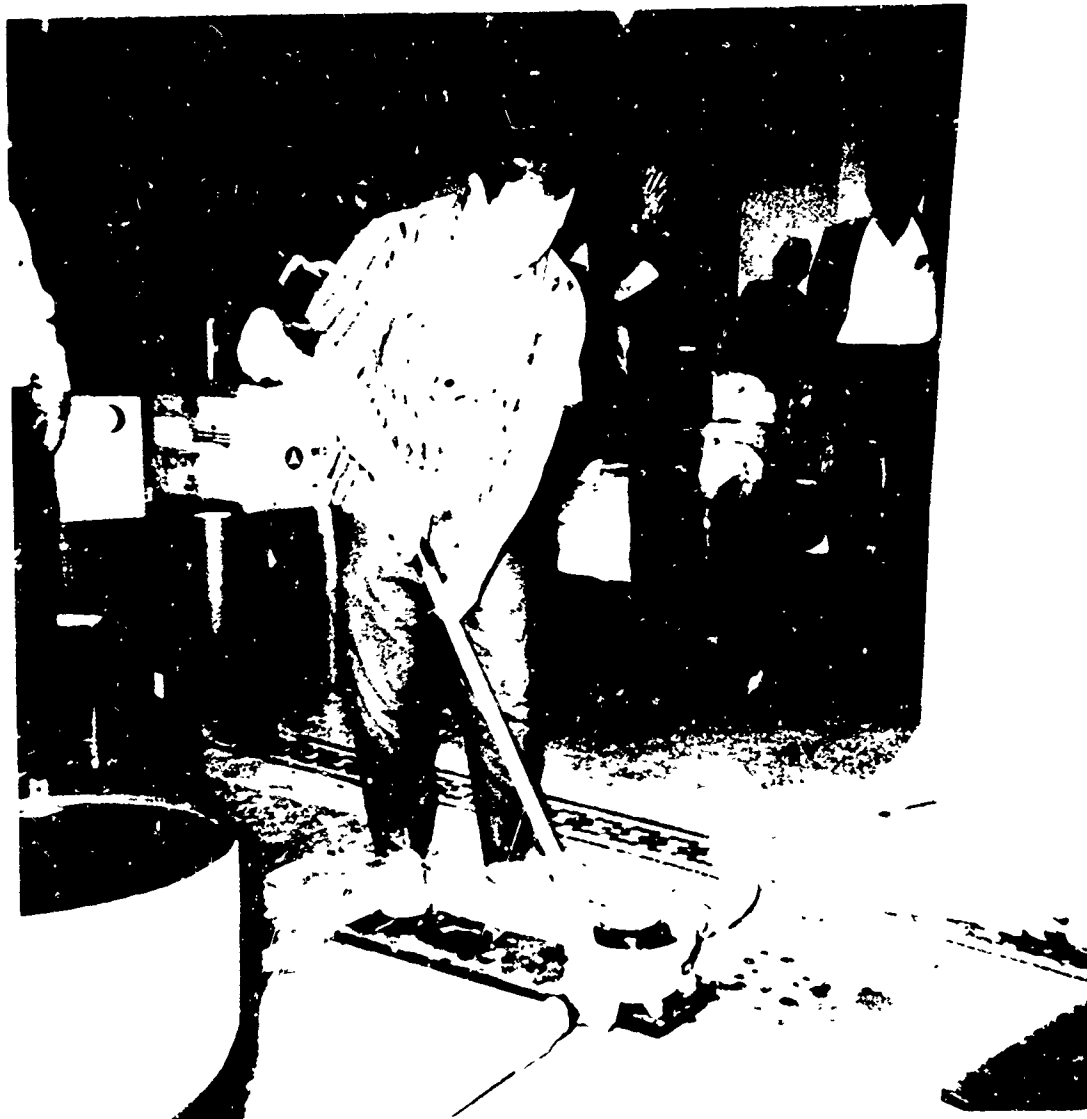
Figure 15. Technician Pumping Waste from Vault D with Diaphragm Pump.
