**ARPA Coupling Program on
Stress-Corrosion Cracking
(Seventh Quarterly Report)**

Sponsored by
*Advanced Research Projects Agency
ARPA Order No. 878*

October 1968

**NAVAL RESEARCH LABORATORY
Washington, D.C.**

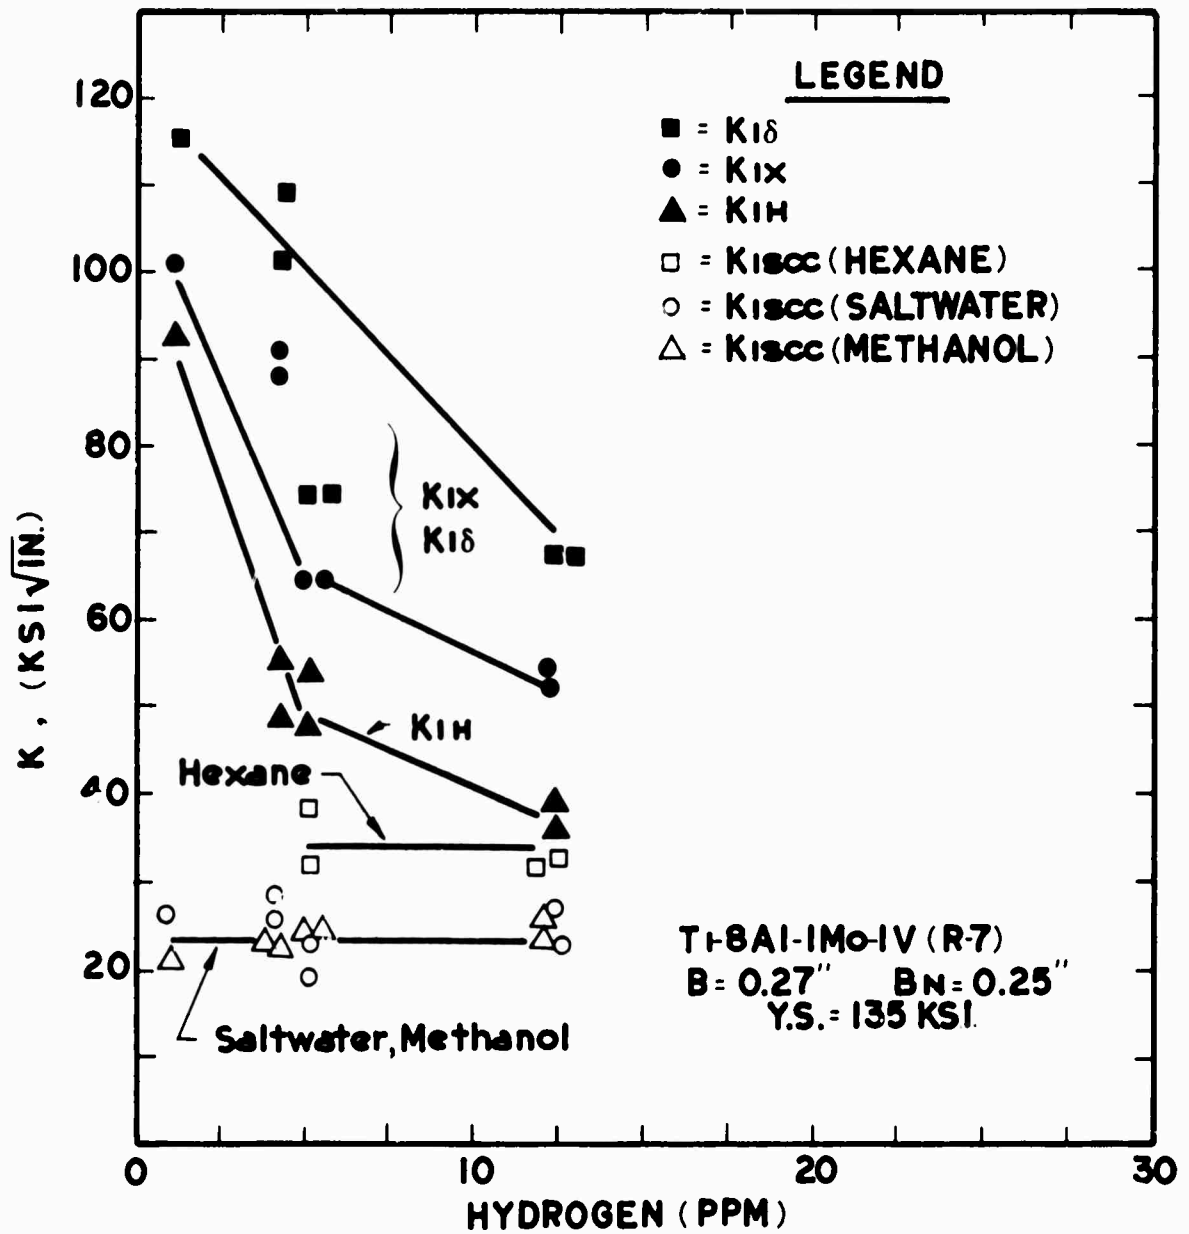
Fig. A-1 - Effect of hydrogen content of Ti-8Al-1Mo-1V (R-7) on fracture toughness and resistance to slow crack growth in air, hexane, salt water, and methanol

At NRL, the effects of hydrogen content on subcritical crack growth for two Ti-8Al-1Mo-1V heats in air, hexane, salt water, and methanol were determined by cantilever-beam testing techniques. The hydrogen content was controlled by vacuum annealing.

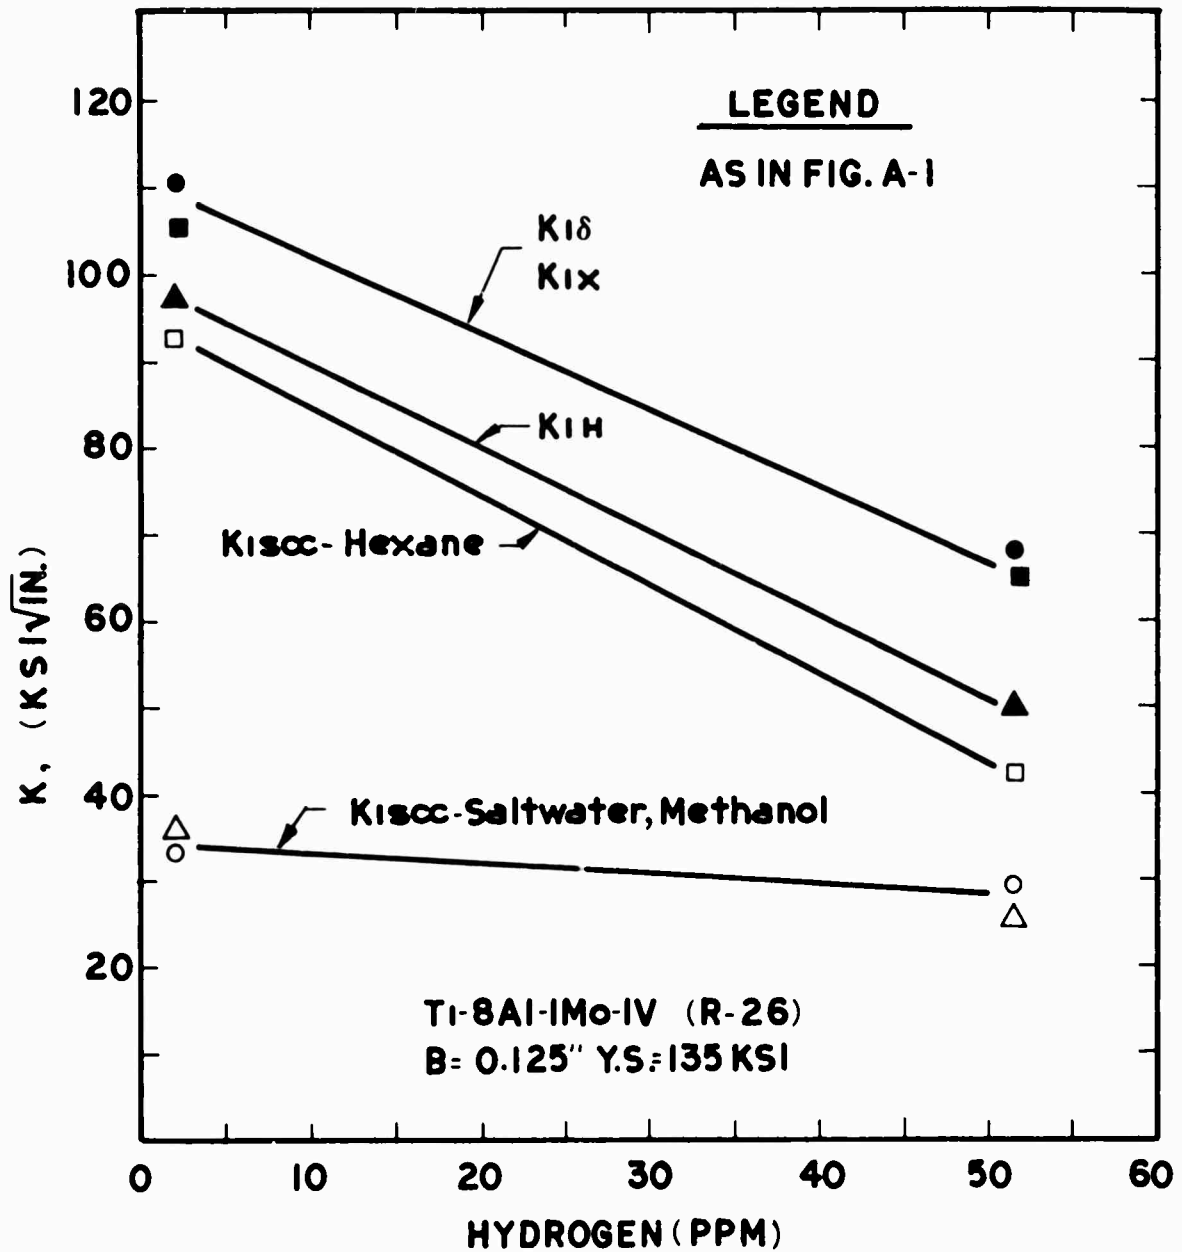
Fig. A-2 - Effect of hydrogen content of Ti-8Al-1Mo-1V (R-26) on fracture toughness and resistance to slow crack growth in air, hexane, salt water, and methanol

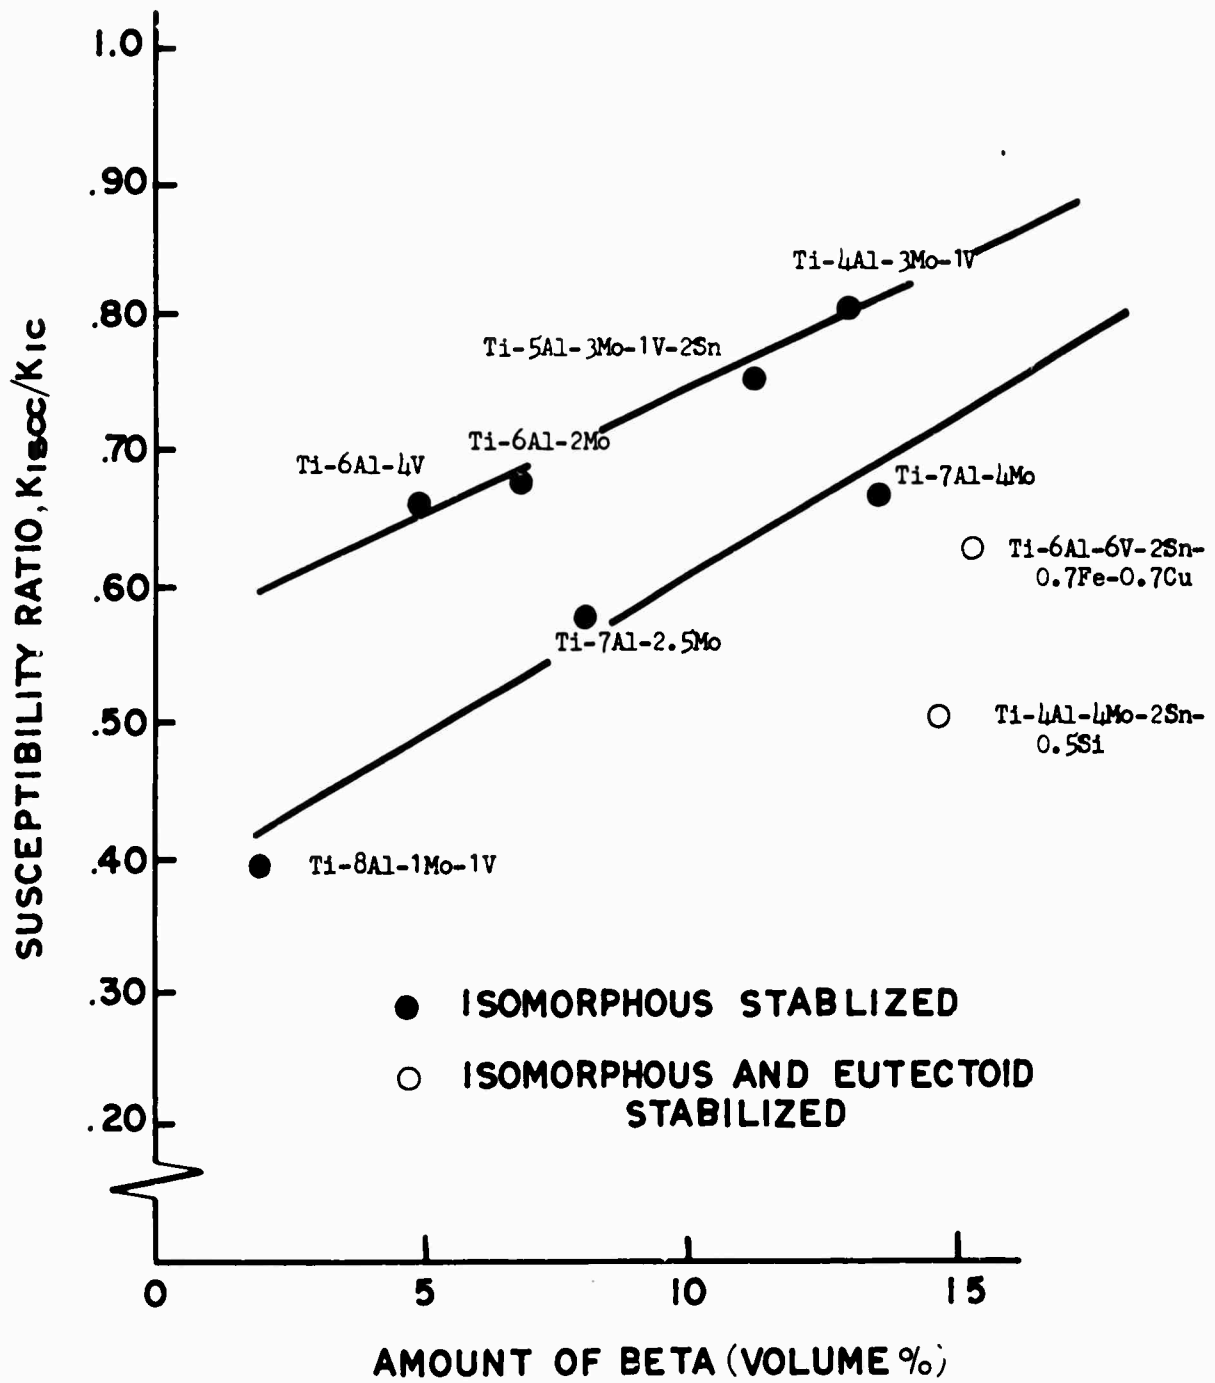
Fig. A-7 - Effect of beta phase on stress-corrosion susceptibility, beta-STA heat treatment.

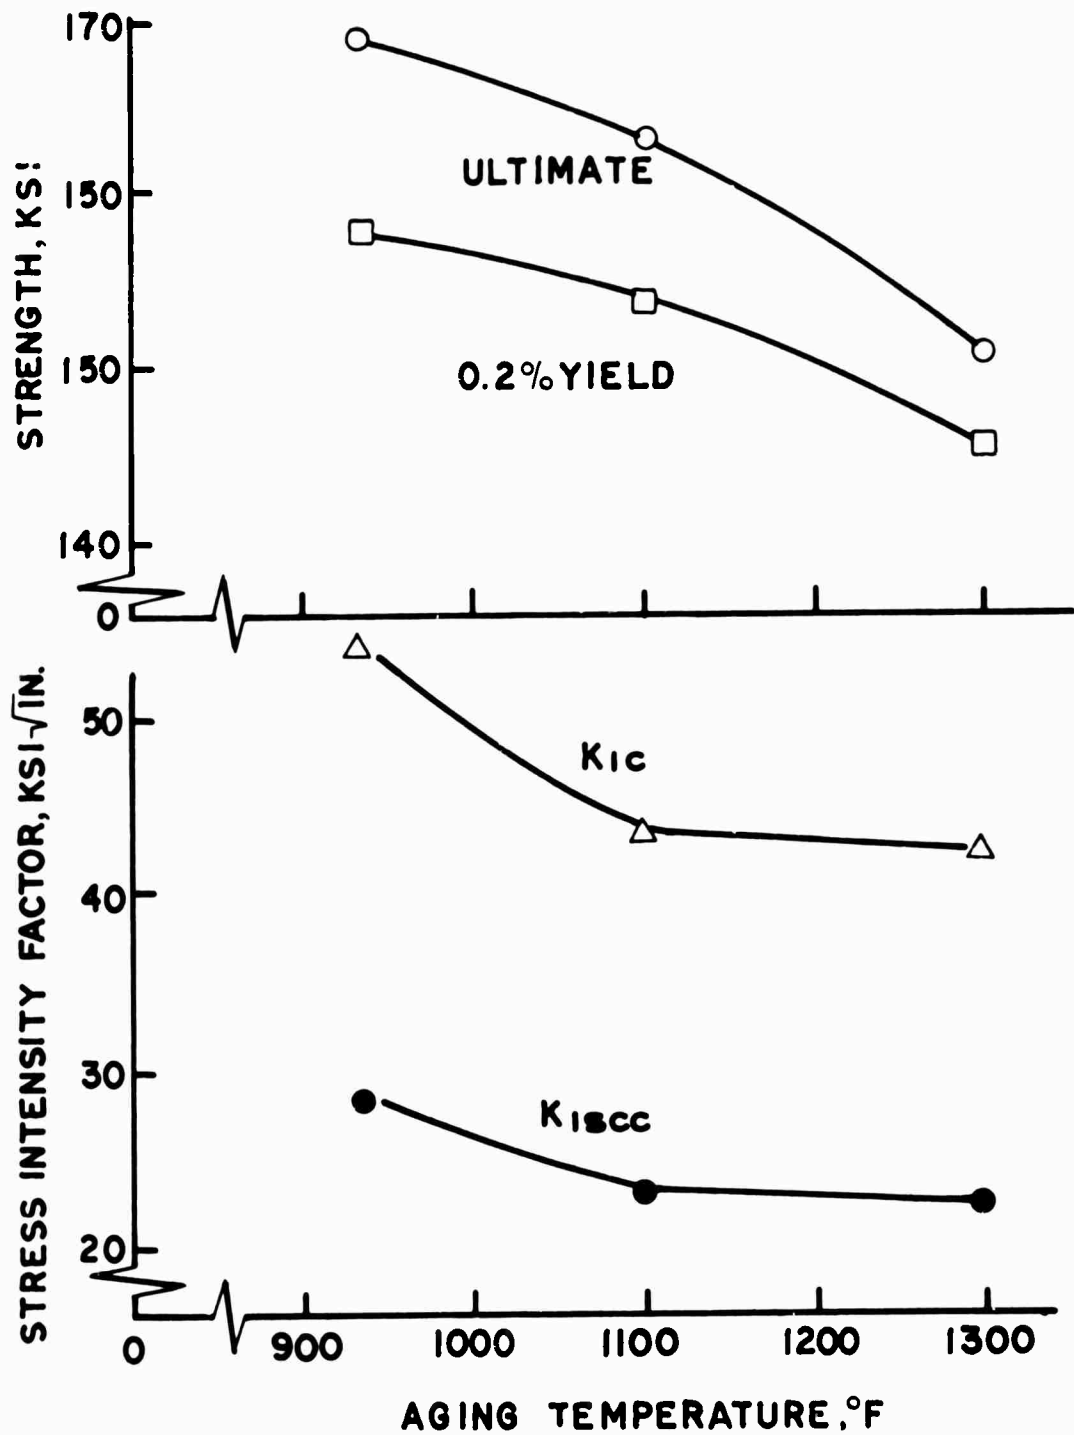
Fig. A-8 - Effect of aging temperature on the properties of Hylite 50: solution heat treated 1650° F/1/2 hr/AC prior to aging for 24 hr at temperature shown.

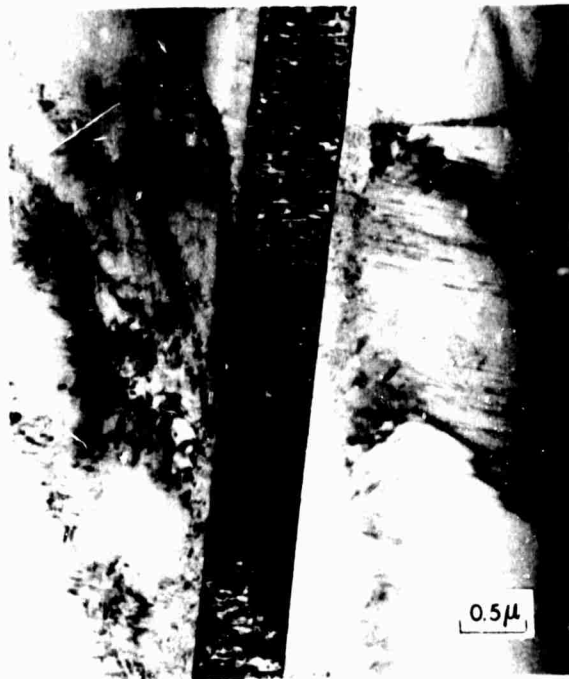
Fig. A-16 - Bright-field electron micrograph of a twin formed during 2% uniform elongation

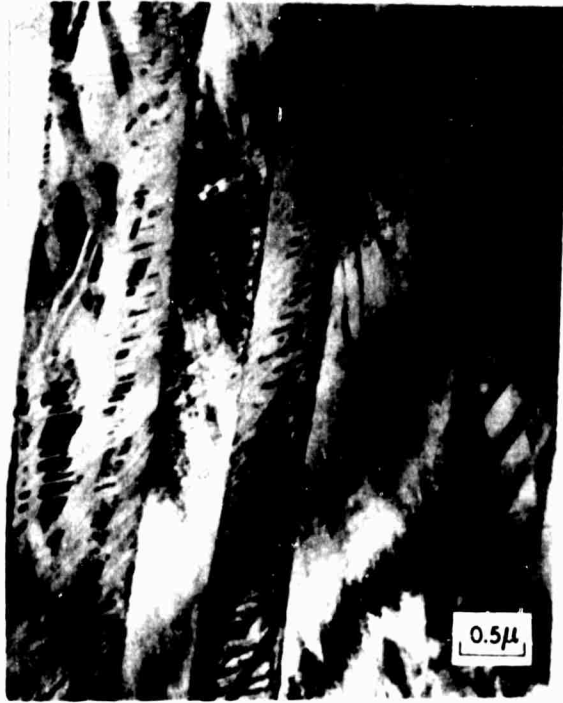
Fig. A-18 - Bright-field electron micrograph of twins formed during 10% uniform elongation

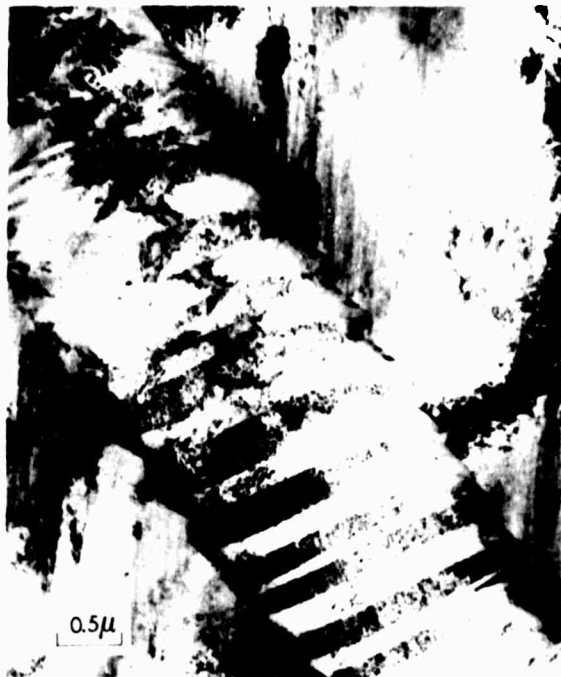
Fig. A-19 - Bright-field electron micrograph of twin formed during 10% uniform elongation

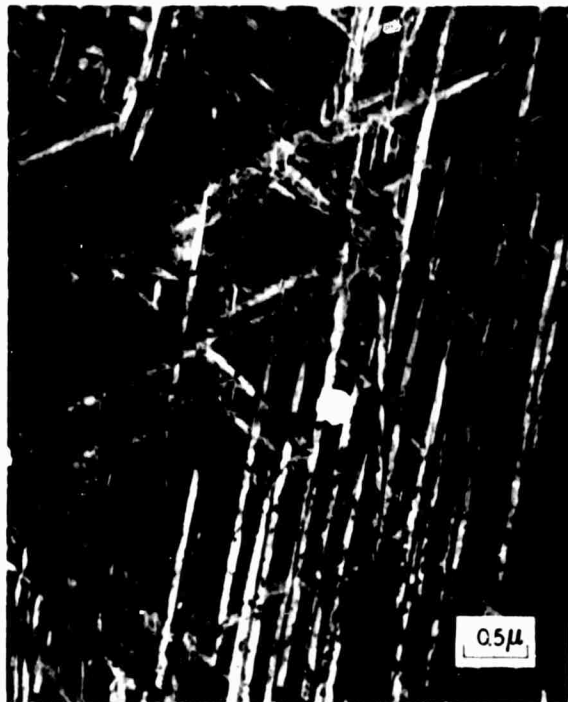
Fig. A-22 - Bright-field electron micrograph of Widmanstätten alpha formed during aging at 850° F for 64 hr.

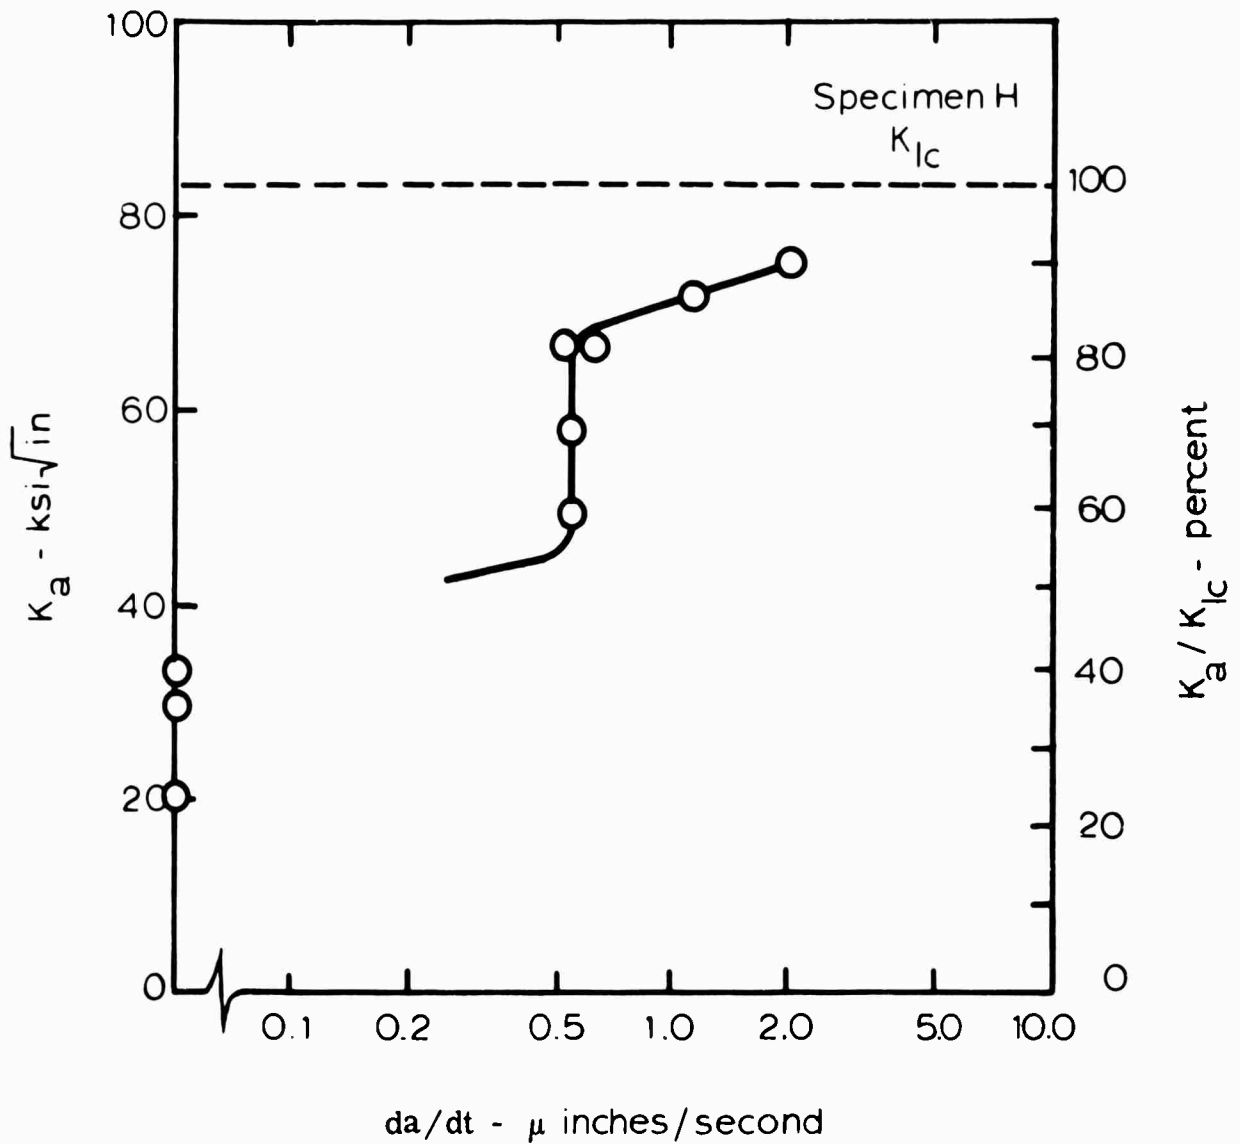
Fig. B-1 - Crack Growth Rate, da/dt , versus Applied Stress Intensity Factor K_a , and Ratio of K_a to K_{Ic} for 18Ni(250) Maraging Steel; Fully Heat Treated. Specimen Immersed in a 3-1/2% NaCl Solution at Room Temperature. Specimen with 25 percent Total Face Grooves (1/8 inch Cylindrical Grooves).

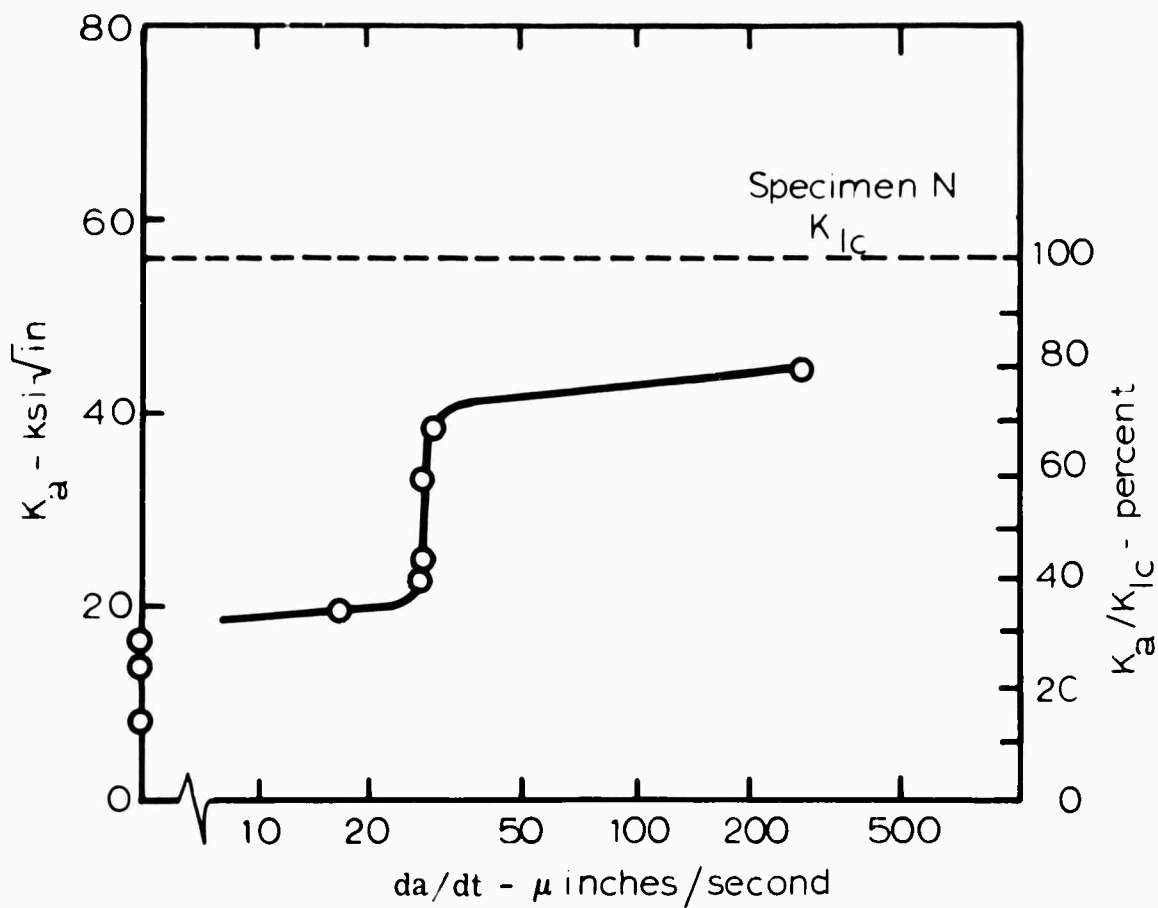
Fig. B-2 - Crack Growth Rate, da/dt , versus Applied Stress Intensity Factor, K_a , and Ratio of K_a to K_{Ic} for AISI 4340 M Steel, Tempered for 2 hours at 550° F. Specimen Immersed in a 3-1/2% NaCl Solution at Room Temperature. Specimen with 50 percent Total Face Grooves (1/8 inch Cylindrical Grooves).

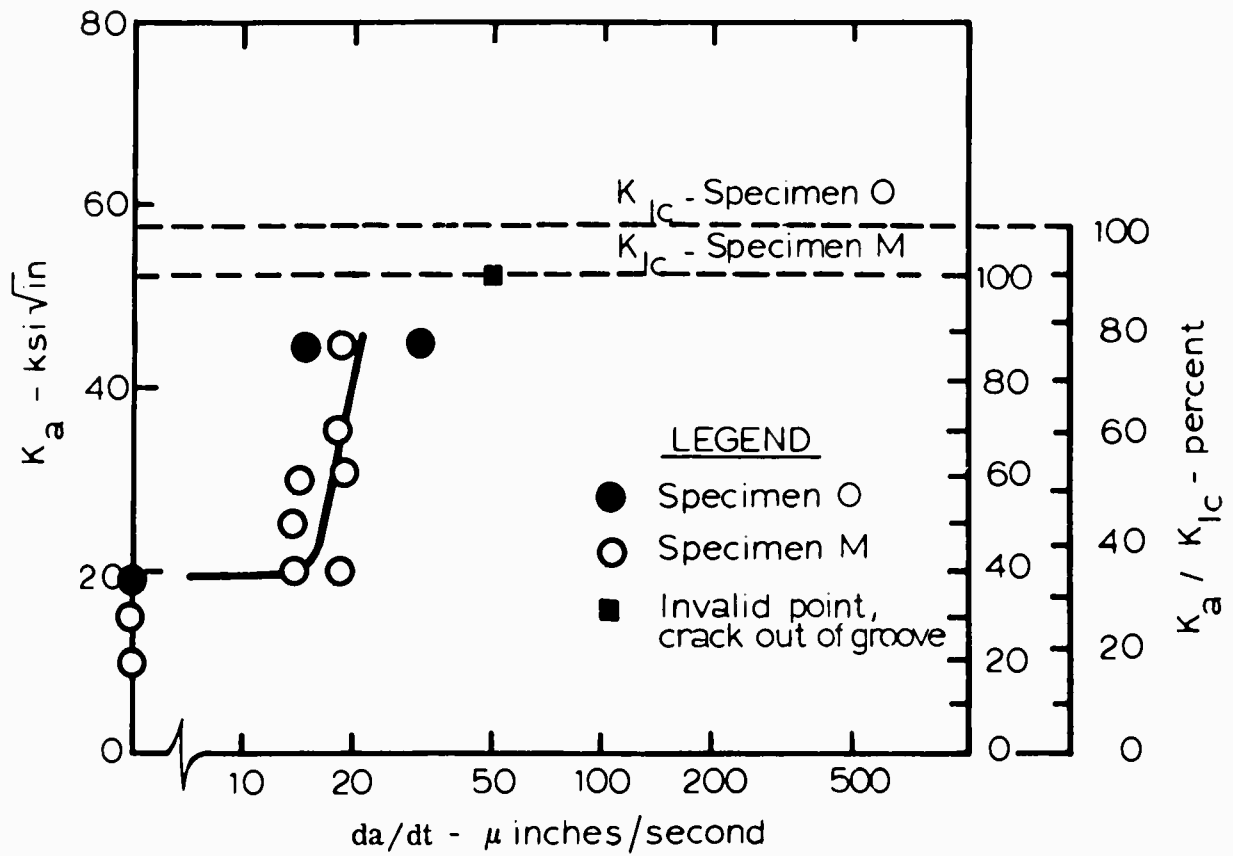
Fig. B-3 - Crack Growth Rate, da/dt , versus Applied Stress Intensity Factor, K_a , and Ratio of K_a to K_{Ic} for 9Ni-4Co-45C Steel. Specimen immersed in a 3-1/2% NaCl Solution at Room Temperature. Specimen M with 25 percent and Specimen O with 50 percent Total Face Grooves (1/8 inch Cylindrical Grooves).

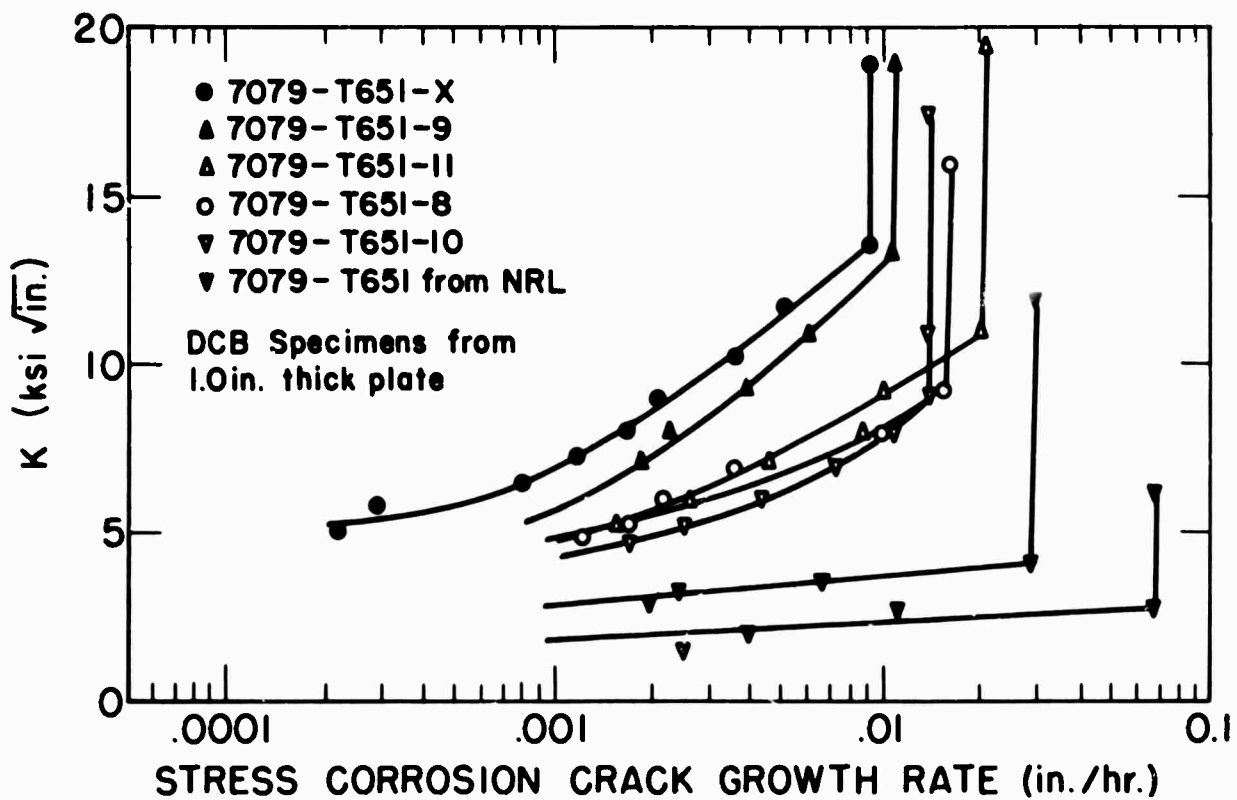
Fig. C-3 - K vs SCC Growth Rate Curves for 7079-T651 subjected to intermittent wetting in 3.5% NaCl solution, except as noted

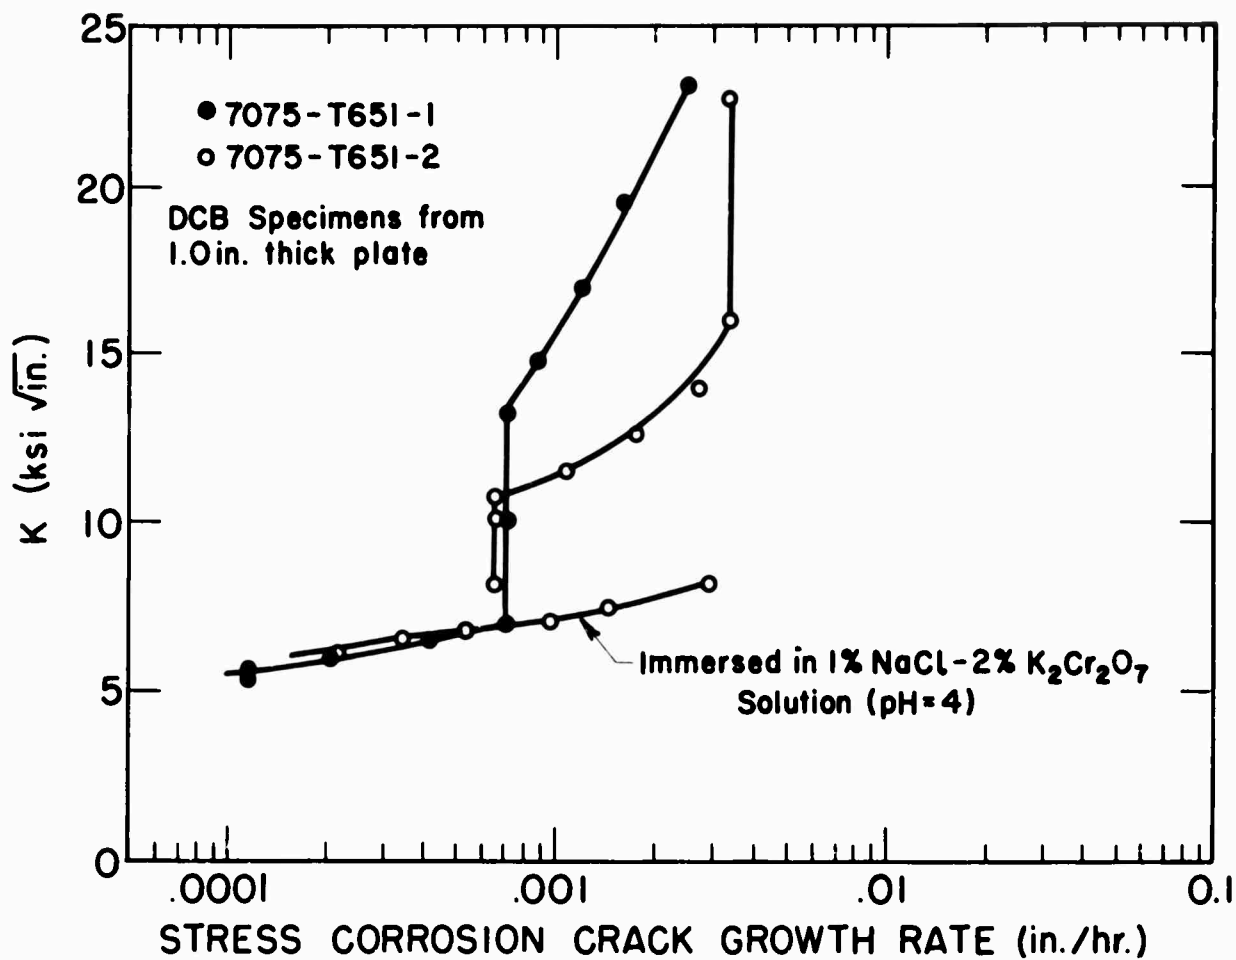
Fig. C-4 - K vs SCC Growth Rate Curves for 7075-T651 subjected to
 intermittent wetting in 3.5% NaCl solution, except as noted

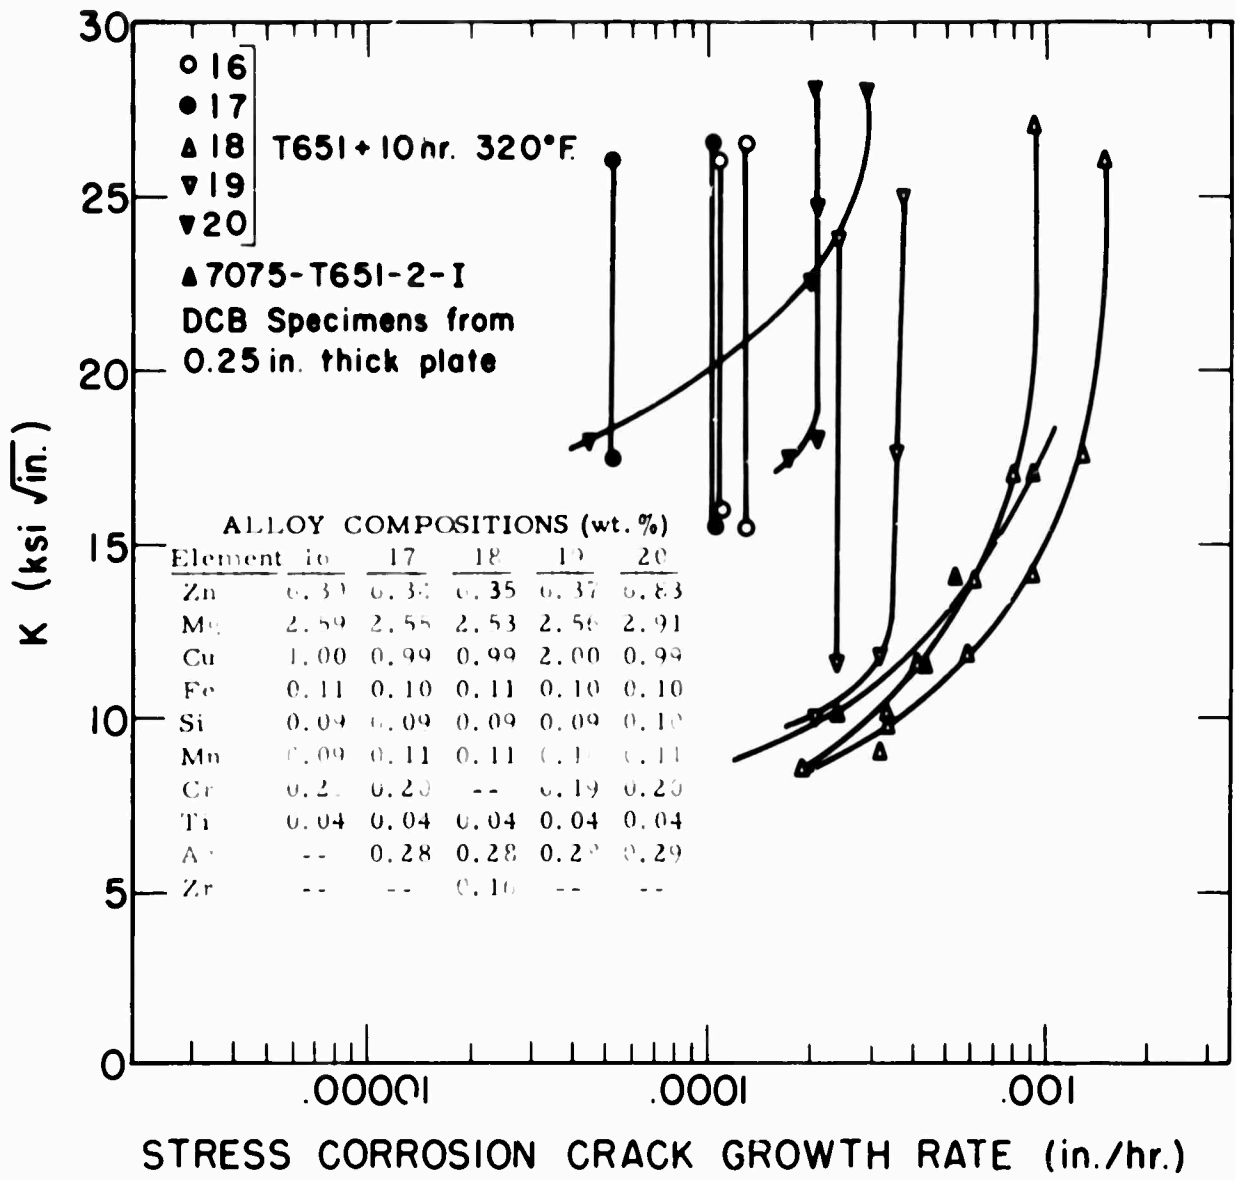
Fig. C-5 - K vs SCC Growth Rate Curves for 7075-T651 and Experimental 7000 Series Alloys subjected to intermittent wetting in 5% NaCl solution

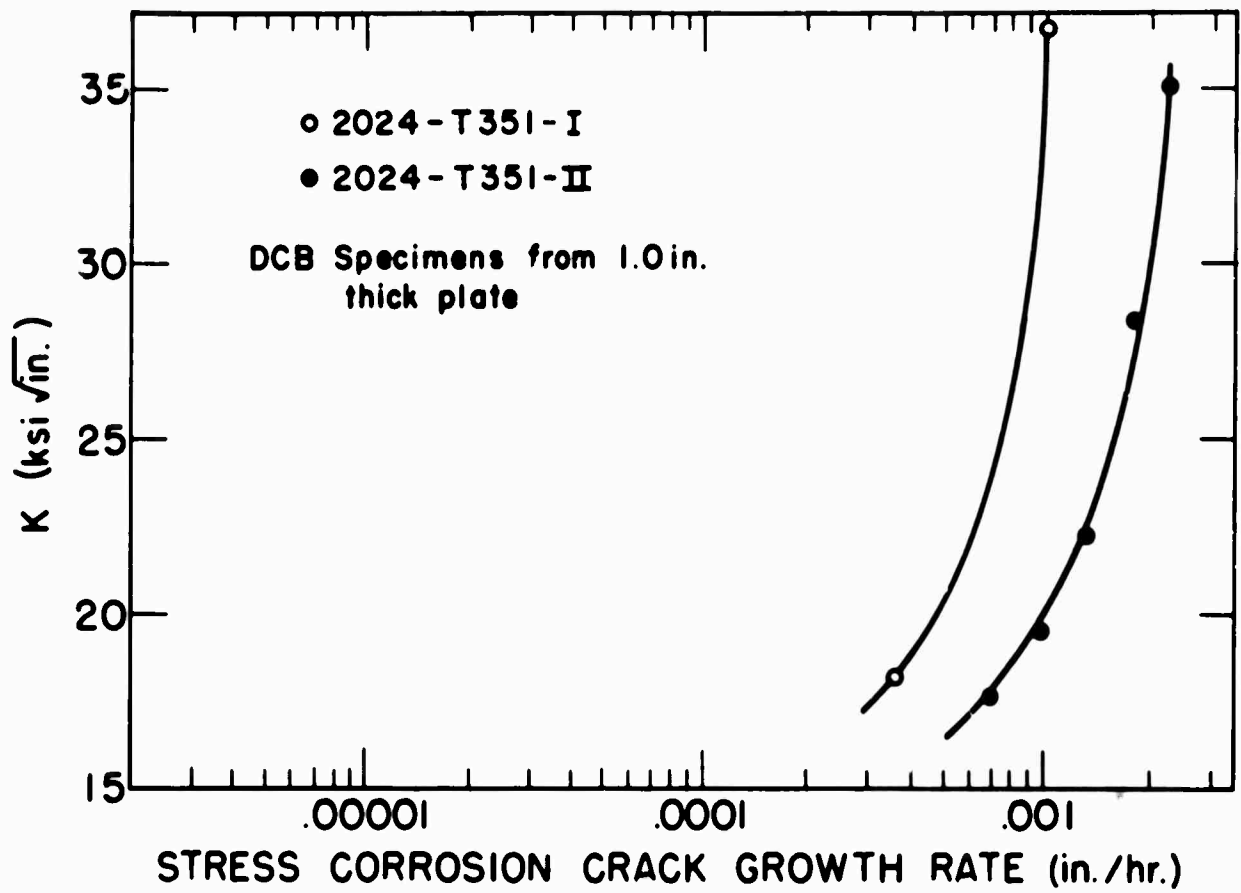
Fig. C-6 - K vs SCC Growth Rate Curves for 2024-T351 subjected to intermittent wetting in 3.5% NaCl solution

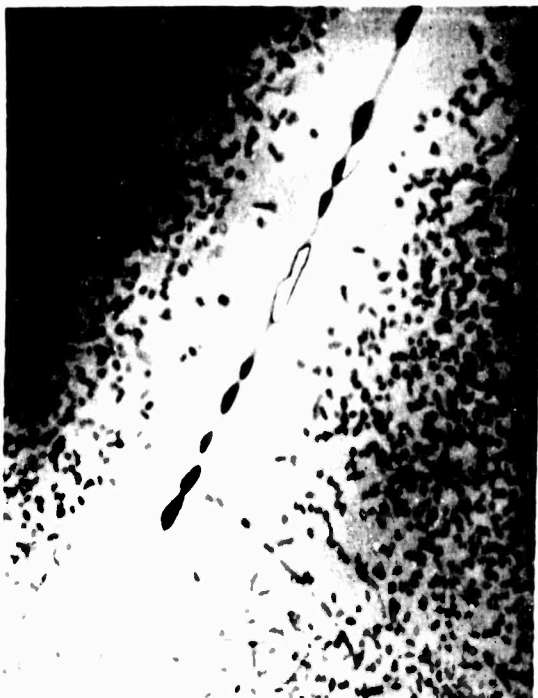
Fig. C-8 - Type 1 specimen underaged.
×60,000 0.2% Proof Stress = 40,000 p.s.i.

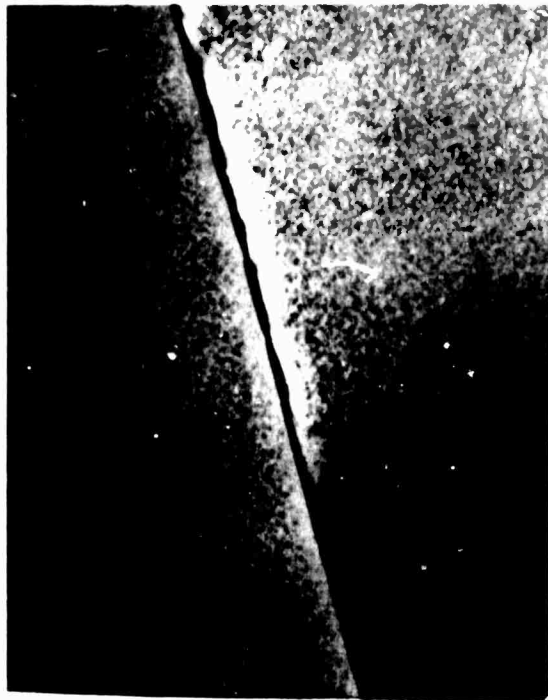
**Fig. C-9 - Type 2 specimen underaged.
× 100,000 0.2% Proof Stress = 40,000 p.s.i.**

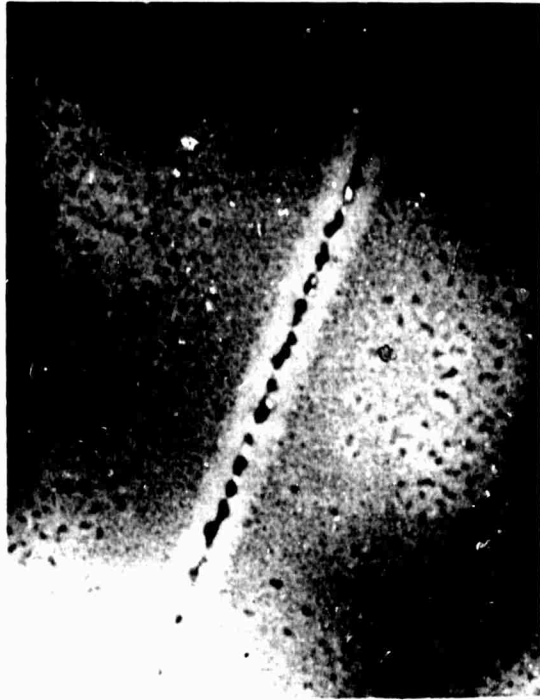
Fig. C-10 - Type 3 specimen underaged.
× 80,000 0.2% Proof Stress = 40,000 p.s.i.

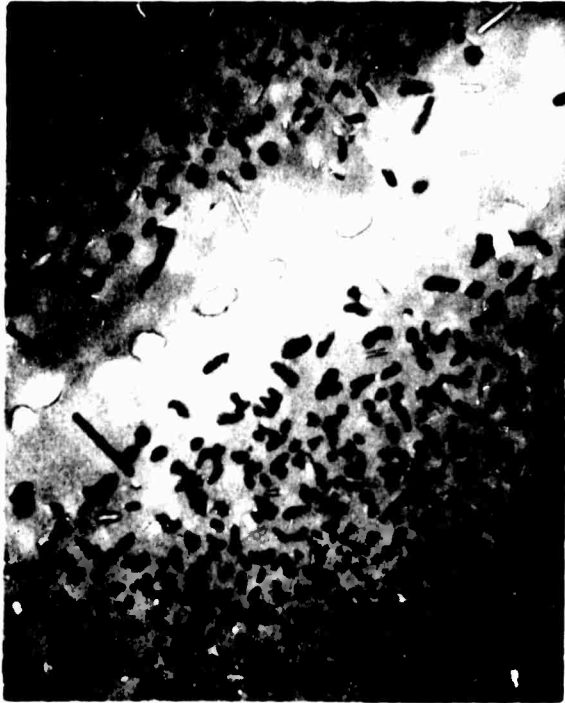
Fig. C-11 - Type 1 specimen underaged.
× 60,000 0.2% Proof Stress = 40,000 p.s.i.
