# USAF Nuclear Safety

AFRP 122-1 JAN/FEB/MAR 1970, NO. 1

## PROJECT CRESTED ICE

# EVALUATION OF POSSIBLE HAZARDS

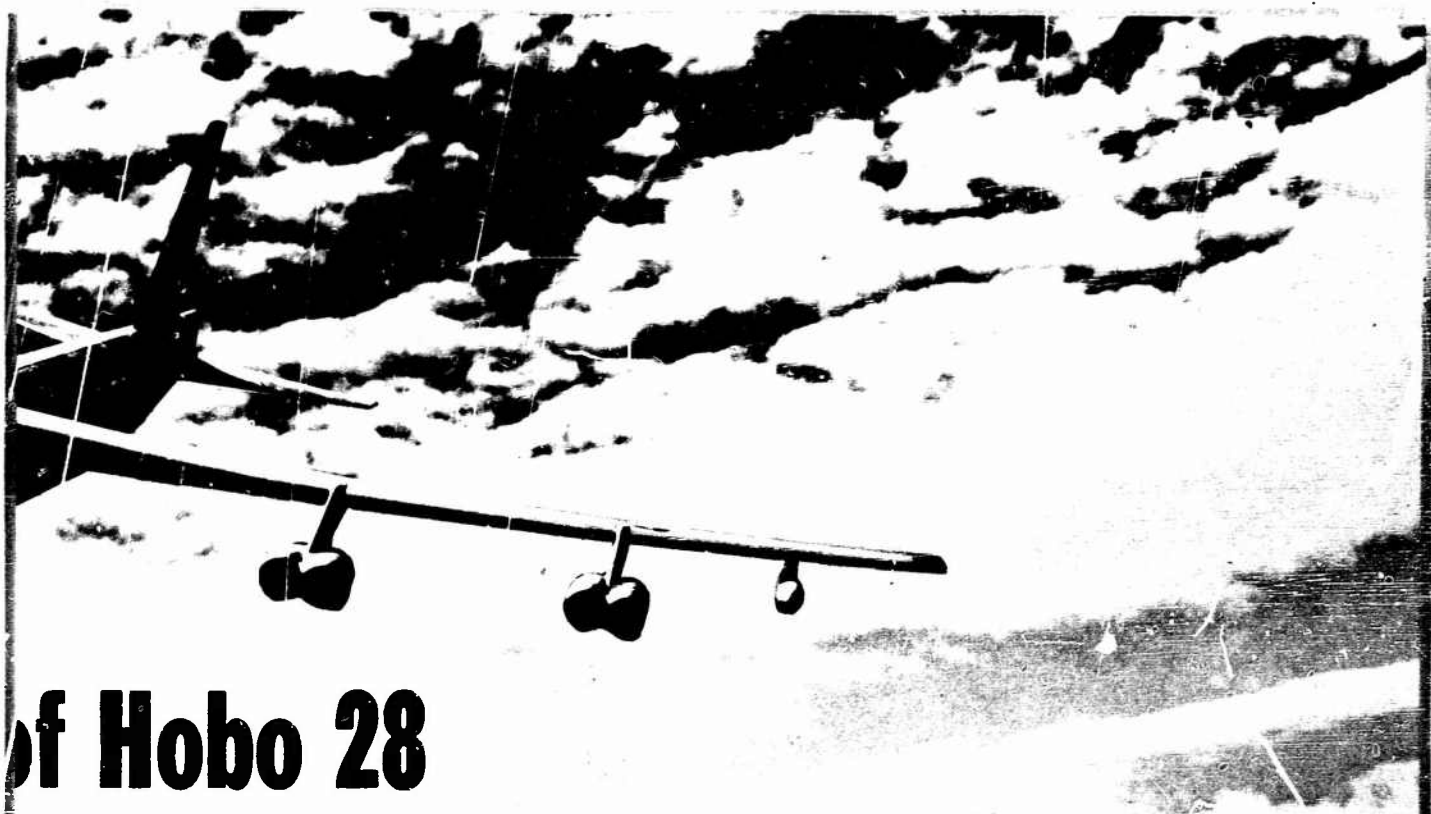
Crash path prior to impact on the ice.

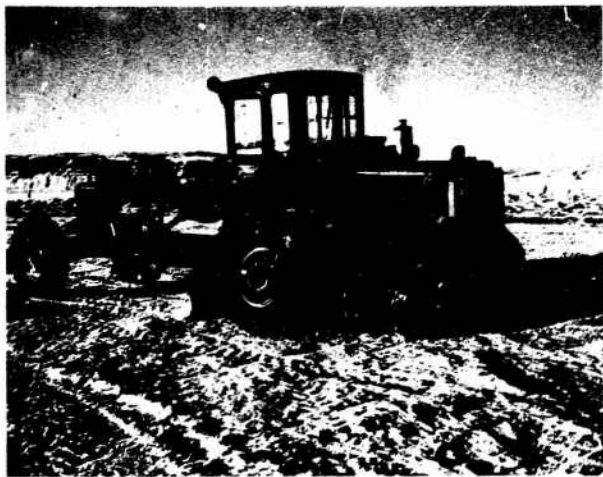
Equipment failure—road grader with broken front axle.

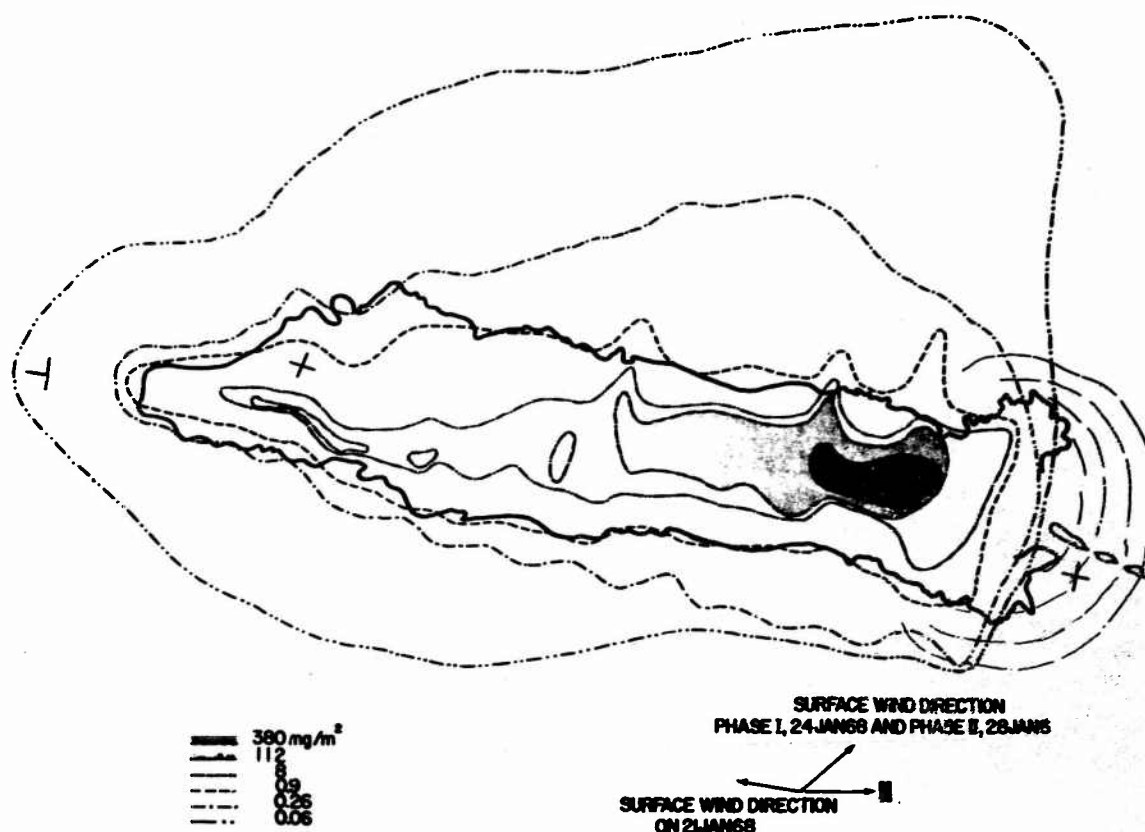
Figure 1 Plutonium contamination levels observed.

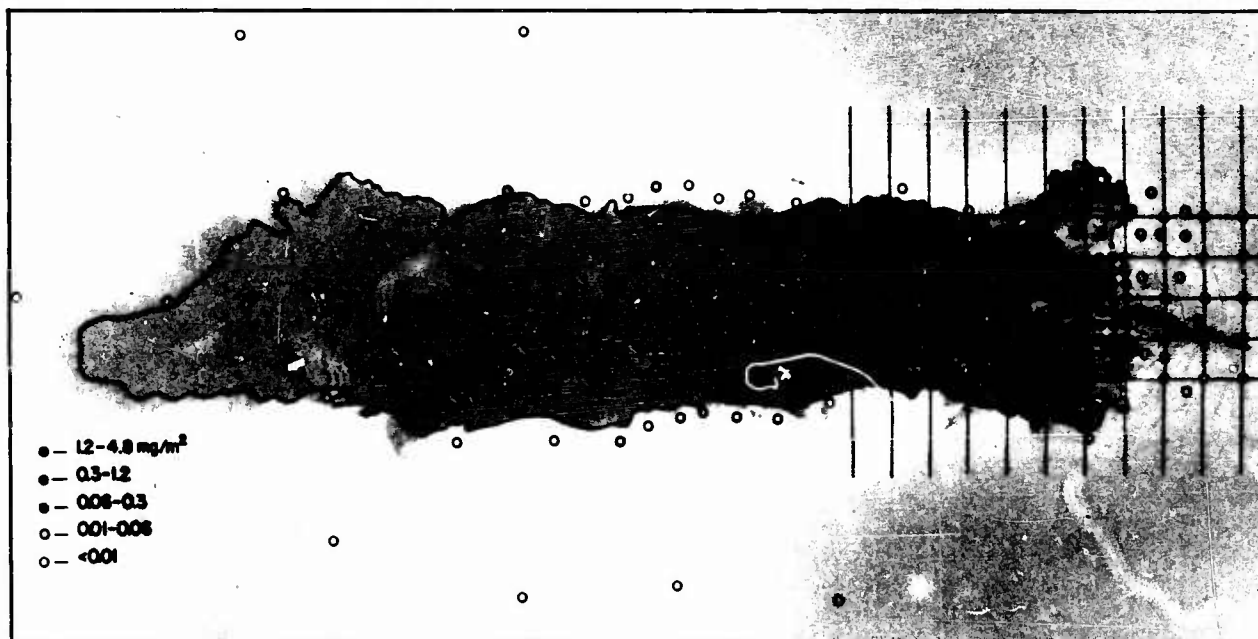
Figure 2 Ice core sample locations.

The fact that cores were scanned inch by inch permitted a crude statistical estimate of the depth-distribution of the plutonium in the ice. It appeared that about 13 per cent of the total plutonium in the crushed and refrozen area was in the top 2 inches, 36 per cent was in the top 4 inches, and 45 per cent was in the top 6 inches. About 15 per cent was in the bottom 10 inches. The remaining 40 per cent was distributed between 6

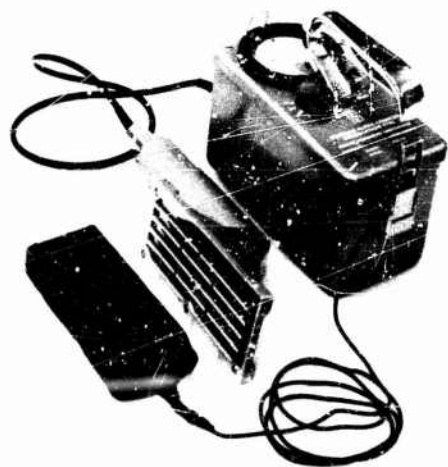
PAC-1S with external battery pack.

Both instruments were operational upon arrival at the crash site but the carbon zinc batteries in the PDR-27 and the mercury batteries in the PAC-1S soon failed in the extreme cold (-30°F). Neither type of battery is rated below 0°F. During the short operational period no beta-gamma radiation was detected with the PDR-27; however, using the PAC-1S, widespread alpha contamination was detected on the surface of the snow, ice, and aircraft debris.

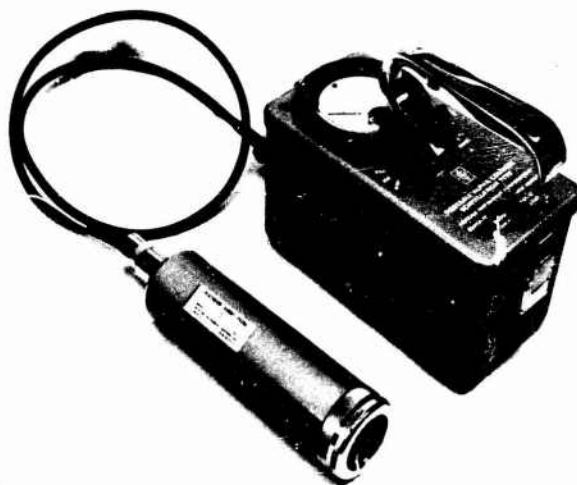
PAC-1S with PG-1.

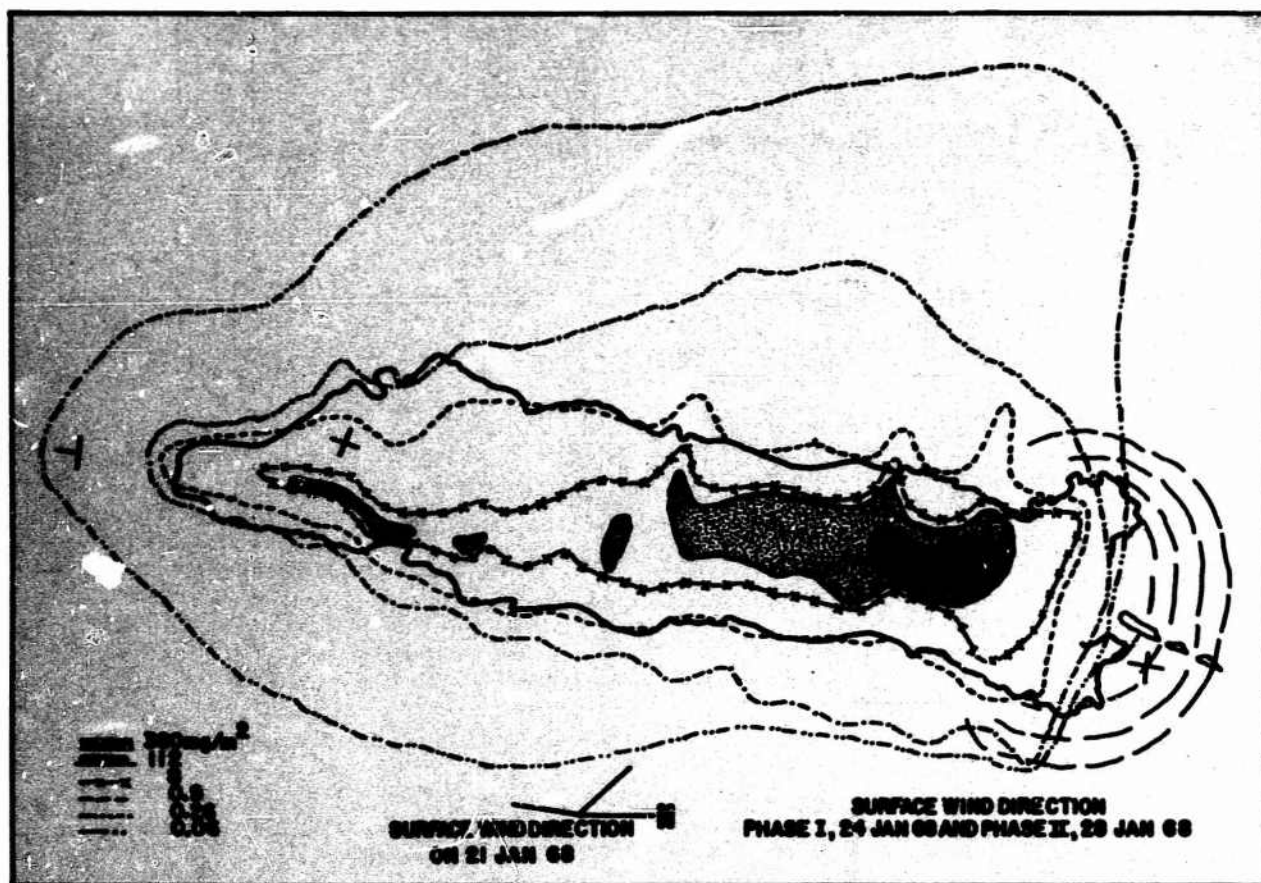
Isocontour map of plutonium contamination.

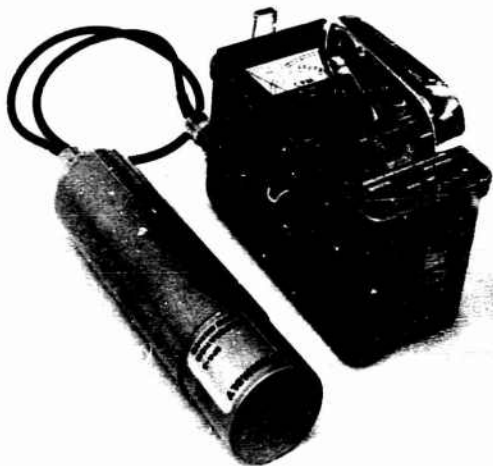
PMR-5 with SPA-3.

Still another application of radiac instrumentation was employed at Thule. The PRM-5 analyzer and the SPA-3 scintillation detector were used in search for weapons components. The SPA-3 detector contains a 2x2-inch NaI(Tl) crystal coupled to a 2-inch photomultiplier tube. This device is particularly suited for detecting 185KEV gamma rays from the uranium 235 used in various weapon components.

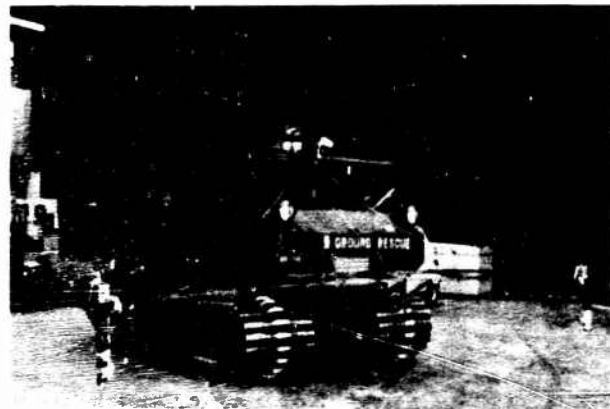
SPA-3 probes on the weasel.

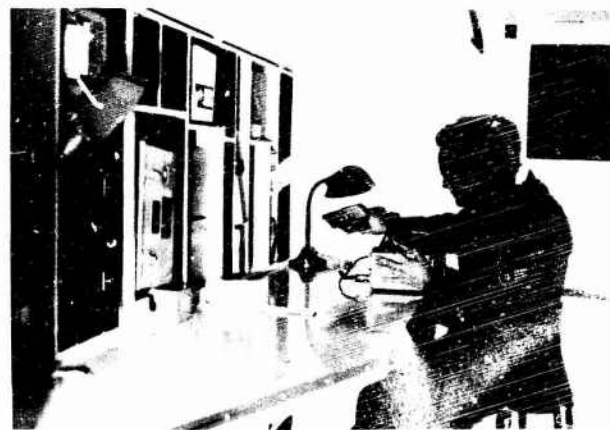
Inside the air-transportable radiac package.

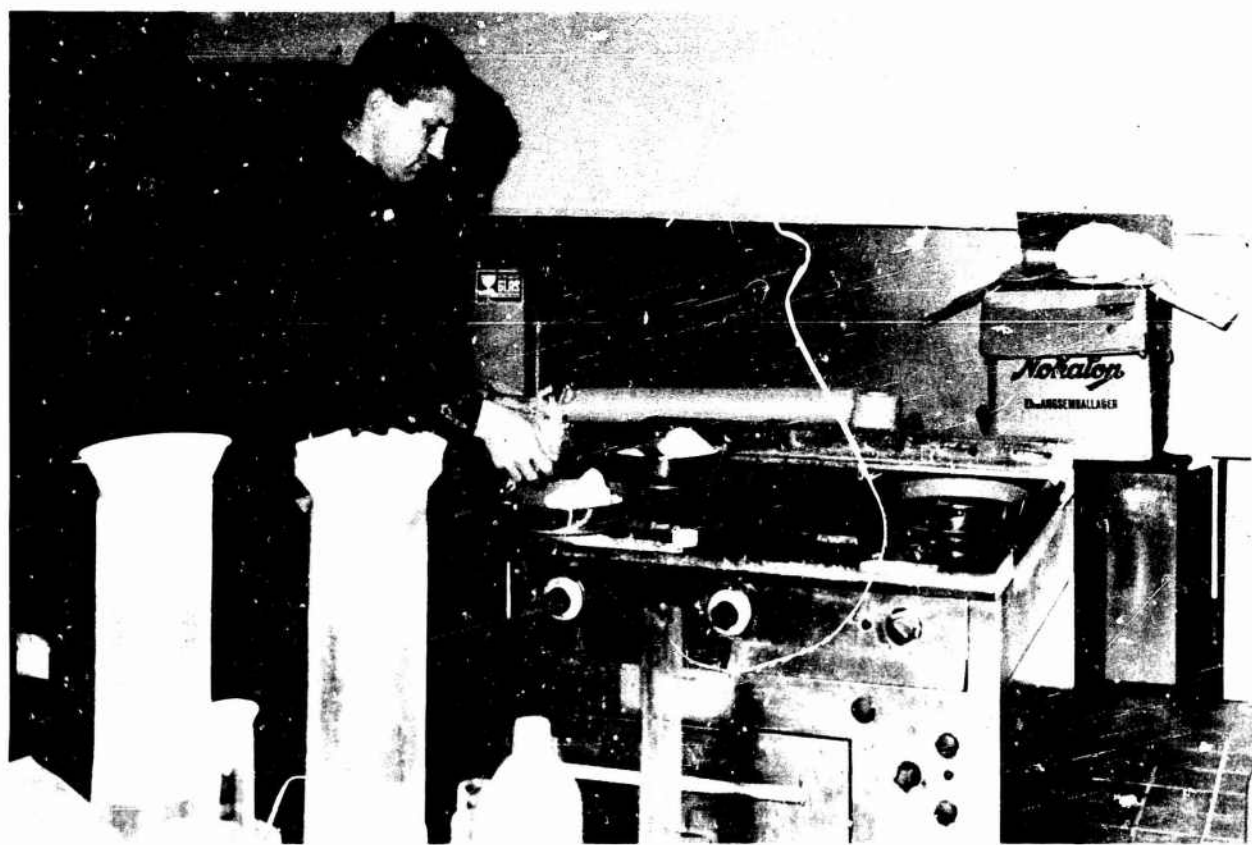
Figure 2. Melting and evaporation of snow samples.

The six snow samples from each location were bulked in the laboratory where they were melted and partially

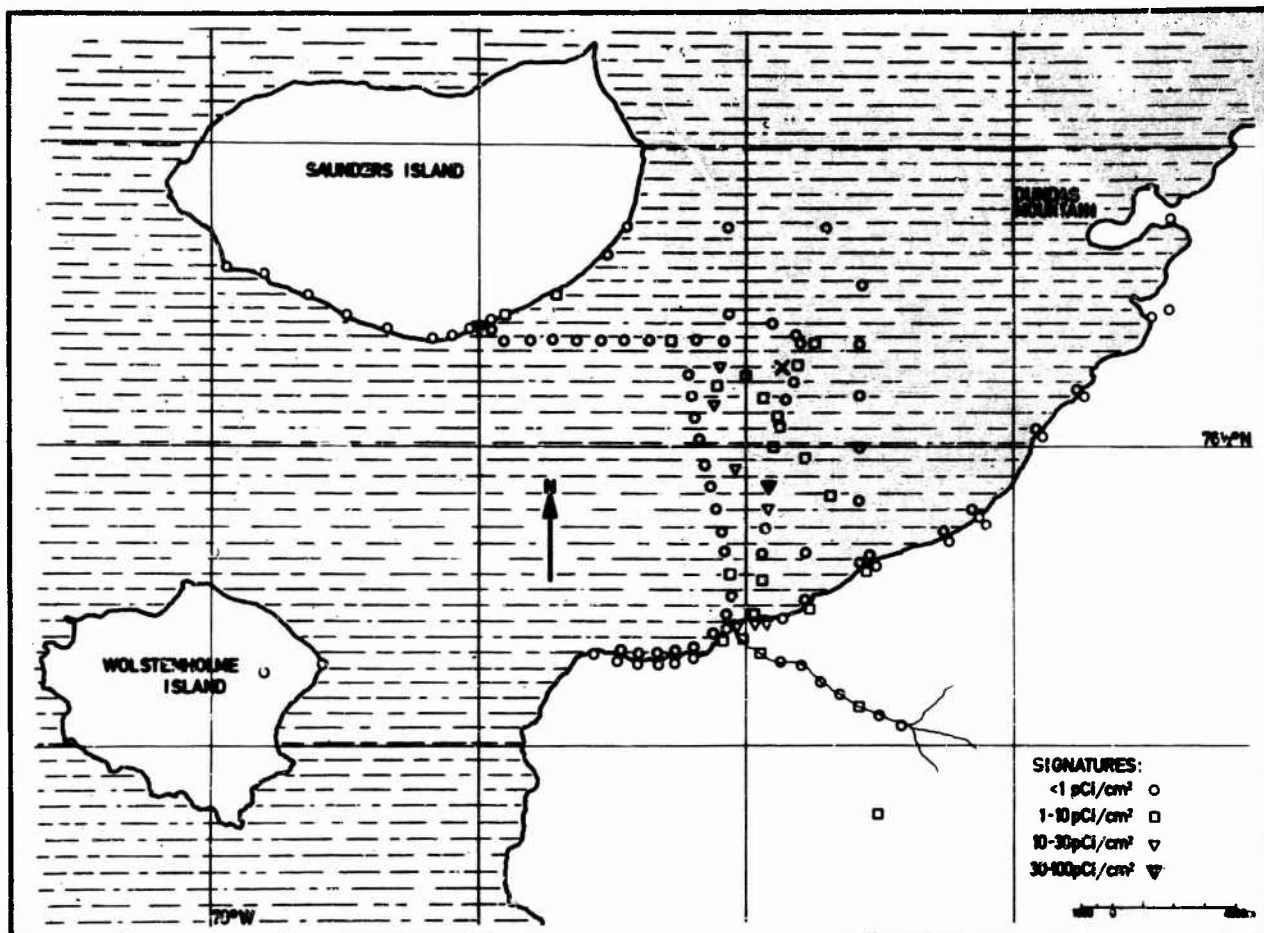
Figure 3. Map of the Bylot Sound area showing plutonium contamination levels. The point of impact is marked with a cross.

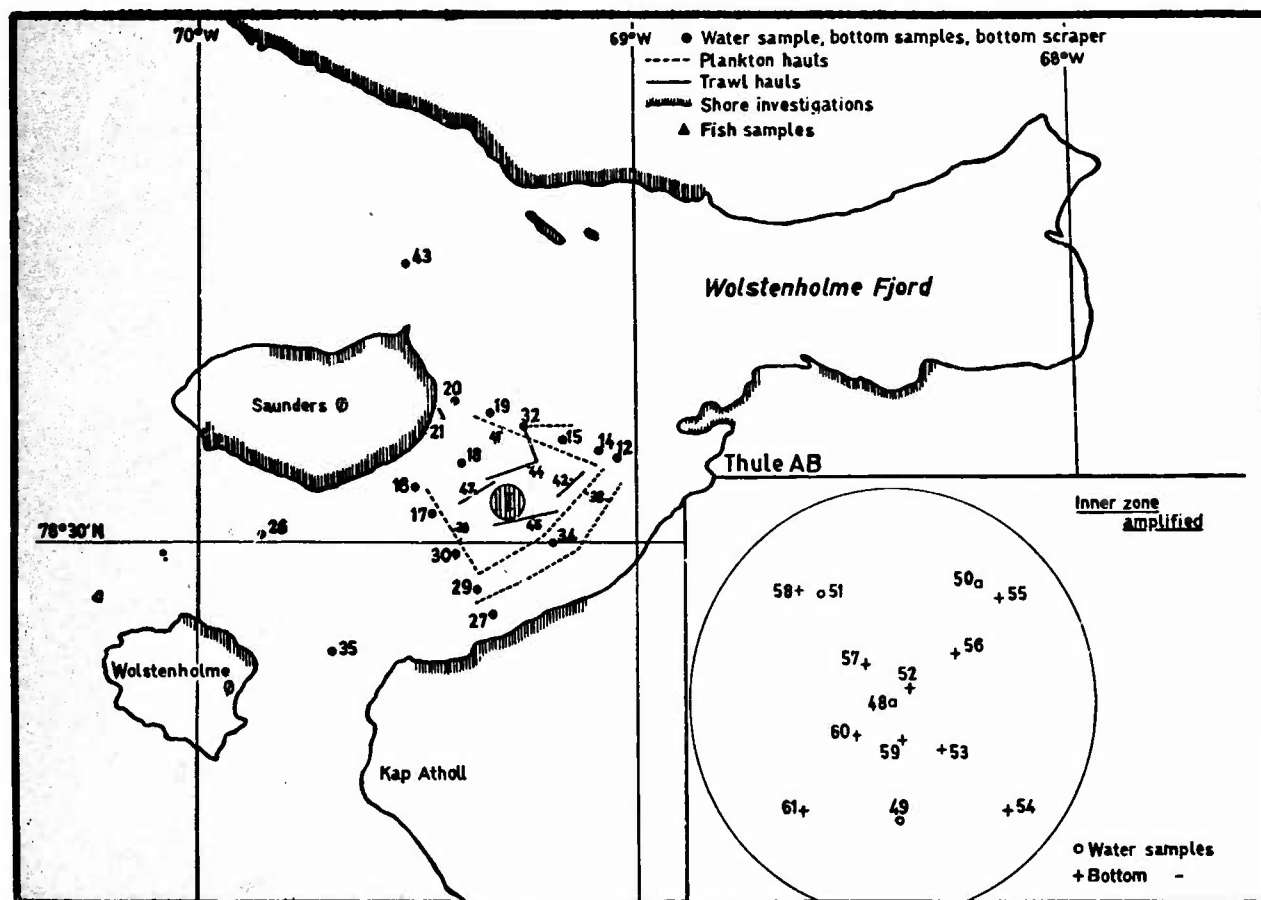
Map showing the sea stations where samples of water, sea bottom, and animals were collected.

- 250 water samples from bottom to surface, collected for hydrographical purposes at 22 stations.
- 4 water samples, each of 100 litres, from Zone 1 (the impact area).
- 14 water samples, each of 50 litres, from Zone 2 (outside the impact area).
- 10 samples of bottom material from Zone 1.
- 10 samples of bottom material with animals, including bivalves, from Zone 1.
- 14 samples of bottom material from Zone 2.
- 25 dredge hauls for bottom animals at 14 stations in Zone 2.
- 6 trawl hauls for *Crustacea* and fish in Zone 2.

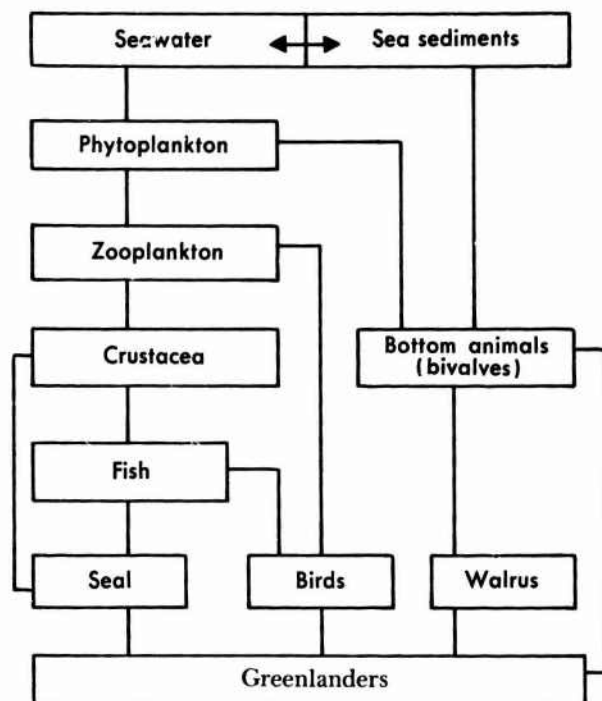
Figure 1 Food chains in an arctic, marine environment.

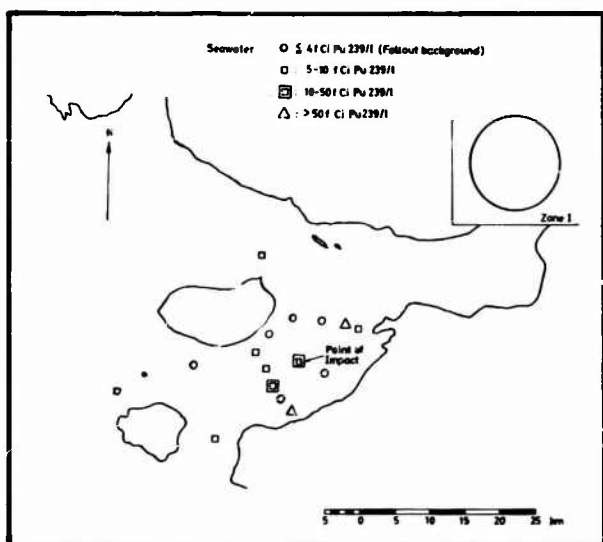
Figure 6 Pu 239 levels in seawater. Thirteen samples were collected in zone I.

- *Sea water.* In Figure 6 the results of the seawater analysis are shown. The maximum for water samples was 76 fCi Pu 239/litre found in a sample collected approximately 5 km west of Dundas Mountain. The median fallout background in seawater from five Greenland locations far away from Thule (Danmarkshavn, Angmagssalik, Prins Christians Sund, Godthåb, and Godhavn) was 4 fCi Pu 239/litre as compared with the median level found at Thule: 5 fCi Pu 239/litre. At Qanaq, approximately 100 km north of Thule, the level was 3 fCi Pu 239/litre. In Zone I the seawater samples were collected both at the surface and at the bottom.

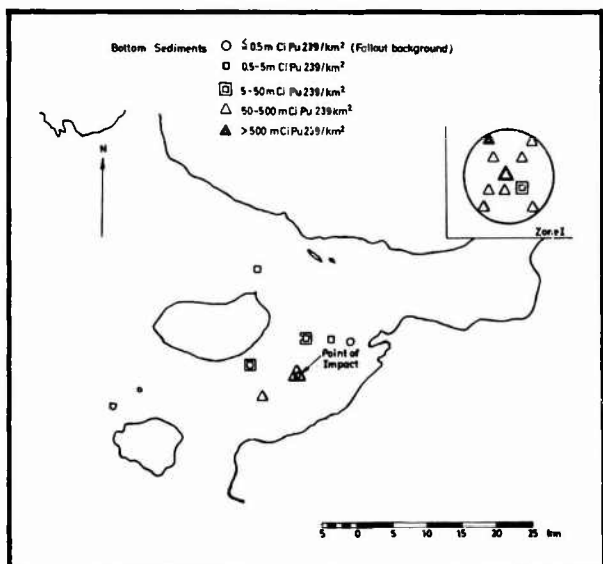
Figure 7 Pu 239 levels in bottom sediments. Ten samples were collected in zone I.

It is concluded that the accident caused only a slight

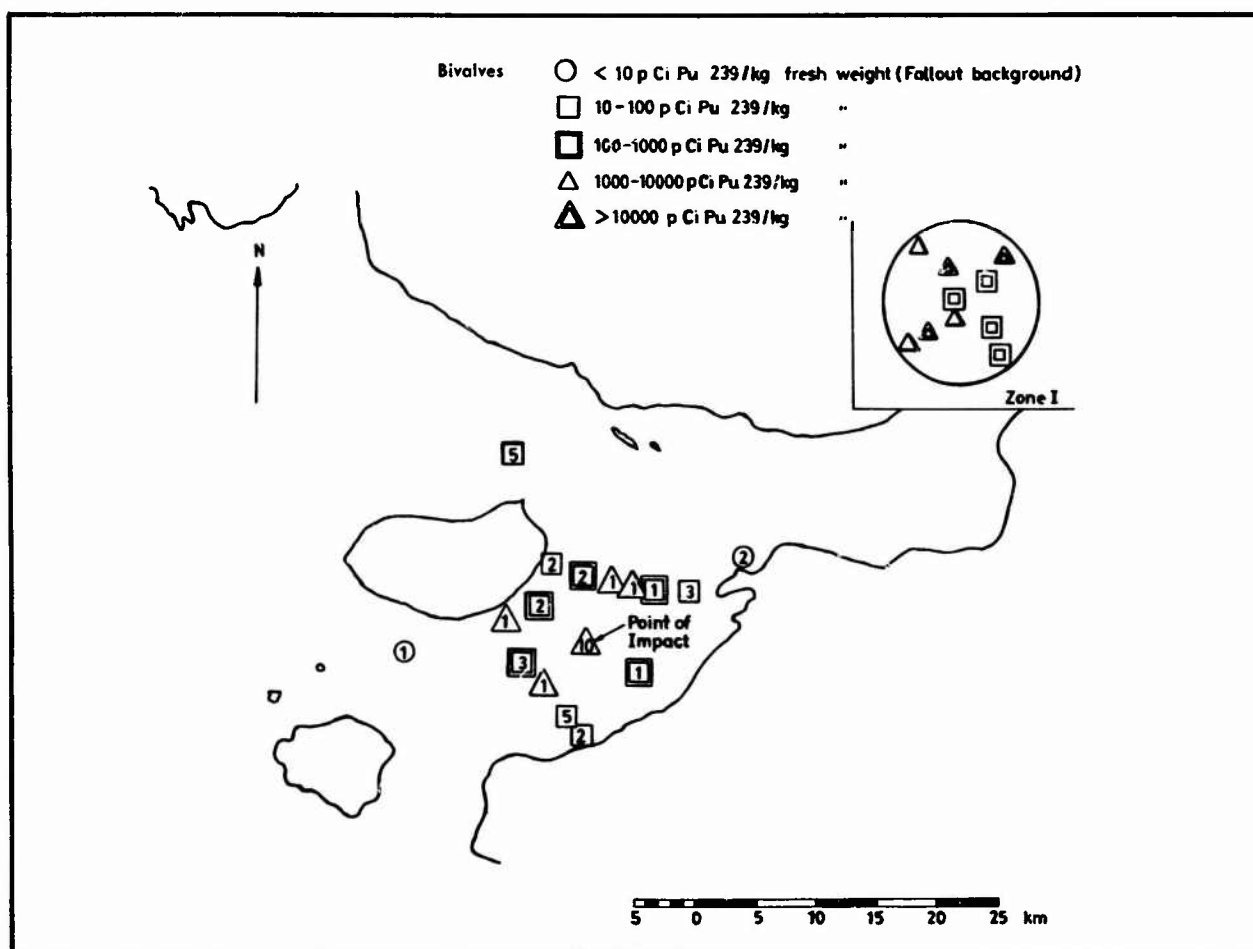
Figure 8 Pu 239 levels in bivalves. The numbers refer to the number of samples analyzed from each location.

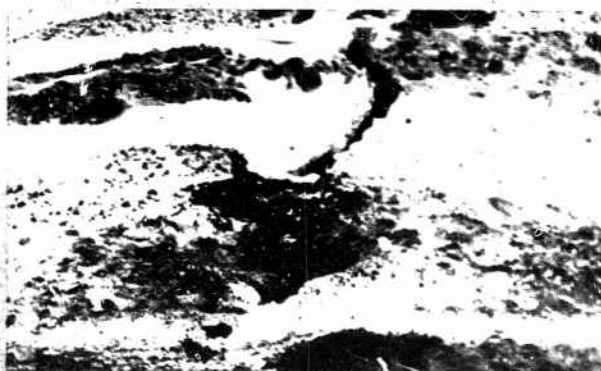
Crack in the ice.

The two roads were crossed by a number of tidal and thermal cracks. Tidal cracks are produced when the tide lifts and breaks the ice. These cracks usually refreeze and fill with snow. They normally present no danger once the entire bay is frozen over. Thermal cracks are produced when the ice surface is subjected to extremely

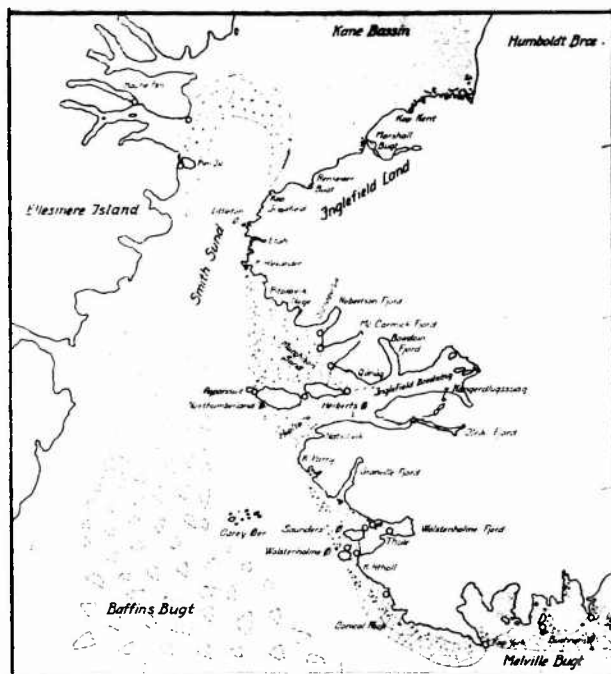
Figure 1. Ice conditions north of Baffin Bay. (Old Map)

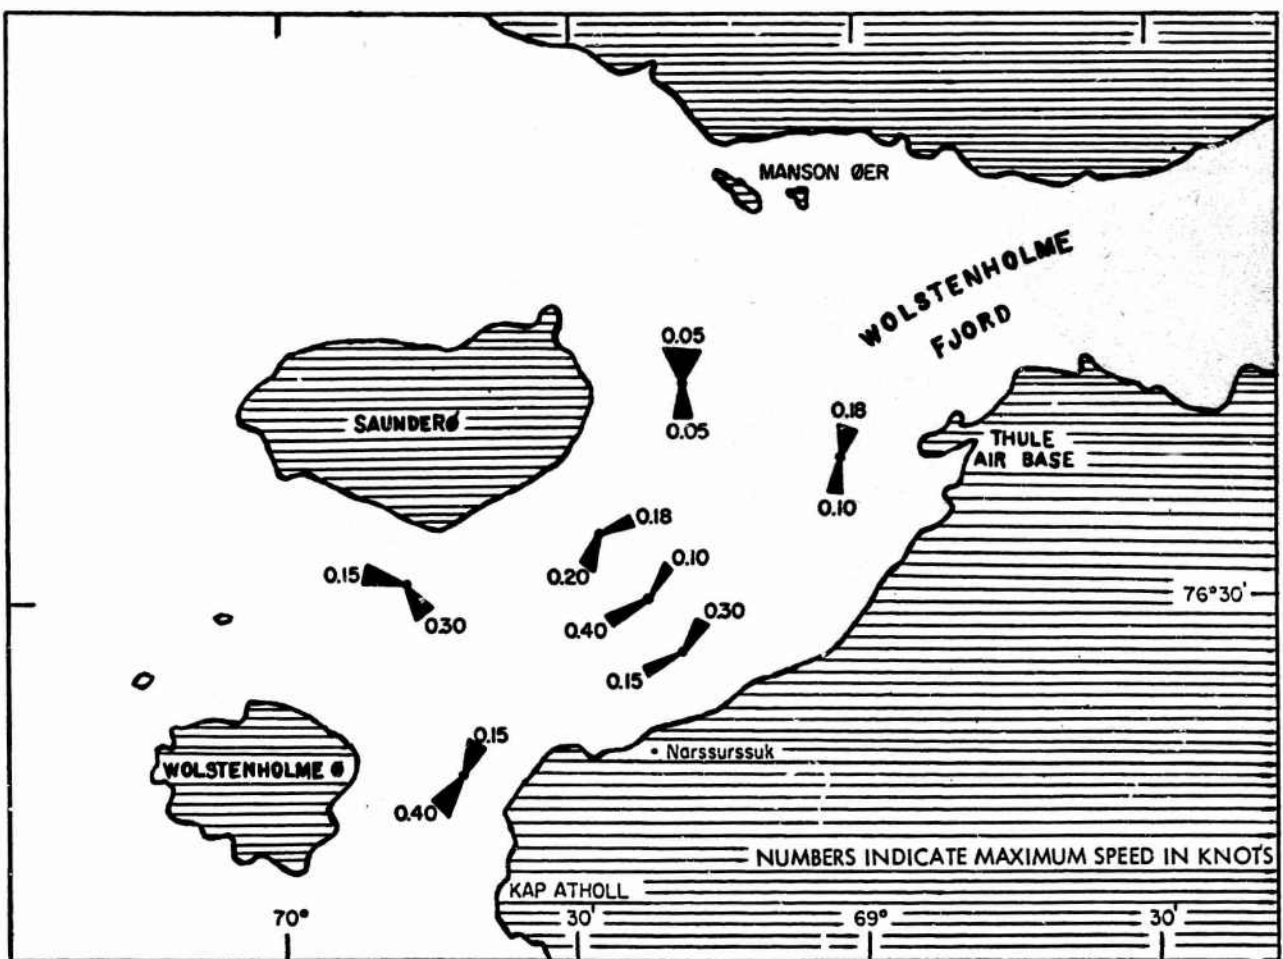
Figure 2. Summary of current data.
