AN ELECTRON-MICROSCOPICAL STUDY OF
THE TEMPERING OF TUNGSTEN-
HIGH SPEED STEELS

E. TEKIN and M. H. RICHMAN

ARPA E-71

March 1970

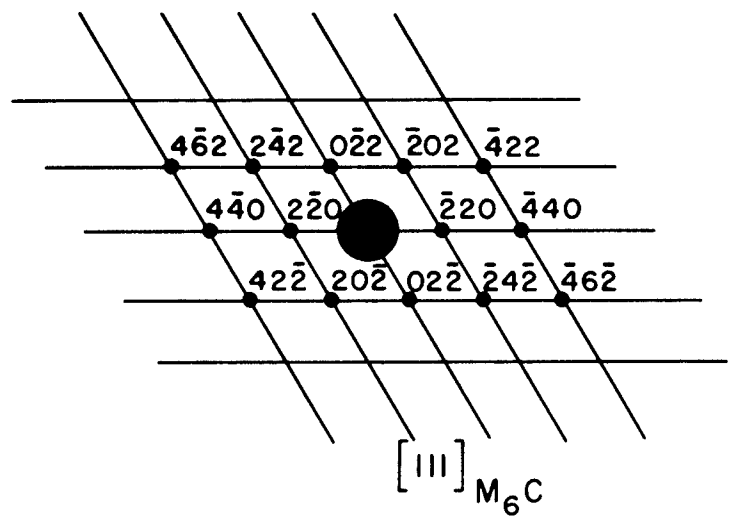
FIG. - 2

Electron diffraction photograph of an undissolved M_6C
carbide extracted from the as-quenched structure.

Differential etching techniques⁽¹⁵⁻¹⁶⁾ revealed the presence of only M_6C carbides in the as-quenched structures. Electron diffraction patterns such as that shown in Fig. 2 provide the same conclusion. These differential etching techniques indicated, furthermore, that these undissolved M_6C carbides do not undergo any transformation during tempering, but, rather, that certain precipitation occurs within the matrix (Fig. 3). This becomes even more obvious when the microstructures are examined at higher magnifications in the electron microscope. In Fig. 4 precipitation on a fine-scale is illustrated. Similarly, plastic-replica electron micrographs also illustrate (Fig. 5) precipitation of a new phase.

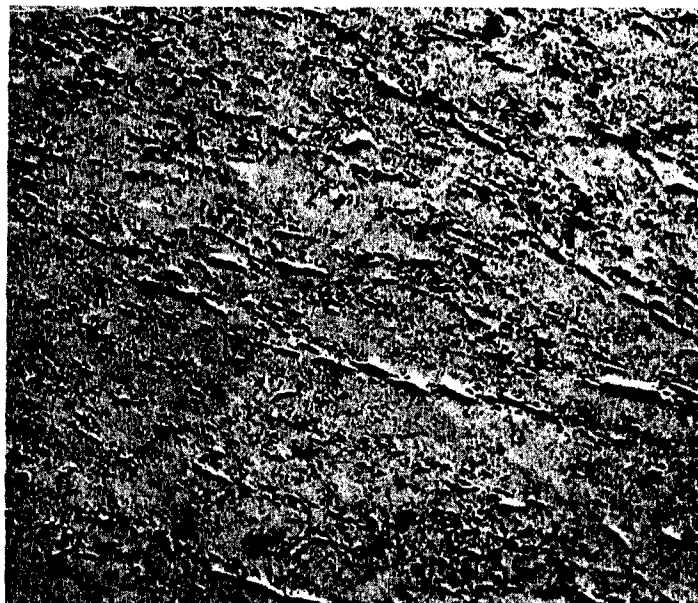
FIG. - 4

Plastic replica micrograph of 18-4-1 steel tempered at 500°C for 40 hrs. - 8000 X.

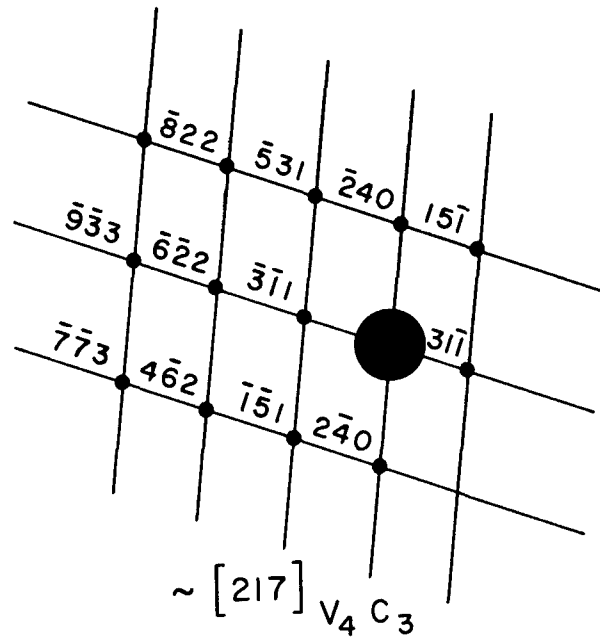
FIG. - 9

Electron diffraction photograph of a V_4C_3 carbide extracted from a specimen tempered at 700°C for 22 hrs.

The overaged structures, i.e. specimens tempered at 650° or above, occasionally show V_4C_3 and new M_6C carbides, neither of which plays any important role in the secondary hardening.
