TECHNICAL REPORT NO. LWL-CR-02P69

LISTENING POST SURVEILLANCE DEVICE (LPSD)  
AN/PPS-14

Final Report  
Contract No. DAAD05-69-C-0279

By  
Aerospace Research, Inc.  
130 Lincoln Street  
Brighton, Massachusetts 02135

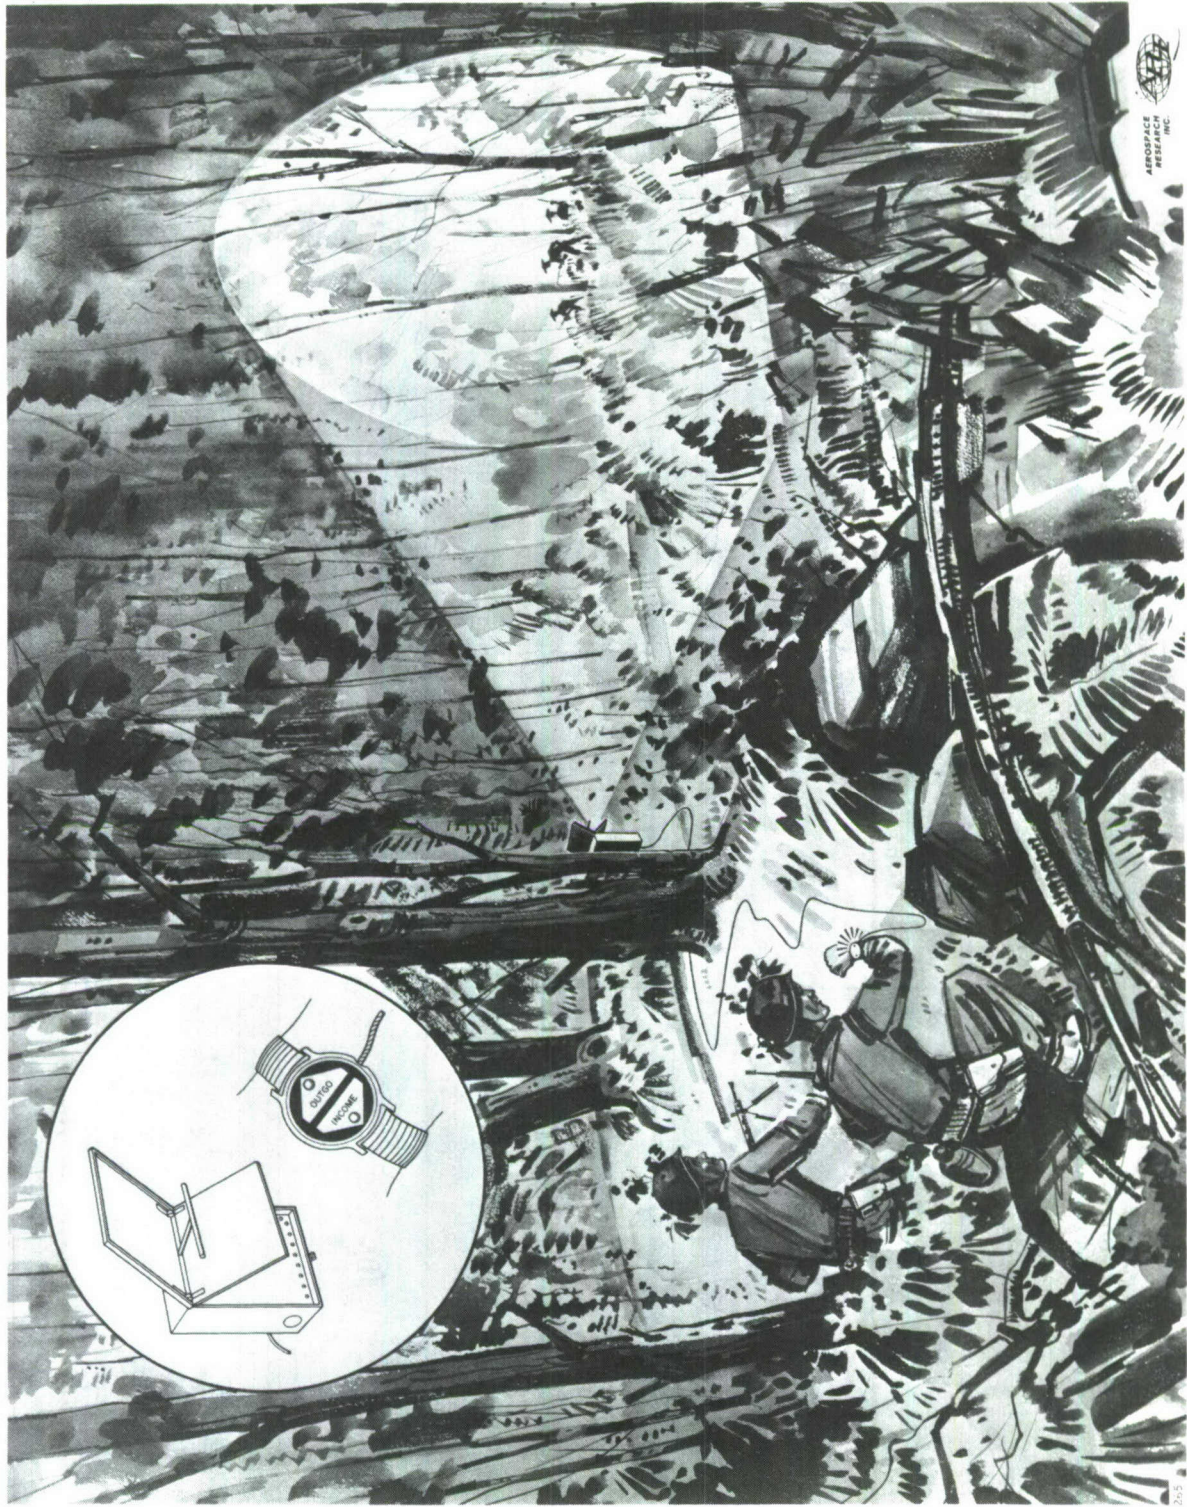
Figure 8: Artist's Conception of LPSD in Operational Use

An artists conception of the field operation of the LPSD is shown in Figure 8. The LPSD radar unit with its antenna in the operate position, and the wrist alarm is shown in the insert.

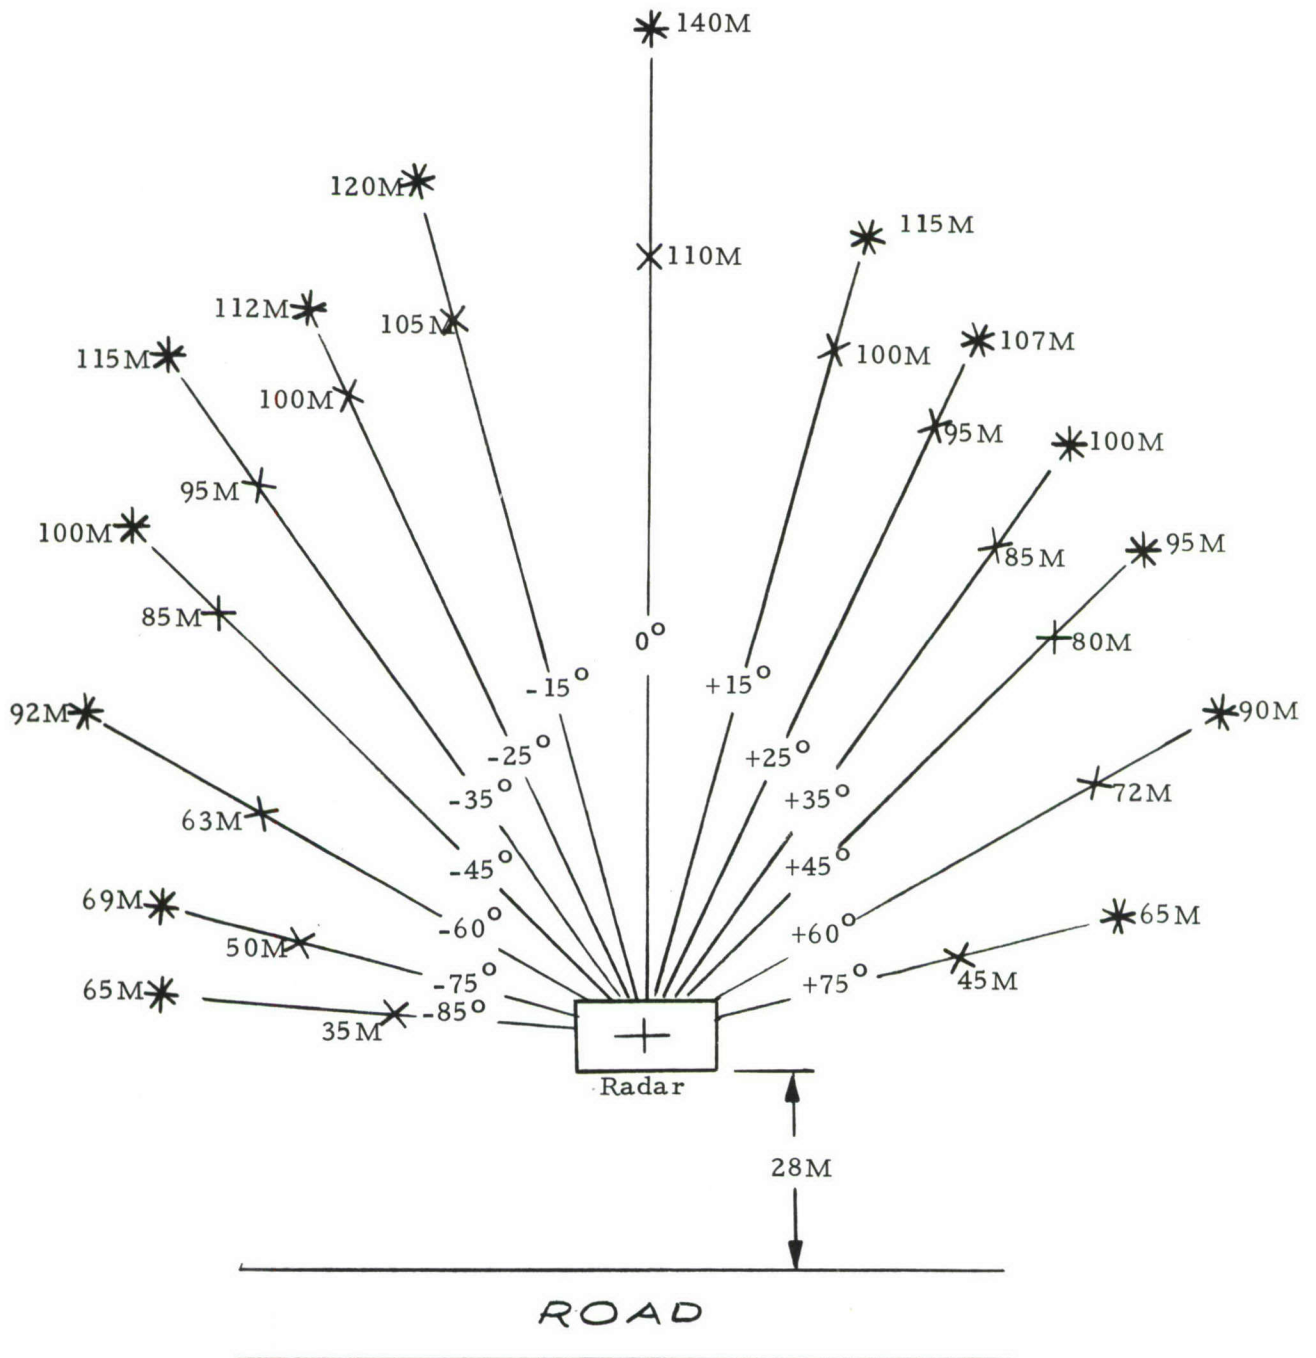
Figure 12: Detection Range vs. Angle of Detection

X = Max. Incoming Alarm Point

\* = Max. Outgoing Alarm Point

The crawling target was detected at 70 meters with the radar height set at 1 meter. This range increased to 80 meters when the radar height was increased to 1.5 meters. With this radar height, the low crawl was detected at 68 meters.

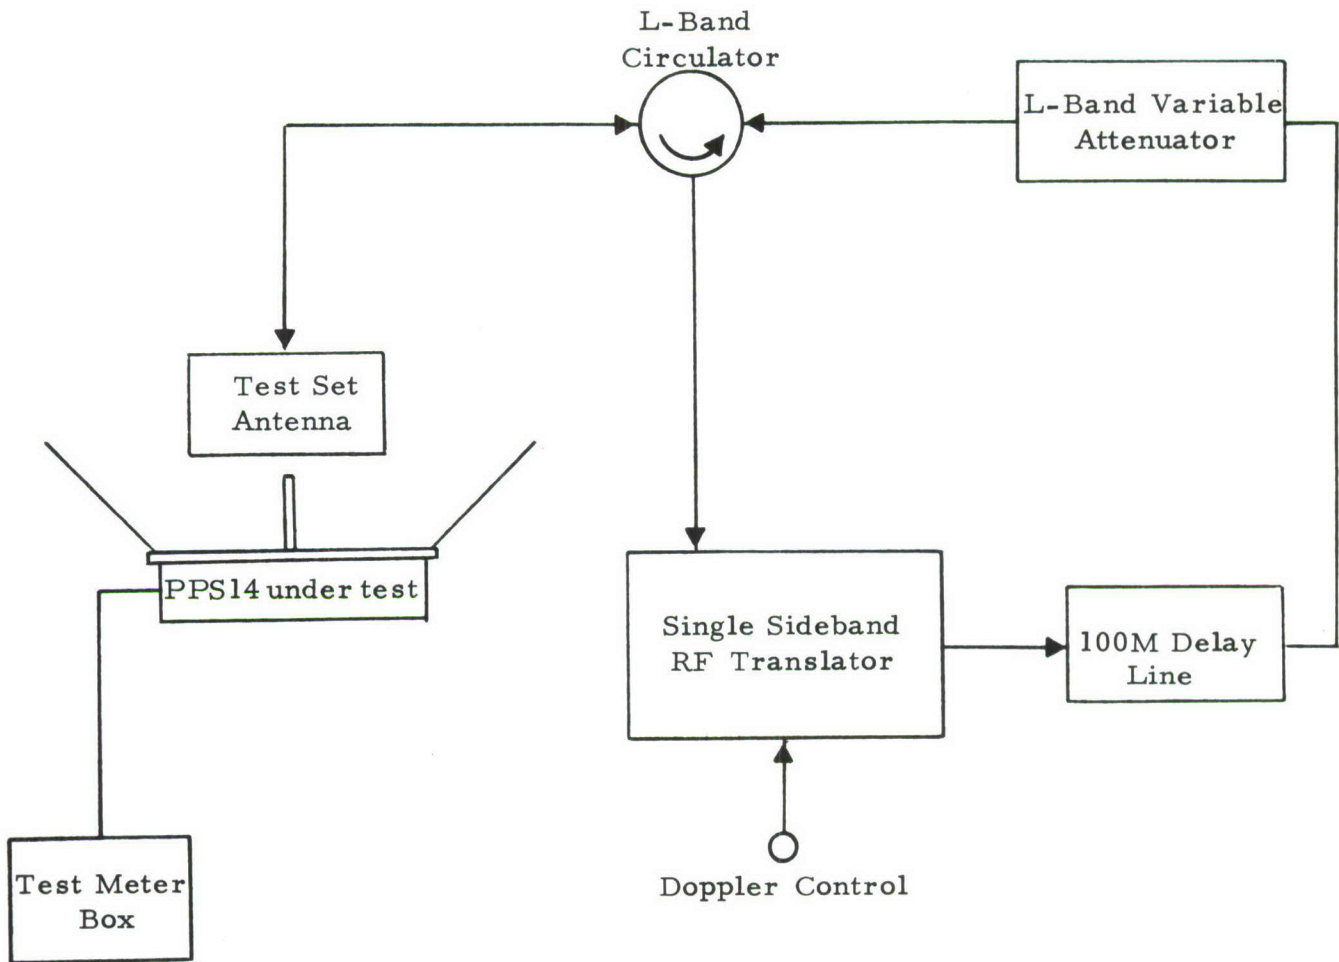
Figure 20: Block Diagram of PPS-14 Test Set

Environmental tests were carried out at Aerospace Research, Inc., and the Associated Testing Laboratory of Burlington, Massachusetts during June 1970. PPS-14 performance was monitored throughout the test program with the aid of ARI's PPS-14 Test Set. This test set, shown in block diagram form in Figure 20, performs a complete system

test by sampling the radar transmission, single-sideband converting it (at RF) by an adjustable Doppler frequency, delaying it, attenuating it, and sending it back into the radar's antenna at normal "receive" time, all of which normally occurs when the radar is viewing a moving target in the field. It therefore provides a good measure of PPS-14 performance. Small degradations in performance can clearly be observed, if and when, they occur on the test meter box included with the test set.

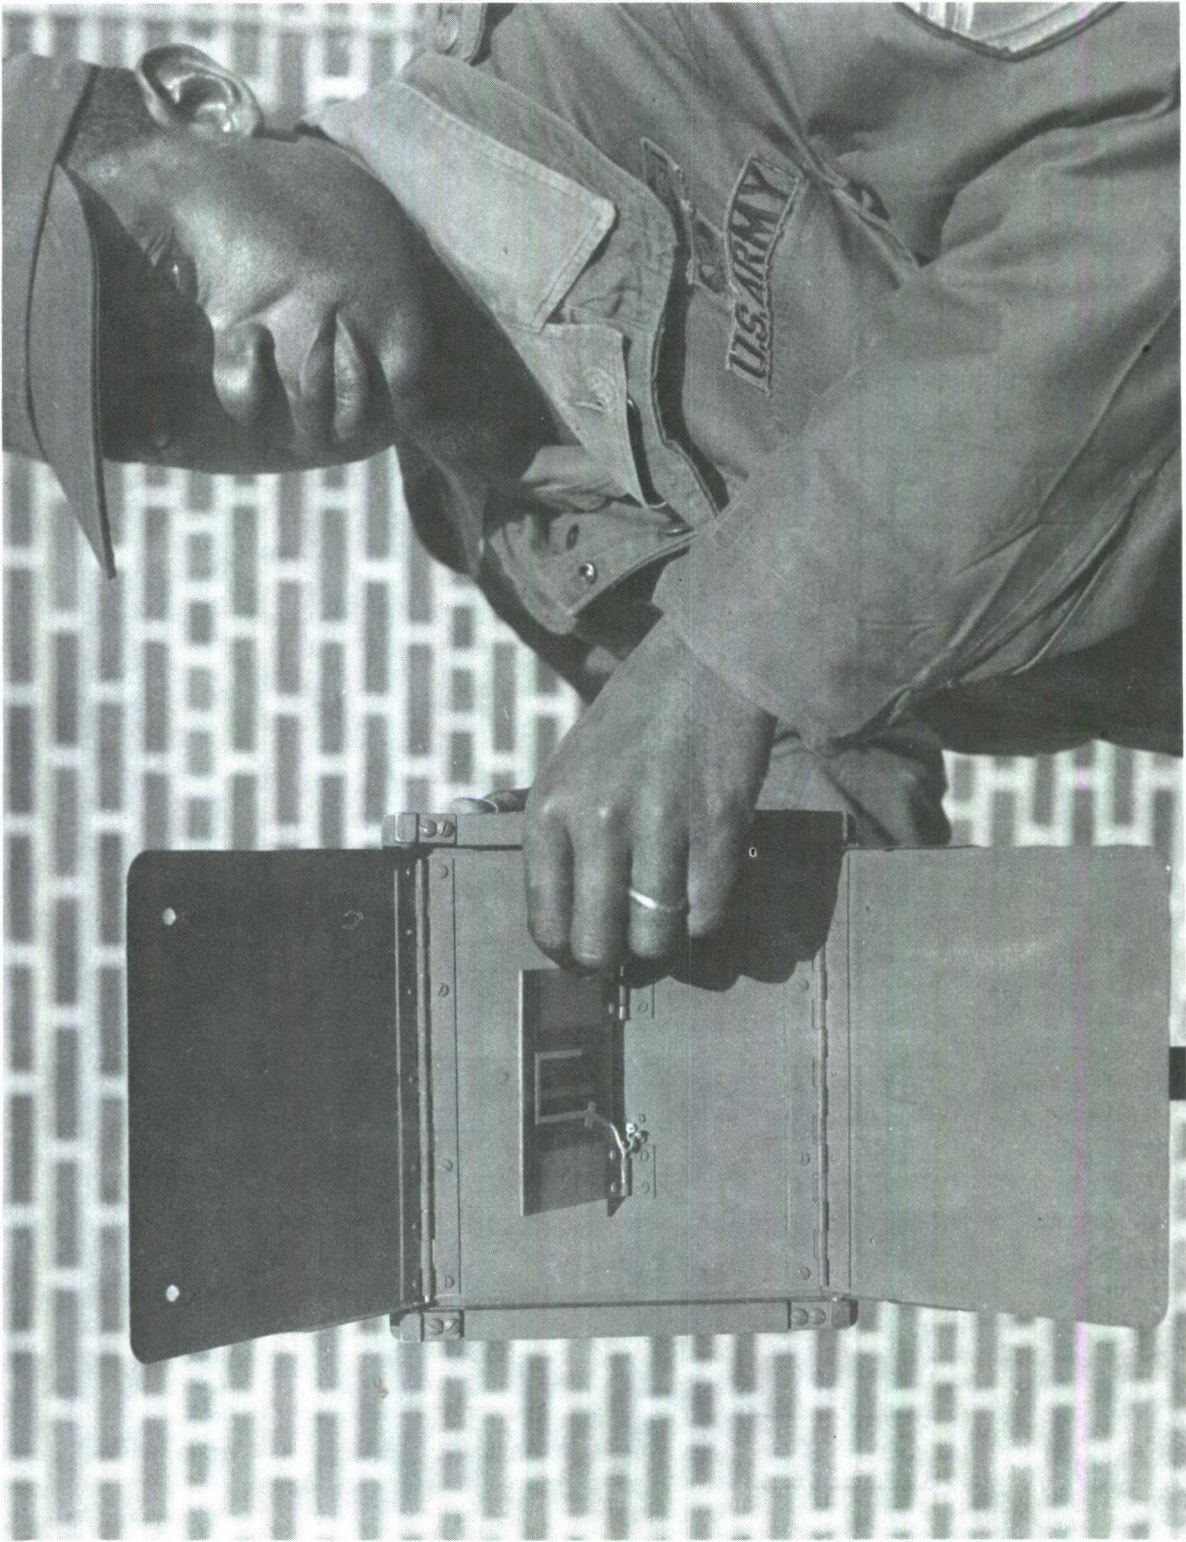
Figure 23: Radar Unit with Antenna in Operating Position

A photograph of the Radar with the reflector plates extended to its operating position is shown in Figure 23. The dipole is also shown in its operating position and is horizontally polarized.
