USAAMRDL TECHNICAL REPORT 71-74

HELICOPTER DEVELOPMENT RELIABILITY TEST REQUIREMENTS

CONTRACT DAAJ02-70-C-0040
SIKORSKY AIRCRAFT
DIVISION OF UNITED AIRCRAFT CORPORATION
STRATFORD, CONNECTICUT

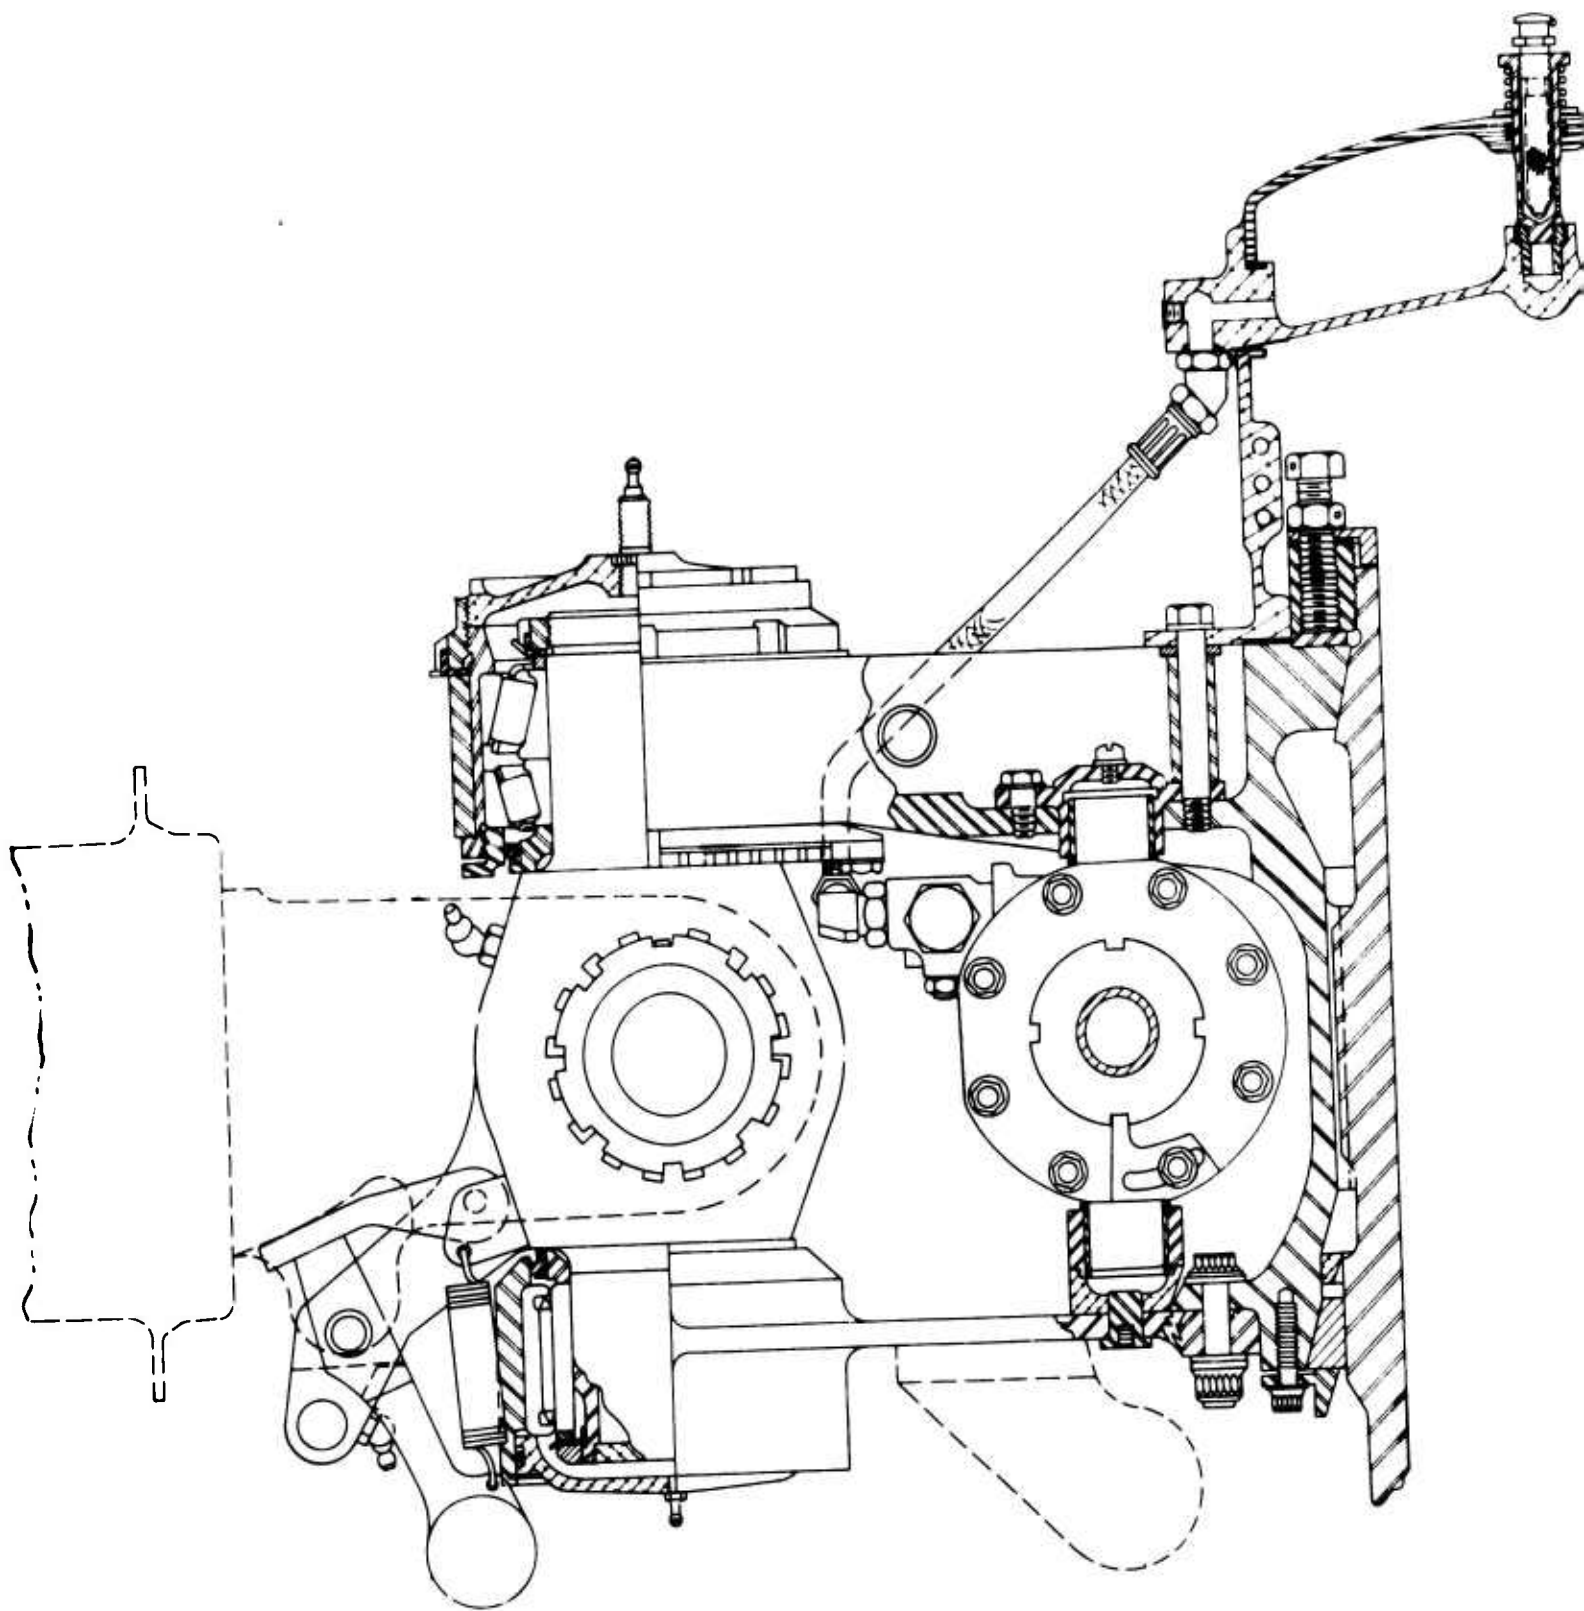
Figure 11. Main Rotor Head, Section View.

As can be seen in Figure 11, the integral upper plate and hub are splined to the rotor shaft to transmit the torque to the rotor head. The lower plate, capable of transmitting only centrifugal force, is attached to the hub and encloses the vertical and horizontal hinge, the damper assemblies, and other miscellaneous hardware. The rotor head is mounted on and secured to the main rotor shaft by two tapered cone seats and a large-diameter nut.

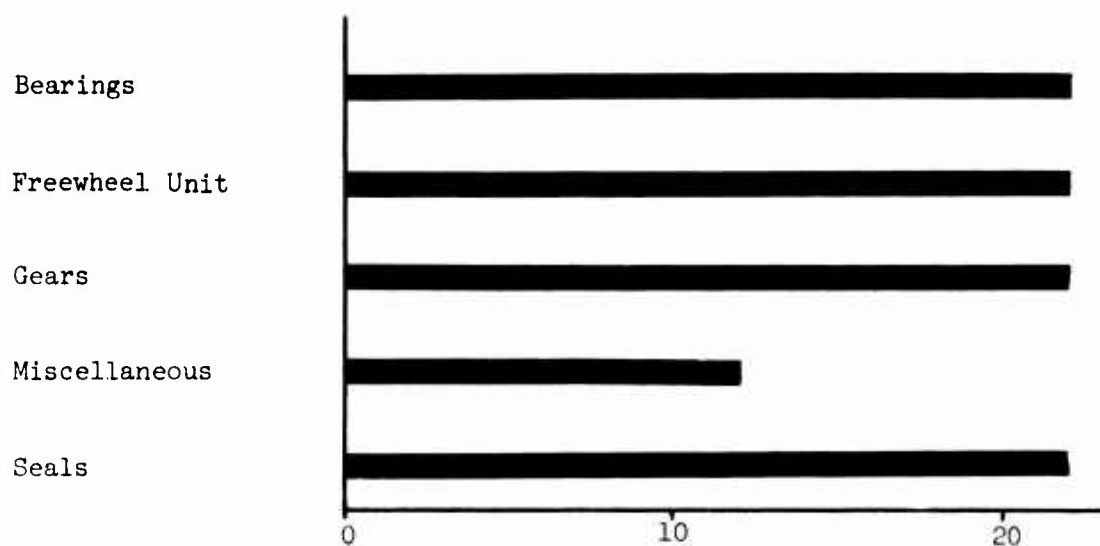
Figure 20. H-3 Main Gearbox Failures,
Propulsion System Test Bed.

*Based on 9 Failures

PERCENT OF TOTAL FAILURES*

Several different testing techniques were employed in this test program. As noted in Figure 17, the main gearbox was developed on a propulsion system test bed, a tiedown aircraft, a regenerative test stand, and the flight aircraft. Each of these tests or types of test has advantages in relation to the overall program, since different testing techniques were employed in each. The malfunctions experienced in the various types of tests on the early gearboxes are strikingly similar, as can be seen from Figures 20, 21, and 22. From these figures, it would appear that inherent reliability will be revealed in any development test program that includes realistic loading simulating operating conditions. But this is not necessarily the case. In fact, simulating service environment and operation is a very involved problem, not usually done during previous test programs. In this H-3 program, the environmental conditions were similar for the propulsion system test bed and the tiedown aircraft. The regenerative test stand was very similar also, except that the temperature of and the moisture in the air were more uniform in the test cell. With the test conditions fairly identical, the similar failures during the test program are not surprising.

for the fuselage and the entire aircraft propulsion system is tested, is the least effective approach to testing. However, it must be remembered that the initial debugging and development effort was accomplished on this test

stand. When a difficulty was experienced with any portion of the system, the entire test was delayed, producing a low test hour per month value. It would be expected that the most complicated test approach, the tiedown aircraft, would exhibit the lowest test hours per month; however, this is not borne out by the H-3 program. Long delays caused by early malfunctions, lack of backup test hardware, and modifications to the test stand itself lengthened the calendar time required for the propulsion system test bed testing, while the tiedown tests proceeded rather smoothly.

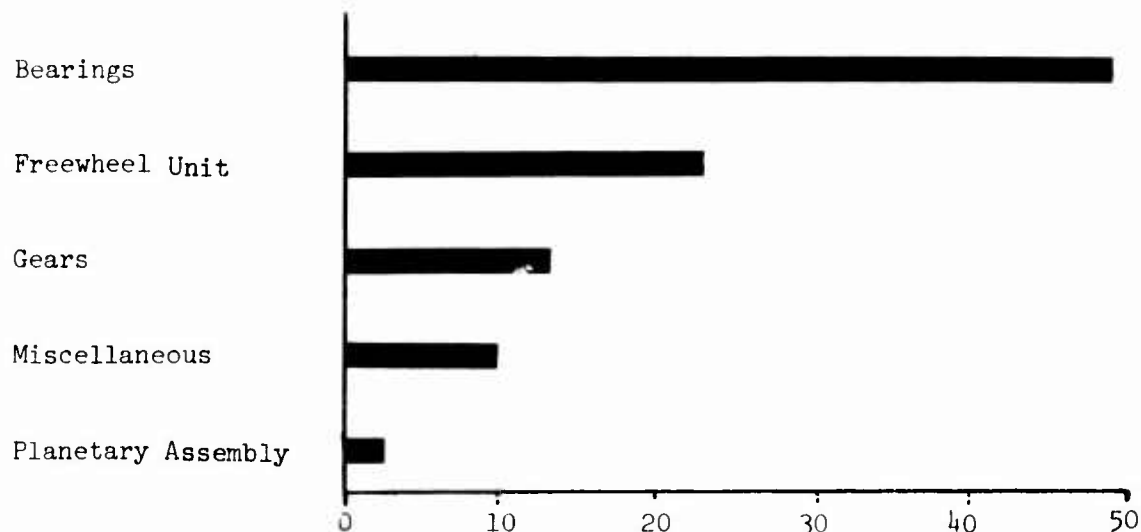
Figure 21. H-3 Main Gearbox Failures,
Tiedown Aircraft.

*Based on 39 Failures

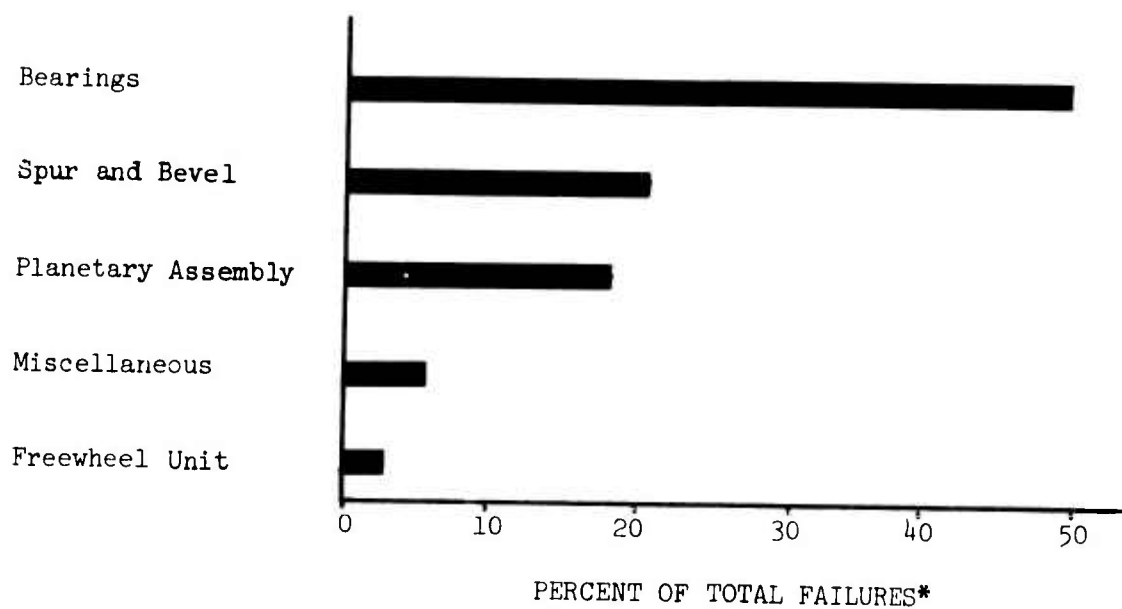
Figure 22. H-3 Main Gearbox Failures,
Regenerative Test Stand.

*Based on 118 Failures

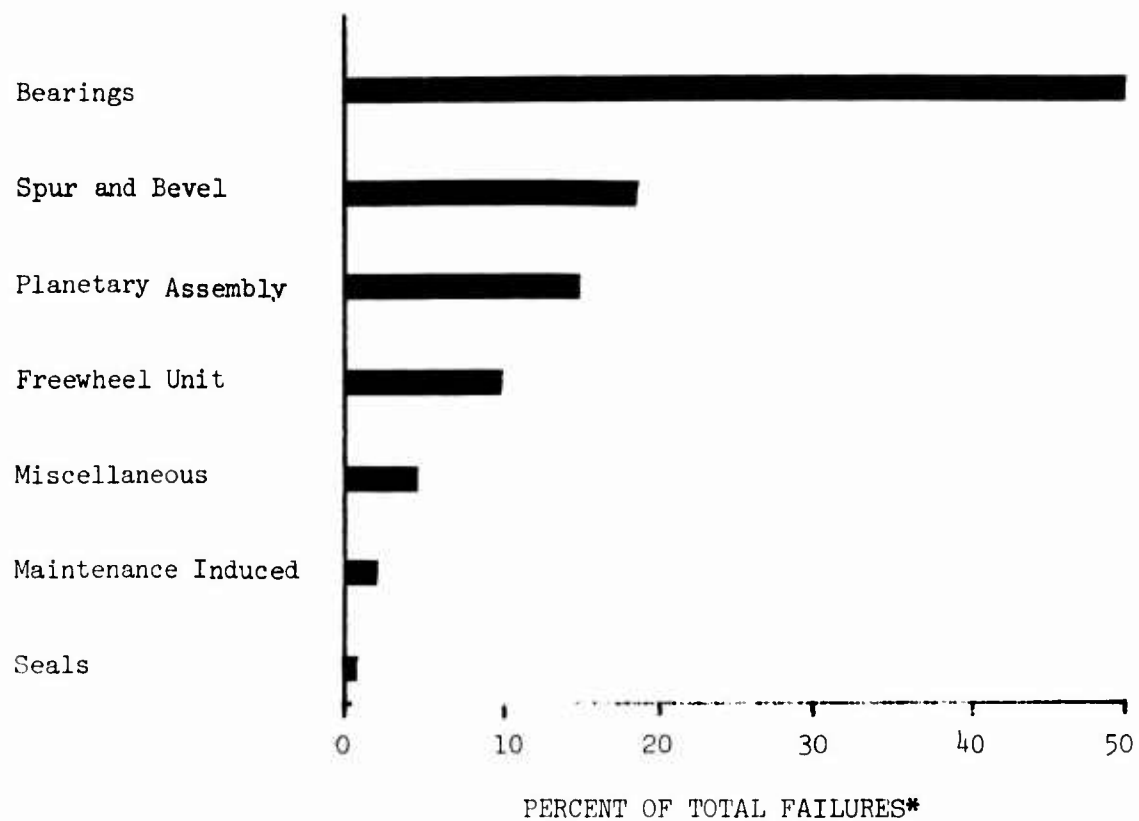
Figure 23. H-3 Main Gearbox Failures,
All Test Programs.

*Based on 166 Failures

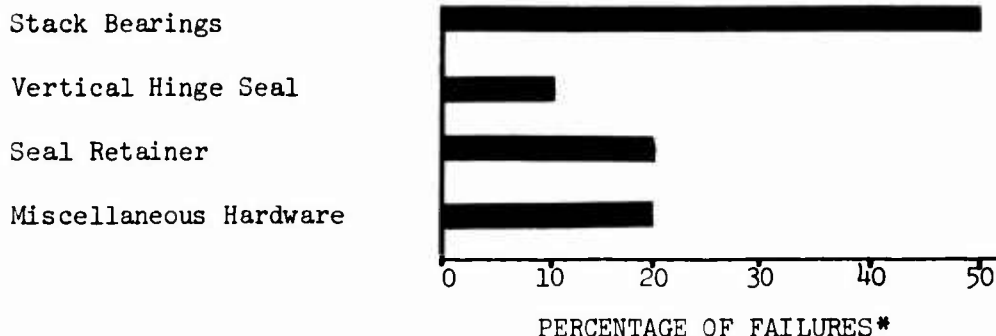
Figure 25. H-3 Main Rotor Failures,
Propulsion System Test Bed.

Initial testing of the rotor system was coincident with the transmission system testing, since the PSTB was the first test for both systems. Interface and assembly problems were resolved in the rotor and control systems during the early phases of testing and before significant power was absorbed by the rotor system. The ensuing testing evaluated the effects of variations in flapping angle, magnitude, and direction of the resulting thrust vector; vibratory response of the rotor system; and environmental factors such as ice, temperature, and humidity on performance of the rotor system. Figure 25 depicts the types of failures that were experienced during operation of the propulsion system test bed; bearing failures were predominant.

*Based on 10 Failures

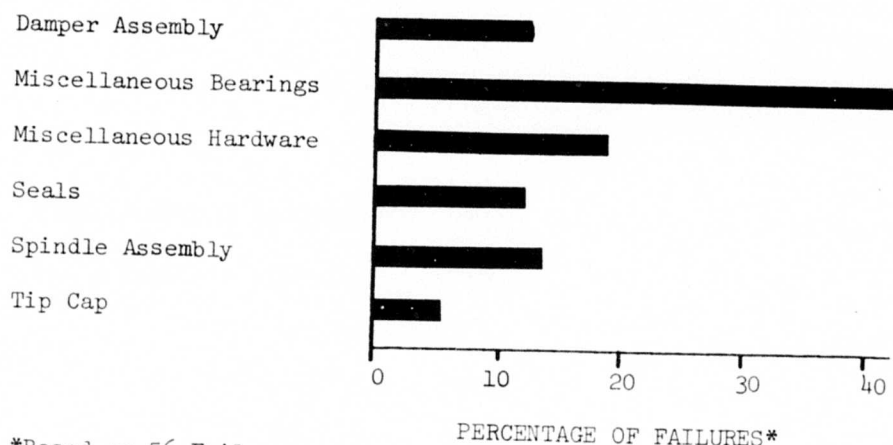
Figure 28. H-3 Main Rotor Head Component Failures, All Test Programs (Excluding Laboratory Fatigue Test Programs).

*Based on 56 Failures

first glance, bearing failures appear to predominate. However, there are different bearing arrangements for each blade in the rotor head and each damper assembly. It follows that the relative failures of three different components are essentially equal. A composite picture of all test stand failures on the main rotor assembly and a list of the various components that required removal are given in Figure 28.

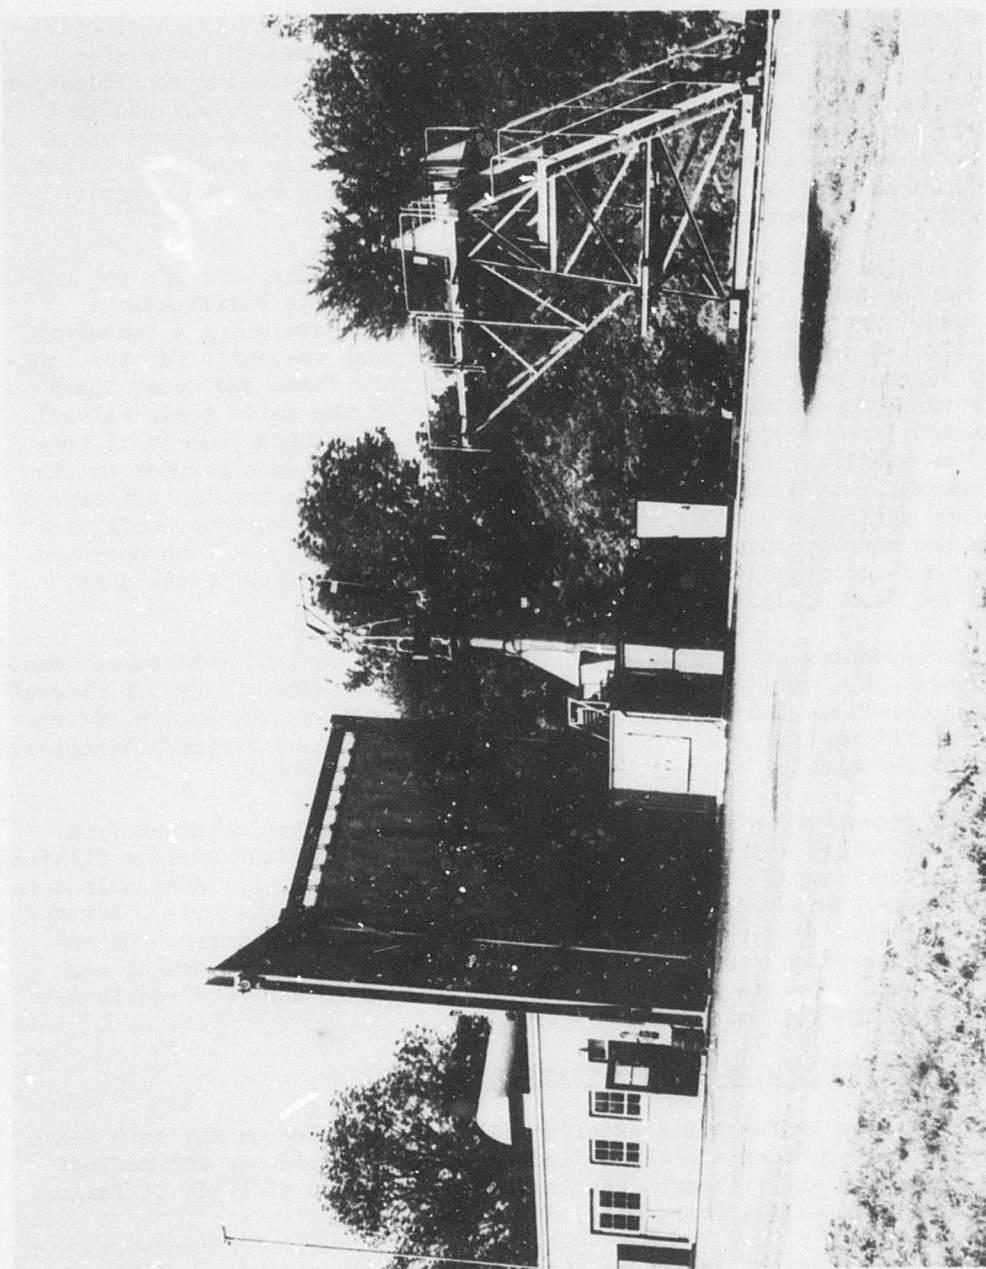
Figure 30. 2000-Horsepower Tail Rotor Test Facility.

The tail rotor system testing was similar to the main rotor except that the whirl testing was conducted on a tail rotor test stand that permitted precessing of the rotor during operation. Since 80 percent of the failures occurred during whirl testing, and similar modes and types of failures were experienced in the various tests, all failures have been combined and are presented in Figure 29. Even though there are two sets of bearings for each tail rotor blade, this mode of failure predominated during the test program. This test stand is shown in Figure 30.

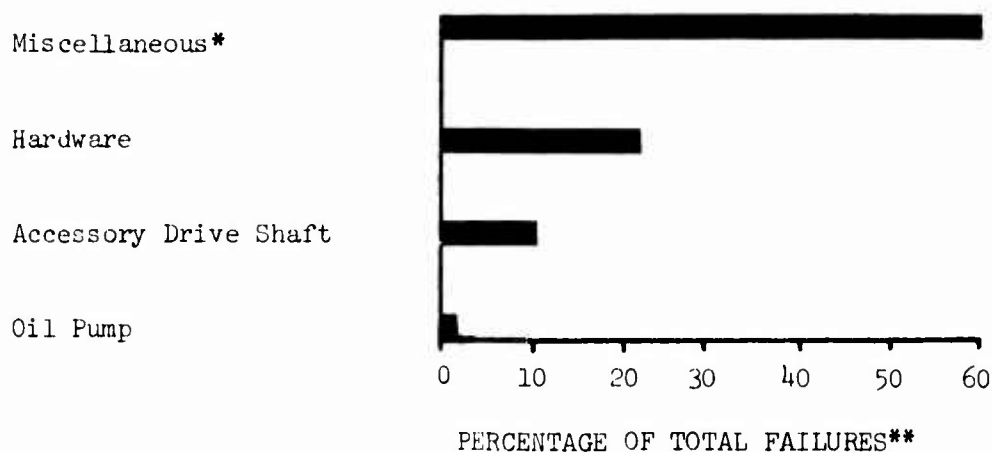
Figure 35. H-3 Main Gearbox,
Miscellaneous Service Failures.

*Metal contamination, noise, high temperature, corrosion, stripped threads, undefined causes.

**Based on 85 failures (Refer to Miscellaneous of Figure 31, 27 percent of 315 = 85)

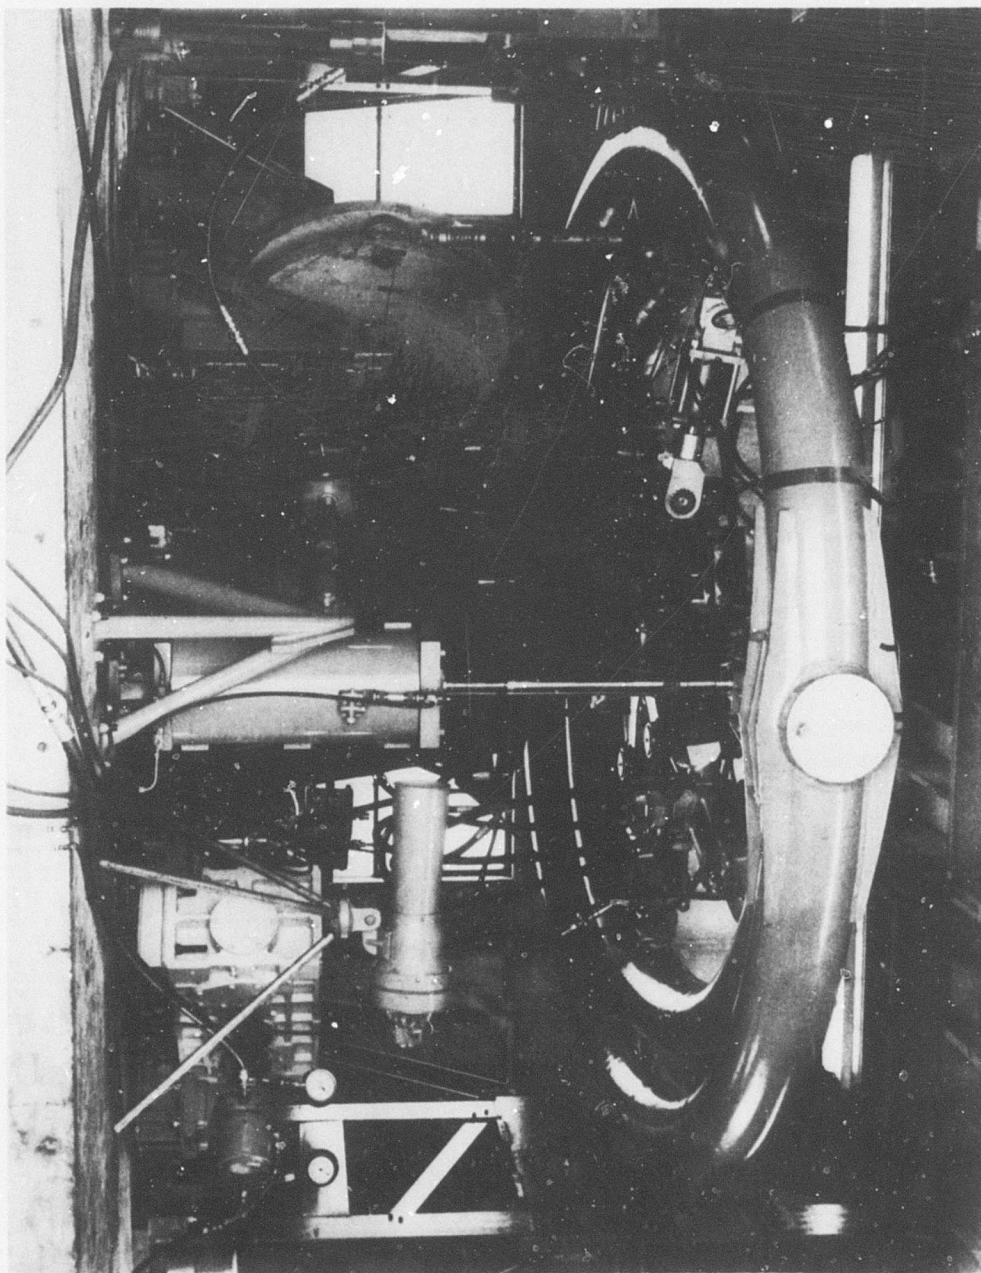
Figure 71. H-3 Main Rotor Head and Shaft Fatigue Test Facility.

The facility will test the entire rotor head, including the inboard portion of the blade, the rotating control system, and the transmission output shaft. Loads and motions will represent flight conditions and will be independently variable and programable. In addition, service environmental conditions will be applied, including salt water spray, dust, sand, water spray, humidity, and temperature. While loads and motions will be accelerated depending on test, environmental conditions will be accelerated as applicable. The tests will consist of mode of failure and endurance testing described below, conducted on a test stand similar to that shown in Figure 71.

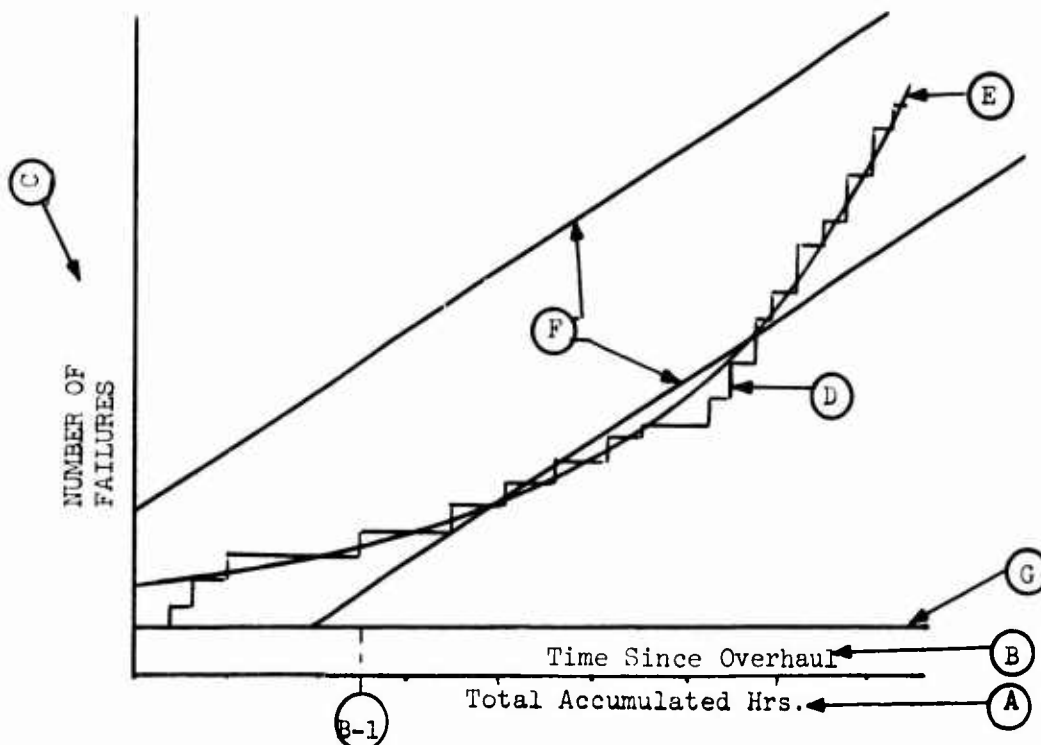
Figure 86. FRAP Failure Versus TSO Plot.

The plot of failure versus TSO is printed out as shown in Figure 86.

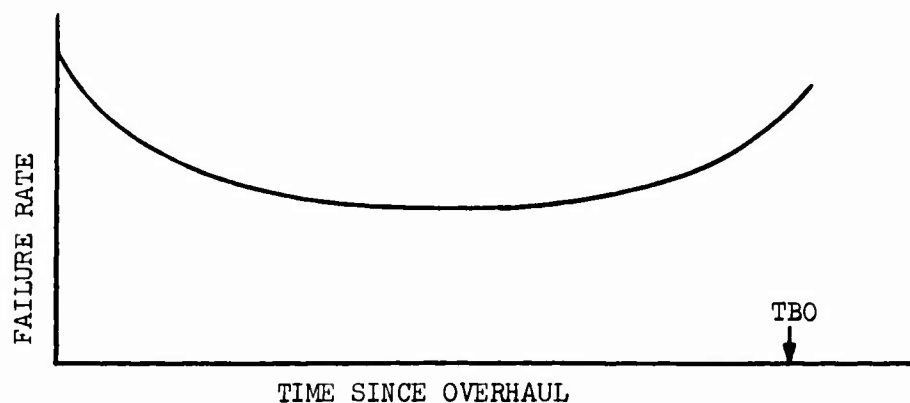
Figure 87. Failure Rate Plot.

1. The instantaneous slope of the best-fit polynominal curve of the failures versus TSO plot is determined and plotted as failure rate versus TSO in Figure 87.

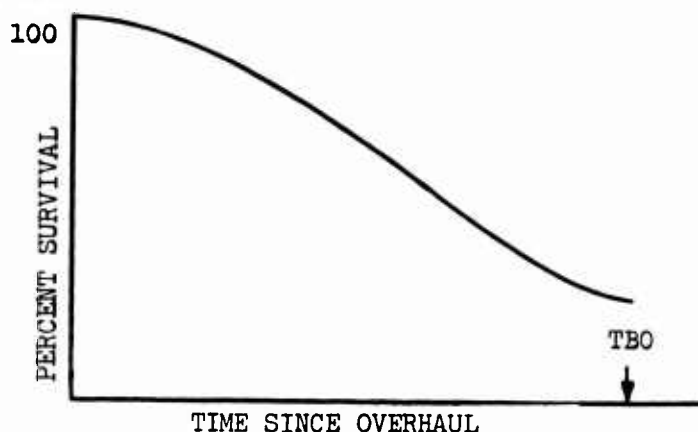
Figure 88. FRAP Survival Plot.

where R is the probability of survival and λ is the instantaneous failure rate. The resulting survival plot is shown in Figure 88.

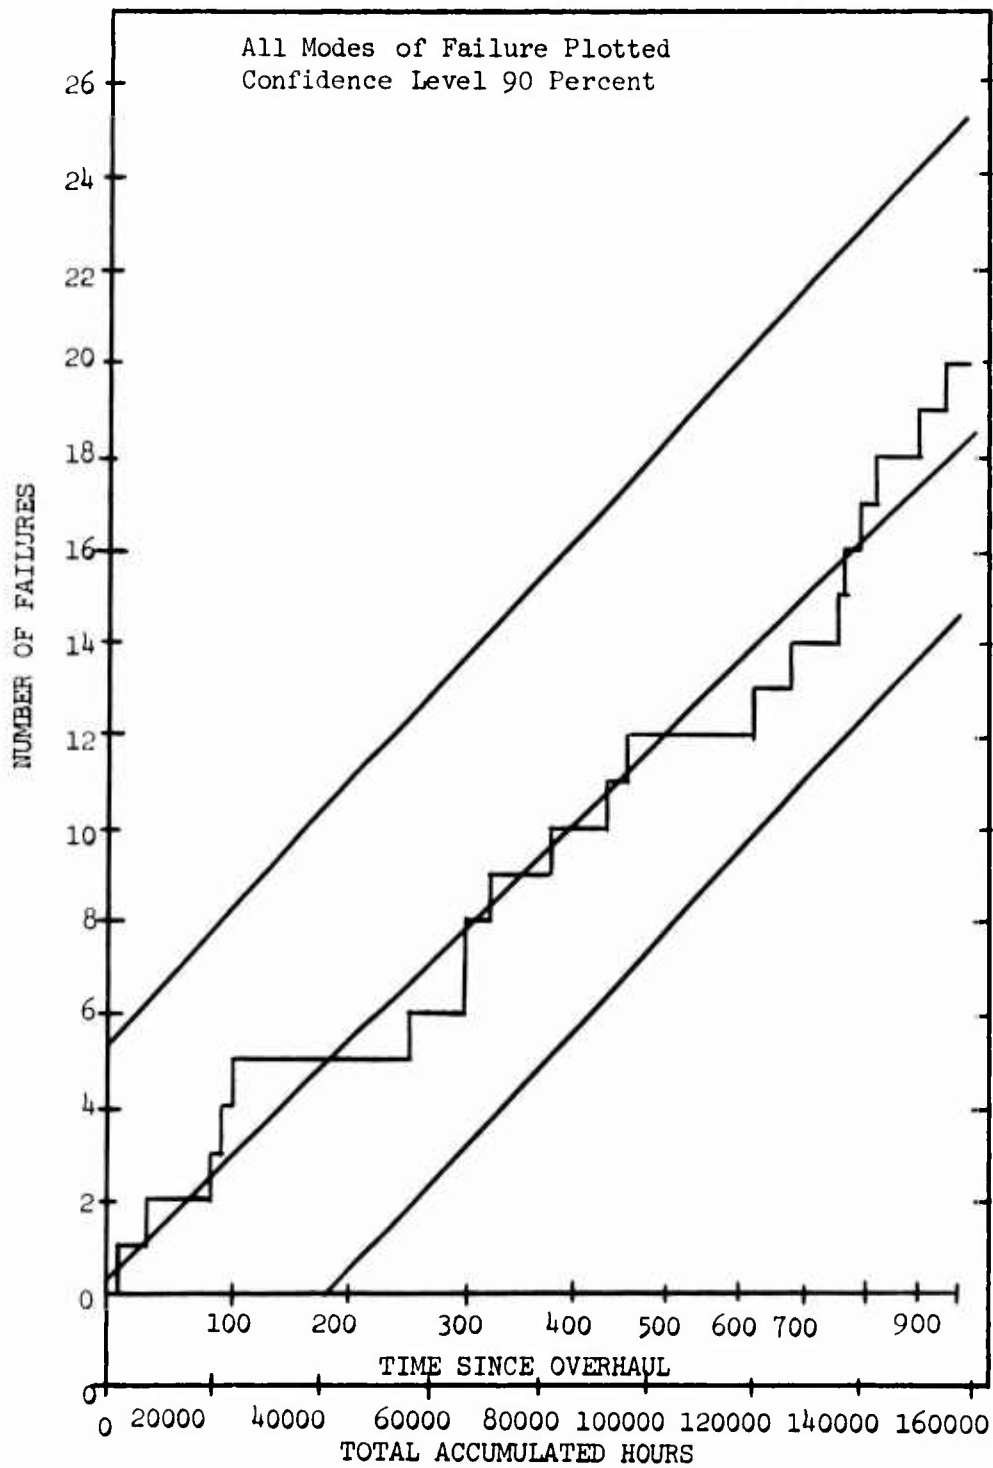
Figure 96. FRAP Failure Versus TSO: CH-3C/HH-3F
Tail Gearbox.

The failure versus TSO plot of the tail gearbox (all modes of failure considered) fell well within the 90-percent confidence K-S boundaries (see Figure 96). This implies a reasonably constant failure rate through the limits of our existing experience. From the failure mode summary, it was

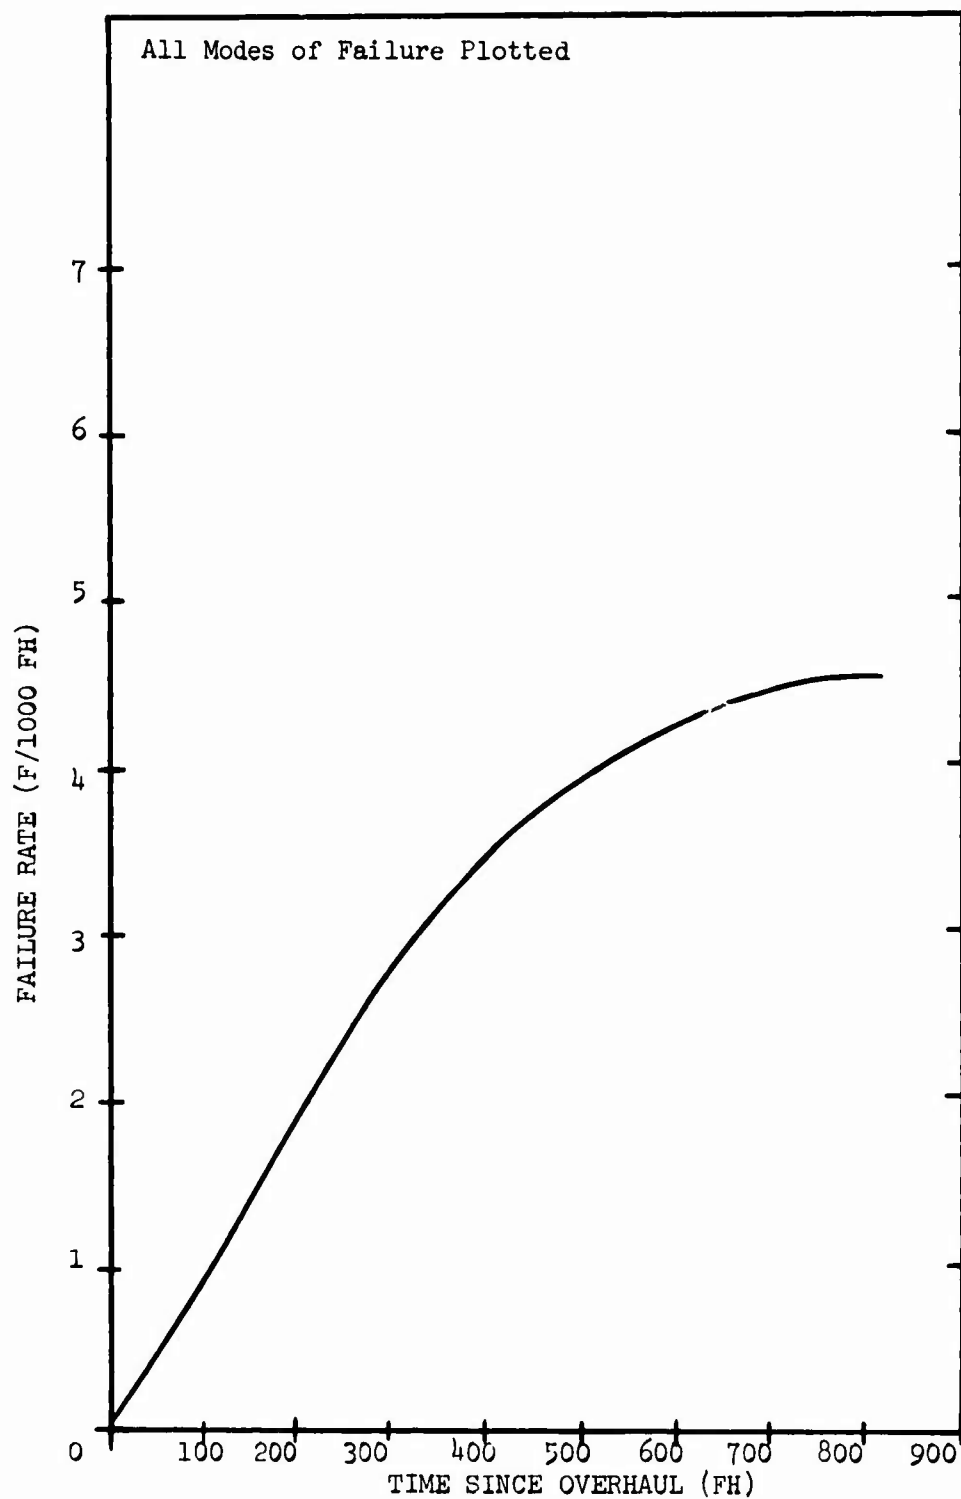
Figure 119. FRAP Failure Rate Plot: CH-3C/HH-3E
Tail Rotor Head .

The failure rate (Figure 119) and the survival plot (Figure 120) reflect that 11 percent of the rotor heads presently survive to the existing TBO (750 hours). With the indication of an increasing failure rate, it is reasonably projected that the probability of survival would drop off sharply beyond the existing TBO. As the probability of survival approaches zero, we have very few rotor heads removed for a scheduled overhaul; hence, our policy becomes, in fact, that of an "on-condition" philosophy. An extension of the TBO beyond 750 hours would therefore reap diminishing economic benefits.
