FAA Technical
Report No. FS-70-601-120A

THE EFFECTS OF 2,2 DICHLOROVINYL DIMETHYL PHOSPHATE (DDVP) USED AS AN AIRCRAFT DISINSECTANT

James W. Ross, Jr.
Flight Standards Technical Division
FAA Aeronautical Center
Oklahoma City, Oklahoma

December 1971
Final Report

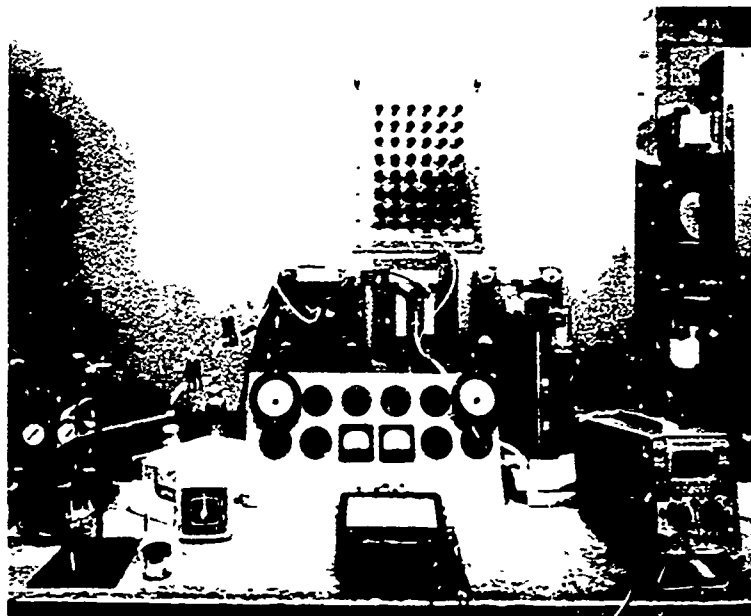
5.2.2 The system used for dispensing DDVP into the avionics test chamber was designed by TDL personnel. TDL also provided air sampling equipment for monitoring the DDVP/air concentration in the chamber. The arrangement of these units is shown in figure 5-2.

FIGURE 5-2: AVIONICS TESTING-DDVP DISPENSING UNIT AND MONITORING EQUIPMENT

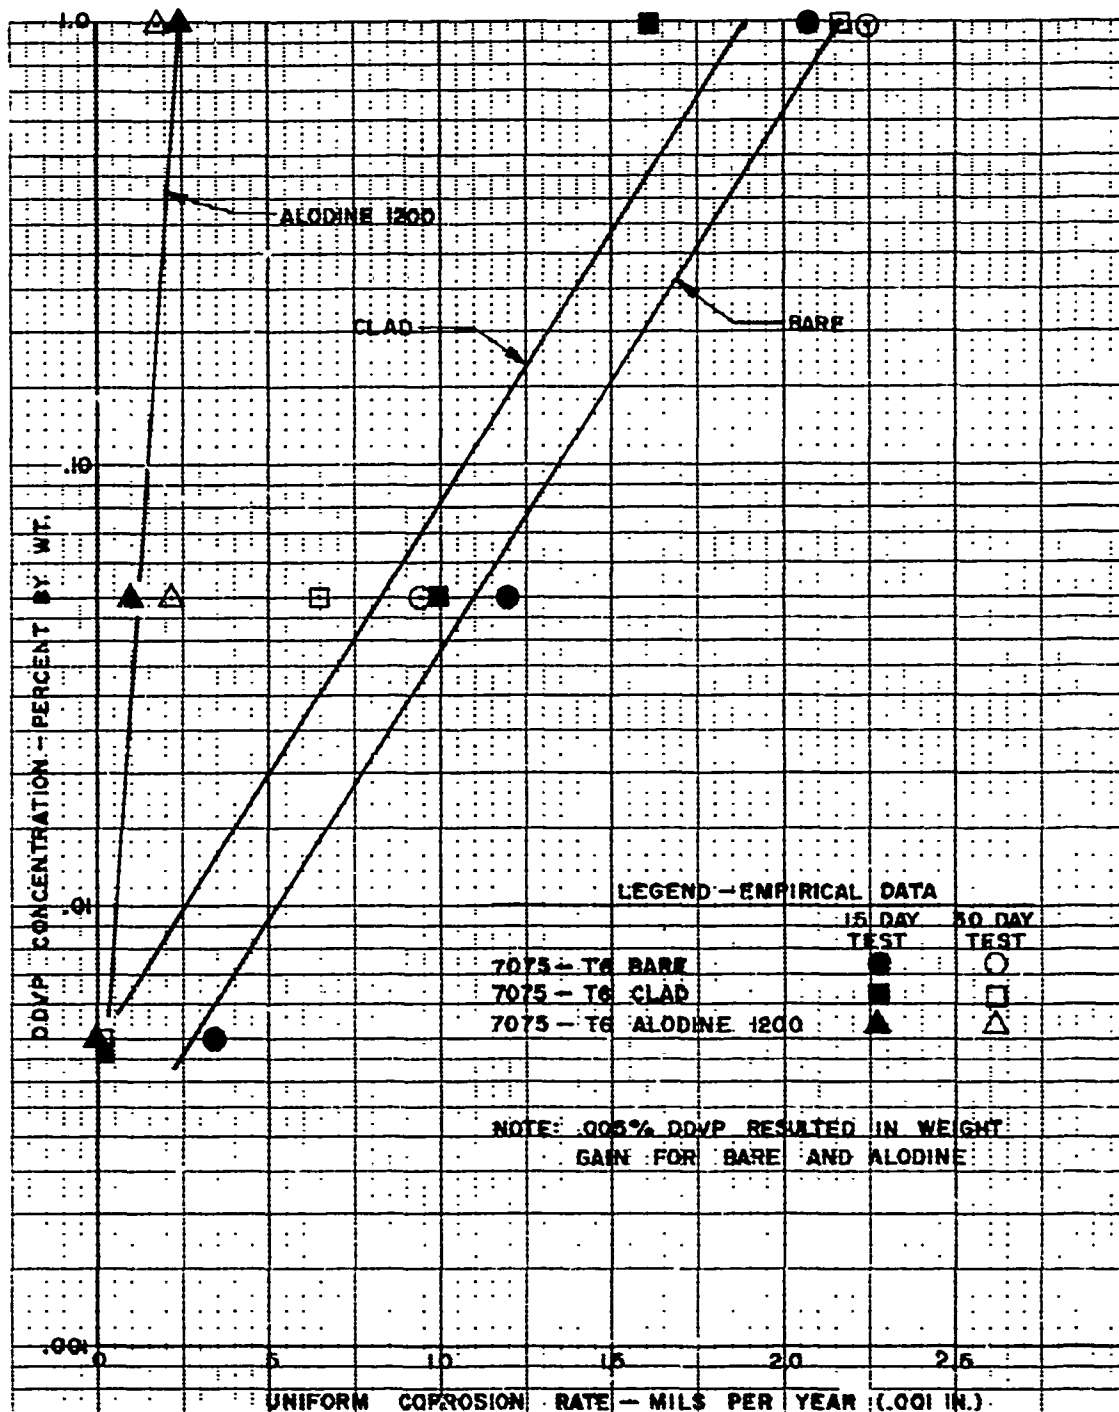
FIGURE 6-7: 7075-T6 ALUMINUM - CORROSION RATE VS. DDVP CONCENTRATION - EFFECTS OF PROTECTIVE COATINGS. [DDVP Wt. Loss Corrosion Tests]

- 6.3.28 Results of the DDVP "weight loss" corrosion tests are consolidated in figures 6-6 and 6-7. Measured weight losses were converted to uniform corrosion rates with the following formula:

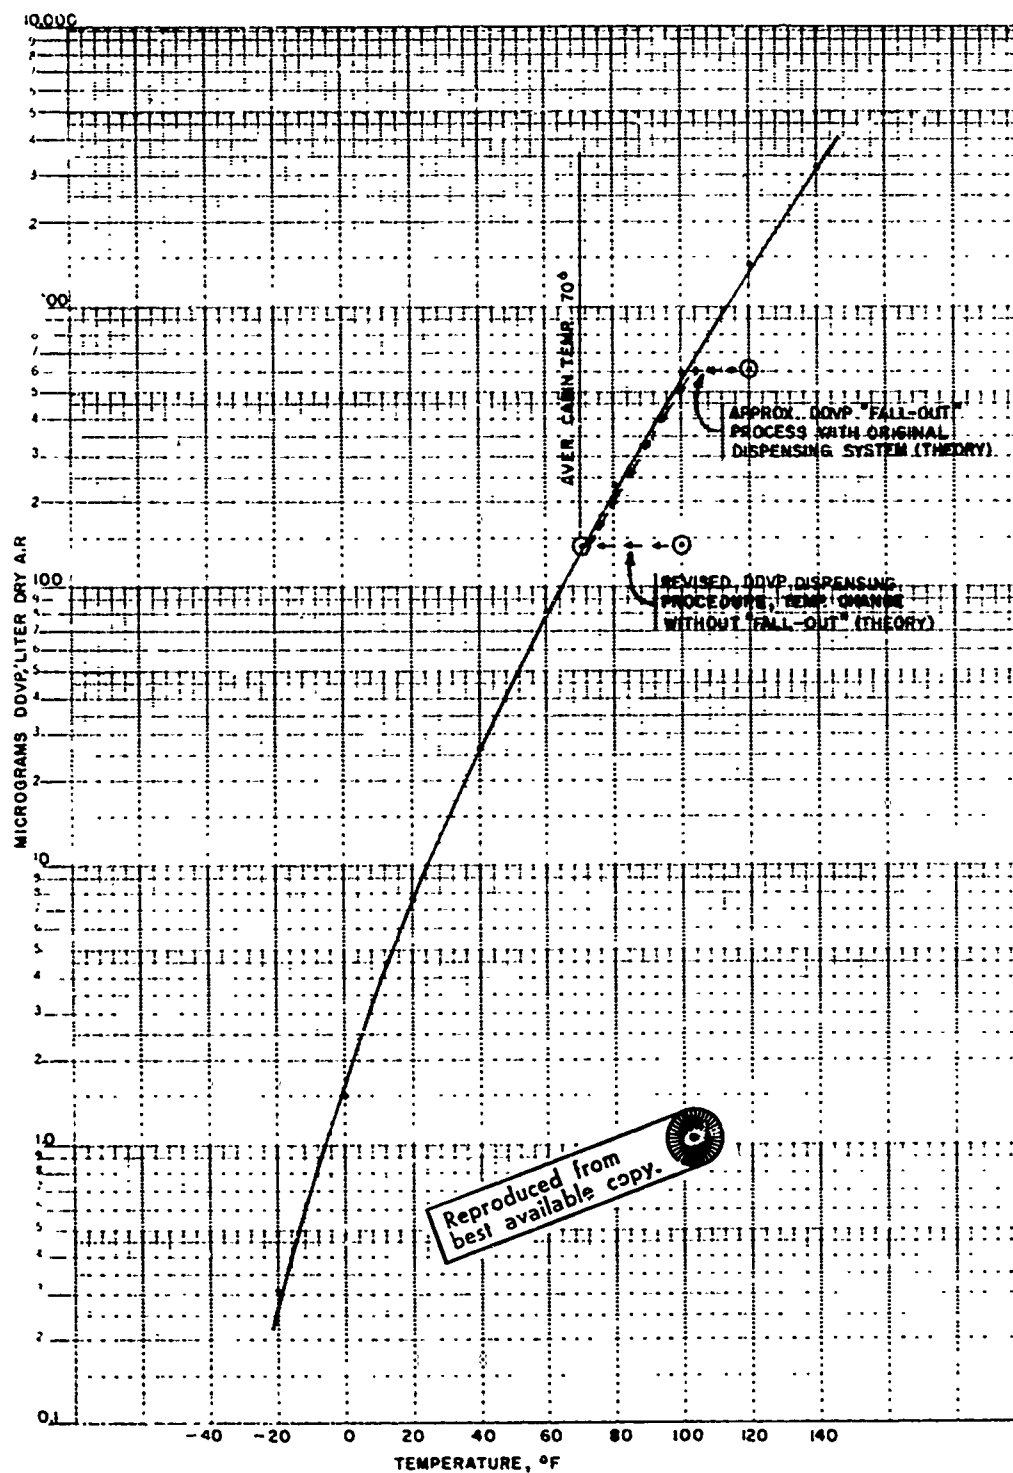
FIGURE 6-15: DDVP SATURATION VS. TEMPERATURE
[USPHS-CDC-TJL]
