DESIGN STUDY OF EXPENDABLE MAIN ROTOR
BLADES

Army Air Mobility Research and Development
Laboratory

USAAMRDL TECHNICAL REPORT 72-48

**CONTRACT DAAJ02-71-C-0041
KAMAN AEROSPACE CORPORATION
BLOOMFIELD, CONNECTICUT**

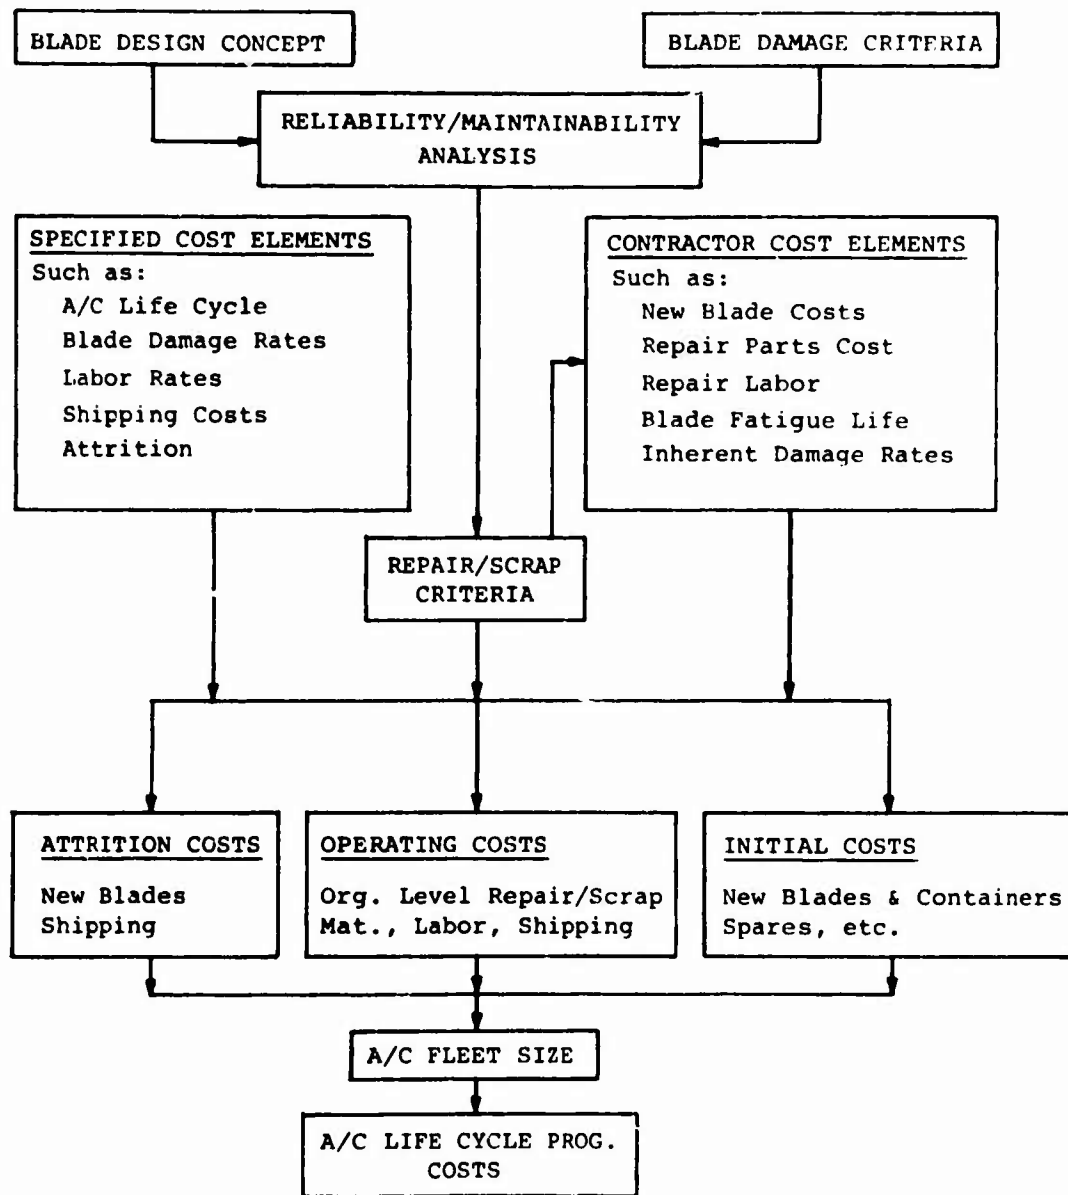
Figure 1. Expendable Blade Cost Model Schematic.

These initial costs (to the Army) were combined with maintenance, replacement, and attrition costs to give the total life-cycle costs, using the cost model below.

- C_{nb} = Cost of a new blade FOB
- C_p = Cost of repair kit FOB
- C_E = Cost of any GSE required per aircraft
- T_R = User repair MMH required, mean per repair
- AOT = Allowable blade operating time due to fatigue criteria, blade hours
- K_{BRO} = Fraction of damaged blades repaired at organizational level

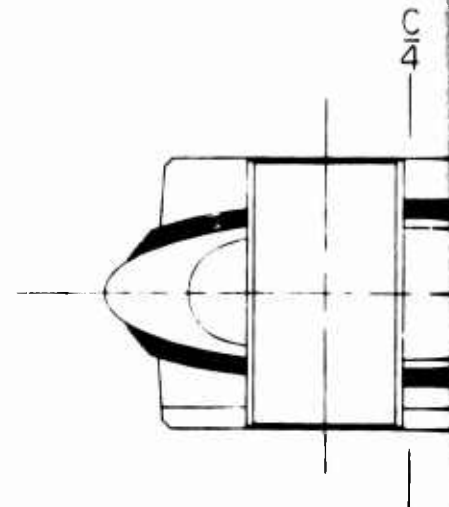
1. THICK LEADING EDGE TOLERANT OF ABRASION DAMAGE .
2. LEADING EDGE READILY BLENDED TO REMOVE DAMAGE .
3. DAMAGED AFT SECTION CANNOT BE REPAIRED IN FIELD .

Figure 2. Design 1, Expendable Rotor Blade, All-Aluminum Structure.

The four design concepts which were examined during this program are shown in Figures 2 through 5. These concepts were chosen because the number of component parts is minimized and the components themselves are simplified; thus, the first cost of the delivered blade will be sufficiently low that it will be cost-effective to scrap a damaged blade rather than to return it for repair. The susceptibility to external and inherent damage of the various blade and component designs and materials was considered in the light of possible trade-off between first cost and service life. Table I presents the design features of each concept.

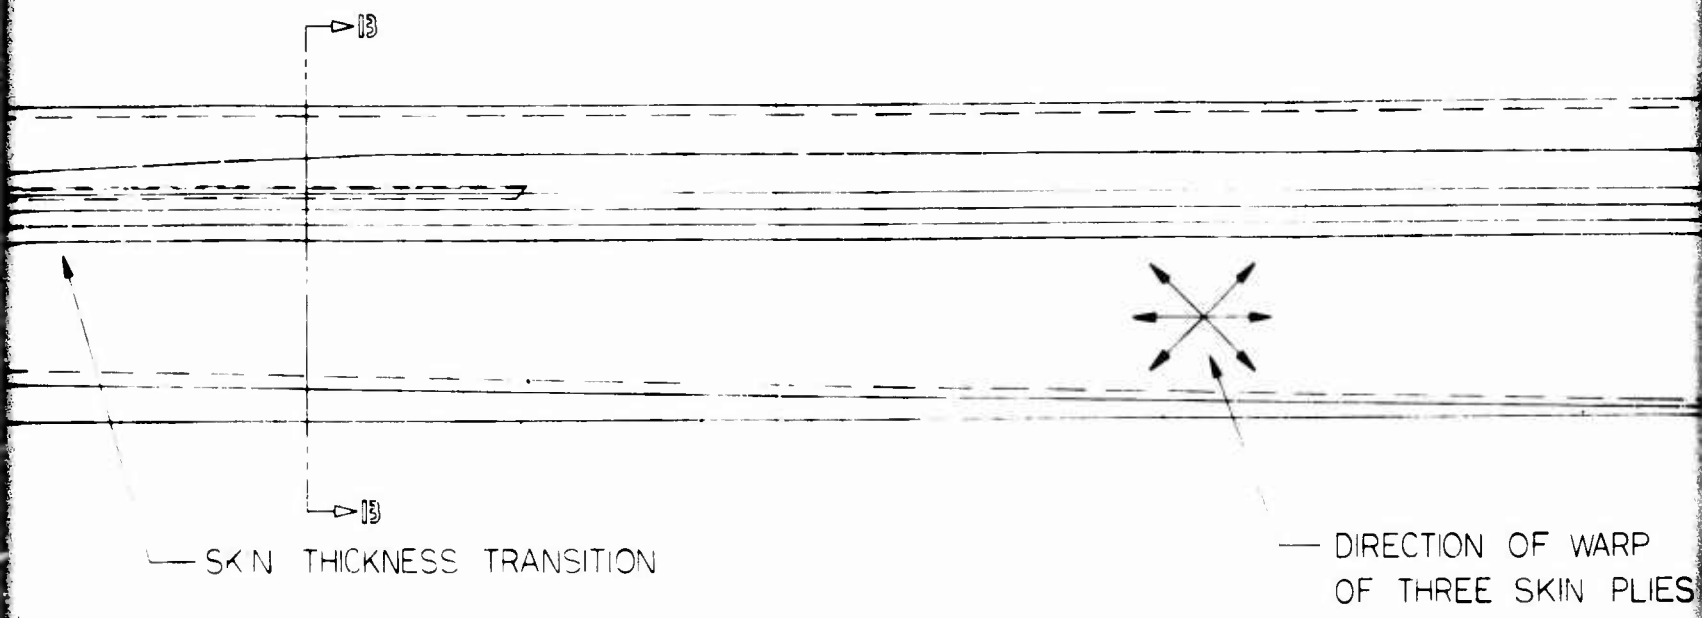
1. AIRFOIL SECTION MODIFIED TO PROVIDE STRAIGHT-SIDED AFT SECTION .
2. SPAR ASSEMBLED FROM SIMPLE FORMED STAINLESS STEEL SHEET .
3. UTILIZES EXISTING RETENTION .
4. GLASS FIBER REINFORCED AFT SECTION TO MINIMIZE STRESSES DUE TO BONDING TEMPERATURES .
5. SECTION PROPERTIES TAPERED TO MATCH PRESENT UH-1 BLADE .
6. PRETWIST OF SPAR COMPONENTS NOT REQUIRED
7. INTRODUCTION OF AIRFOIL VARIATIONS POSSIBLE .
8. AFT SKINS LOCALLY THICKER UNDER ROOT DOUBLERS .
9. LIGHTWEIGHT "NOMEX" HONEYCOMB CORE WITH STRAIGHT SIDES FOR SIMPLE CARVING .

1. INHERENT ABRASION RESISTANCE WITH STAINLESS STEEL SPAR .
2. RUGGED DAMAGE-RESISTANT SPAR .
3. AFT SECTION REPAIRABLE IN FIELD .
4. HIGH FATIGUE RESISTANCE .

Figure 3. Design 2, Expendable Rotor Blade, Formed Sheet Metal Spar.

This concept is illustrated in Figure 3. The basic blade consists of a spar constructed from two formed stainless steel sheet parts, bonded together with the airfoil shape completed by a glass-fiber-reinforced plastic afterbody. For section balance, a stainless steel ballast bar is bonded into the nose. Because the nose skin is a heavy stainless steel sheet, additional protection against abrasion and erosion is not required. To facilitate carving of the core, the modified airfoil section described in Design 1 is utilized.

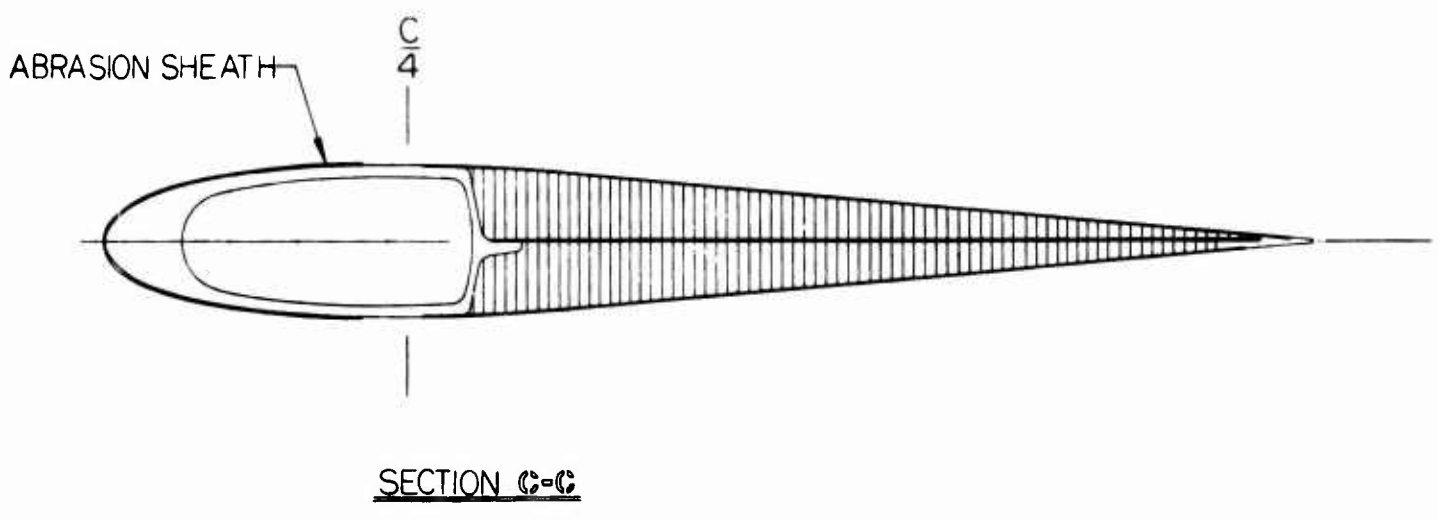
1. THICK LEADING EDGE TOLERANT OF ABRASIVE DAMAGE.
2. LEADING EDGE READILY BLENDED TO REMOVE DAMAGE.
3. AFT STRUCTURE PROTECTED FROM EXTERNAL DAMAGE.
4. AFT SKINS REPAIRABLE IN FIELD.

Figure 4. Design 3, Expendable Rotor Blade, Buried Chord Plane Shear Web.

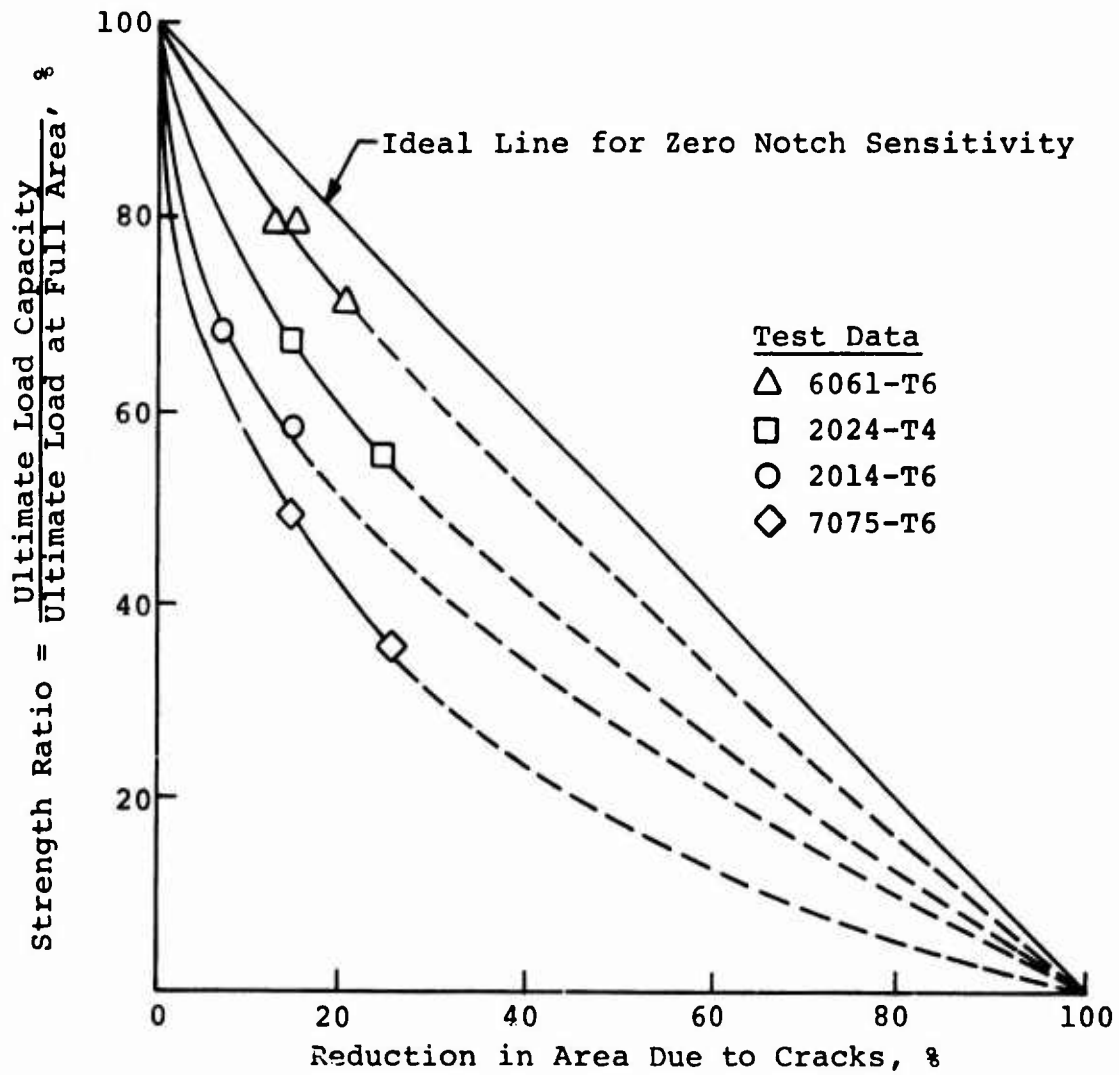
Figure 46. Fracture Toughness of Aluminum Alloys.

As a structural material, particularly in a fatigue environment, 6061 alloy has one significant advantage in its fracture toughness. The crack propagation rate of this alloy is appreciably slower than that of other structural aluminum alloys. Figure 46, redrawn from Figure 7 of Reference 6, graphically illustrates this characteristic. The hypotenuse of the triangle represents an ideal material where the loss of strength is in direct proportion to the loss of area due to cracking. The deviation from this line for each of the real alloys is the additional reduction in strength due to notch-sensitivity. Although the data from which this figure was plotted were generated some fifteen years ago, they represent valid experimental results in spite of the more sophisticated testing techniques and specimens in use since. More recent experience tends to confirm the fracture-toughness relationship between these alloys. The current UH-1H blade uses 2014-T6 or 2024-T4 aluminum alloy for the extruded spar, so that fracture toughness would improve in the expendable concepts.

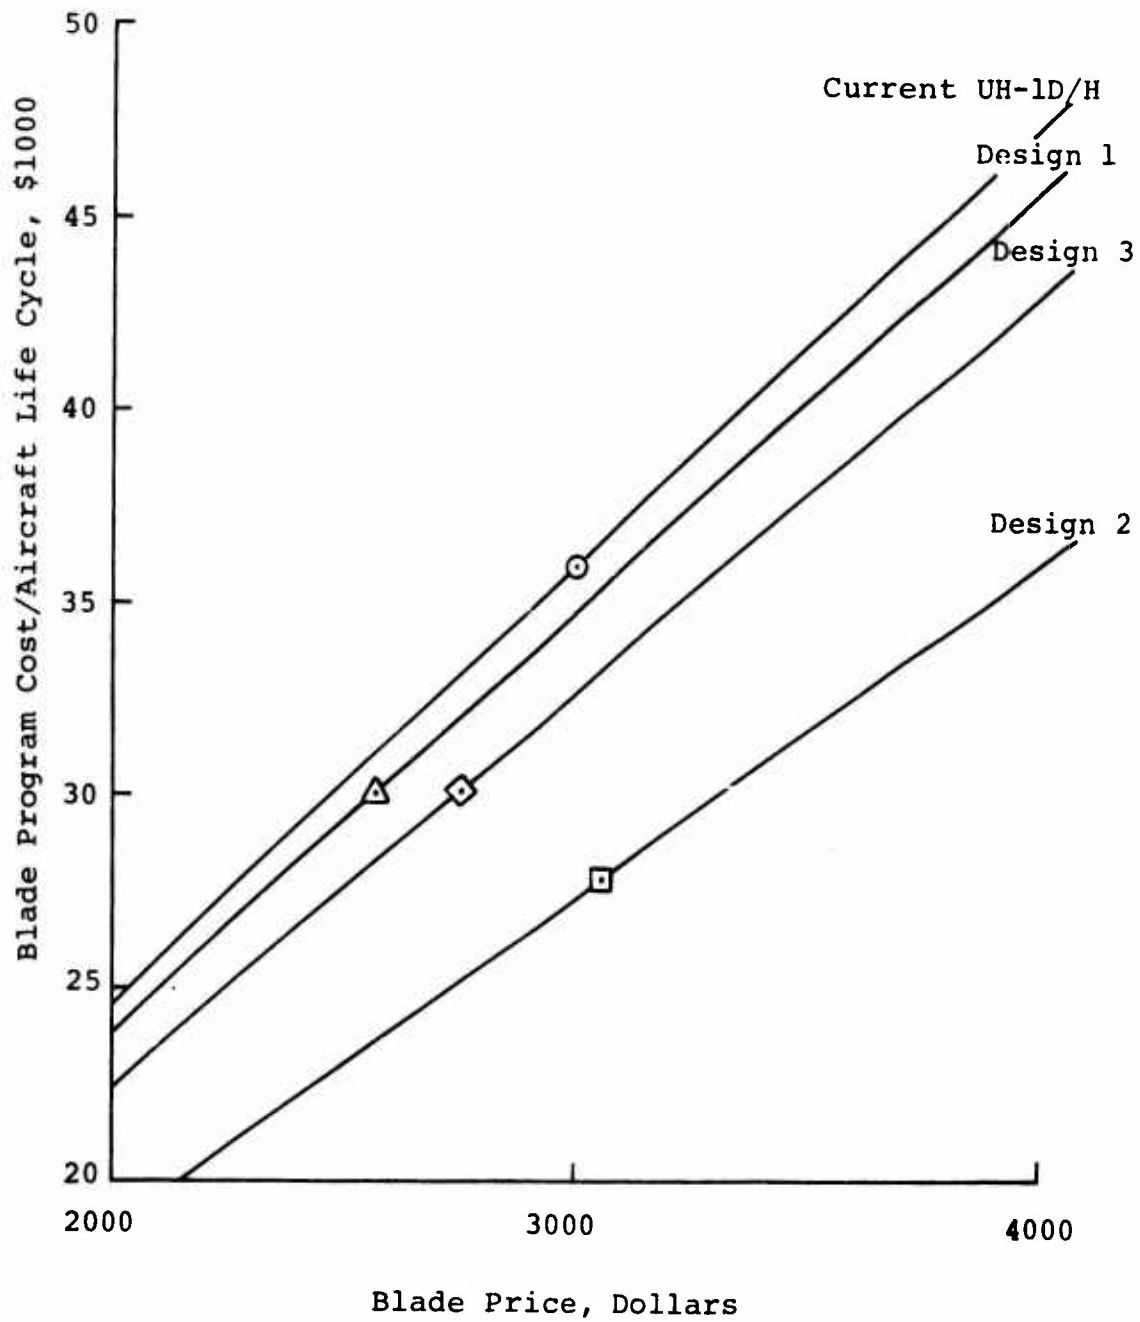
Figure 48. Program Cost vs New Blade Cost.
