AN EXPERIMENTAL INVESTIGATION FOR DETERMINING  
SUSCEPTIBILITY LIMITS AND TECHNIQUES FOR  
DESENSITIZATION OF SOLID STATE ELECTRONIC  
EQUIPMENT TO POWER LINE TRANSIENTS

NAVAL CIVIL ENGINEERING LABORATORY

APRIL 1973

Technical Note N-1256

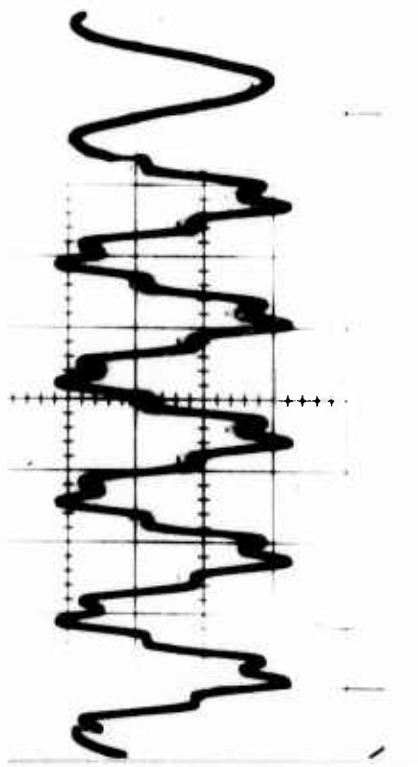
Figure 14. Superimposed high frequency on 60 hz power.

High frequency voltage waveforms from 300 hz to 10 Khz were superimposed on the input AC power with magnitudes of 50 volts RMS and for durations of 1/2 to 20 cycles of the 60 hz frequency. Figures 14a and 14b show 300 hz for durations of 1/2 and 5 cycles. Figures 14c and 14d show 10 Khz for durations of 1/2 and 5 cycles. None of the superimposed high frequencies caused physical damage or operational failure of the test unit.

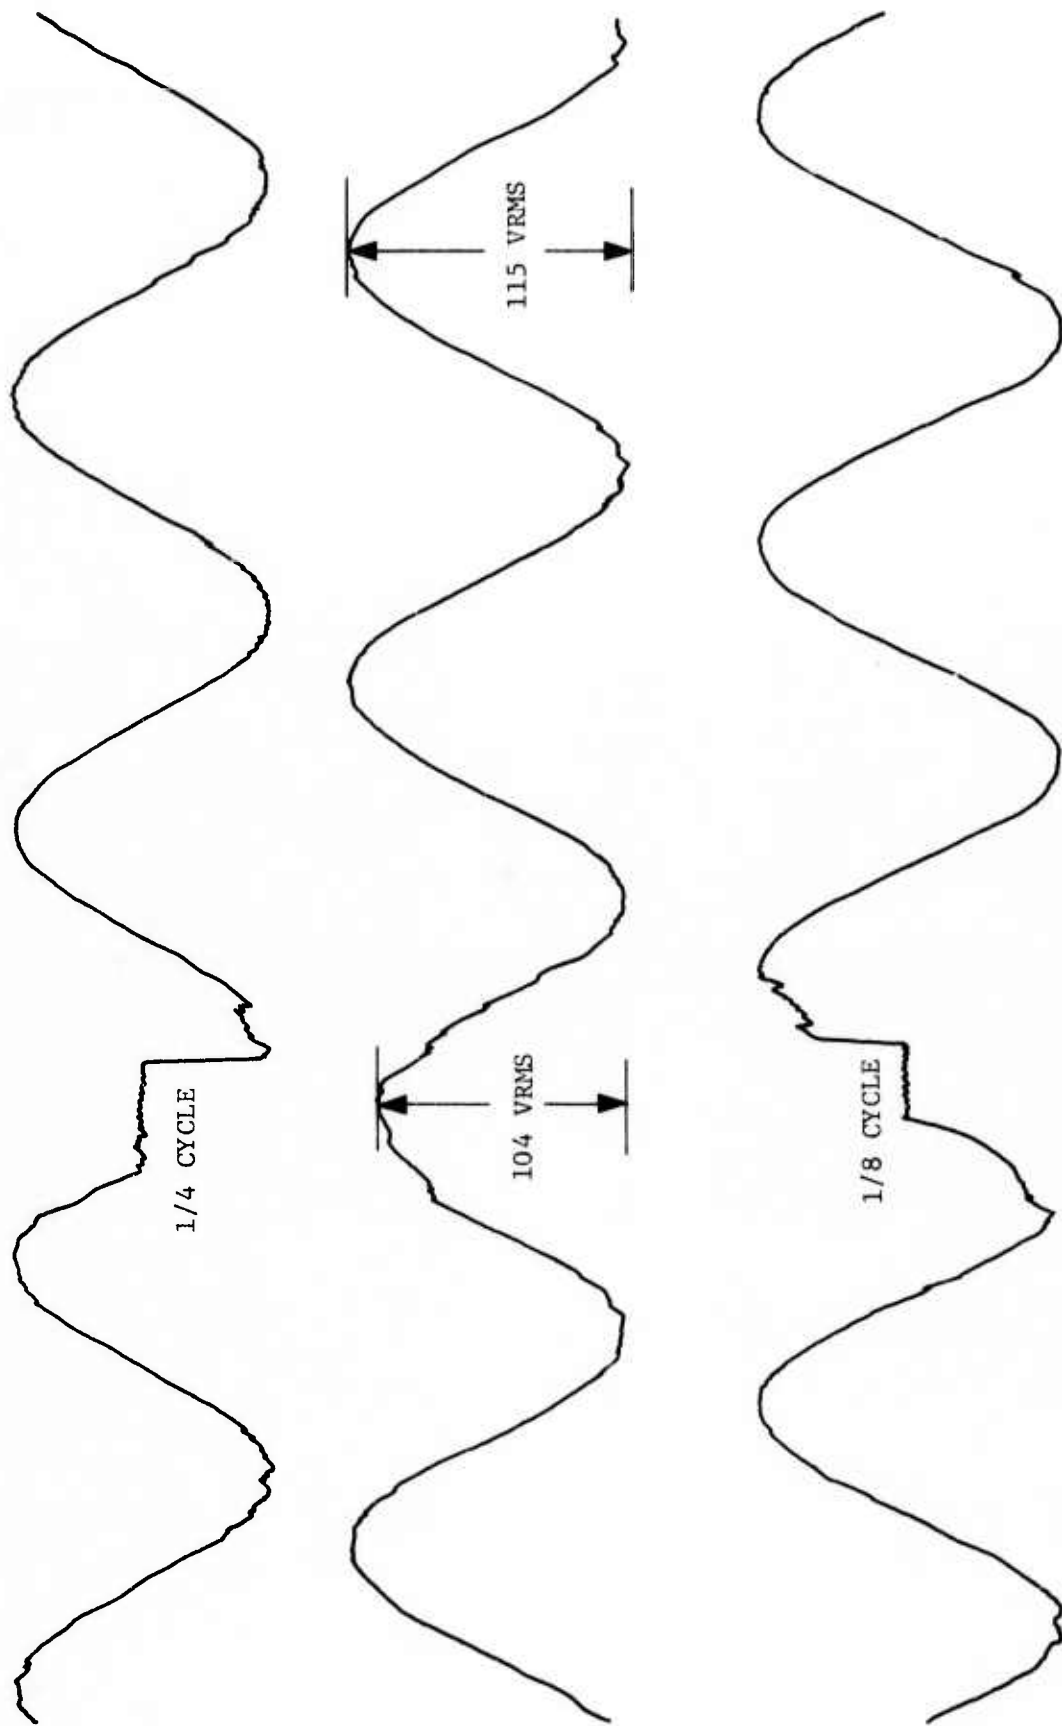
Figure 19. Momentary Power Outage and Voltage Dip.

The test unit used during these tests demonstrates that failures in critical equipment do occur when certain abnormalities occur on the utility power. Also, some of these failures can be prevented, if during the design phase, more attention is given to the actual conditions existing on utility power lines. Figures 16 through 20 are random transients recorded at various geographic locations in the USA. If any of these transients occurred on the power supplied to the test unit, it would, in all probability, have failed. The exact source of these types of transients is usually unknown. These are the transients that propagate through the power line into the critical loads. One thing is certain, the designer has difficulty protecting against something that is unknown. For this reason, when new equipment is
