NICHROME RESISTOR PROPERTIES AND RELIABILITY

ROME AIR DEVELOPMENT CENTER

RADC-TR-73-181
Final In-House Report
June 1973

Clyde H. Lane

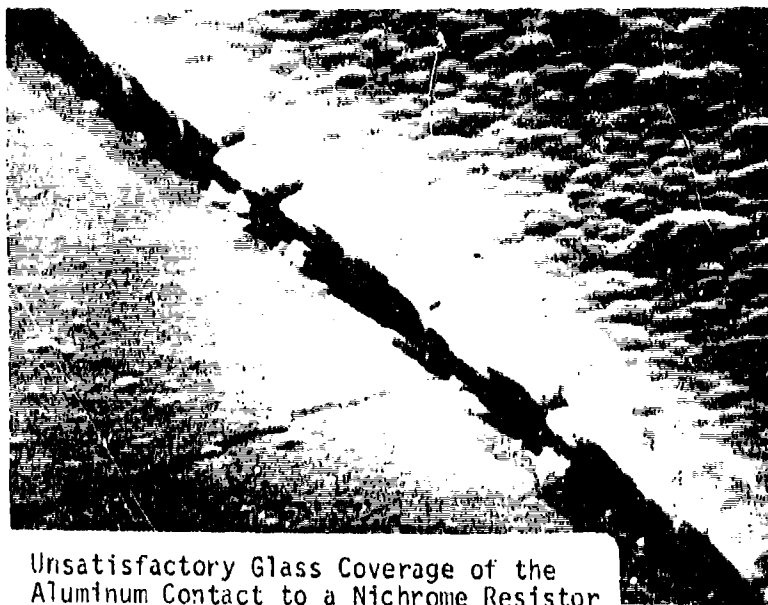
Unsatisfactory Glass Coverage of the
Aluminum Contact to a Nichrome Resistor
Figure 1

Straightforward chemical corrosion can occur as long as the appropriate ions are present. The crack or pin hole simply provides access to the nichrome. Evidence of simple chemical corrosion on the quad gates was later found also. This fact implicates process control in resistor fabrication as well as in packaging. The Scanning Electron Microscope (SEM) photograph in Figure 1 shows another process control problem, poor step coverage of the aluminum-nichrome termination by the evaporated glass. This forms a pocket which readily catches available water.

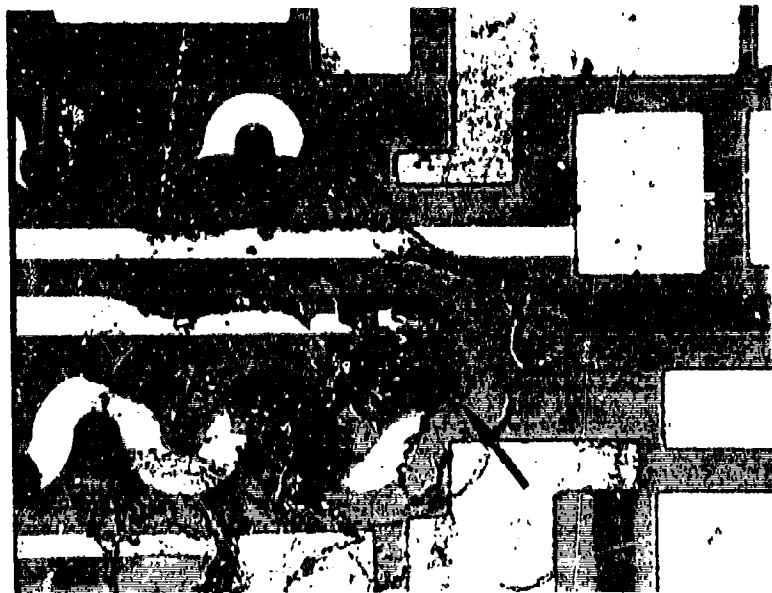
Open Adjacent NiCr Resistors - 240X
Figure 28

2. For the larger thin film resistor widths, a drop of DI water w/bias may not cause failure. It may only decrease the resistance. The residue remaining from the dried water drop may be conductive enough to cause the decrease in the resistance.
