CALIBRATION, TEST, FIELD OPERATION AND  
REFURBISHMENT OF BALLOON BORNE  
RADIOMETER

Arthur G. DeBell

Rockwell International Corporation

FINAL REPORT

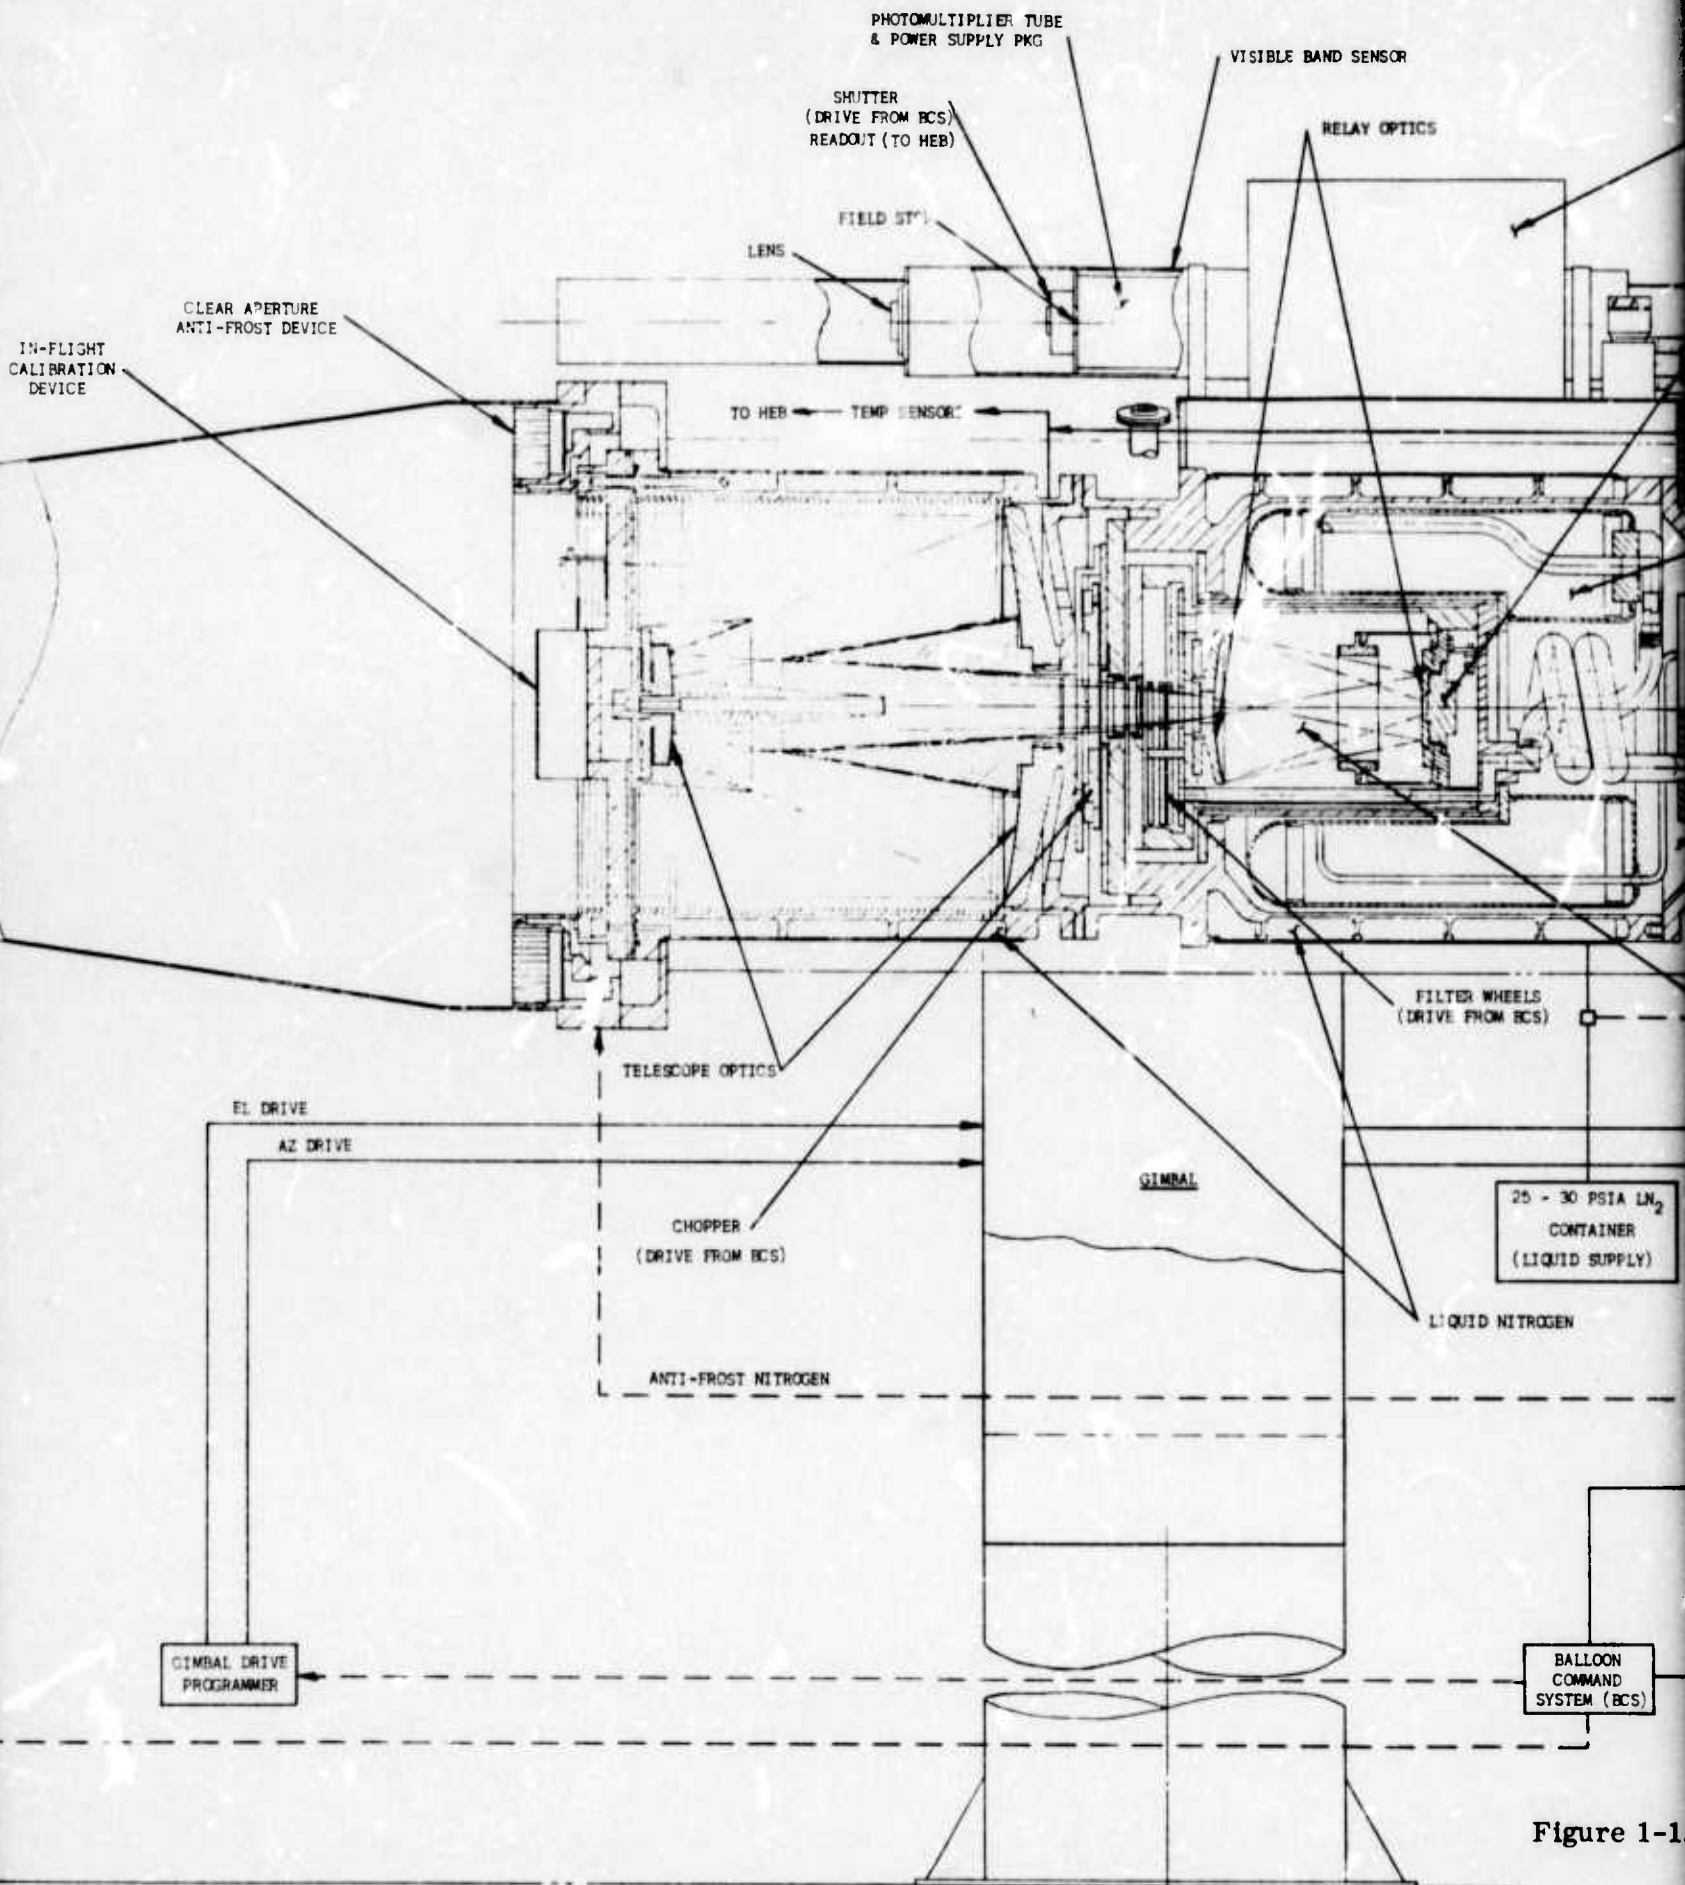
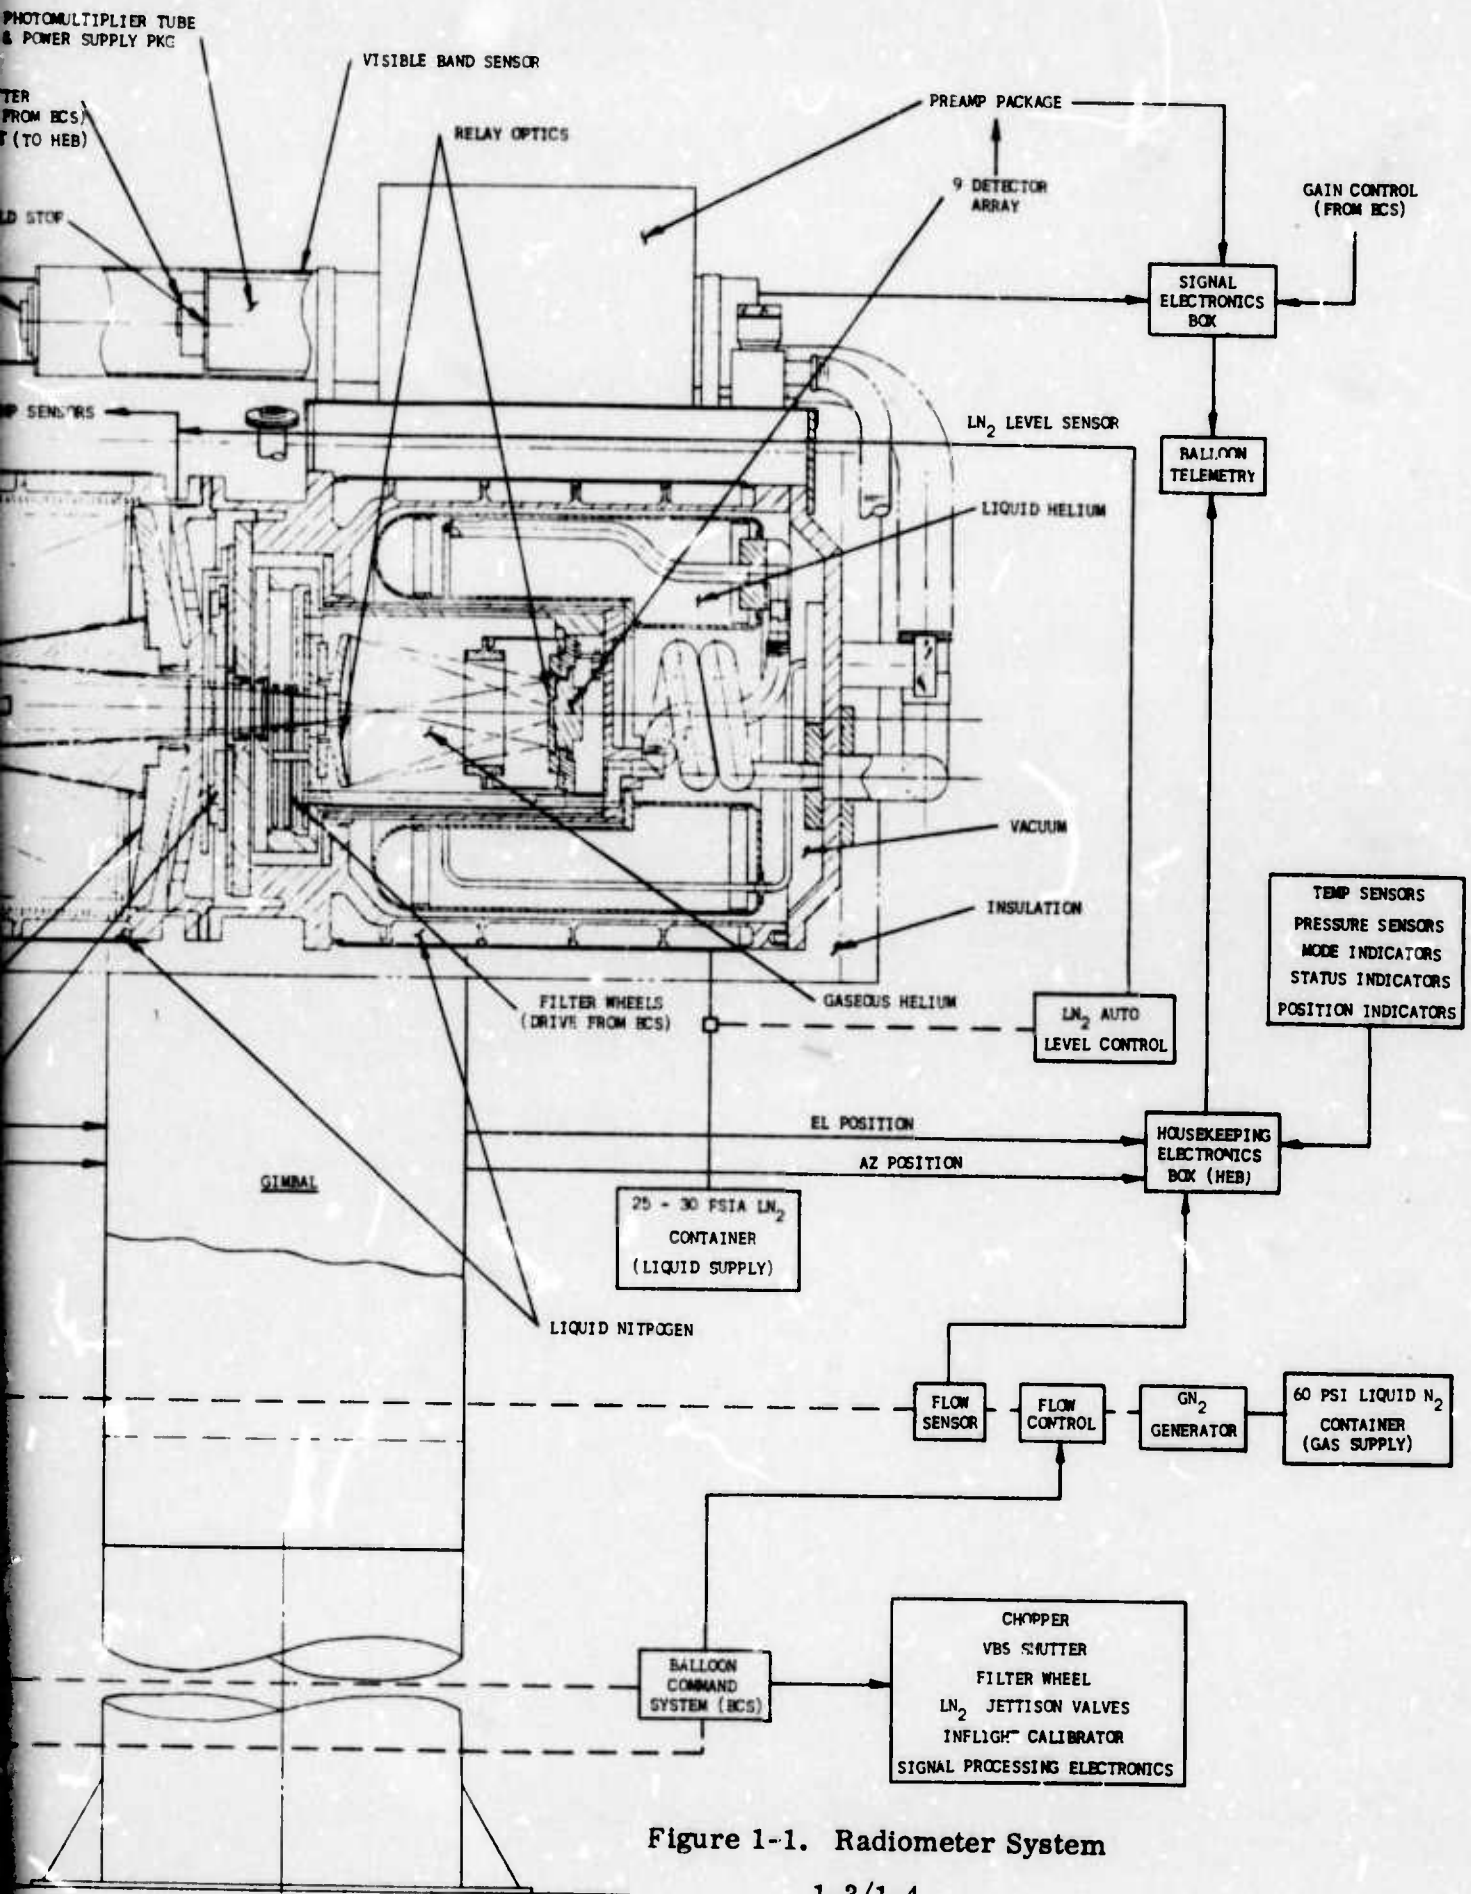
Figure 1-1. Radiometer System

A unique feature of the radiometer is the ability to remotely operate its many controls by means of commands radioed from the ground. Figure 1-1 is a schematic of the radiometer system.

The light gathering system of the radiometer is a well baffled Cassegrain telescope with a 10 in. diameter primary mirror. As the telescope's converging beam of radiation approaches its focus it passes through the plane of the rotary chopper, which upon command is capable of interrupting the beam at 200 Hz, allowing the beam to pass through uninterrupted, or blocking the beam. After passing through the Intran-VI window and the Intran-VI field lens which seal the vacuum space, the beam passes into the helium gas cooled reimaging cavity. The beam comes to focus on a compound field stop which contains nine individual openings each twice as large as the corresponding detector mask.

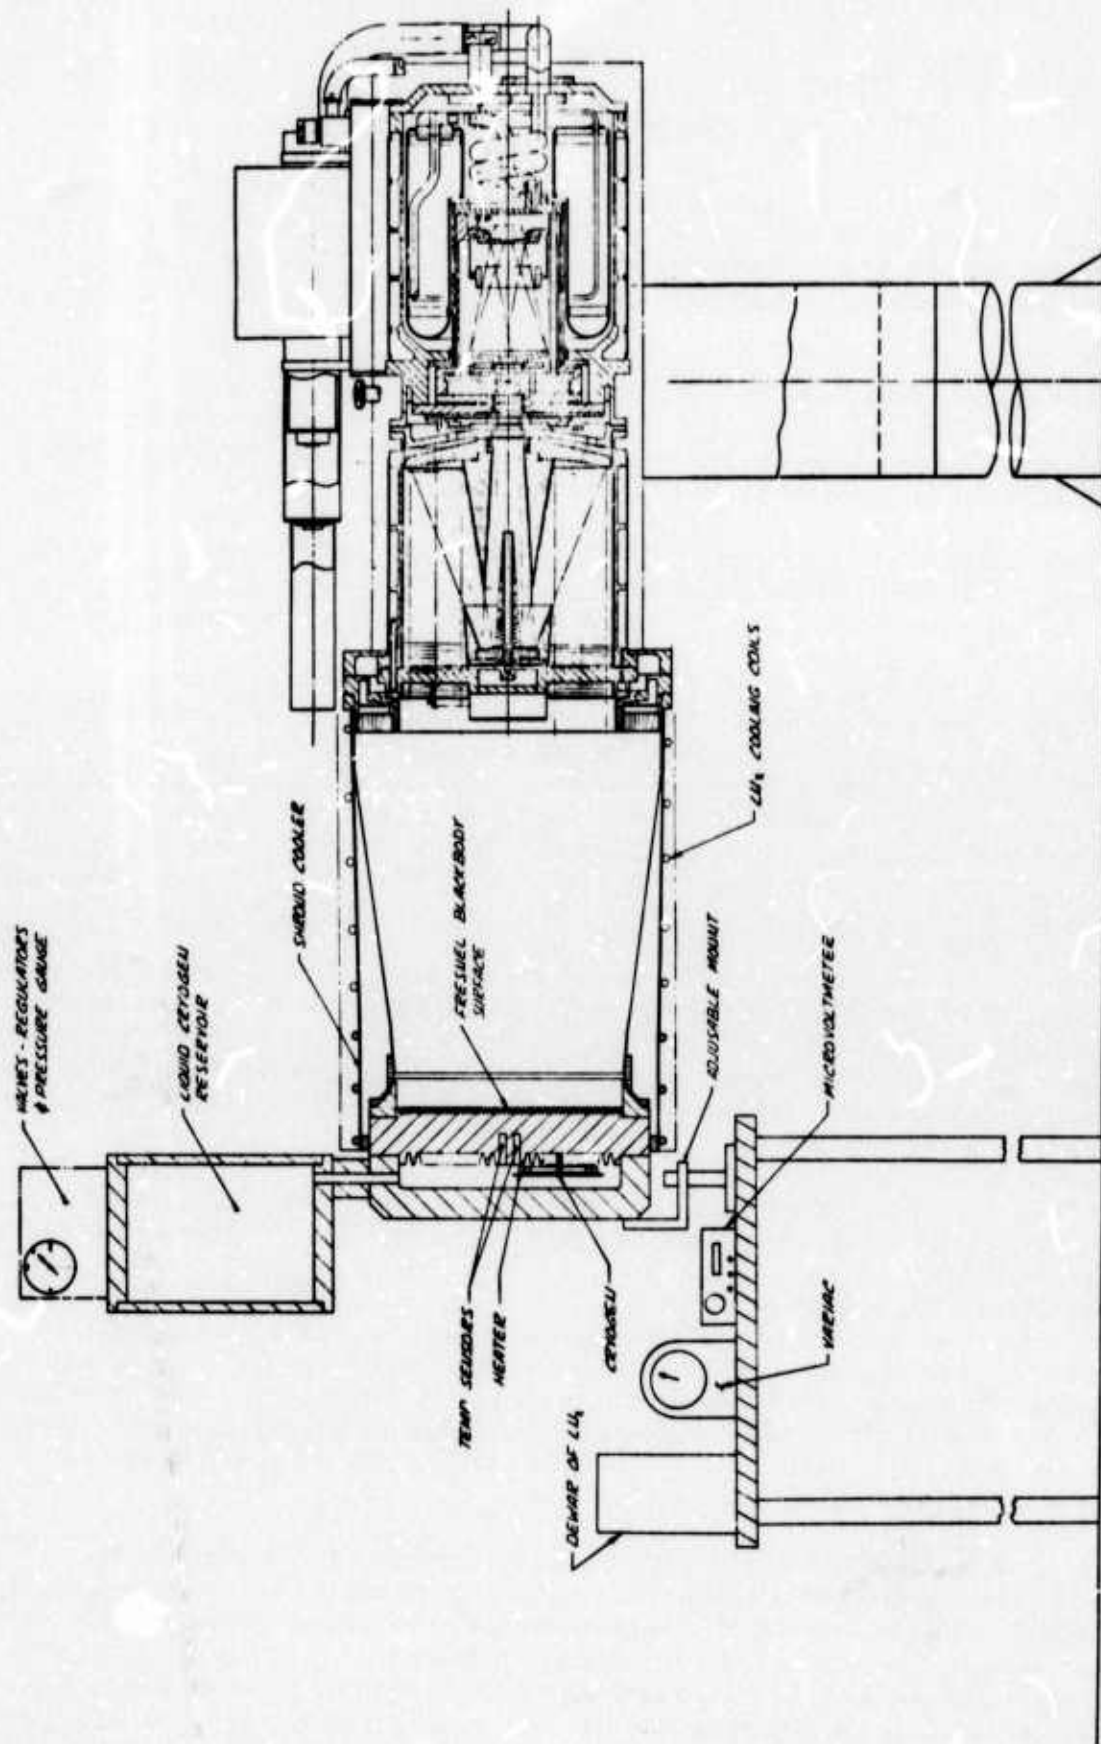
Figure 2-1. Radiometric Calibration Set-Up

Proper calibration of the radiometer with the laboratory calibration device required that the faceplate of the laboratory calibrator be positioned at the end of the antifrost shroud and that no significant radiant energy be allowed to get into the radiometer except that emitted from the calibrator faceplate. This requires that the antifrost shroud be cooled to 77 K, so that any radiance emitted from its inside surface, when reflected by the faceplate into the radiometer, will be very small compared to the emitted radiance of the faceplate itself. For this purpose a shroud cooler has been constructed for use with the laboratory calibrator.

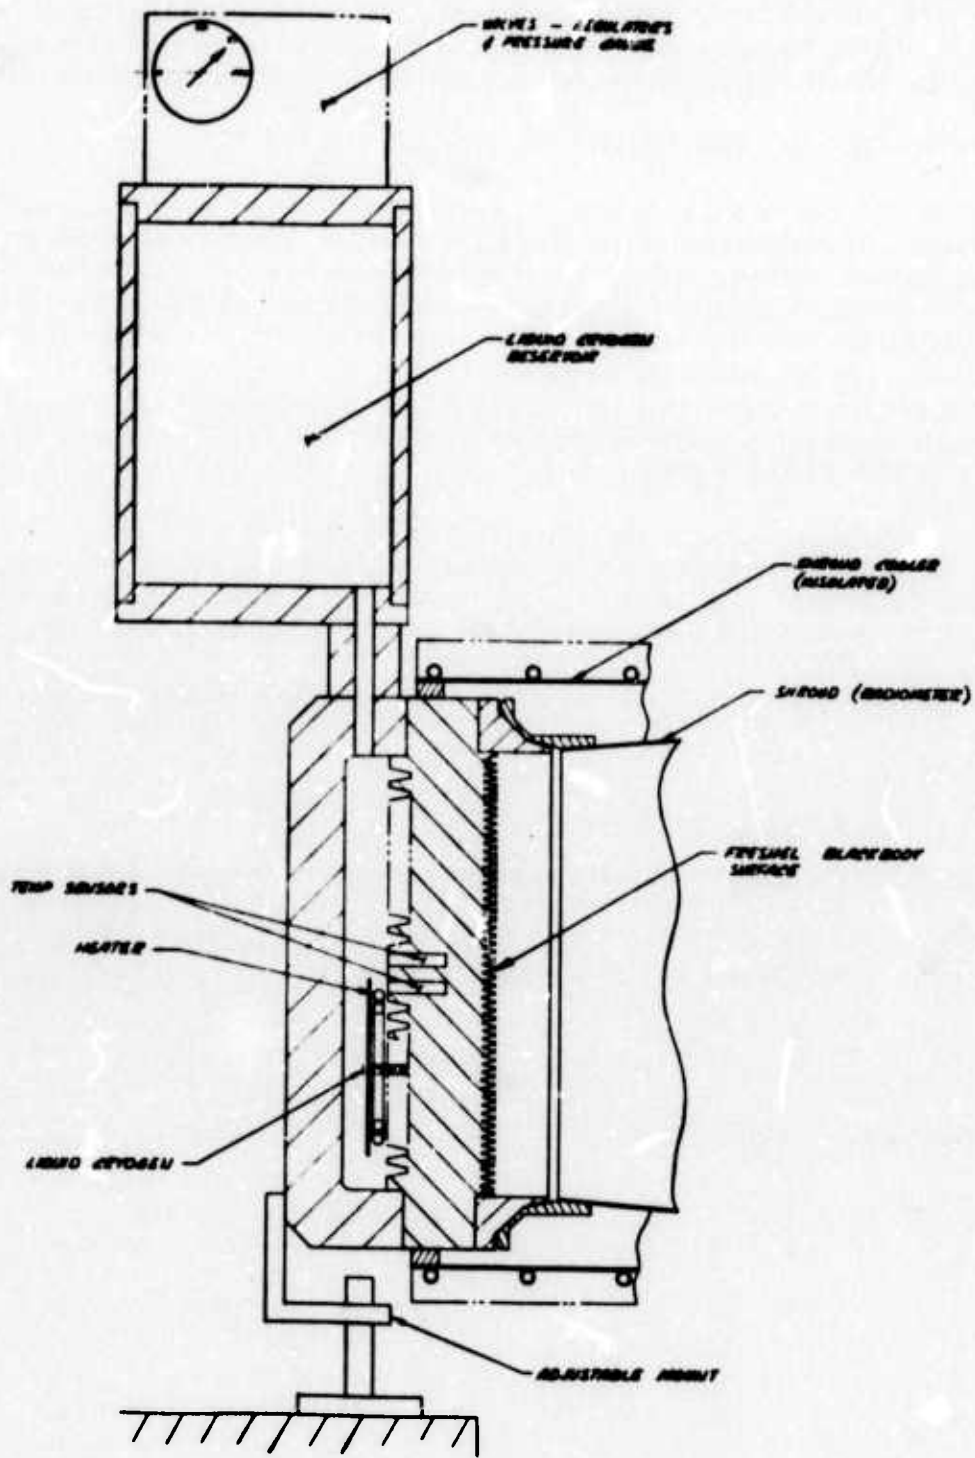
Figure 2-2. Laboratory Calibrator

Concentric circular grooves are also machined on the inside of the plate in order to increase the heat transfer between the cryogen and plate. Mounted on the top of the dewar are a fill valve, vent valve, multi-pin electrical feed-through connector, burst disk, pressure relief valve, and pressure gauge. The temperature is monitored at a number of points within the source plate by copper constantan thermocouples. The sensor output leads are connected to the multi-pin electrical connector. Rigid attachment of the calibration device to the sensor is accomplished by clamps (not shown) which hold the sensor shroud against the mounting ring. The bottom mount supports the calibration device on a table. The pressure vessel is covered with Armaflex insulating material.

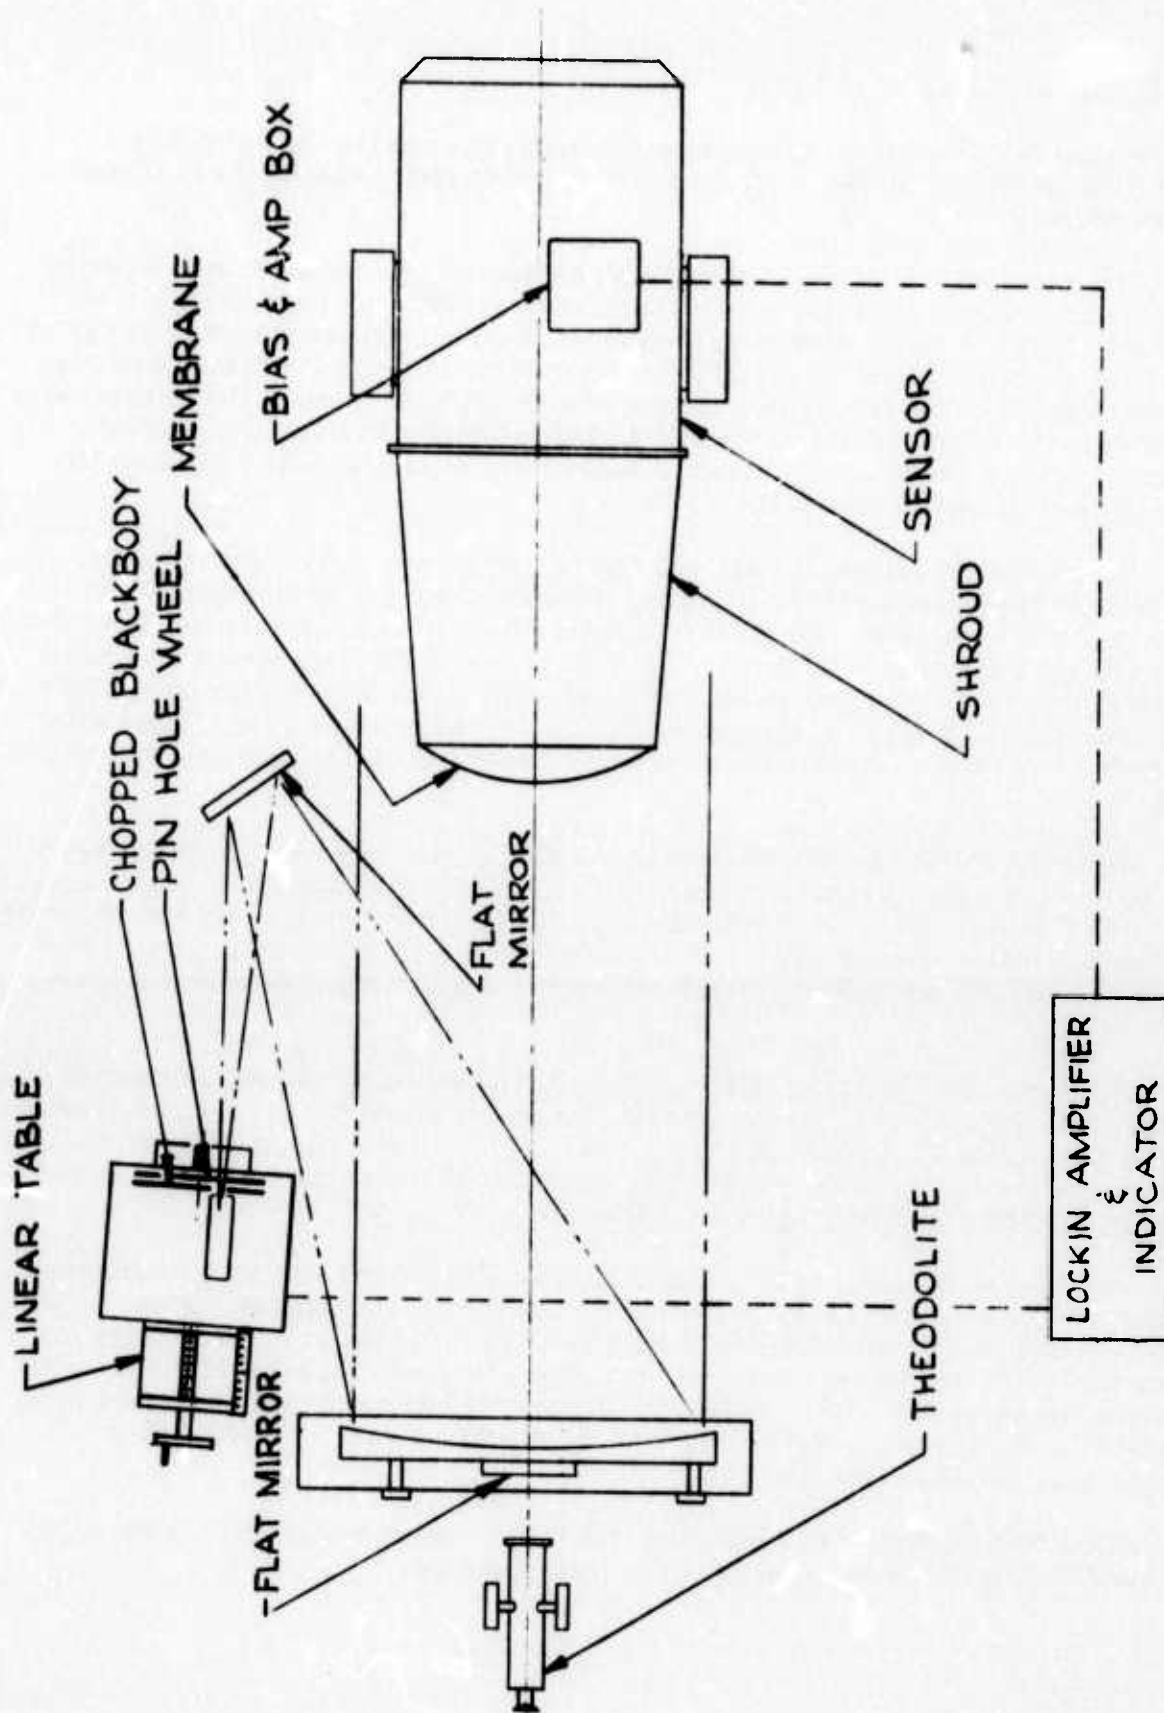
Figure 2-3. Focus and Field of View Arrangement

The instrument is set on its gimbals in the laboratory, its antifrost shroud is in place and a 0.005 mm. mylar membrane is installed to cover the aperture of the antifrost device. A 16 in. diameter, long focal length off-axis collimating mirror in a delicately adjustable mount is set up to send a collimated beam of infrared radiation into the instrument. A small plane mirror is attached to the back of the collimator so that it moves in angle with the collimator as the collimator is adjusted. A Wild theodolite is used as an angle-measuring autocollimator to accurately measure the small angular displacements of the collimating mirror.

Starting with a large pin hole the instrument and the collimator were aligned by searching for and then maximizing the signal on one of the detectors, as the collimating mirror and the instrument were both moved. The signal on the detector was observed by wiring the output of the Detector Test Box (p. 7-88 R&D Information Report) into the lockin amplifier which was synchronized with the frequency pickoff on the blackbody chopper.

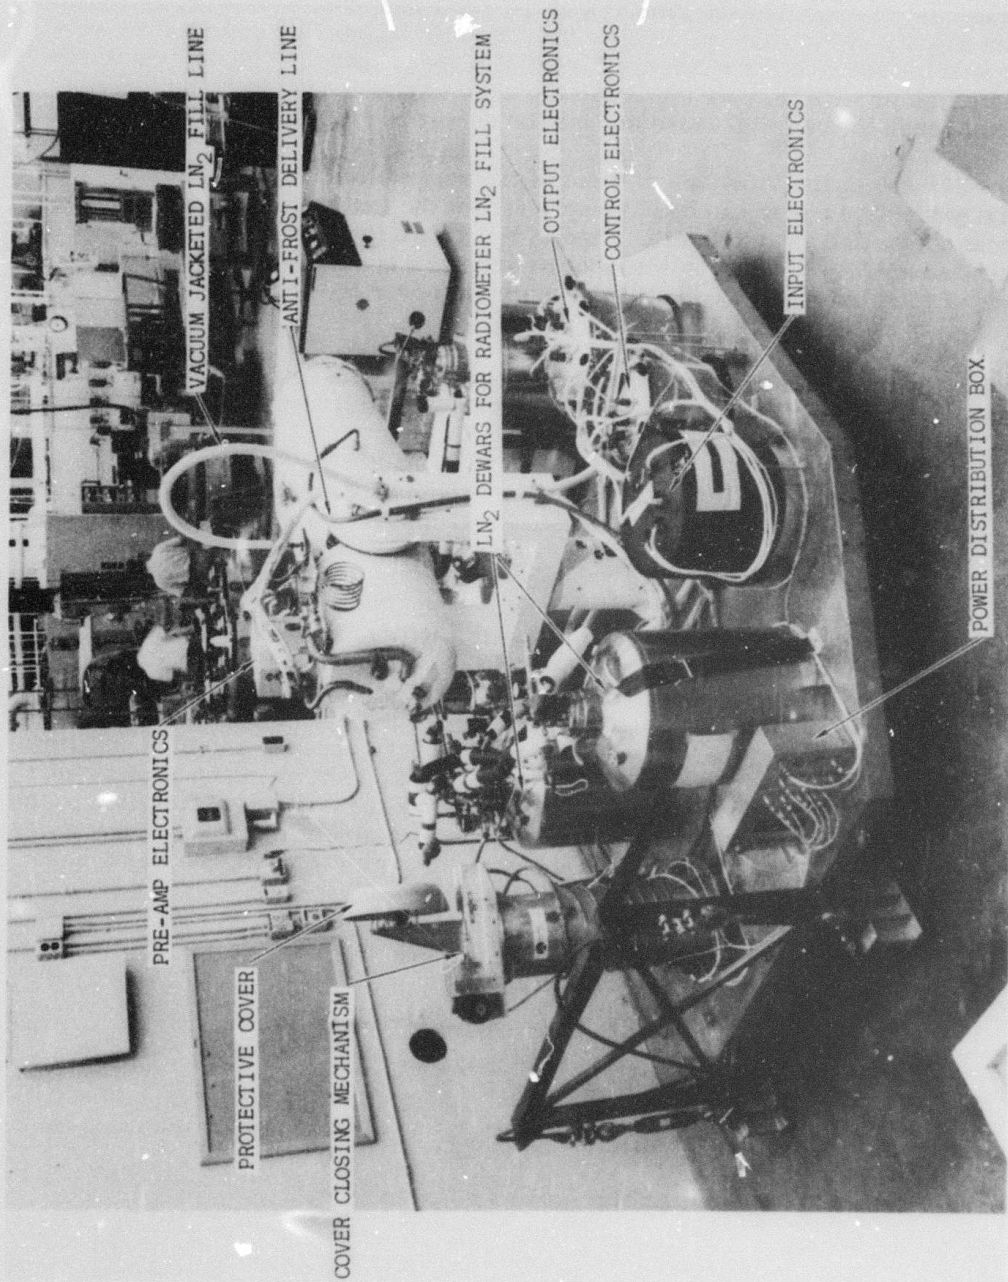
Figure 3-1. View of Gondola

In order for the gimbaling radiometer to clear the liquid nitrogen containers and their associated piping the gimbal (and the cover pedestal) were raised 2 in. above the gondola floor by spacers.

The components were attached to the gondola floor by combinations of bolts, straps and special mounting fixtures. The electrical interconnections were provided by a custom made interconnecting cable set. After the system components were mounted the GN<sub>2</sub> antifrost lines and the LN<sub>2</sub> sensor cooling lines were shaped, installed, and insulated. A flexible vacuum jacketed liquid nitrogen line was installed to supply the sensor with cryogen. A special flexible silicone rubber line was installed to deliver the ambient temperature antifrost nitrogen to the shroud. After the installation was completed, the liquid nitrogen containers were filled, and the system was cooled down. The antifrost flow rates were set up. Clearances between the gimballed radiometer and the various components were checked and the operation of the cover was demonstrated. During the course of this demonstration it was found desirable to improve the cover-gimbal interlock logic by the addition of a switch which would deactivate the gimbals just before the cover was completely seated. Upon the completion of these checks the system was disassembled as required, packaged and shipped to Holloman Air Force Base, New Mexico.

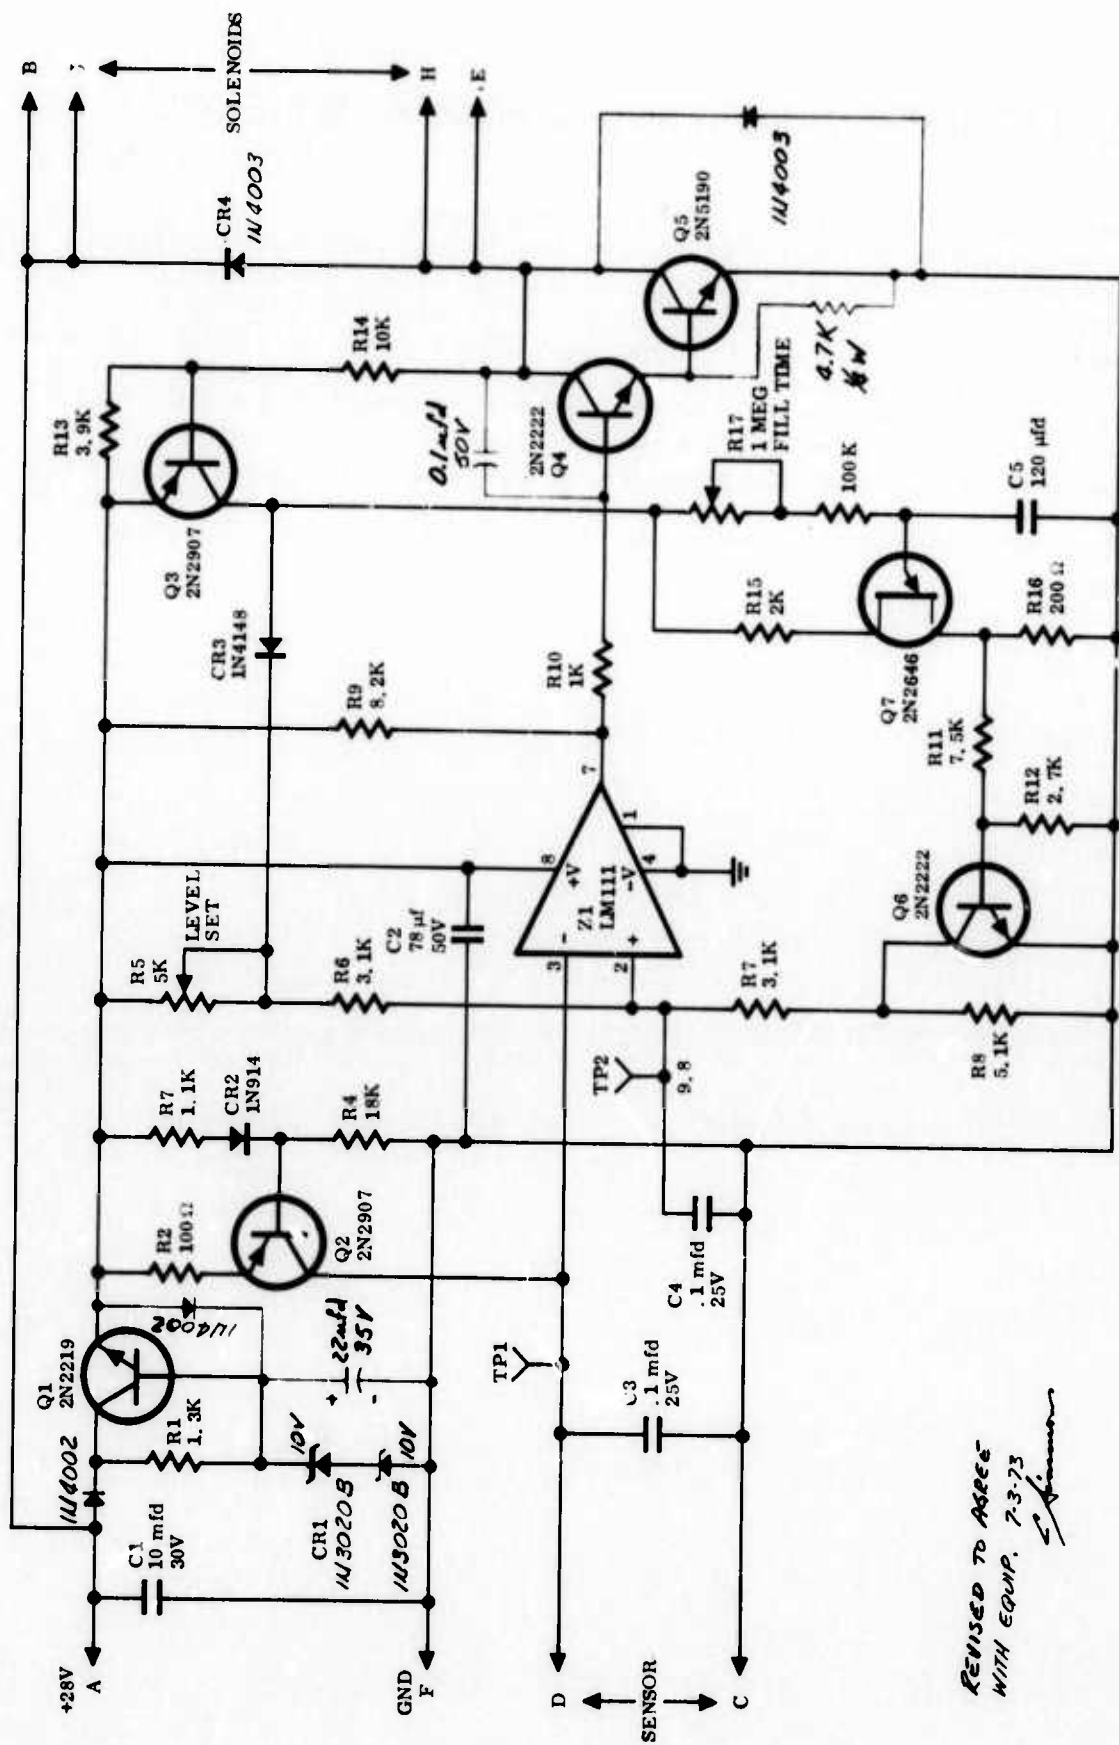
Figure 12-1. (7-24) Schematic - LN<sub>2</sub> Level Control Circuit

During the course of the field work with the instrument it was found desirable to make modifications to the equipment to improve its operating performance. These modifications are documented in this report as revisions to the drawings which were originally included in the Balloon-Borne Cryogenically Cooled Filter Radiometer Research and Development Information Report No. C72-132/401. In this report they are designated with the usual figure notation for this report followed by a number in parenthesis which refers back to their original figure number in C72-132/401, i.e., Figure 12-14 (7-10) Schematic-Output Electronics Board 2002. An additional circuit was added to the instrument during this program. This was done in order to provide a better temperature control for the input electronics canister than could be provided by a thermostat. This circuit is documented as Figure 12-2 Input Electronics Temperature Control Circuit.

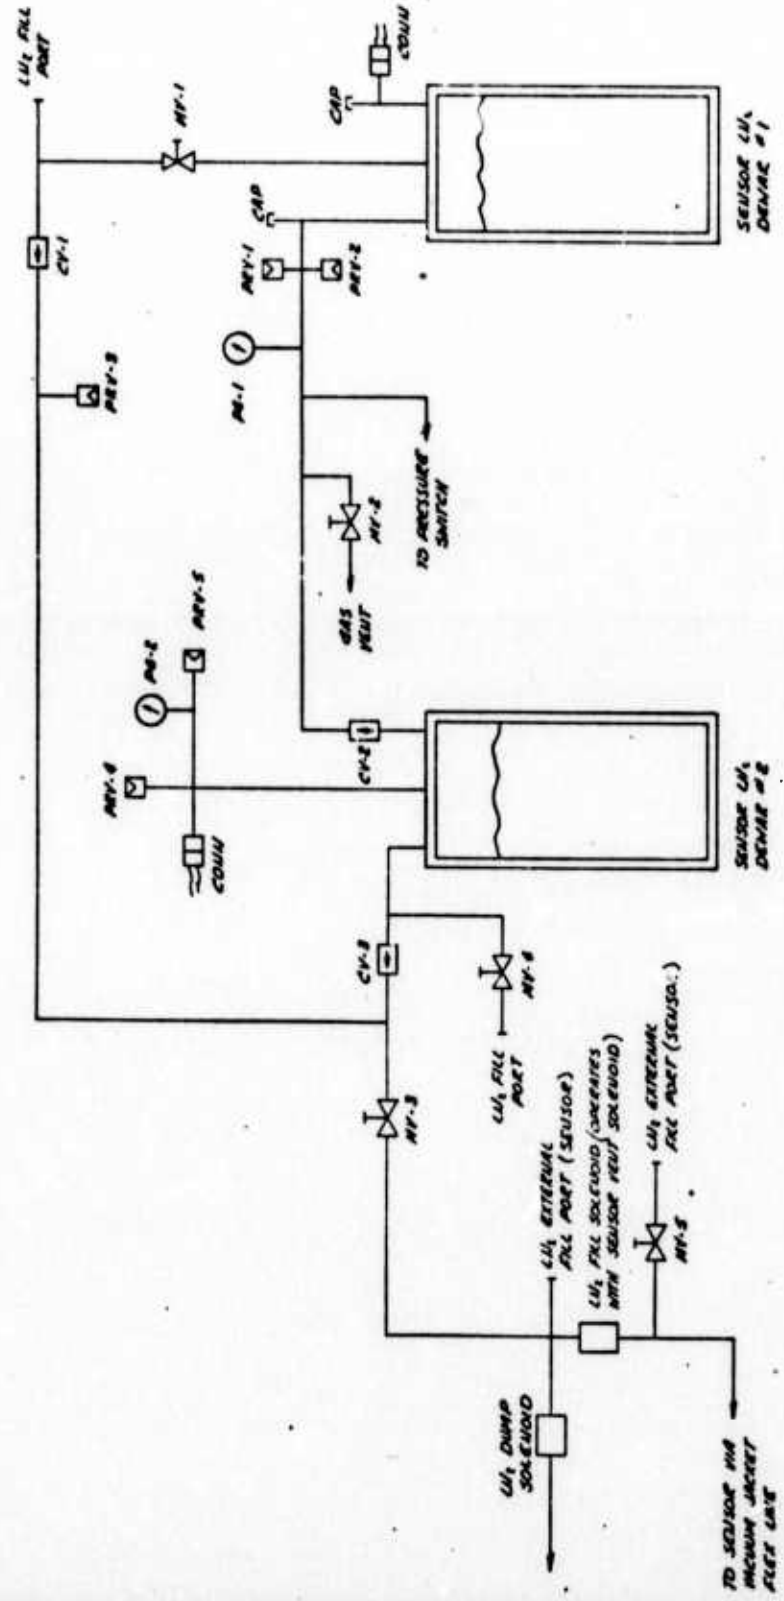
Figure 12-4. (6-3) LN<sub>2</sub> Supply Schematic

APV - PRESSURE RELIEF VALVE  
 PG - PRESSURE GAUGE  
 MV - MANUAL VALVE  
 CV - CHECK VALVE
