USAARL REPORT NO. 74-4

PARACHUTE ESCAPE FROM HELICOPTERS

U. S. ARMY AEROMEDICAL RESEARCH LABORATORY

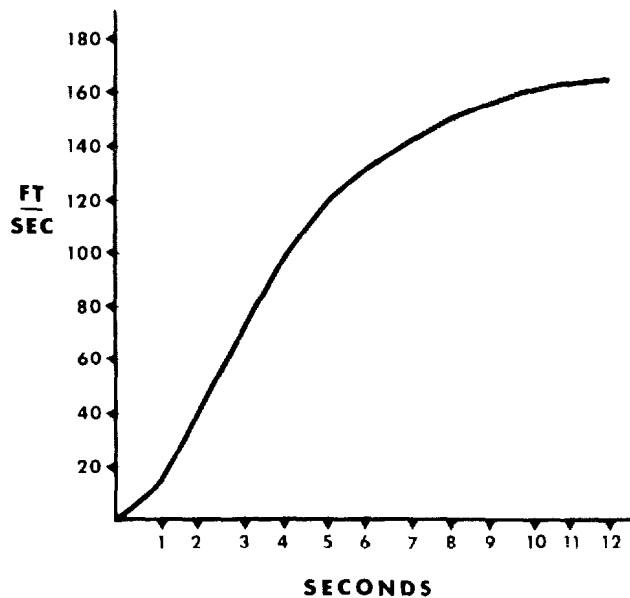
FIGURE 1

The vertical velocity plot of a stable parachutist during his acceleration phase from an initial vertical velocity of zero is shown in Figure 1. Preliminary consideration suggested that as the rate of descent of the helicopter increases, the major modification in the parachutist's acceleration curve would merely be that he would enter the velocity curve at a point equal to the vertical velocity of the helicopter at the moment of his exit. Data from jumps one, two, and three tend to substantiate this premise. However, in jumps four, five, six, and eight, an unusual observation was made. There appears to be a delay in the neighborhood of 0.75 seconds during which time the parachutist falls in close proximity to the descending helicopter before he begins to show the expected rapid separation from the helicopter.

The data we obtained suggest that there is an area close to the skin of the aircraft which provides greater than the expected buoyancy when the helicopter is in steep autorotational glide slopes. When the parachutist escapes from this area of high buoyancy, he then begins an expected acceleration away from the descending helicopter. The uncontrolled rolling of 180° experienced by the parachutist when rates of descent were above 3,000 feet per minute suggests that the parachutist was experiencing differential buoyancy with higher buoyancy on his inboard shoulder and lesser buoyancy on his outboard shoulder which, for an exit from the right door, caused him to rotate clockwise. Eventually, however, after this initial delay of about .75 seconds, the parachutist rapidly fell away from the descending helicopter and experienced no further difficulty in separation.
