FINAL REPORT

AIR - SEA RESCUE BEACON LOCATOR STUDY

PREPARED FOR NAVAL AIR SYSTEMS COMMAND
WASHINGTON, D.C.

THE JOHNS HOPKINS UNIVERSITY APPLIED PHYSICS LABORATORY

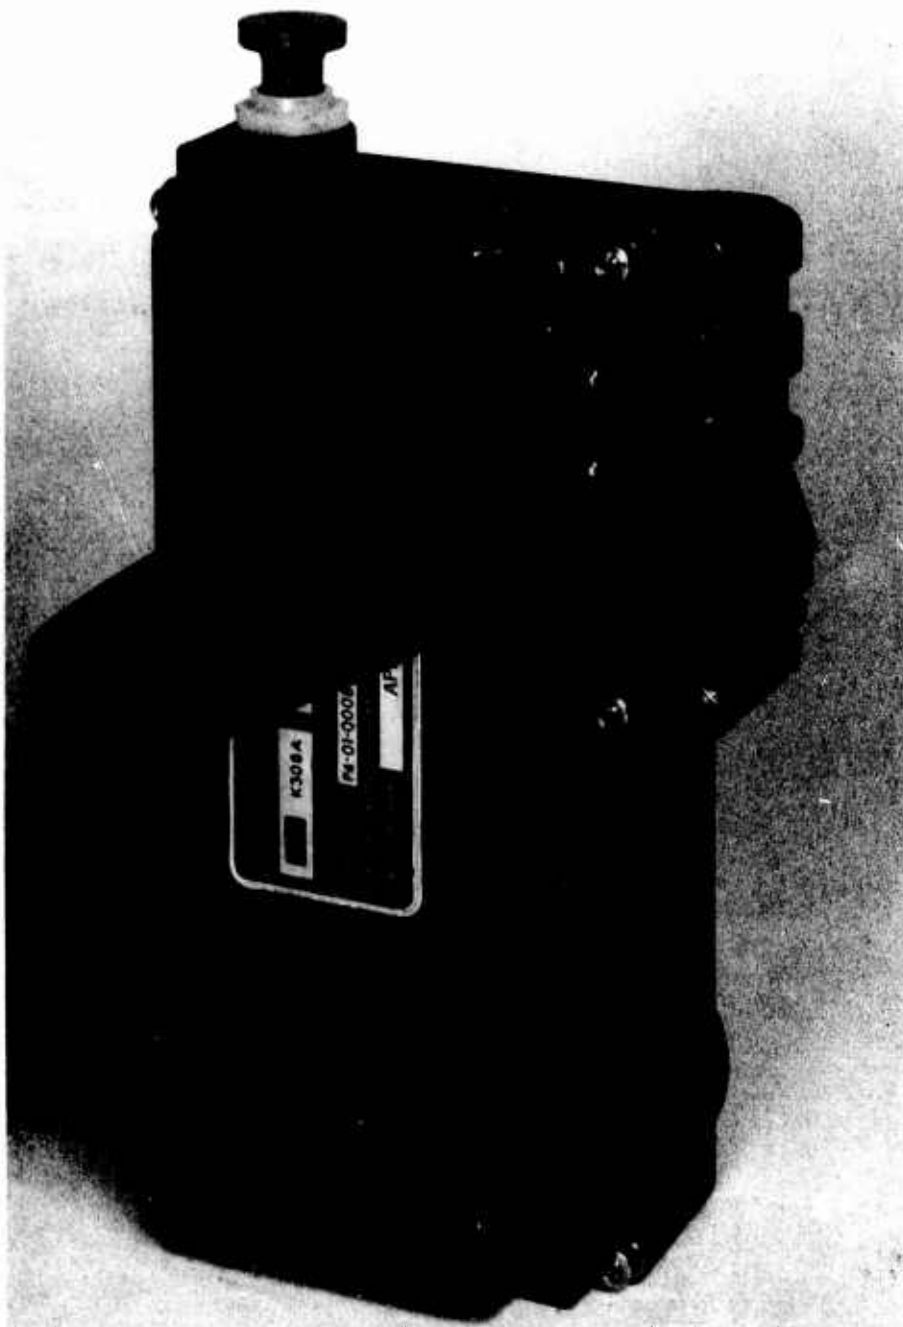
FIGURE 1-2 RT-10 RADIO RESCUE BEACON (REAR VIEW)

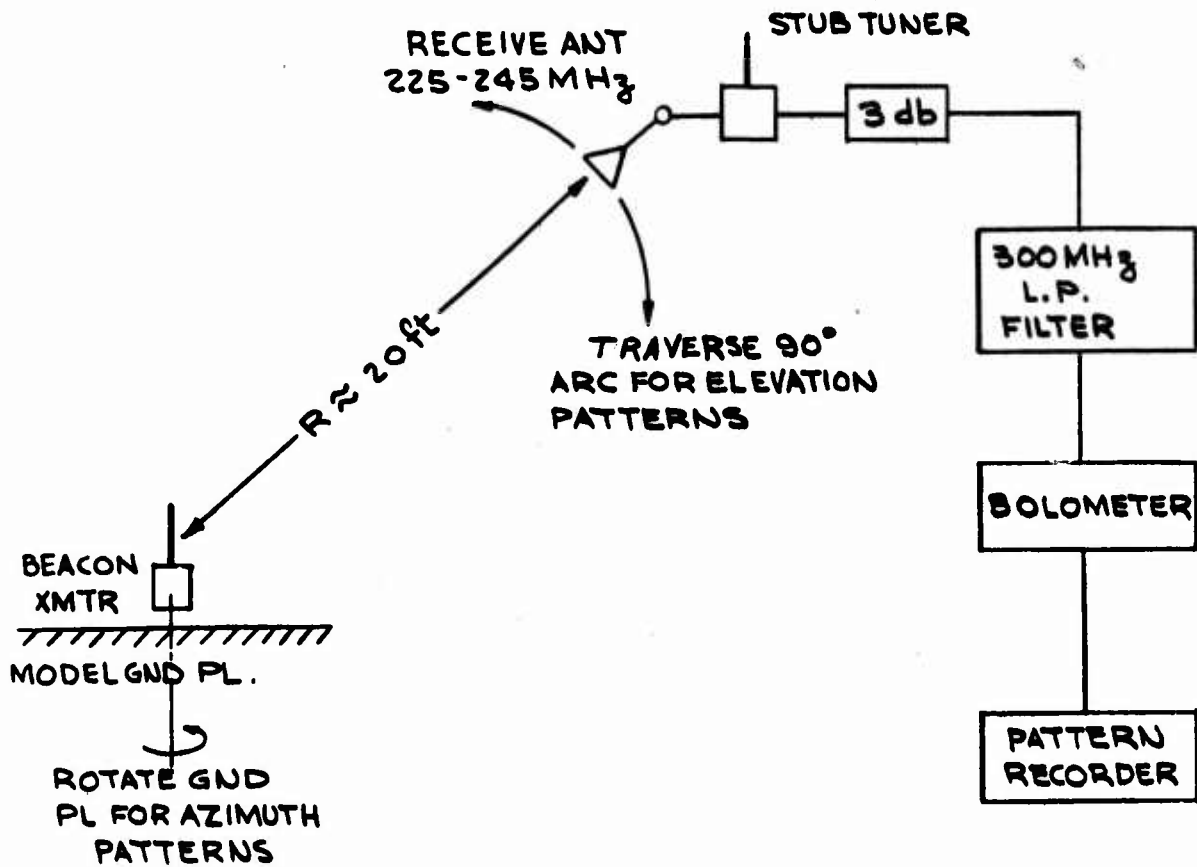
FIGURE 4.1.1-1

TEST SET-UP FOR BEACON RADIATION PATTERN MEASUREMENTS

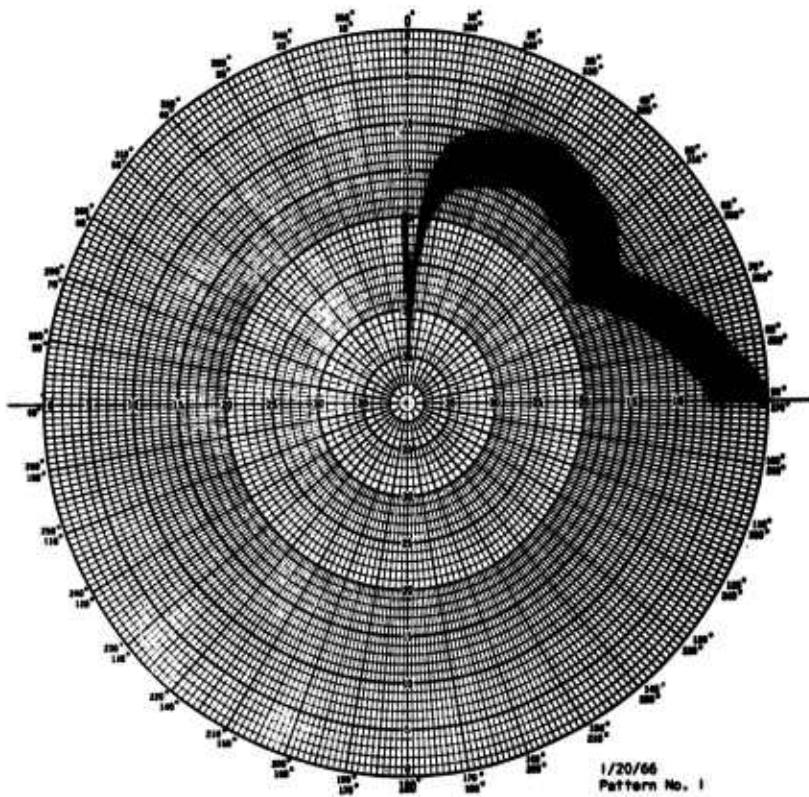
FIGURE 4.1.1-4e

1/20/66
 Pattern No. 1
 Beacon @ 240 MC
 URC/10
 18" above Ground Plane
 Extended Ground Plane

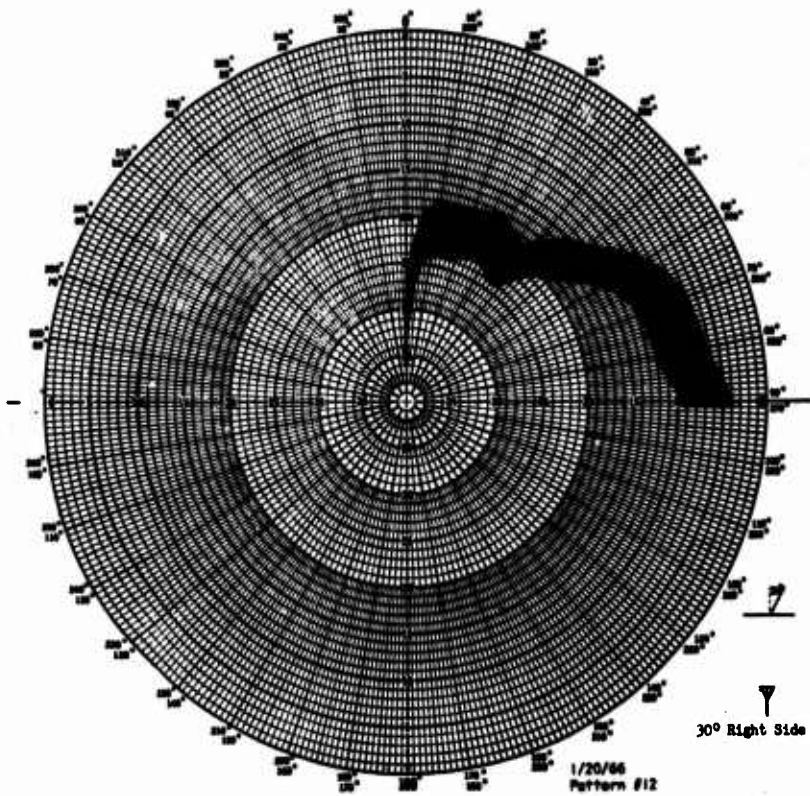
FIGURE 4.1.1-5d

1/20/66
 Pattern #12
 Beacon @ 240 MC
 URC/10
 8.5" above Ground Plane
 Extended Ground Plane

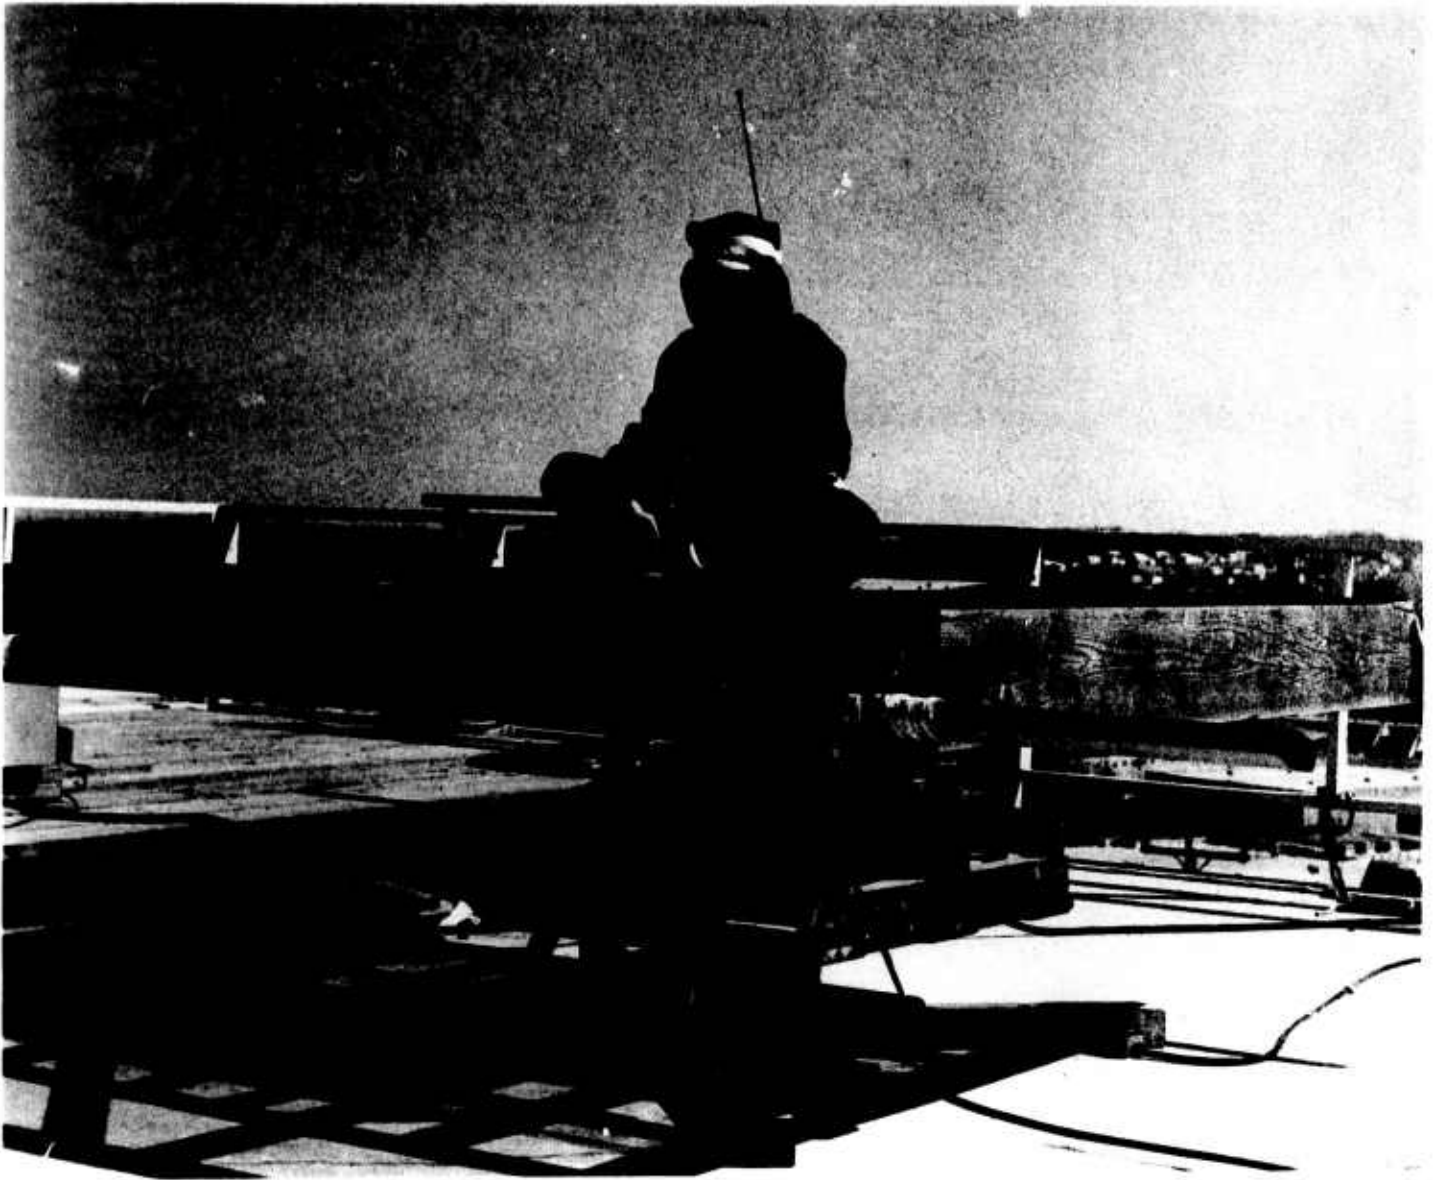
FIGURE 4.1.1-14. MAN WITH BEACON ANTENNA STRAPPED TO HEAD.
