6 Test Methodology and Ballistic Testing
of an
Experimental Aircraft Passive Defense
Armor System.

14 AFATL-TR-70-65

10 Abraham A. Santiago, Jr. 1st Lt, USAF

11 Jul 70

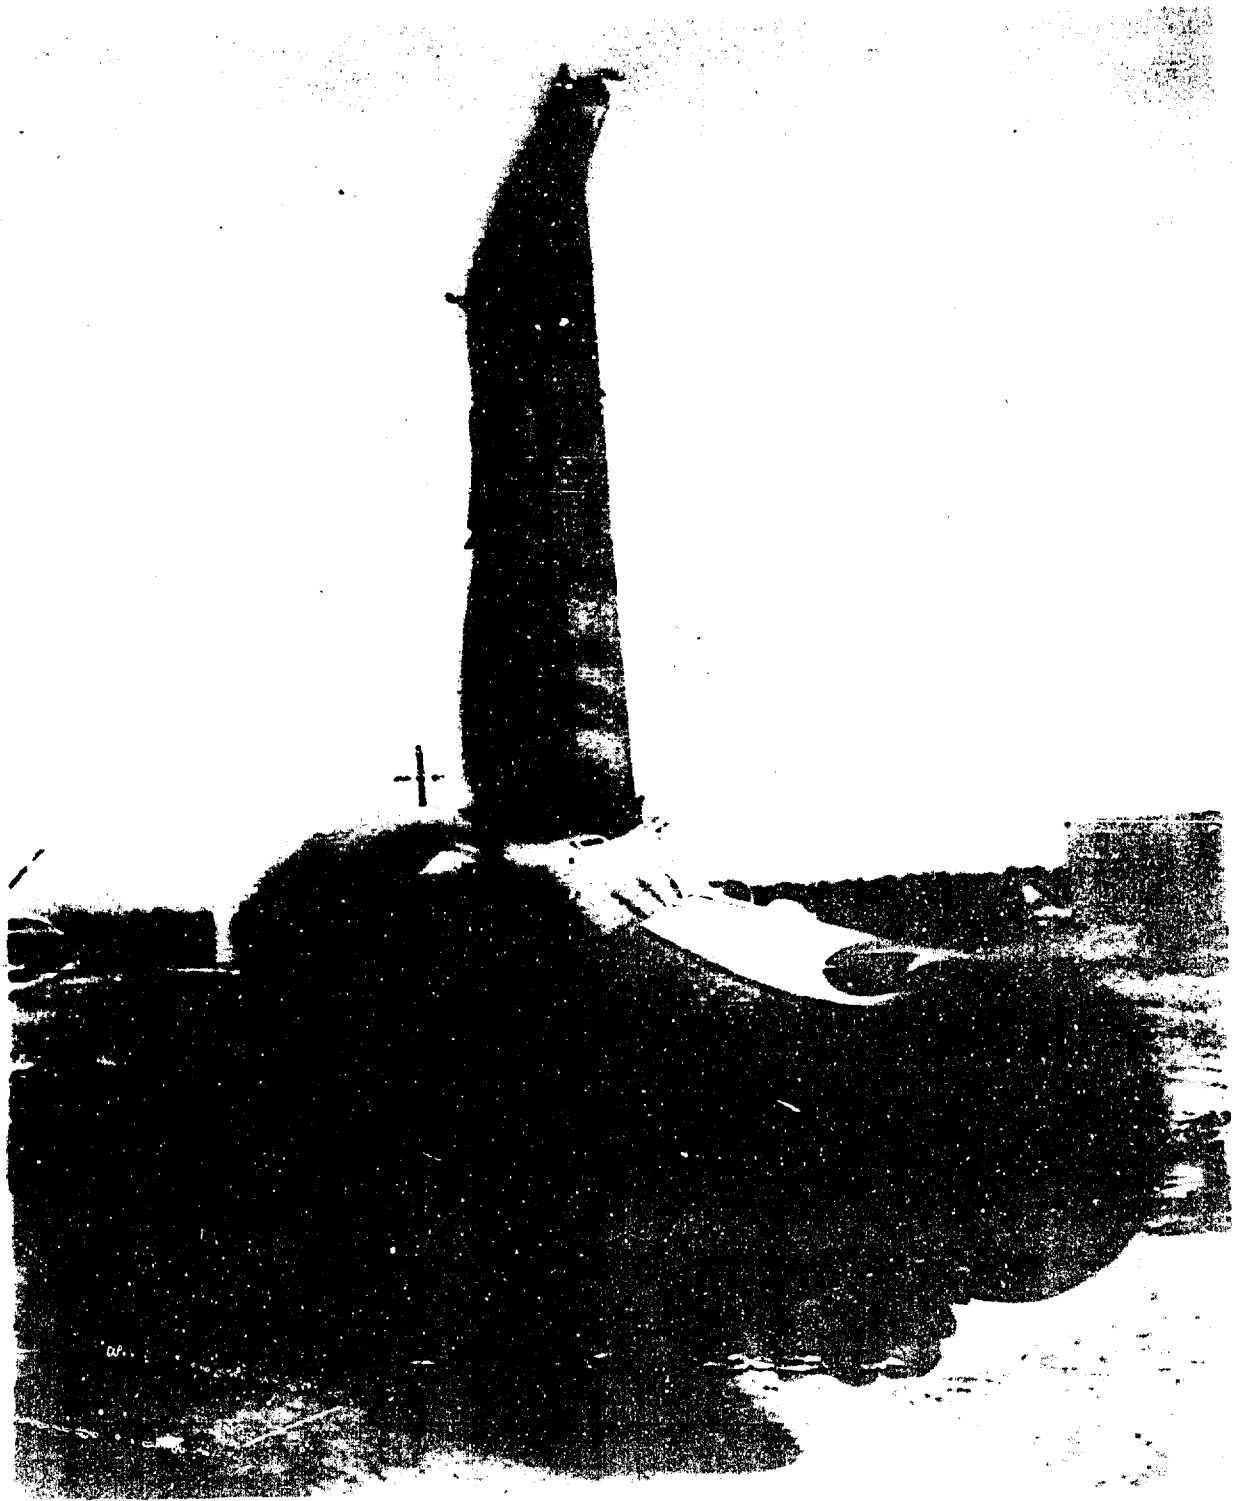
Figure 6. Target Aircraft in 90° Position, Top View

Figure 7. Target Aircraft in 90° Position, Bottom View

Figure 3. Target Aircraft in 90° Position, Front View

Figure 9. Target Aircraft in 90° Position, Rear View

Figures 6 through 9 show the target aircraft ready for firings in the 90° position. Due to the relatively compact shape of the aircraft after disassembly, it was found that it will actually rest in place in this position. However, sandbags were placed all around the aircraft for additional securing and safety.
