Report No. CG-D-03-17

Preliminary Marine Safety Risk Assessment, Brandon Road Lock & Dam Invasive Species Control Measures

December 2016

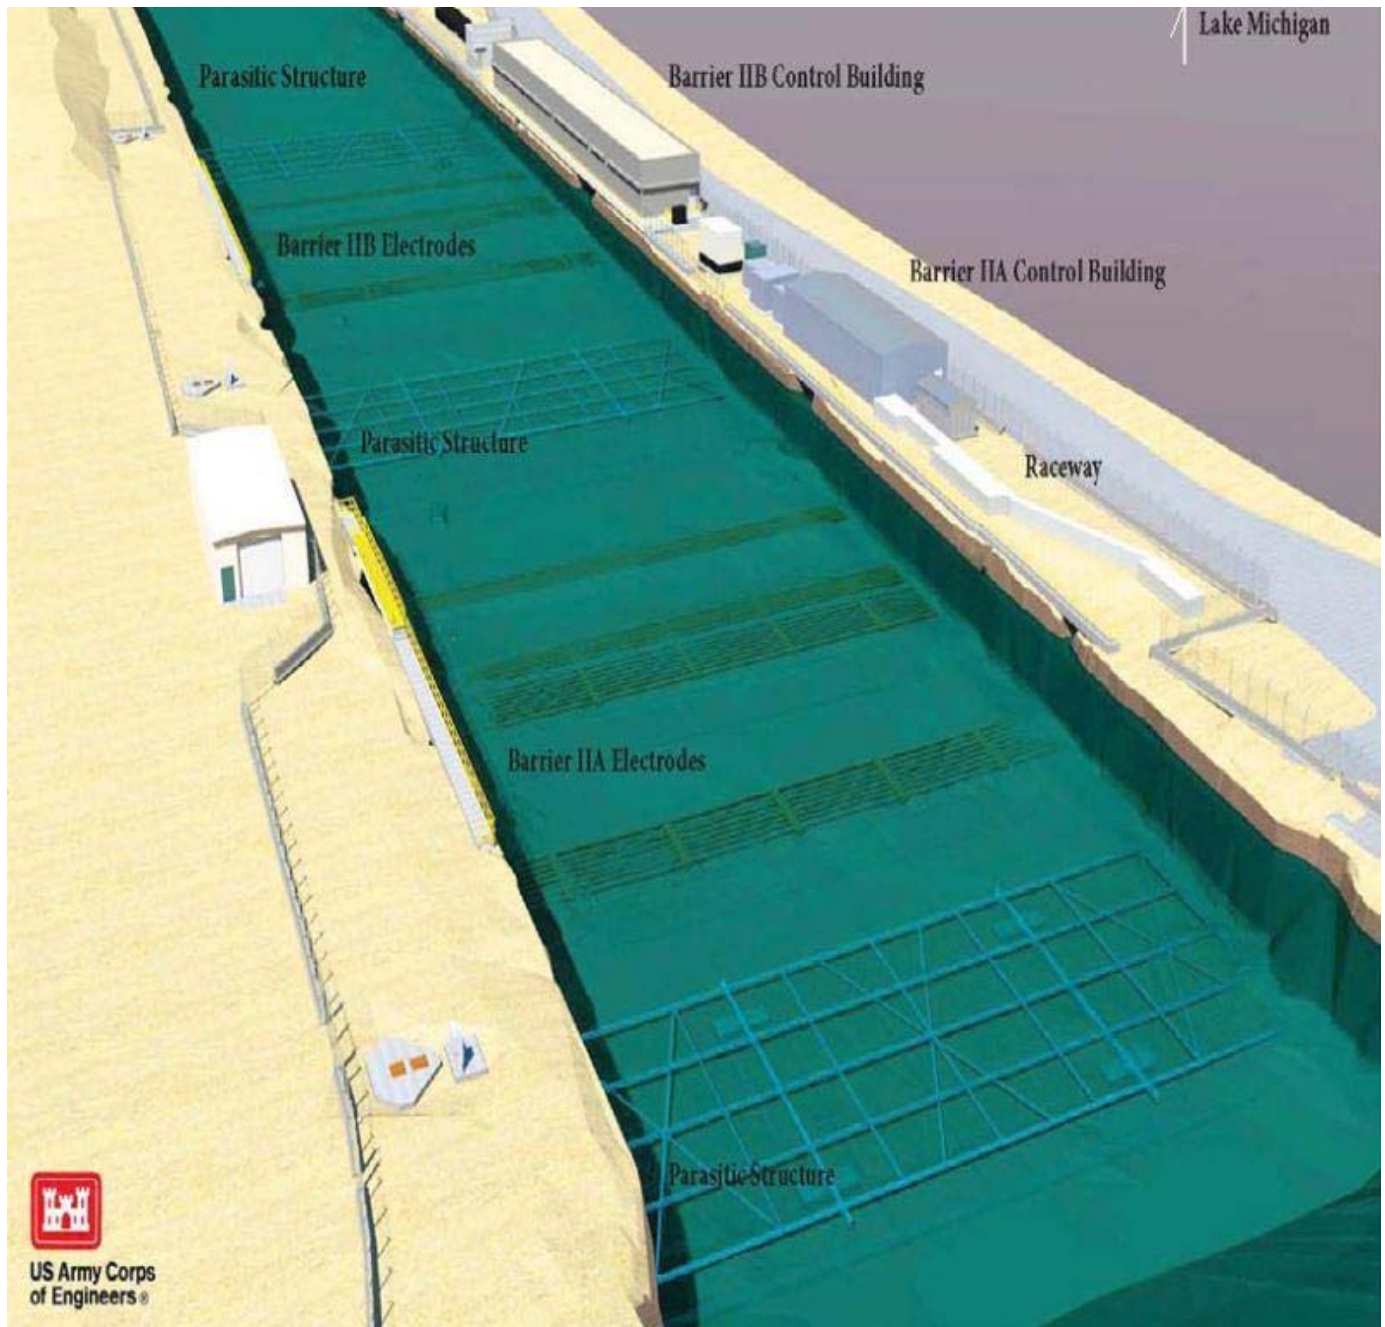
Electric Barrier: The electric barrier is expected to be similar to those in the CSSC at Romeoville, where electrodes of a barrier array lie across the channel bottom, connected to power supply cables through the canal walls, or in the case of BRLD, proposed “engineered-channel” walls. The design includes “parasitic” structures on the bottom of the channel, a short distance upstream and downstream of the electrodes, to limit the upstream and downstream dispersal of the electric field. Figure 1 is from the USACE brochure of the CSSC Barrier. This image shows two of the three, four-electrode barrier arrays at CSSC, the BRLD project plans for one array (with four sets of electrodes).

Figure 1. CSSC barrier IIA and IIB components.

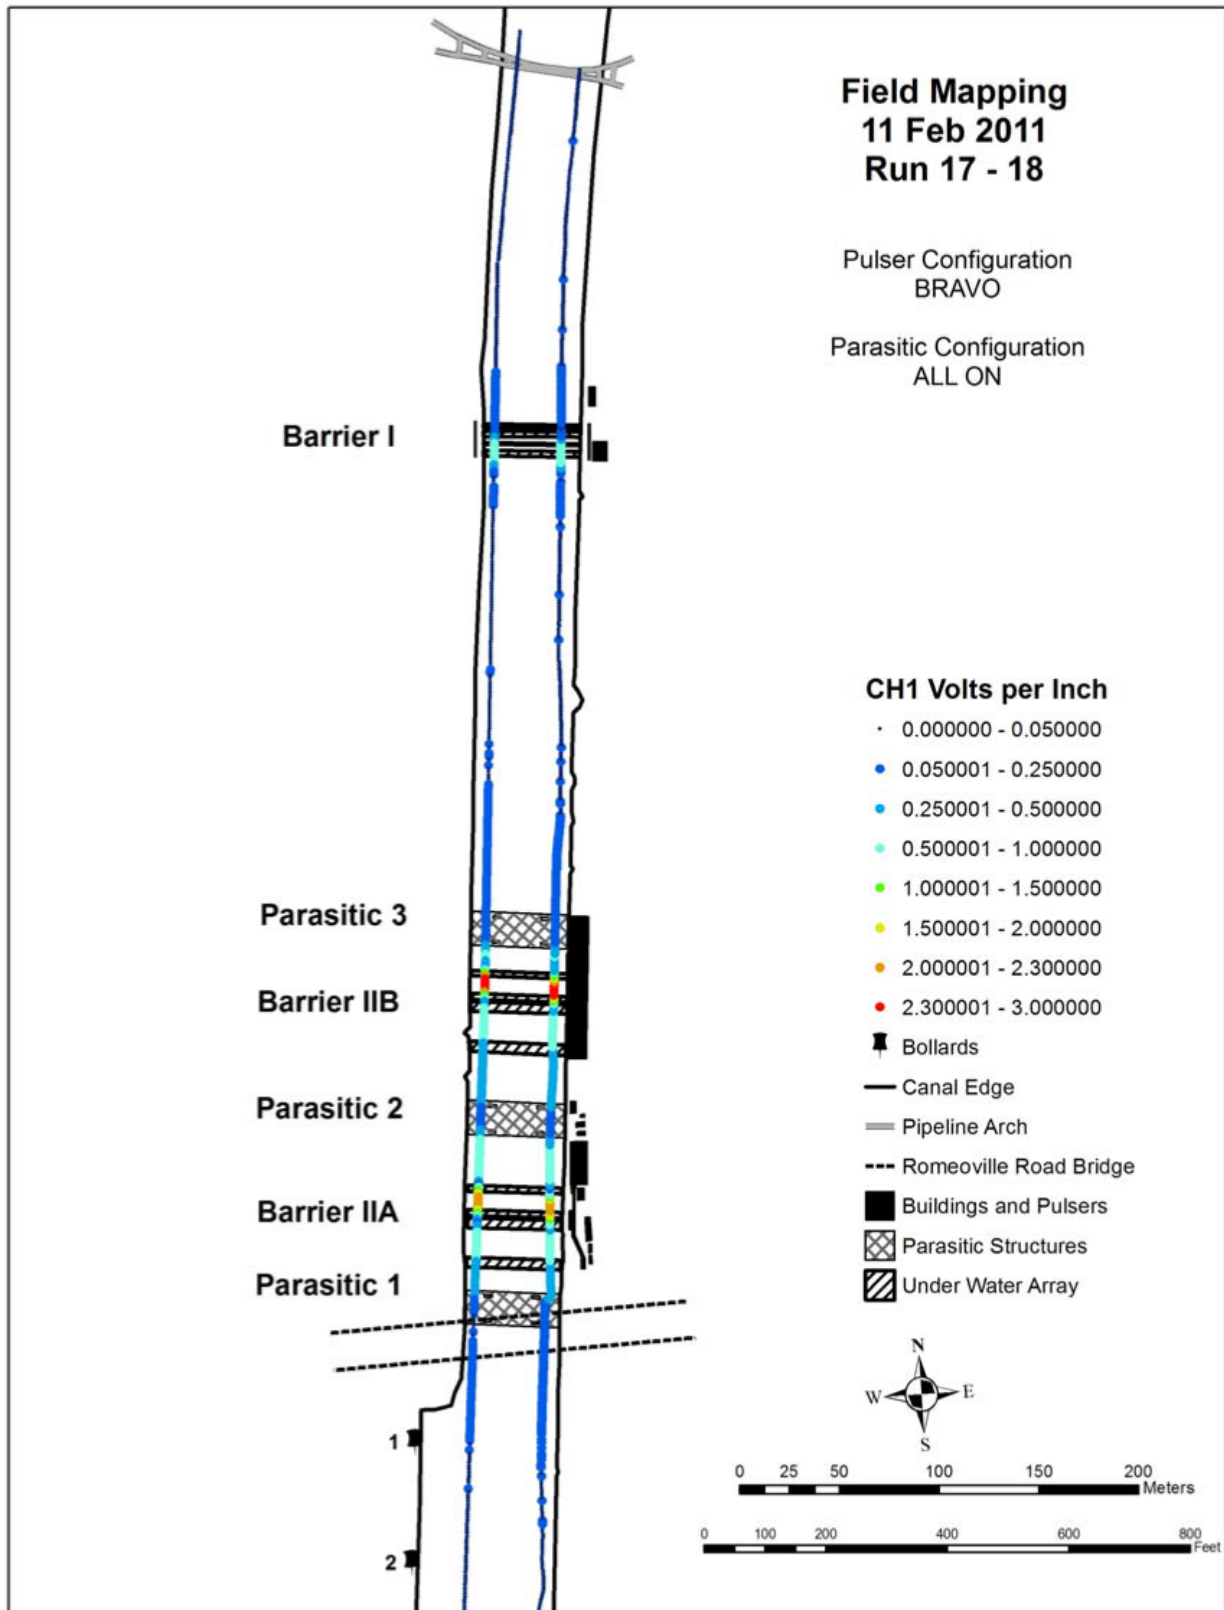
USACE and, to a lesser extent, the RDC have conducted extensive research into the operational safety of the electrified barrier system at Romeoville. Figure 2, Figure 3, and Figure 4 are three images from USACE (McInerney, et al., 2011) and RDC testing (Slater, *ibid.*) to give an indication of the hazard zone in the canal with respect to Barriers IIA and IIB. From these images, the “hazardous area” extends approximately 400-450 feet south of a point estimated between the wide and narrow arrays of Barrier IIA, and 400-450 feet north of a point estimated between the wide and narrow arrays of Barrier IIB.

Figure 2. USACE field mapping (McInerney, ibid.)

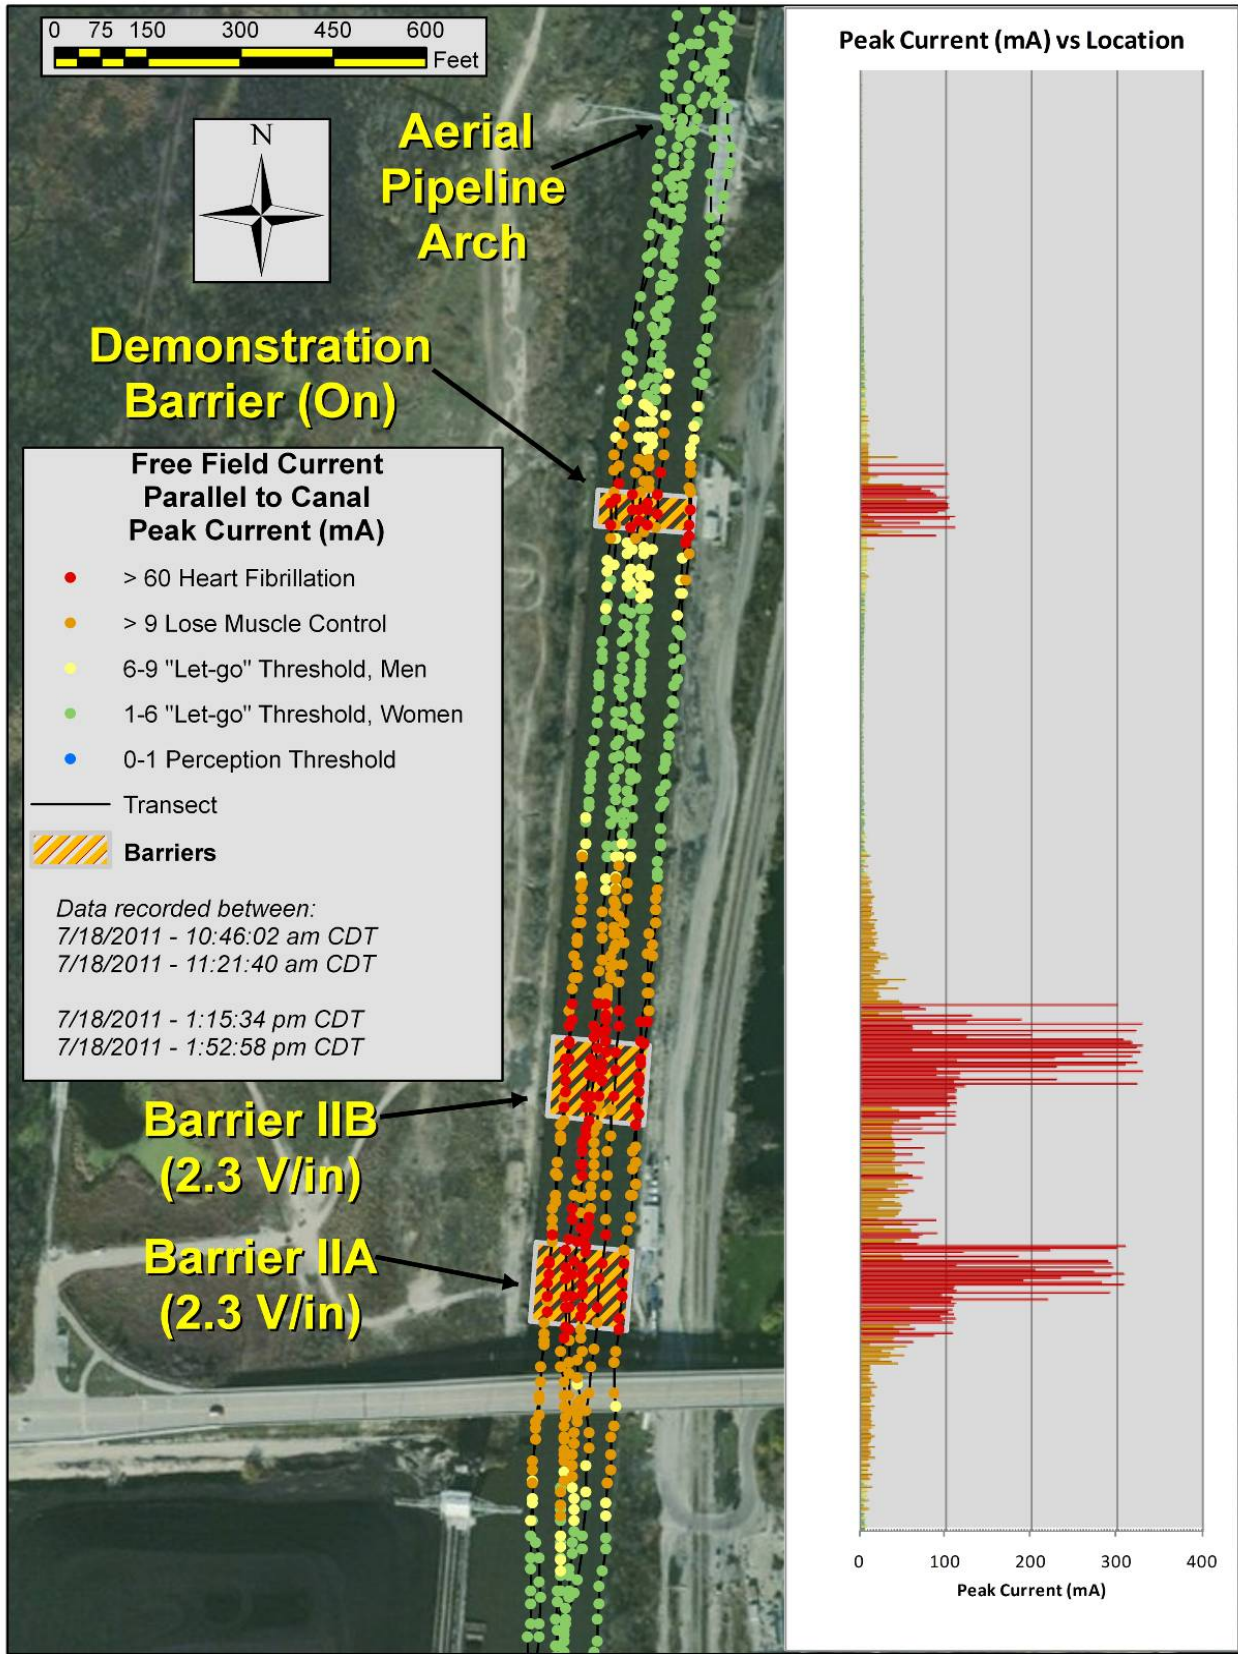
Figure 4. USCG RDC free field current (Slater, ibid.).

Review of a 2011 RDC report on rescue in electrified water at the CSSC showed that free field electrical current greater than 9 milliamps (mA) (the level at which a normal person would lose muscle control) extended approximately 400 feet north of the center of Barrier IIB and south of the center of Barrier IIA. McInerney (ibid.) shows the “hazard zones” for the combination of Barriers IIA and IIB to extend approximately 425 feet north of the center of Barrier IIB and approximately 425 feet south of Barrier IIA.

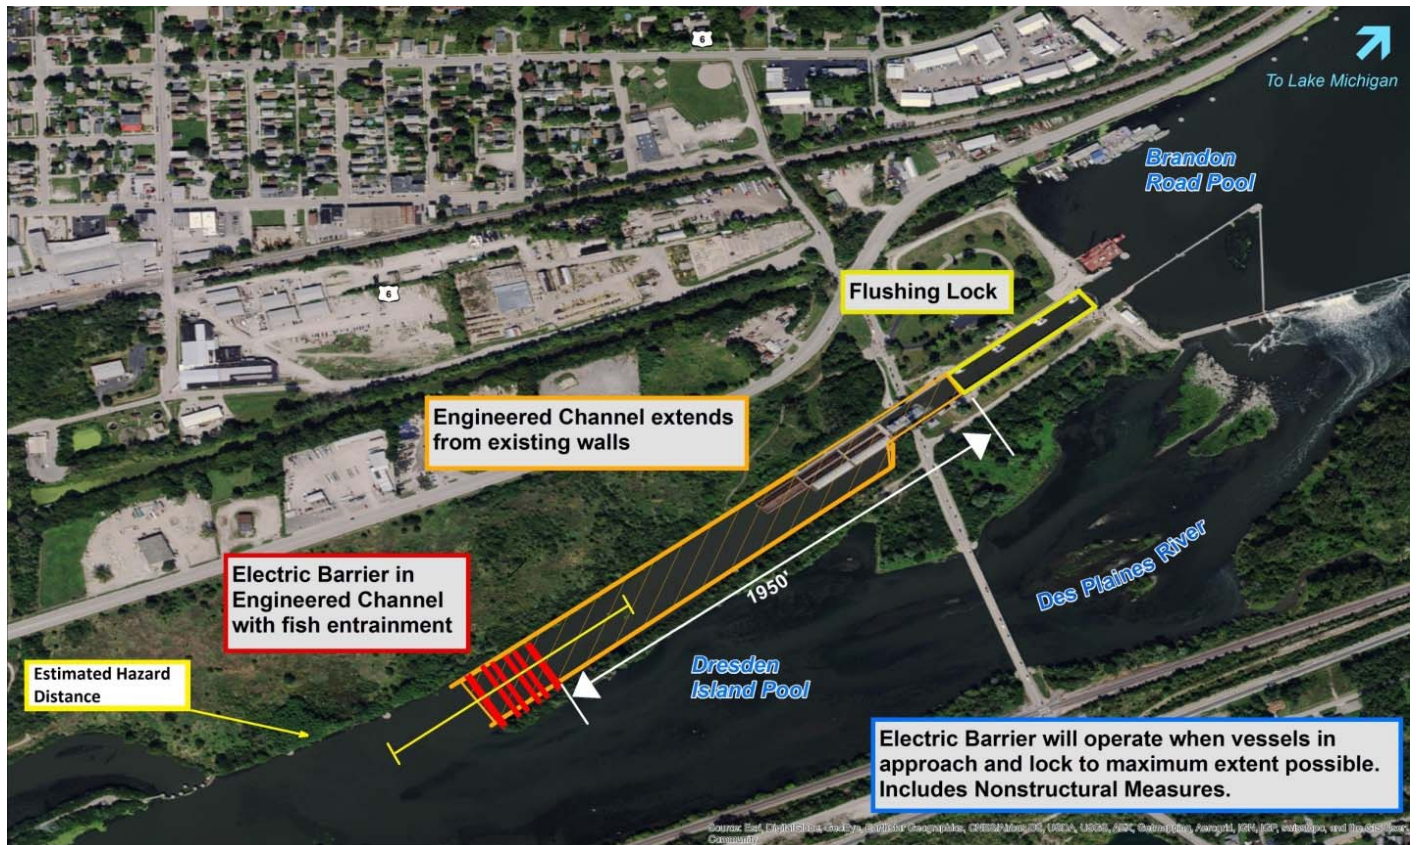
Figure 5. RDC estimate of hazard distance with tentative location of electric barrier.

For the purposes of this risk assessment, we will use an estimated in-water “hazard zone” extending 500 feet, upstream and downstream, from the tentative center of the BRLD barrier location in Figure 5.

As part of the control measures plan for BRLD, USACE diagrams (Figure 5 and Figure 7) indicate an “engineered channel” from the lower lock gate extending approximately 2250’ downstream. With either an engineered channel or the existing limestone formation, there is no information as to whether a tow crossing the electric barrier would induce sparking if the tow contacted the engineered channel walls or the existing limestone. With this in mind, we should consider precisely where tows might contact the new approach wall. We’ll assume two things, (1) the dimensions close-in to the lock will remain the same, with the channel wall (LDB) narrowing to 110 feet approximately 350 feet downstream of the chamber, and (2) when tows lay up for lock drain (as per Figure 9, just downstream of the lower gates), they will be on the RDB. Figure 15 shows a section of the RDB approach wall extending approximately 650 feet downstream from the chamber. Four steel “rub rails” imbedded in the concrete structure allow barge contact (impact) without damage to the concrete. (Figure 16 shows a close-up of the rub rails on the LDB.) Depending on the downstream extent of this steel rub rail, the barrier might induce a spark-related event, should a long-tow contact the steel rub-rails while a portion of the tow is over the electric barrier.

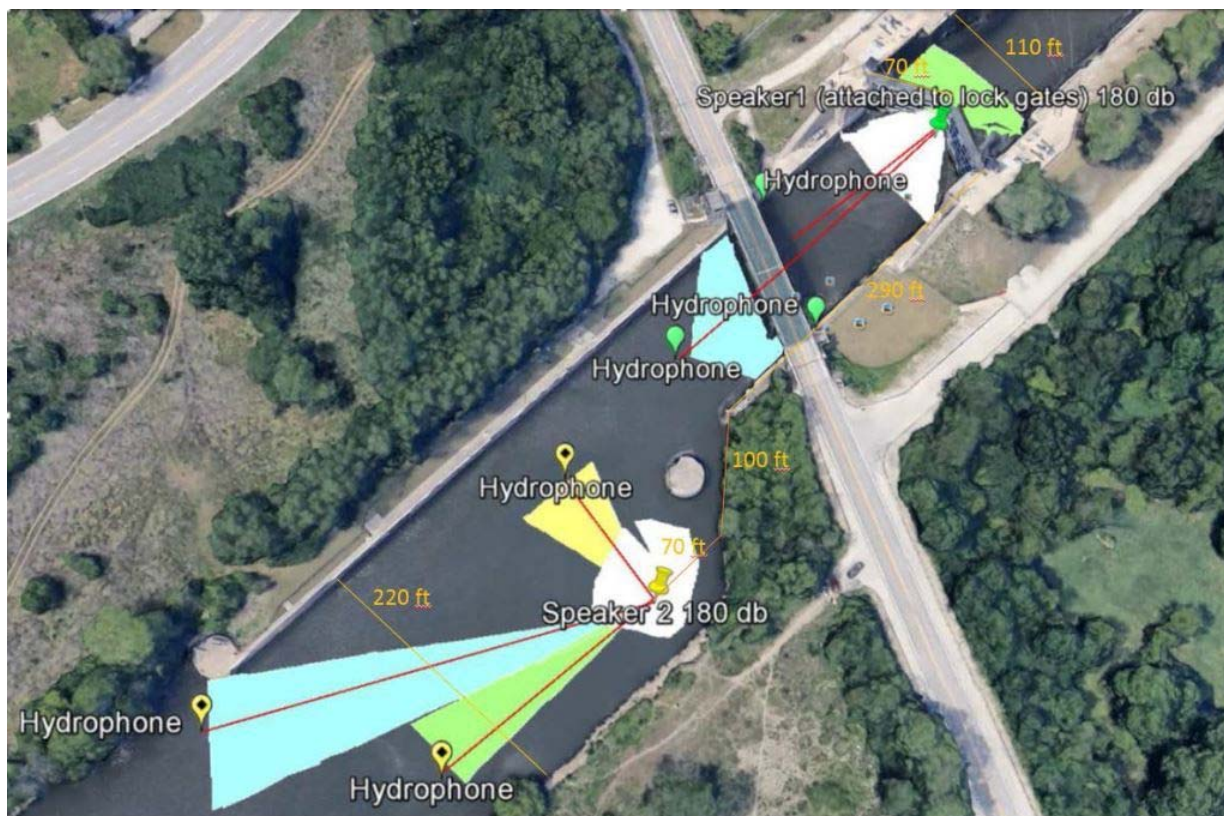
Figure 6. Potential locations of complex noise sound generators for future testing (USACE).

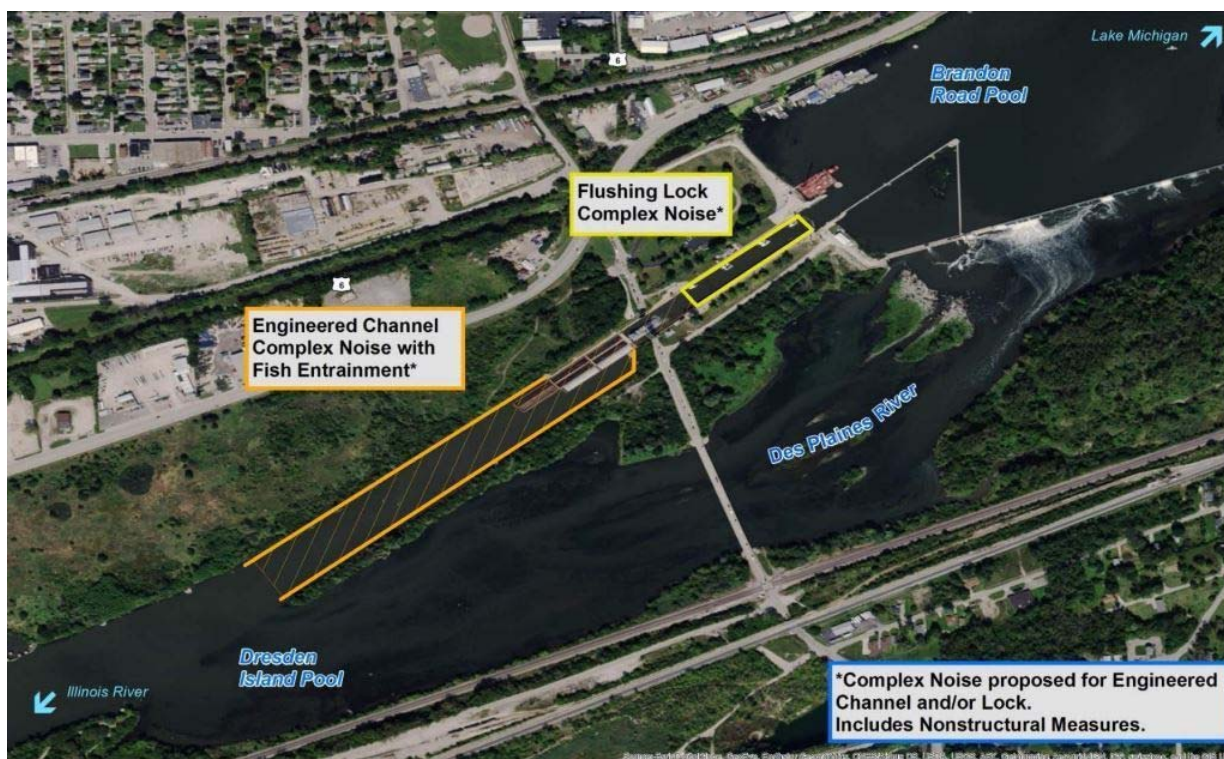
Figure 7. Notional complex noise installation (USACE).

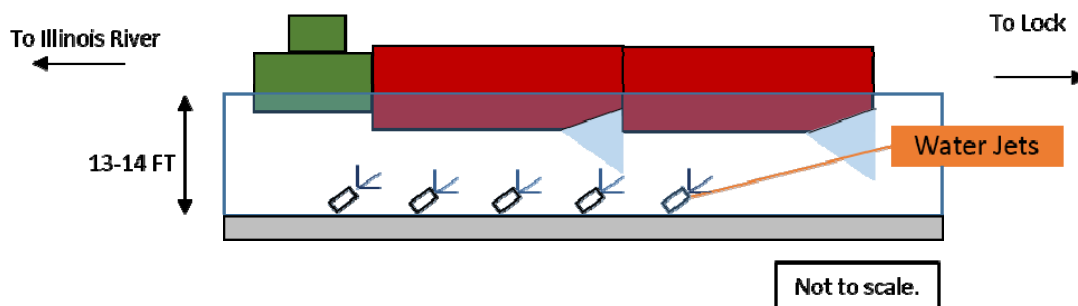
Fish (Barge) Entrainment Mitigation (Water Jets): This measure will have upstream-facing discharge ports on the engineered approach channel bottom to force water at an angle from vertical so as to clear any swimming or floating invasive species out of the box-to-rake- void between two barges (Figure 8).

Figure 8. Conceptual profile view of entrainment mitigation control measure (USACE).

USACE anticipates the water-jets will be parallel to the channel, downstream of and within the electric barrier arrays, and possibly immediately upstream of the most upstream array, as well.³ This places the discharge ports approximately 1850-2100 feet downstream of the lower chamber gates.

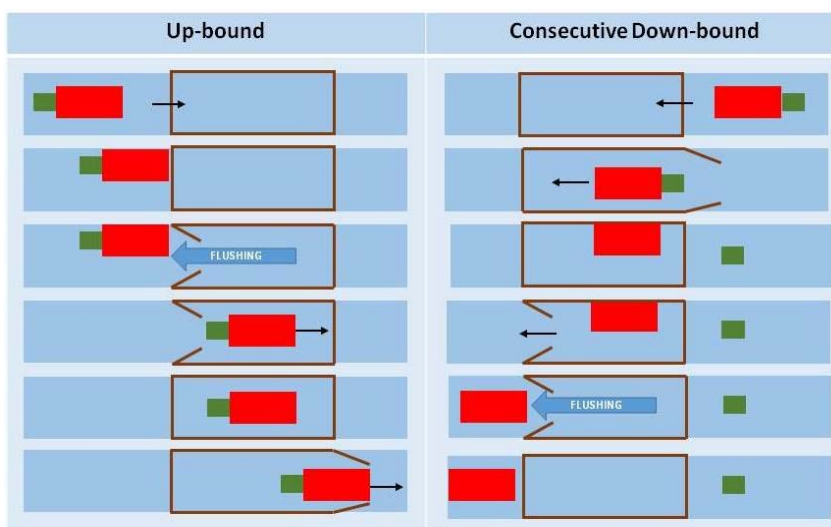
Flushing Lock: For this measure, we will assume a potential of re-aligned lock-fill ports that set up a “flushing” flow condition in the lock chamber and approach channel, before lower-gate closure and lock fill. The current operating assumption is flushing the lock when a flotilla stages immediately downstream of the lock. In further investigation of this measure, USACE will likely perform a physical model analysis to assess various operating considerations. One such consideration may be whether a vessel can stage within the lock during lock flushing, in light of safety impacts and flushing effectiveness.⁴ The flushing would stop before the closing the lower gates (Figure 9).

Figure 9. Diagram indicating when flushing occurs during lockage (USACE).

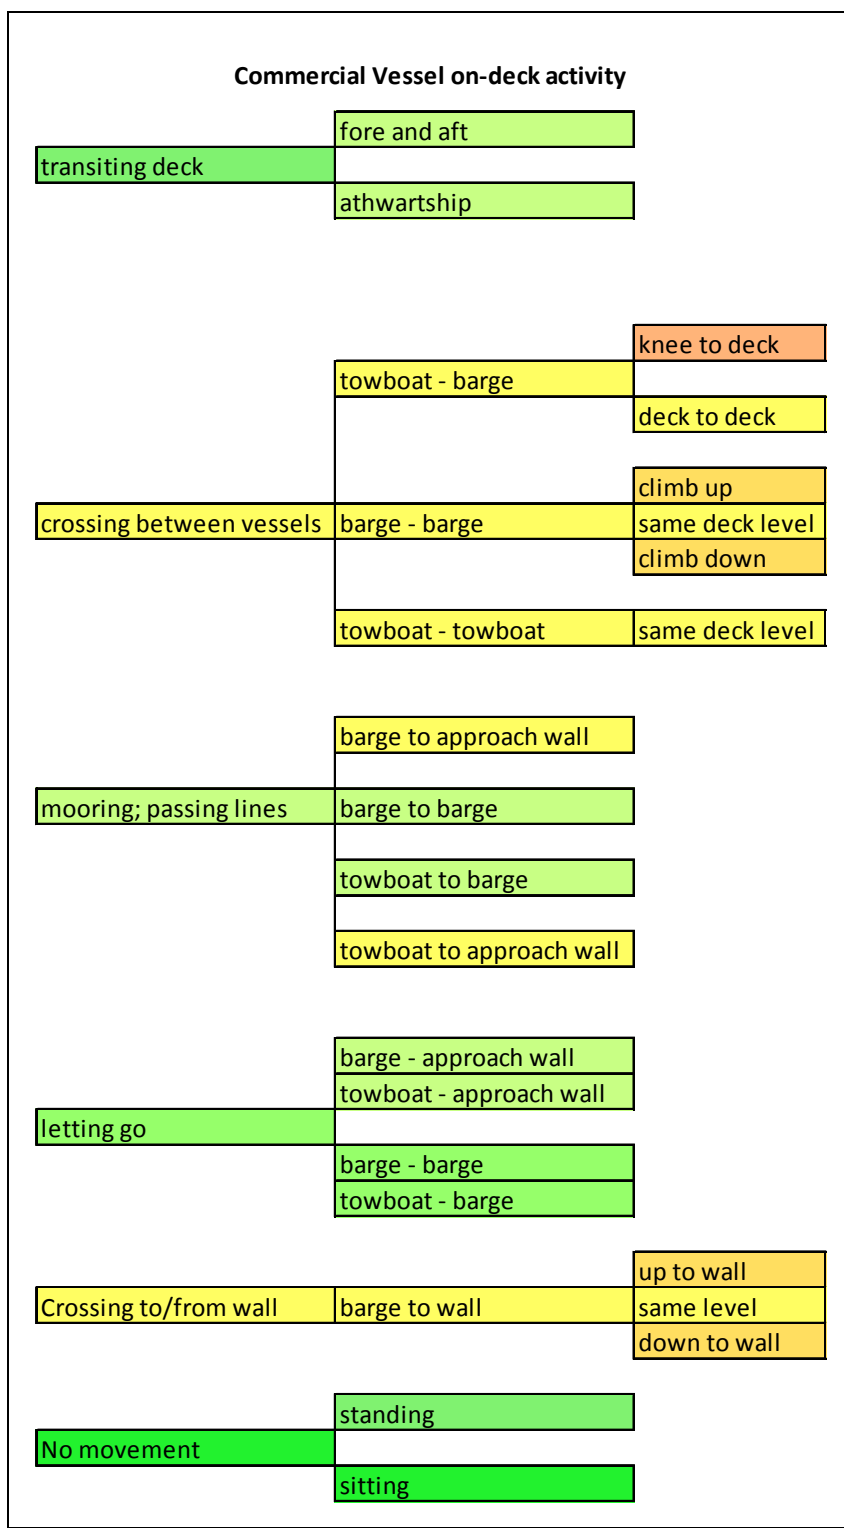
As a matter of developing comparative relationships for the different types of commercial vessel, on-deck activity, Figure 11 identifies multiple situations and applies “condition color-rankings” as done with the distances for the lock in Table 2.

Figure 11. Comparative activity condition, commercial vessel, on-deck activity.

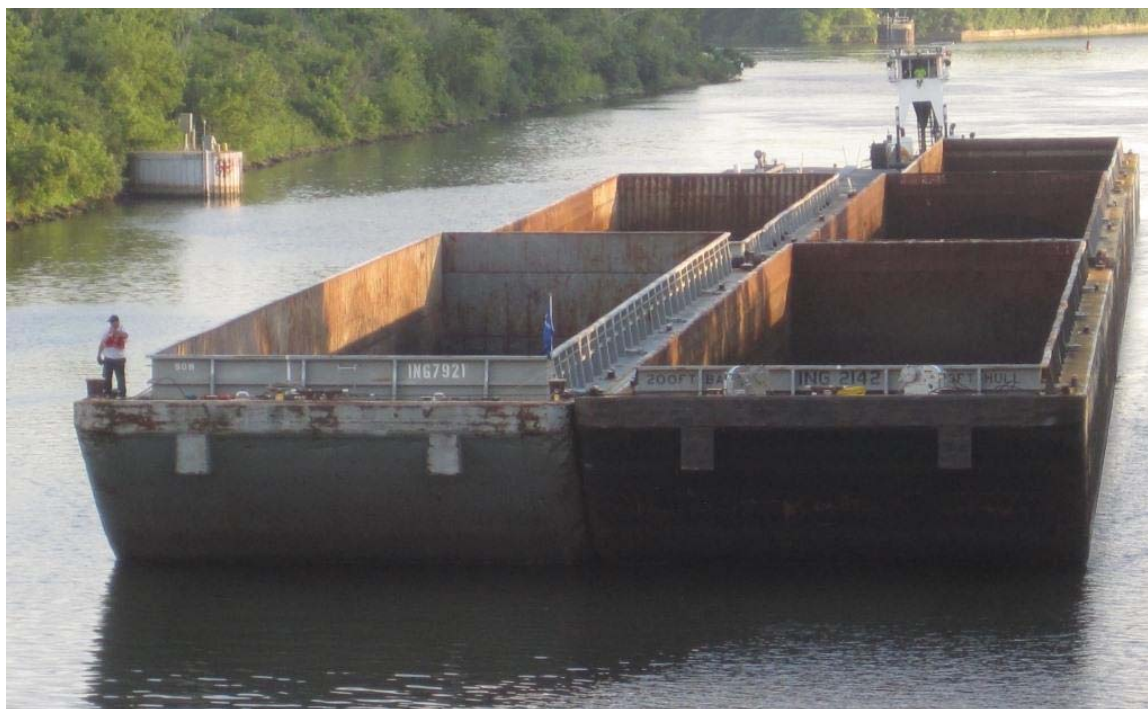
We next consider a different PIW scenario. Figure 13 shows a deckhand at the rake of an empty barge calling distances as it nears the approach wall. In this instance, the tow proceeded directly into the lock chamber. Under a potential lock-flush scenario, the tow might or might not moor, or otherwise keep station, while awaiting the lock flush. (As noted earlier, as of this writing, there is no specific procedure for vessel operations with respect to the lock flush.)

Figure 13. Deckhand at rake of light barge.

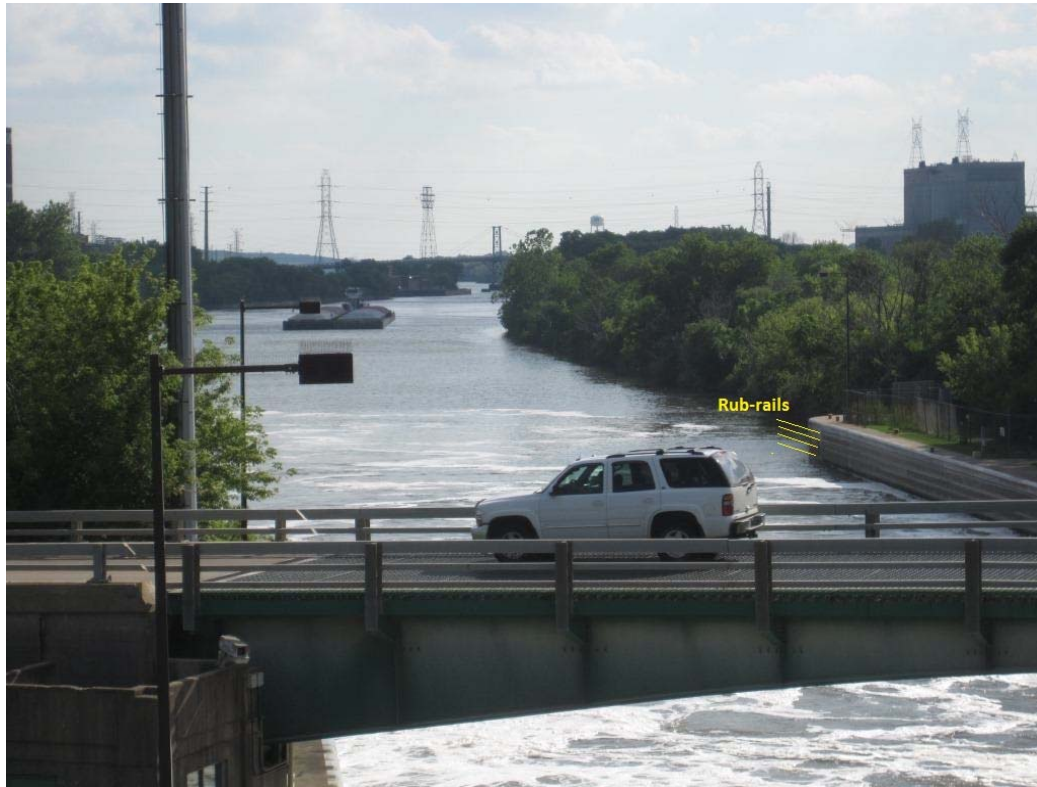
Figure 15. Location of rub-rails on LDB lower approach wall.

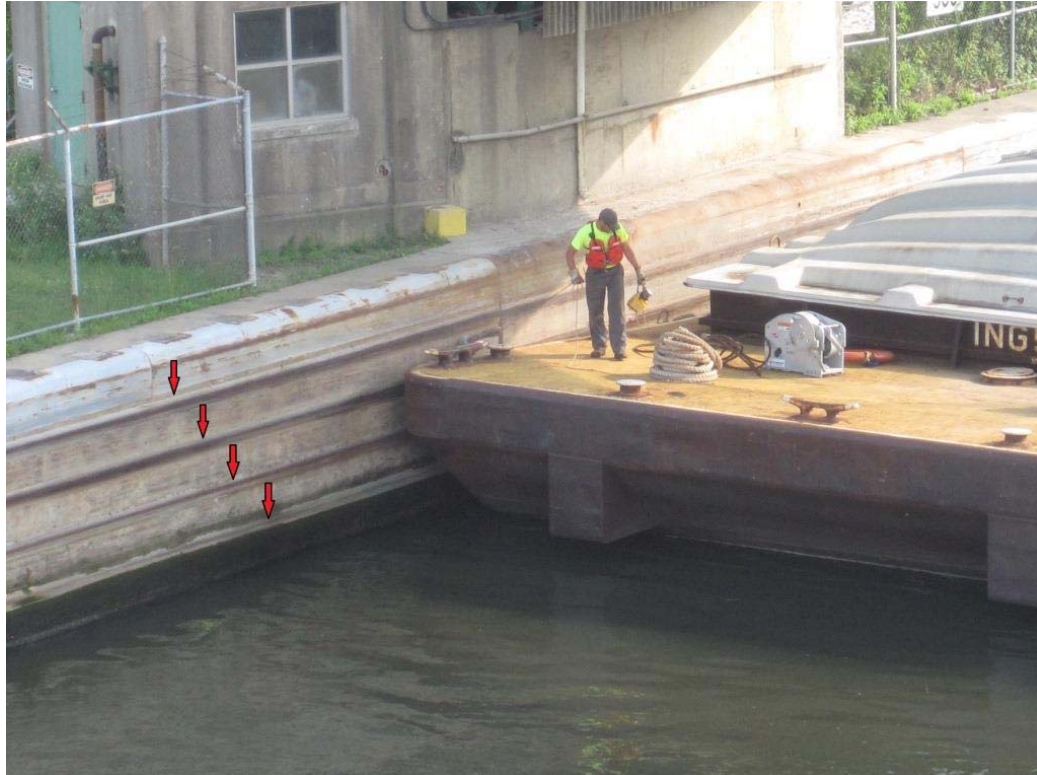
Figure 16. Close-up of rub-rails on LDB approach wall.

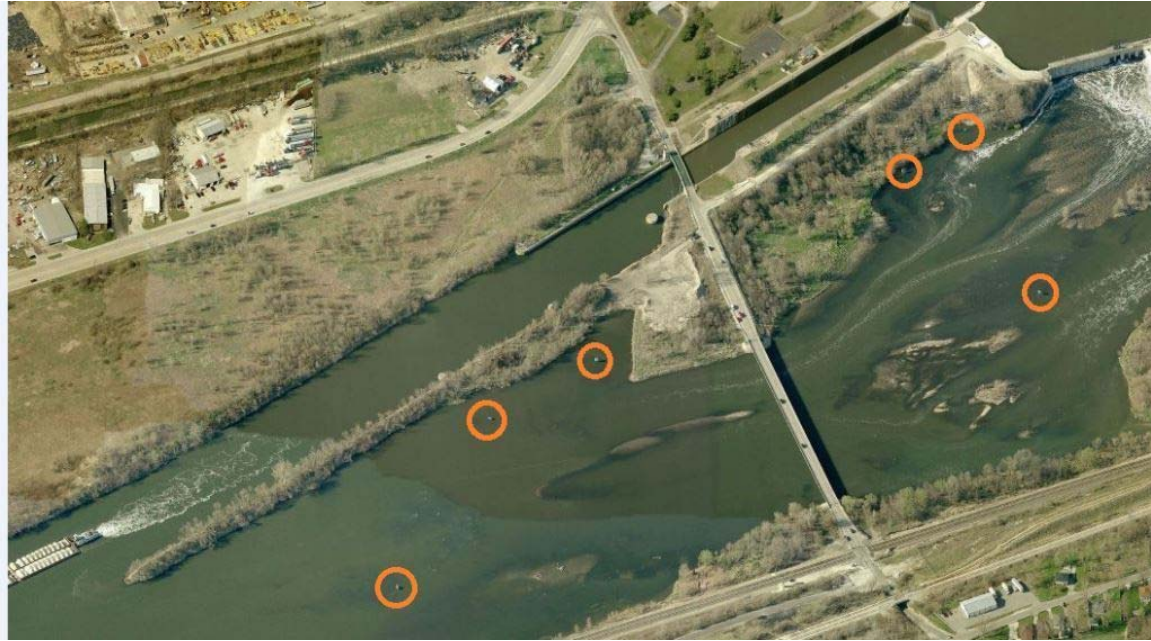
The photo and satellite image do not fully indicate the water shallowness around the blinds, but the number of visible shoals give some indication. To navigate these shoal areas, sportsmen must either use a small (less than 20' LOA), shallow draft boat, or access the blinds from the USACE controlled area between the lock and the spillway.

Figure 19. Location of waterfowl hunting blinds in Des Plaines River.

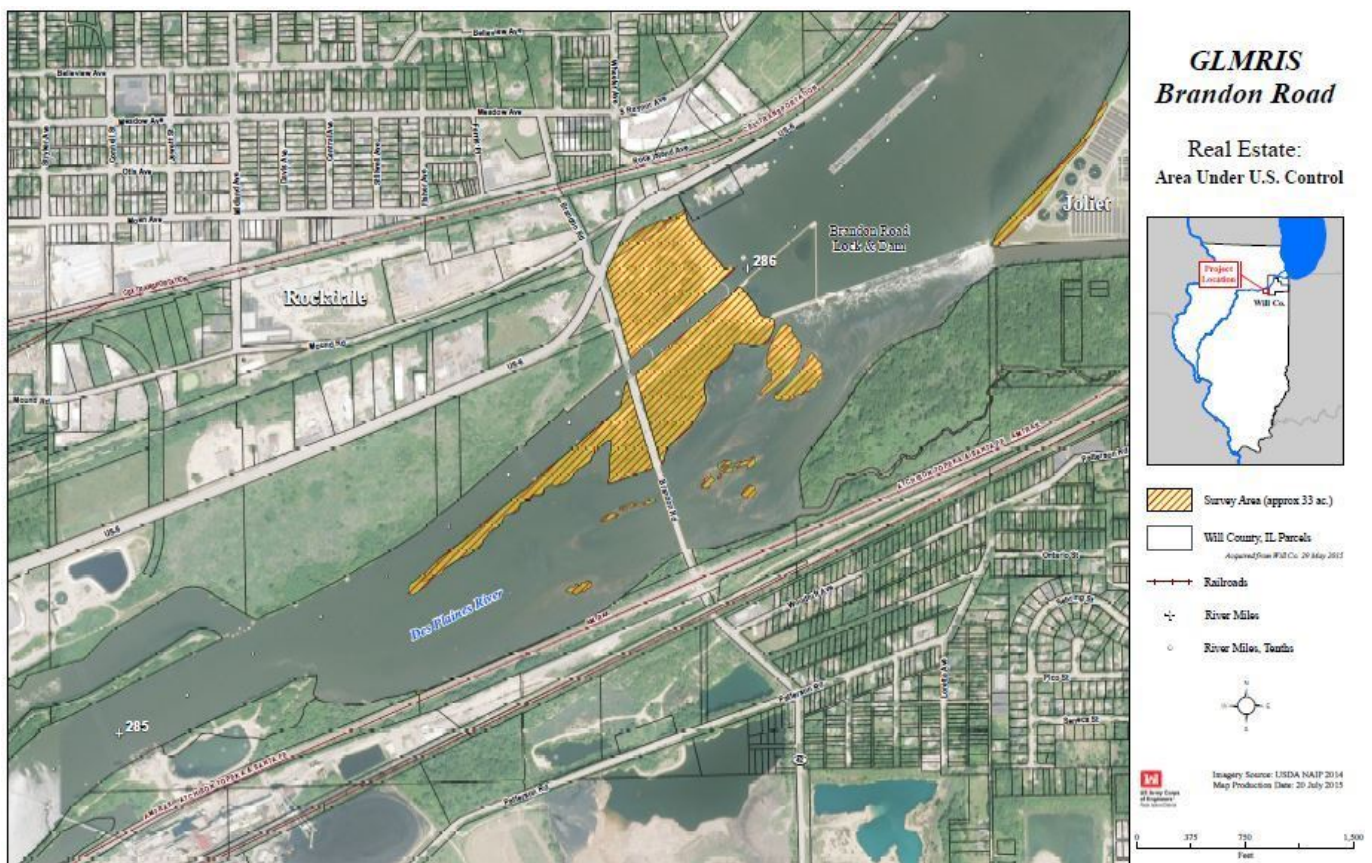
Figure 21 shows the areas associated with BRLD that USACE controls. Though fencing, gates, and surveillance limits access to the working areas East of Brandon Road, on a November 2015 walk in the vicinity of the LDB approach area, the author saw signs of trespass, including litter.

Figure 21. Brandon Road real estate under US control (USACE).
