ANALYSIS OF FRACTURED TEETH UTILIZING DIGITAL MICROSCOPY:

A PILOT STUDY

A thesis submitted to the Faculty of the
Endodontic Graduate Program
Naval Postgraduate Dental School
Uniformed Services University of the Health Sciences
in partial fulfillment of the requirements for the degree of
Master of Science
in Oral Biology

June 2016

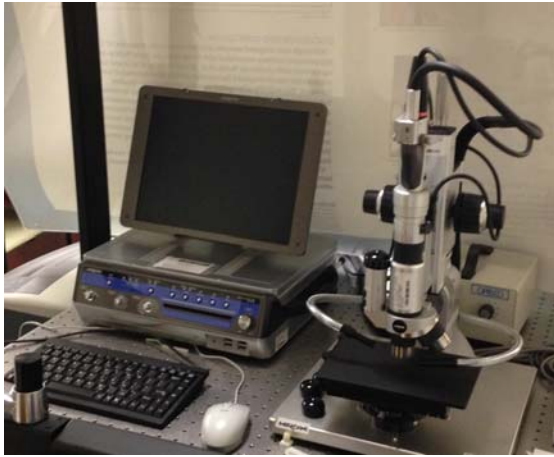
Figure 1: Hirox KH-7700 Digital Microscope System

The Hirox model KH-7700 digital microscope consists of a monitor, computer processor, lens, platform, light source and camera (Figure 1). The Hirox digital microscope is a system that has the ability to capture real-time color images and produce high-resolution two-dimensional images immediately. Hirox samples do not need to be prepared with any special coatings, preserving the sample for future imaging if required. The Hirox system can also allow the investigator to take several measurements from one image. The sample consisted of five human teeth (3 mandibular and 2 maxillary). Three of the teeth had in vivo fractures and two teeth were cracked mechanically utilizing the method described by Monaghan et al. (16). A wedge was placed within 2-3 mm of the working length and hit lightly with a hammer until 1 mm short of the working length.

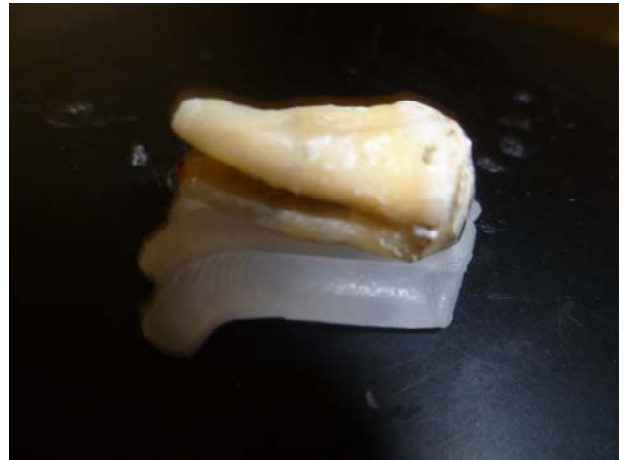
Figure 2: Extracted tooth and rope wax

All teeth were individually positioned on wax and analyzed in a similar fashion using the Hirox 3D digital microscope (Figure 2). Each specimen was imaged using the KH-7700 Hirox digital microscope at 250x magnification utilizing the MXG-5040RZ high performance zoom lens. Based on Bornstein's methodology, three regions were imaged, coronal, middle, and apical (17). The most optimal microscope position to capture measurements of the tooth fracture was determined to be 5-15 degrees off the perpendicular axis (Figure 3). Lighting proved to be very important in obtaining the correct image. In addition to through lens lighting from the microscope an optical elements corporation additional light source was incorporated to enhance the ability to visualize the fracture (Figure 4). Figure 5 represents the optimum positioning of specimen, microscope, and supplemental lighting utilized in this study. The image in figure 6 is a representation of the image taken with the Hirox digital microscope. The light and dark colors in this fracture image are due to the two opposing light sources. A beam of light will continue to travel through a homogenous structure until it meets a fracture within the substance. This fracture creates a space, which directs the beam of light in a different direction. This results in a light and a dark area in the tooth separated by the fracture line. The light and dark areas define the fracture borders and support a more accurate measurement. Employing the line measurement tool in two-dimensions, three fracture widths were recorded in each region. The average of three measurements from each region was recorded, for a total of nine measurements per tooth. The data were evaluated using descriptive statistics. The results of the measurements according to sample number and region are listed along with the mean, median, maximum, minimum, and standard deviation (i.e. No1 was sample number 1 and region, c= coronal, m=medial, a=apical) (Table 1). This demonstrates how the data will be presented for the follow on study. As this is a pilot study to determine a methodology for fracture measurements, this is a representation of data collection.

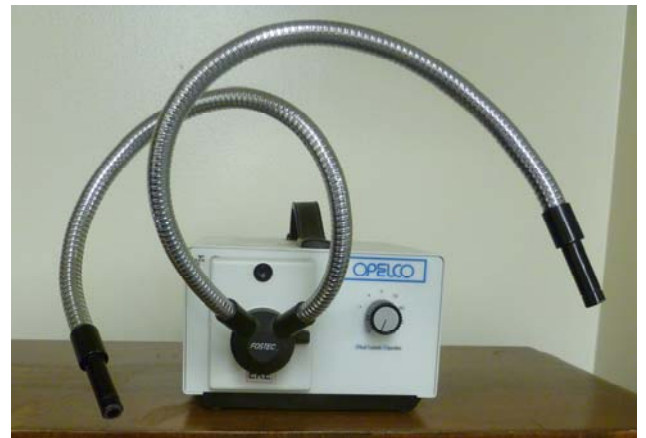
Figure 4: OPELCO (optical Elements Corporation) additional light source
