PHYSICAL PROPERTIES OF ACUPUNCTURE NEEDLES:
DO DISPOSABLE ACUPUNCTURE NEEDLES BREAK WITH NORMAL USE?

A manuscript submitted to the faculty of the
Orofacial Pain Graduate Program
Naval Postgraduate Dental School
Uniformed Services University of the Health Sciences
in partial fulfilment of the requirements for the degree of
Master of Science
in Oral Biology

June 2016

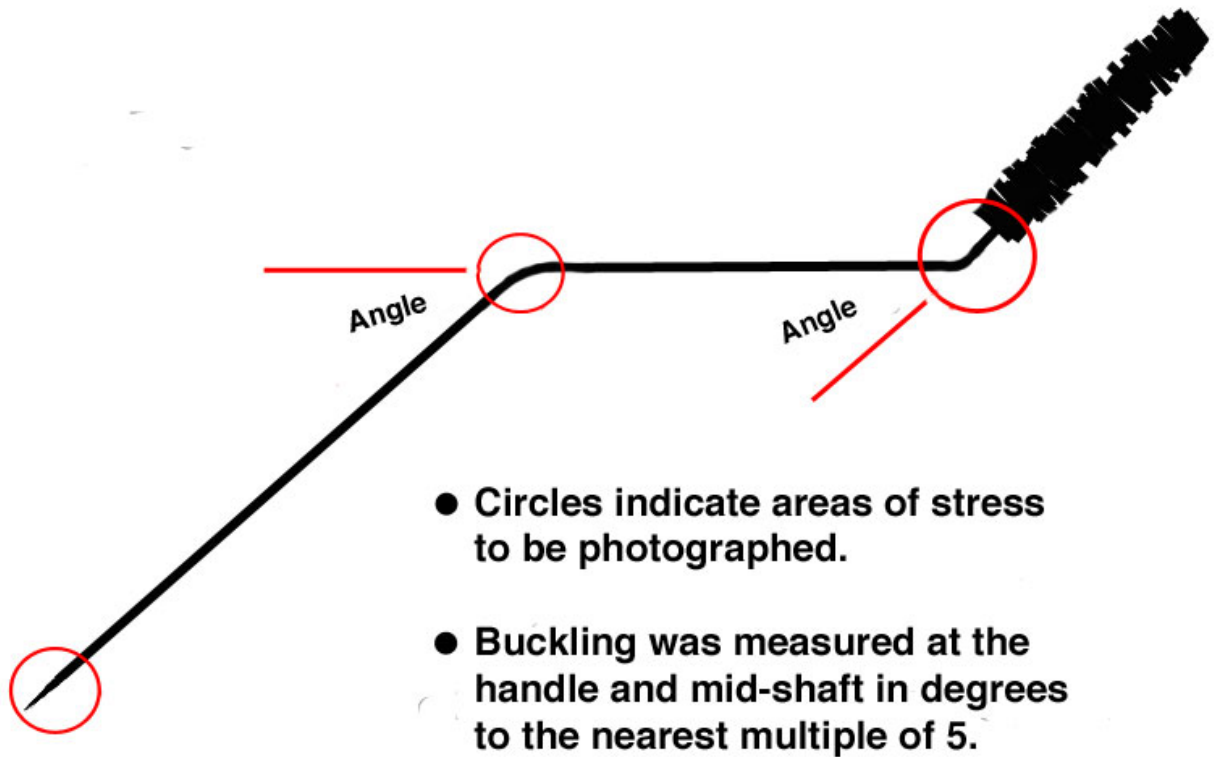
Figure 1

The 90 needles were initially assessed through a Hirox digital microscope at 50x magnification and photographs were taken in key stress areas.(see figure 1) The Model KH-7700 microscope was manufactured by Hirox-USA Inc. Hackensack, New Jersey USA. The examiner recorded any manufacturing defects such as surface scuff marks, cracks, or narrowing of needle shaft diameter before the needles were stressed.

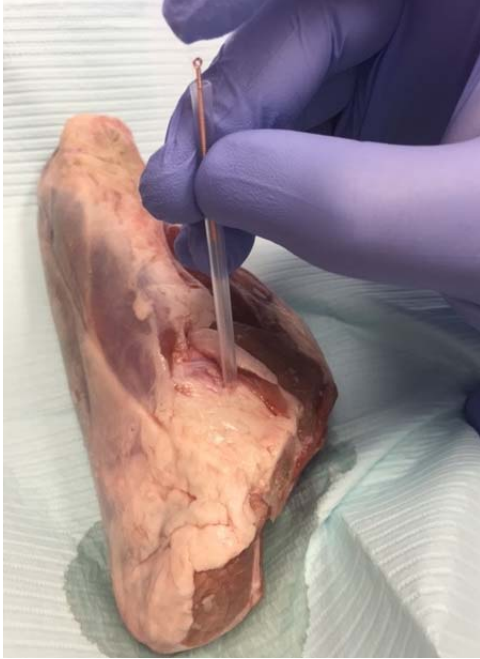
Photograph E

substitute for human tissues. Several of the synthetic tissue models considered for this study did not have a realistic “feel” as they were being needled, as there was more resistance during needle insertion and withdrawal. The lamb shank gave a very similar “needle feedback” to human tissue receiving needle therapy. (See photograph E)
