AFRL-RX-WP-TR-2017-0275

**Sub-Task Order 11: High Speed, Substrate Safe Specialty Coating Laser
Stripping: Project: WP-2146**

Alan Fletcher and Michelle Barga

**22 JUNE 2015
FINAL REPORT**

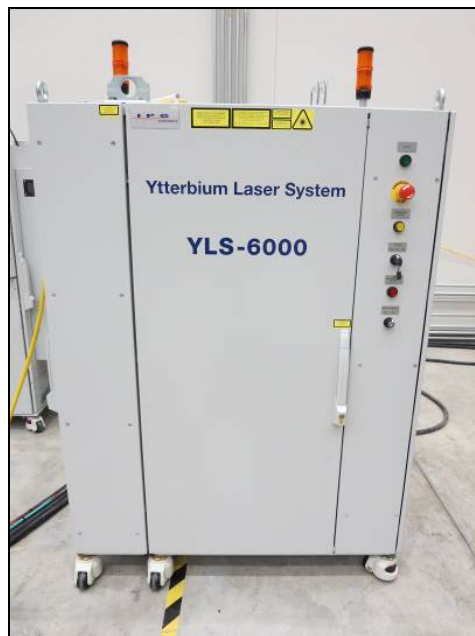
Figure 6. 6 kW Fiber Laser

The fiber laser coating removal system uses a 6 kilowatt (kW) laser system (model: IPG YLR-6000) manufactured by IPG Photonics, Inc, as shown in Figure 6.

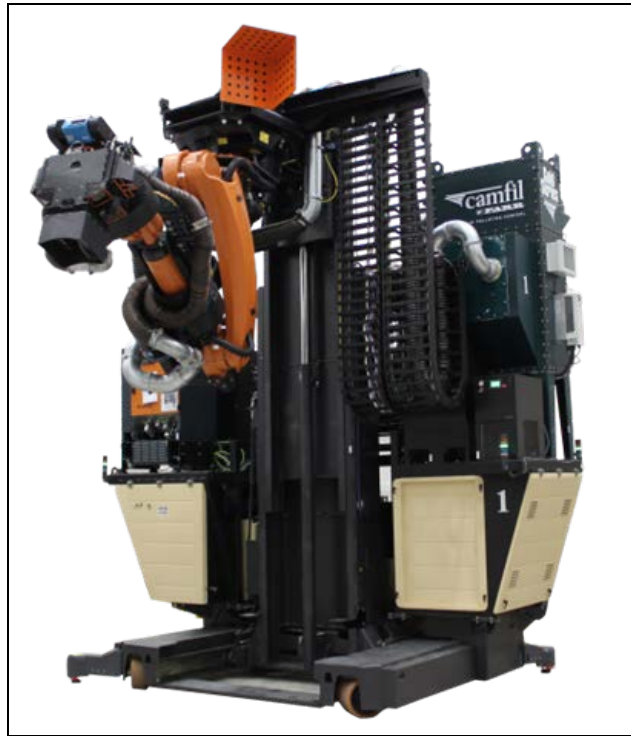
Figure 8. Advanced Robotic Laser Coating Removal System (ARLCRS)

The Full Aircraft ARLCRS, shown in Figure 8, is made of several subsystems that are integrated together into an automated system. The major components include the robotic base, laser, laser process control, and ancillary equipment.

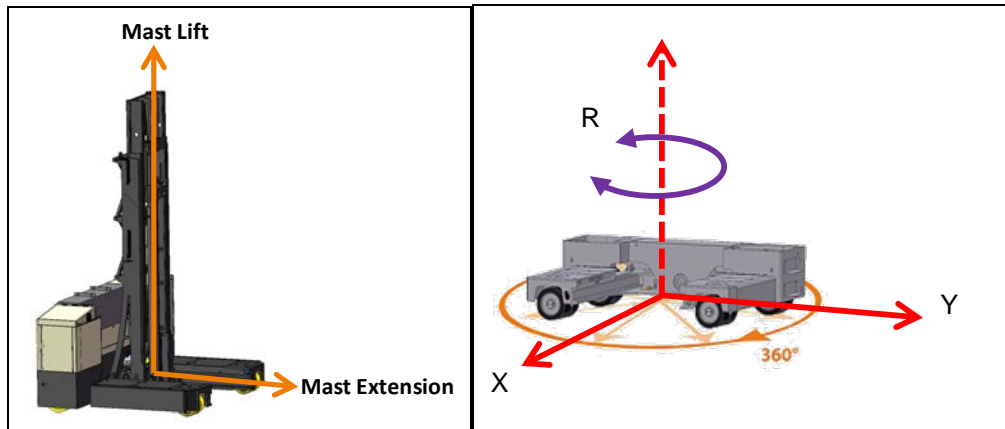
Figure 9. Omni-Directional Mobile Base Platform

Each robot in the system contains several key subsystems. The first subsystem is the mobile base which is a COTS heavy duty side-lift with a vertical boom that is manufactured by Hubtex and shown in Figure 9. These COTS bases are fully multi-directional vehicles that are electrically powered and have lift height and weight capacities that are sufficient for reaching all areas of the aircraft.

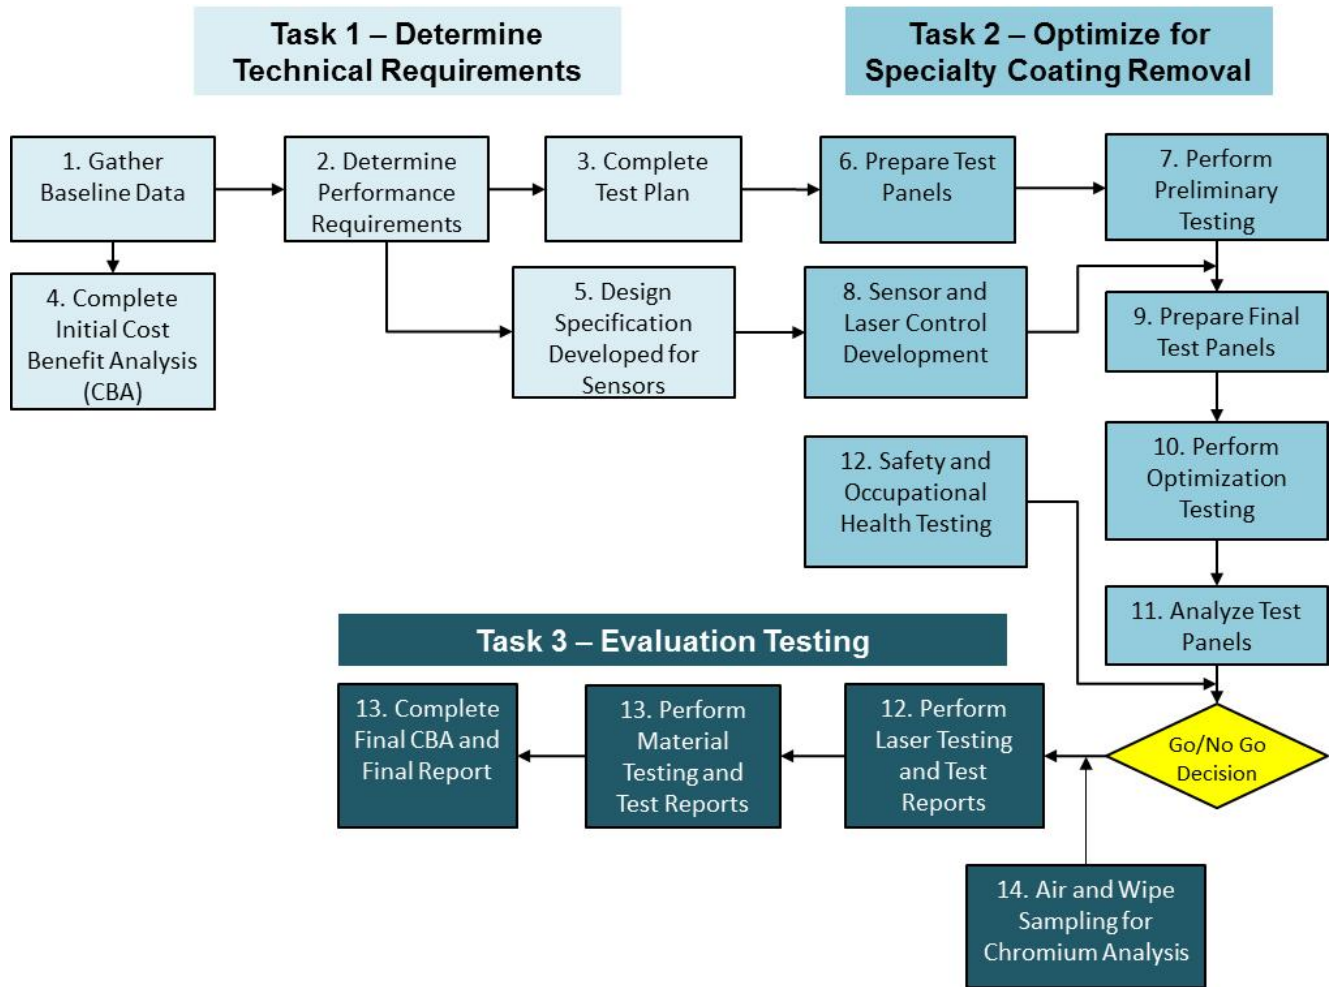
Figure 11. Flow Chart of Technical Activities

The development and evaluation of the laser coating removal process for specialty coating removal was achieved through the technical activities as shown in Figure 11. These activities were broken out into three main tasks which are outlined further in Sections 3.1 – 3.3.

- Task 1 – Determine Technical Requirements
- Task 2 – Optimization for specialty Coating Removal
- Task 3 – Evaluation and Material Testing

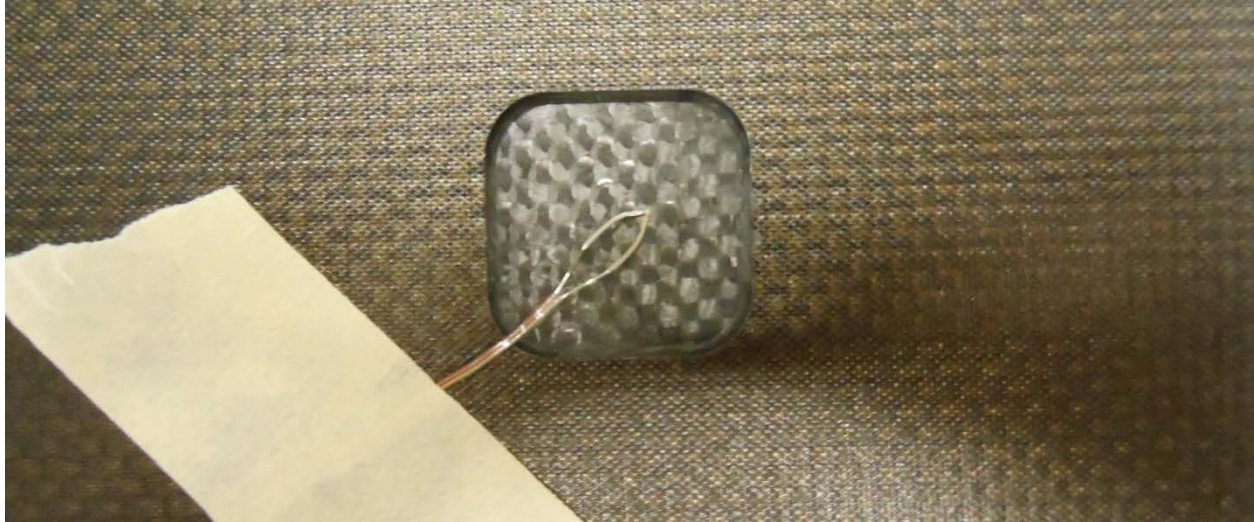
Figure 16. Thermocouple Placement

The thermocouple was bent slightly to ensure that the tip was in direct contact with the bottom of the recess. The lead wire is held in place with masking tape as shown in Figure 16.

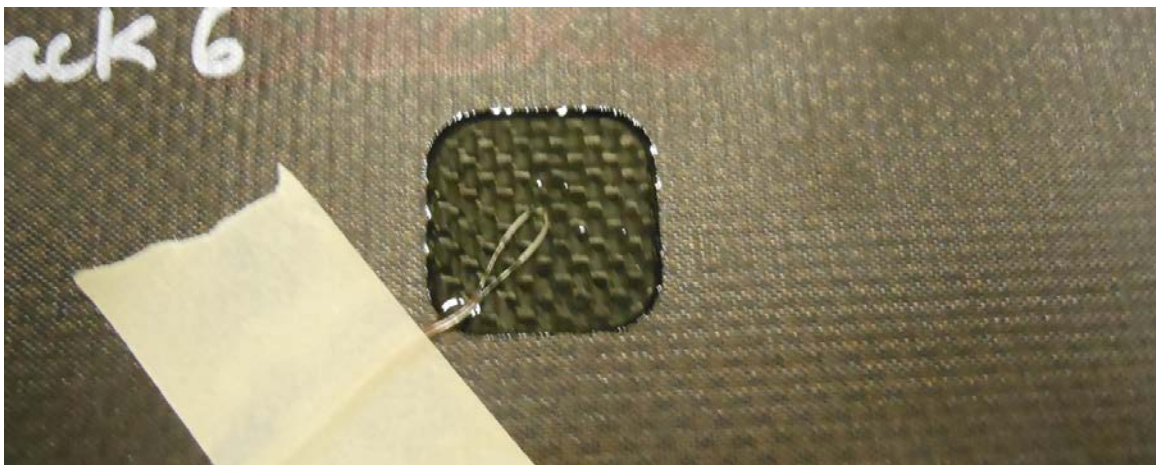
The recesses were filled with 3M Scotch Weld DP 270 clear potting compound, which was the potting compound recommended by AFRL (see Figures 17 and 18).

Figure 17. Potting Compound Installation

Figure 18. Cured Potting Compound

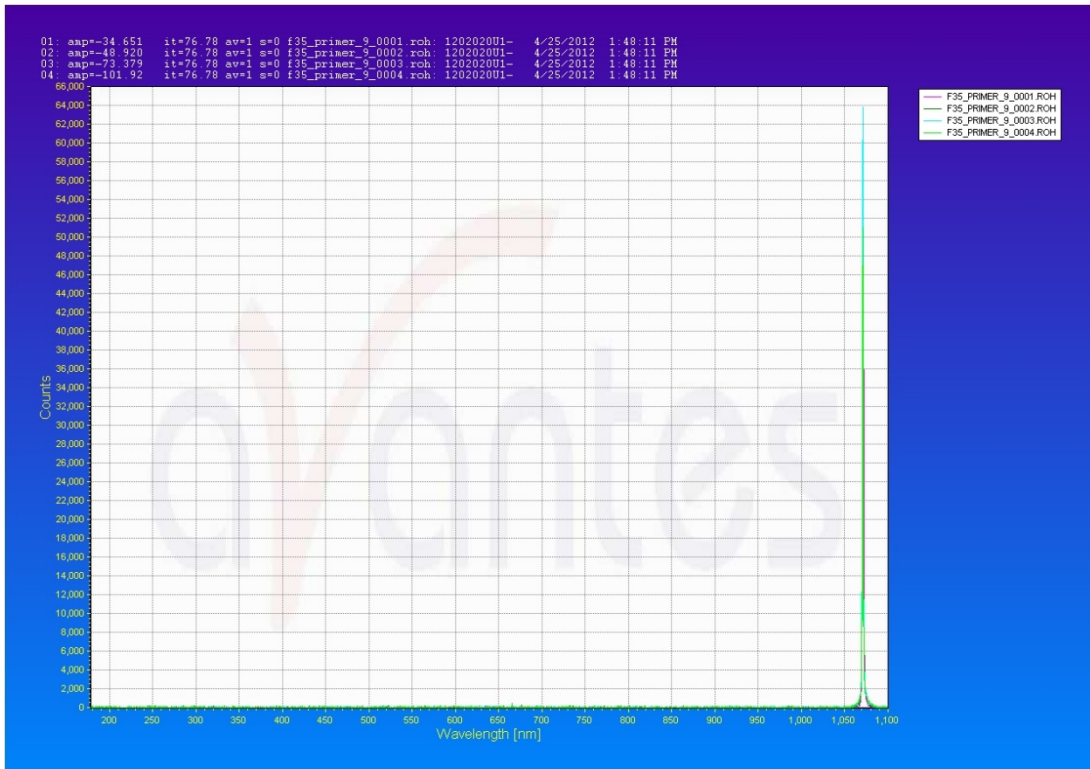
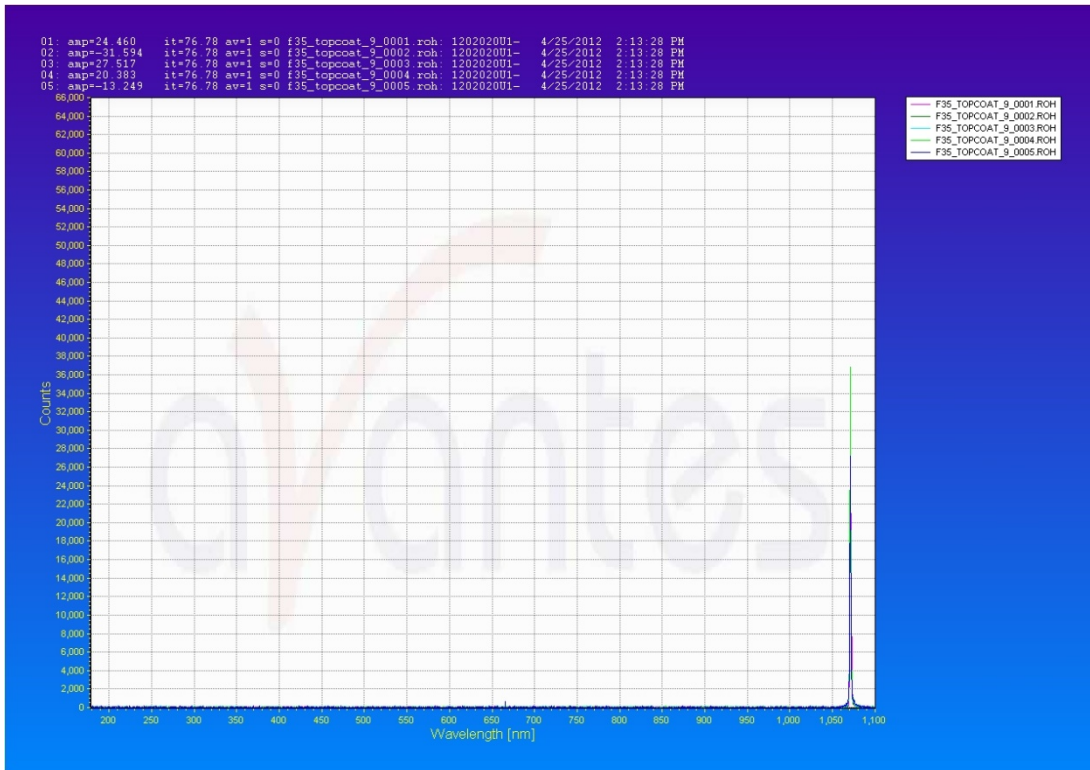
A comparison of Figures 21 and 22 show that at the minimum power level (540W), a significant difference in signal amplitude exists at 1070nm between the primer and topcoat. A comparison of Figures 23 and 24 shows that, at 6000W, a difference in signal amplitude exists not only at 1070nm, but in the region of 500 to 800nm as well. It is possible that these differences can be used in a control scheme to effectively remove the topcoat, while leaving the Deft 098 primer intact thus meeting Goal #2.

Figure 21. Primer Response at 540W (9% Laser Power)

Figure 22. Topcoat Response at 540W (9% Laser Power)

Figure 23. Primer Response at 6000W (100% Laser Power)

Figure 24. Topcoat Response at 6000W (100% Laser Power)

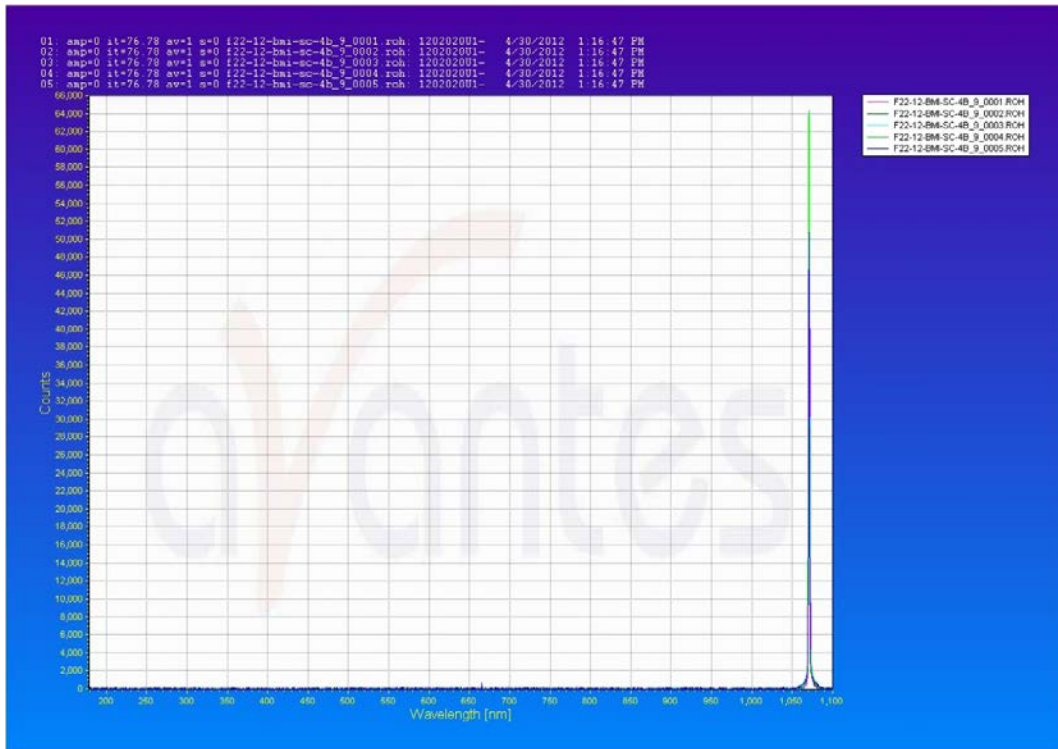
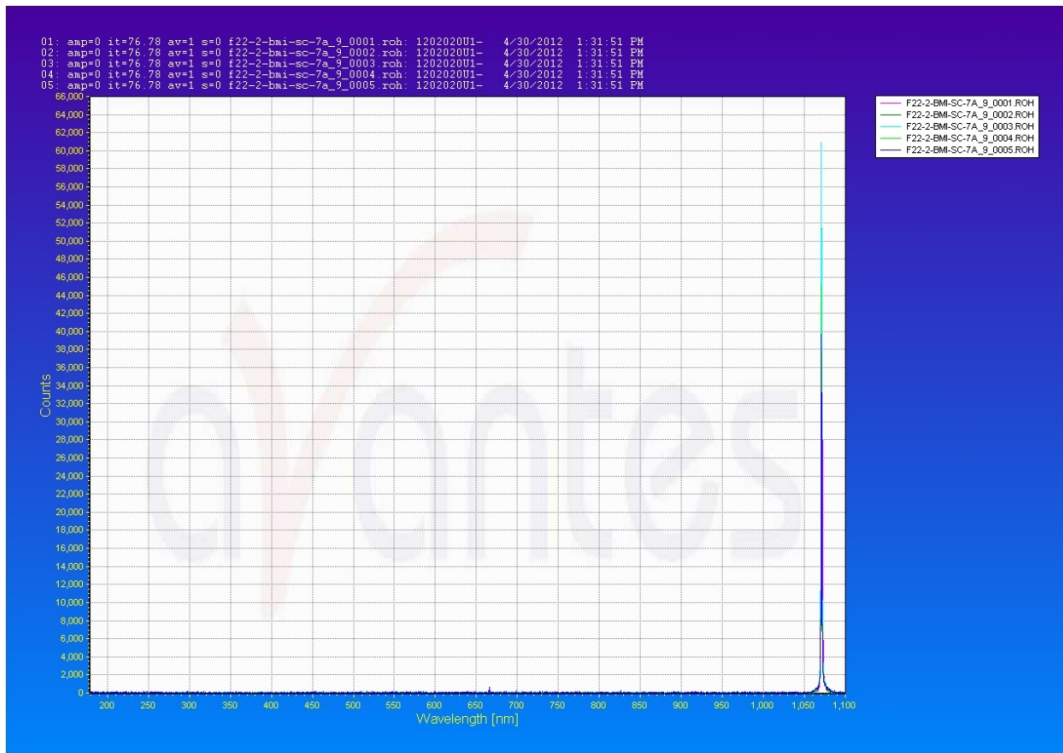
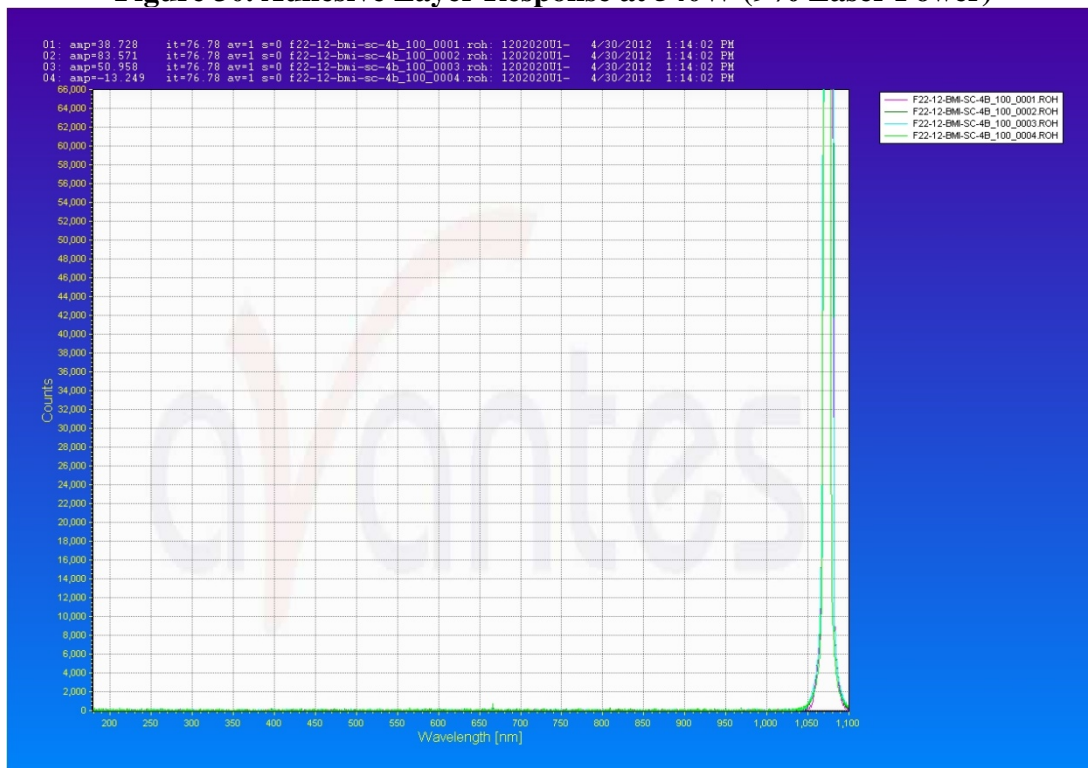
In order to accomplish Goal #2, a difference in spectral response must be seen between the PR-1829 Adhesive and the intermediate primer layer. Figures 29 through 32 document the spectral responses of these coatings at laser power levels of 540W (9%) and 6000W (100%).

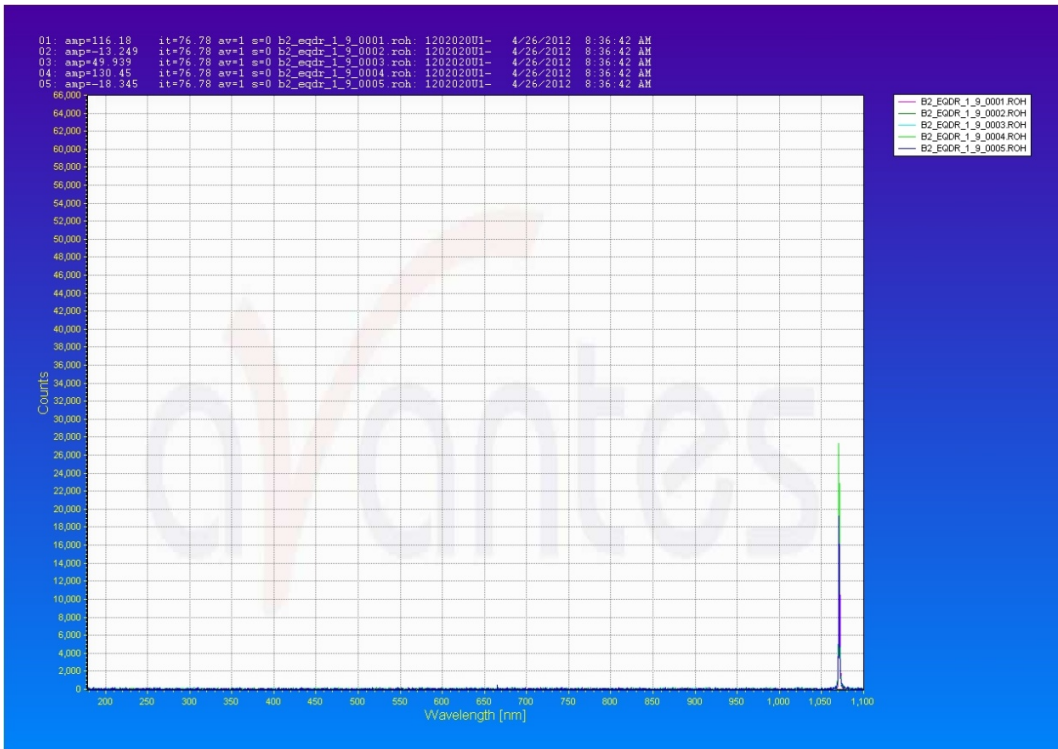
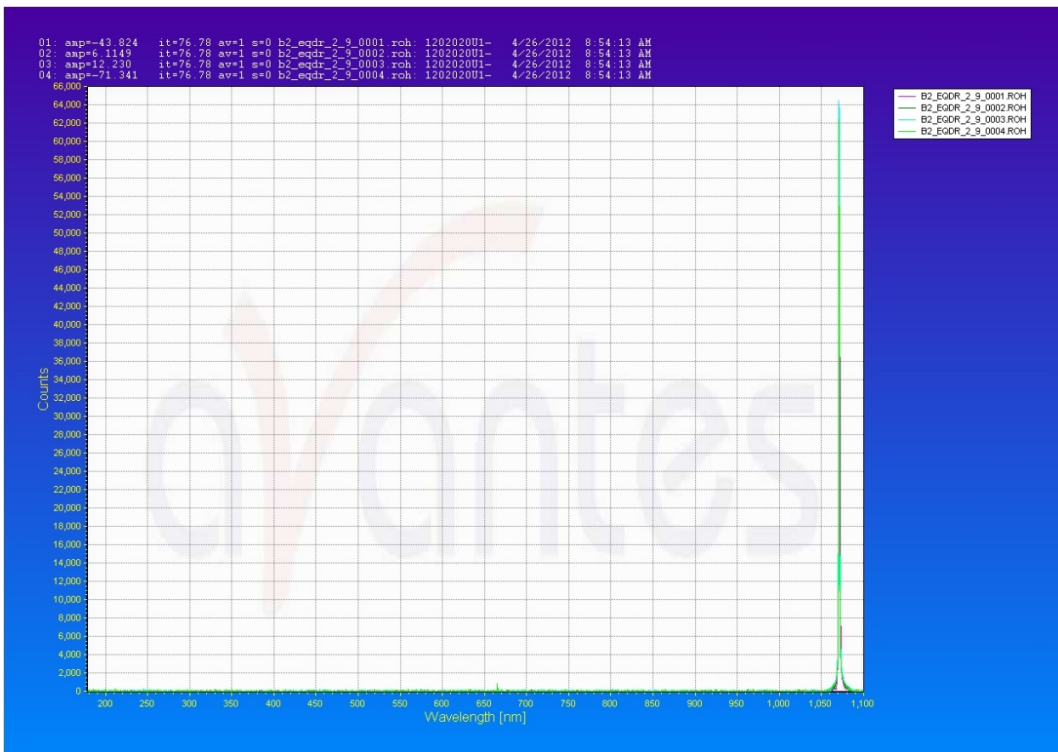
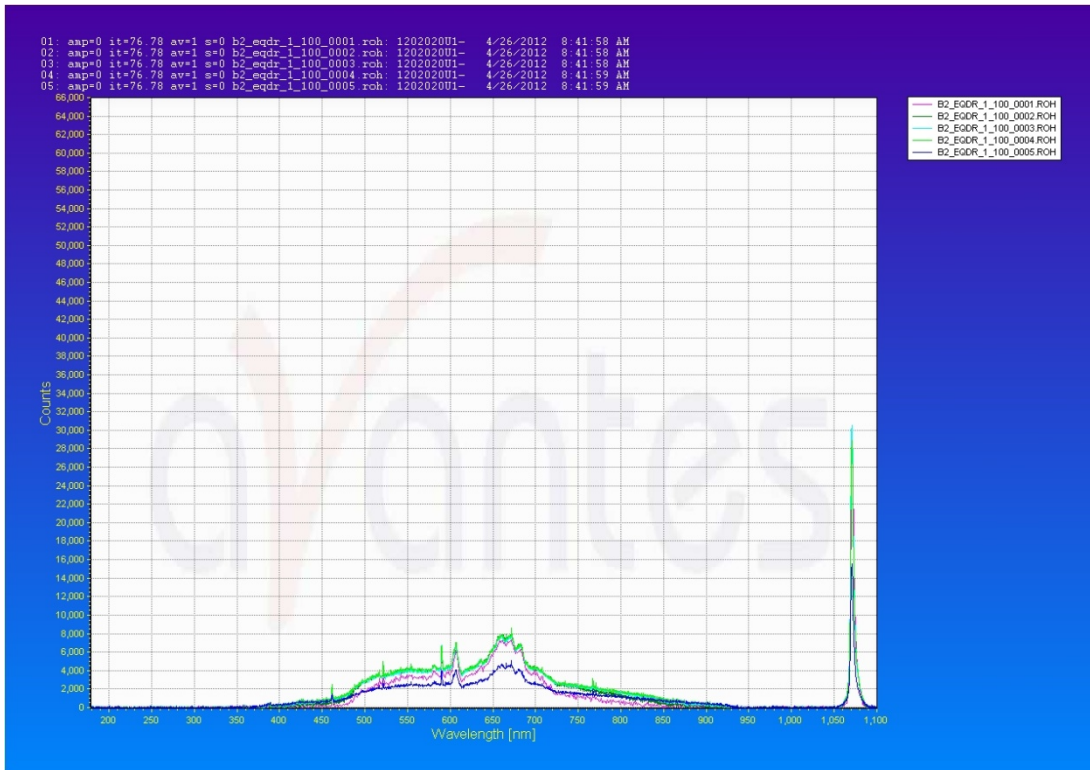
Figures 33 through 36 depict the spectral responses to be evaluated for Goal #1b where coating is laid on the base primer.

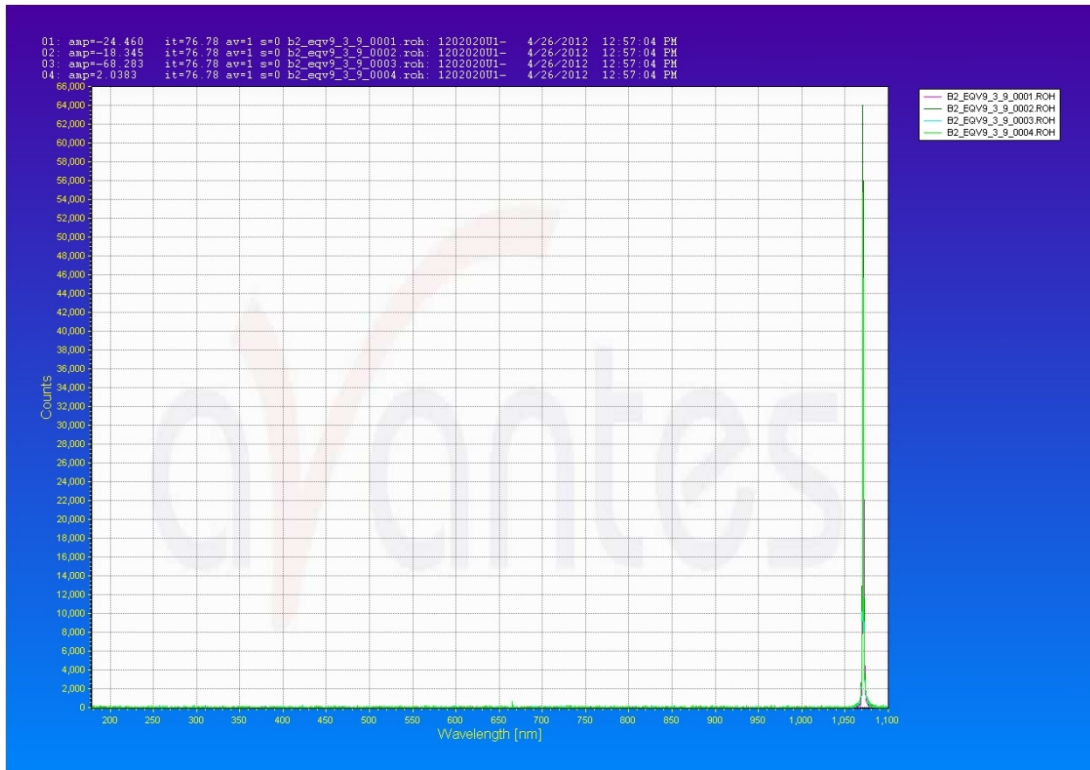
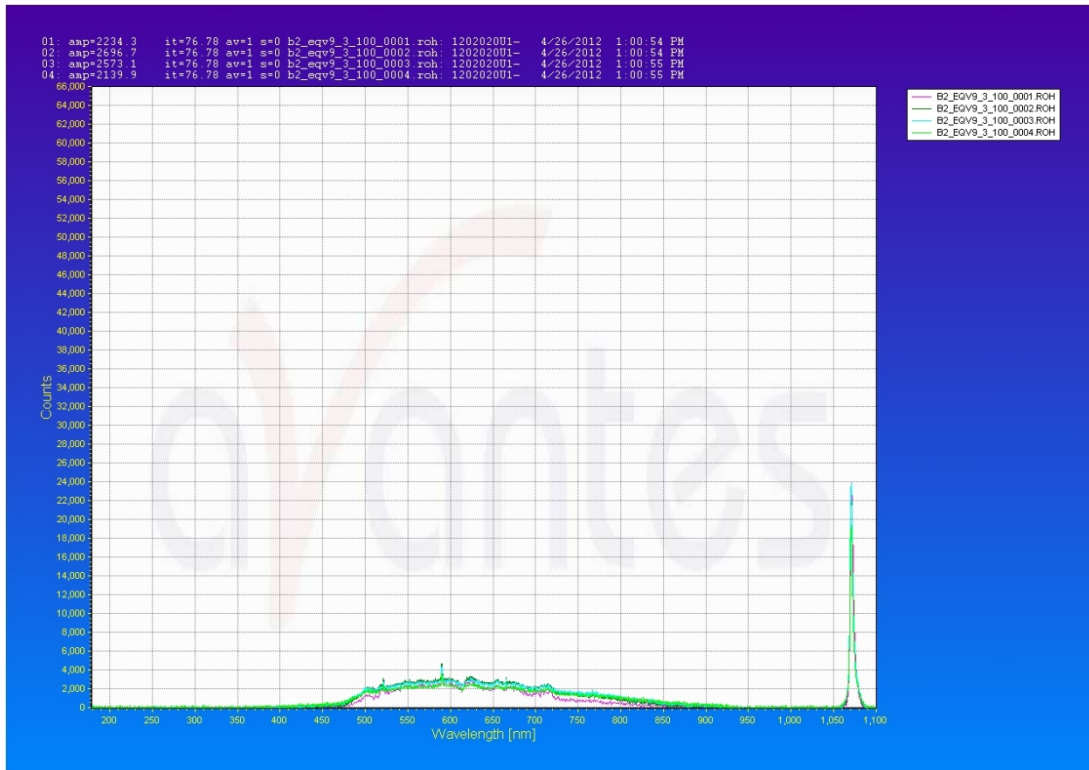
During spectral response testing, it was noted that the rain erosion stack-up was very sensitive to the fiber laser power and was easily damaged. Since the base primer layer is necessarily thin, it is doubtful that all coating layers could be removed without destroying the film. Therefore, CTC proposes that coatings in this particular stack-up be removed only to the base layer of primer in an attempt to prevent substrate damage (Goal #1b). To this end, Figures 37 through 38 show the spectral responses of the base primer and rain erosion coating at 540W (9% laser power) and 6000W (100% laser power). The Figures 39 and 40 are shown in order to see the comparisons more clearly.

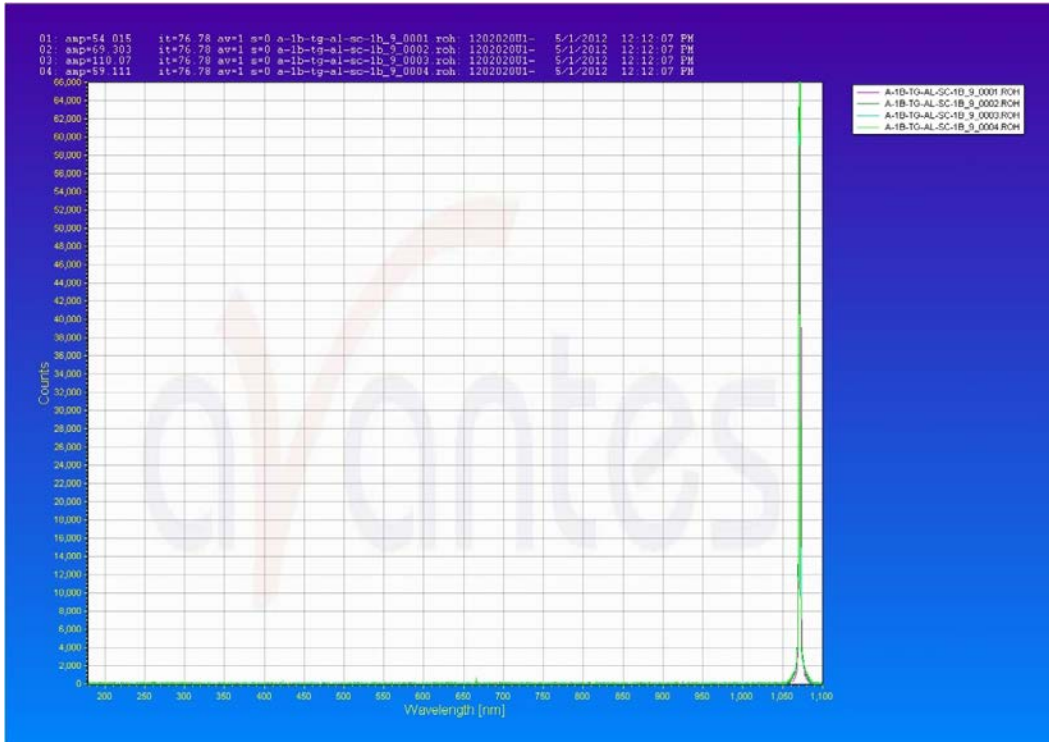
The coating stack-up presents a difficult set of challenges for a spectral sensor-based coating removal control system. With the possible exception of the green and tan CARC topcoats at 100% laser power, the spectral responses of all the coatings in the stack-up are nearly identical. Figures 42 through 44 show the responses of the base primer and surrogate coating (in support of Goal #1).

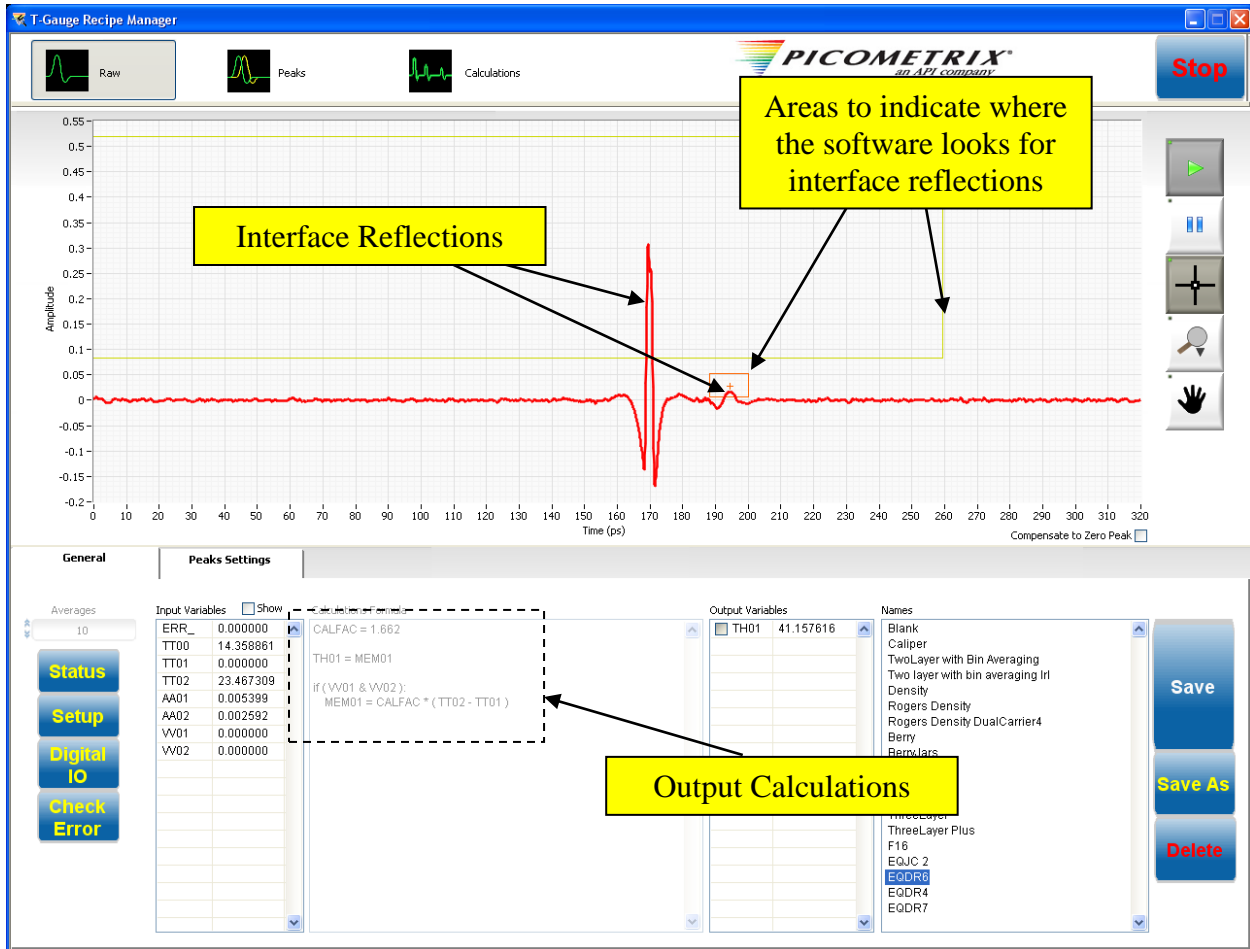
Figure 50. Picometrix Recipe Setup

Results: The system can be instructed to begin operation and stream data through the client software application. It can simply continue running in this fashion until a change in recipe is required, at which point the user can select and execute a different recipe. The operator can use the client software application capture streamed measurement data and save it to a .CSV file (which the operator can name). The data capture start/stop and file naming is accomplished through typical data acquisition commands available in the application.

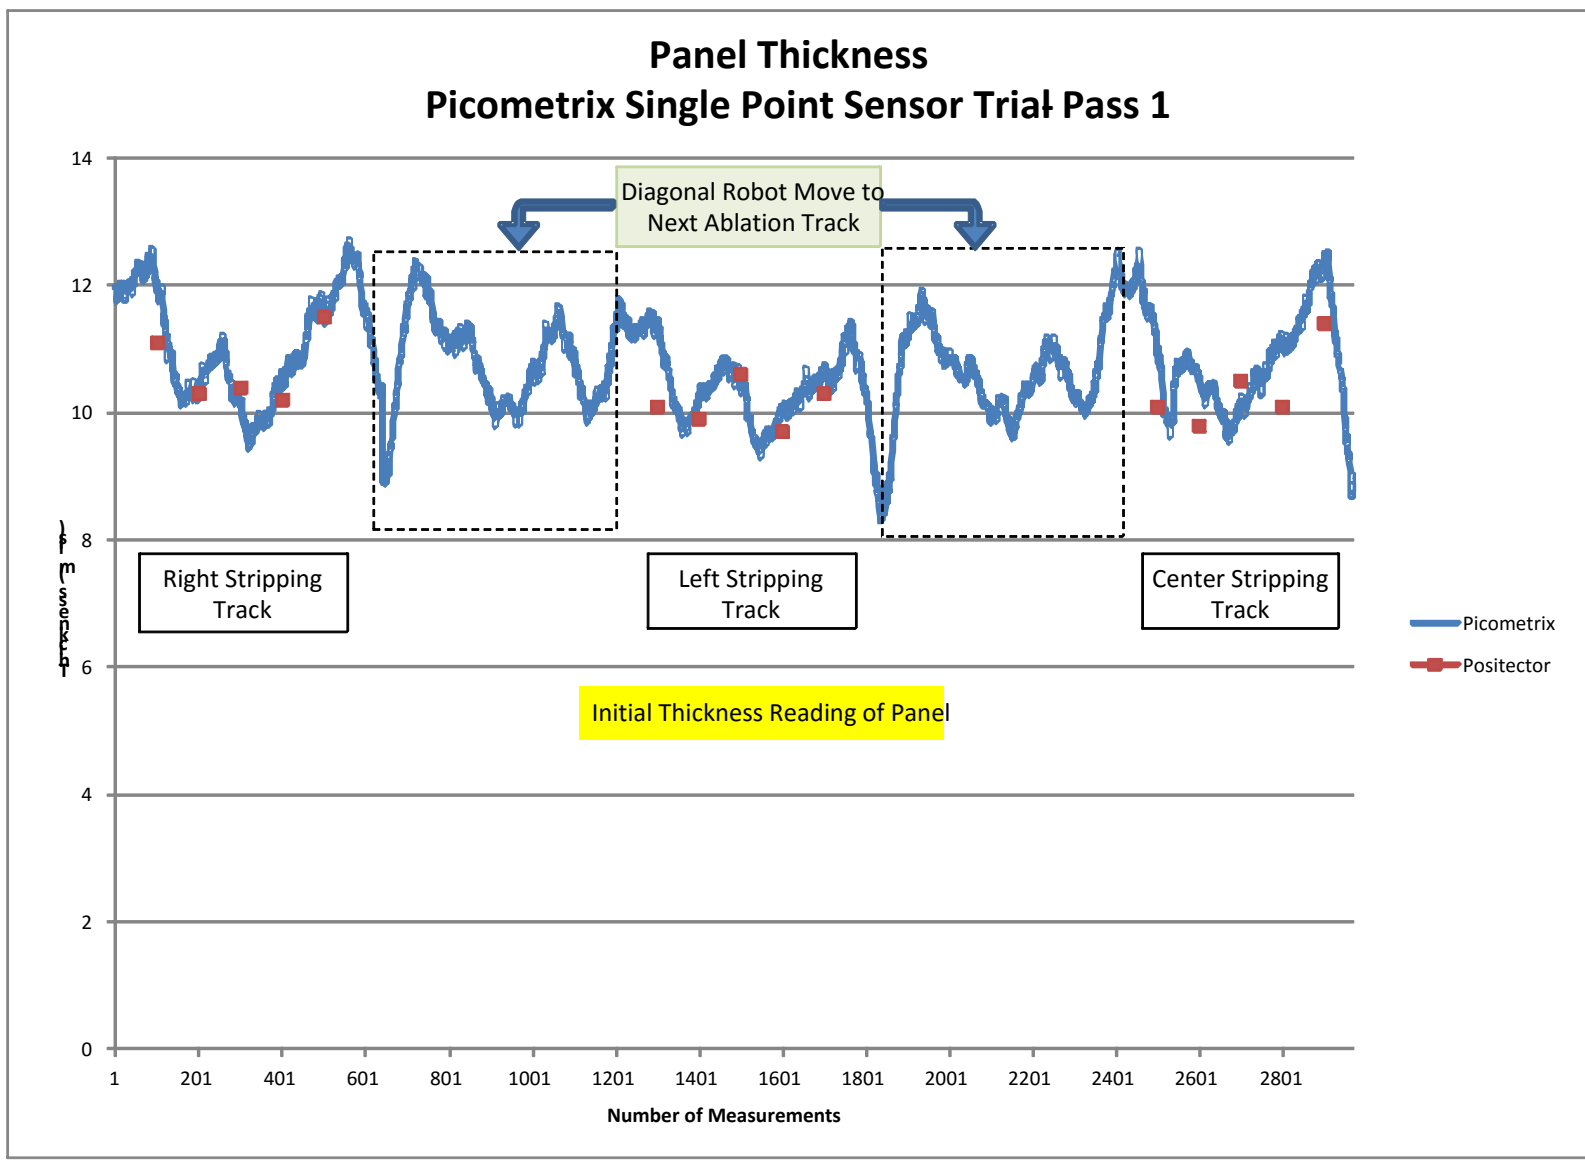
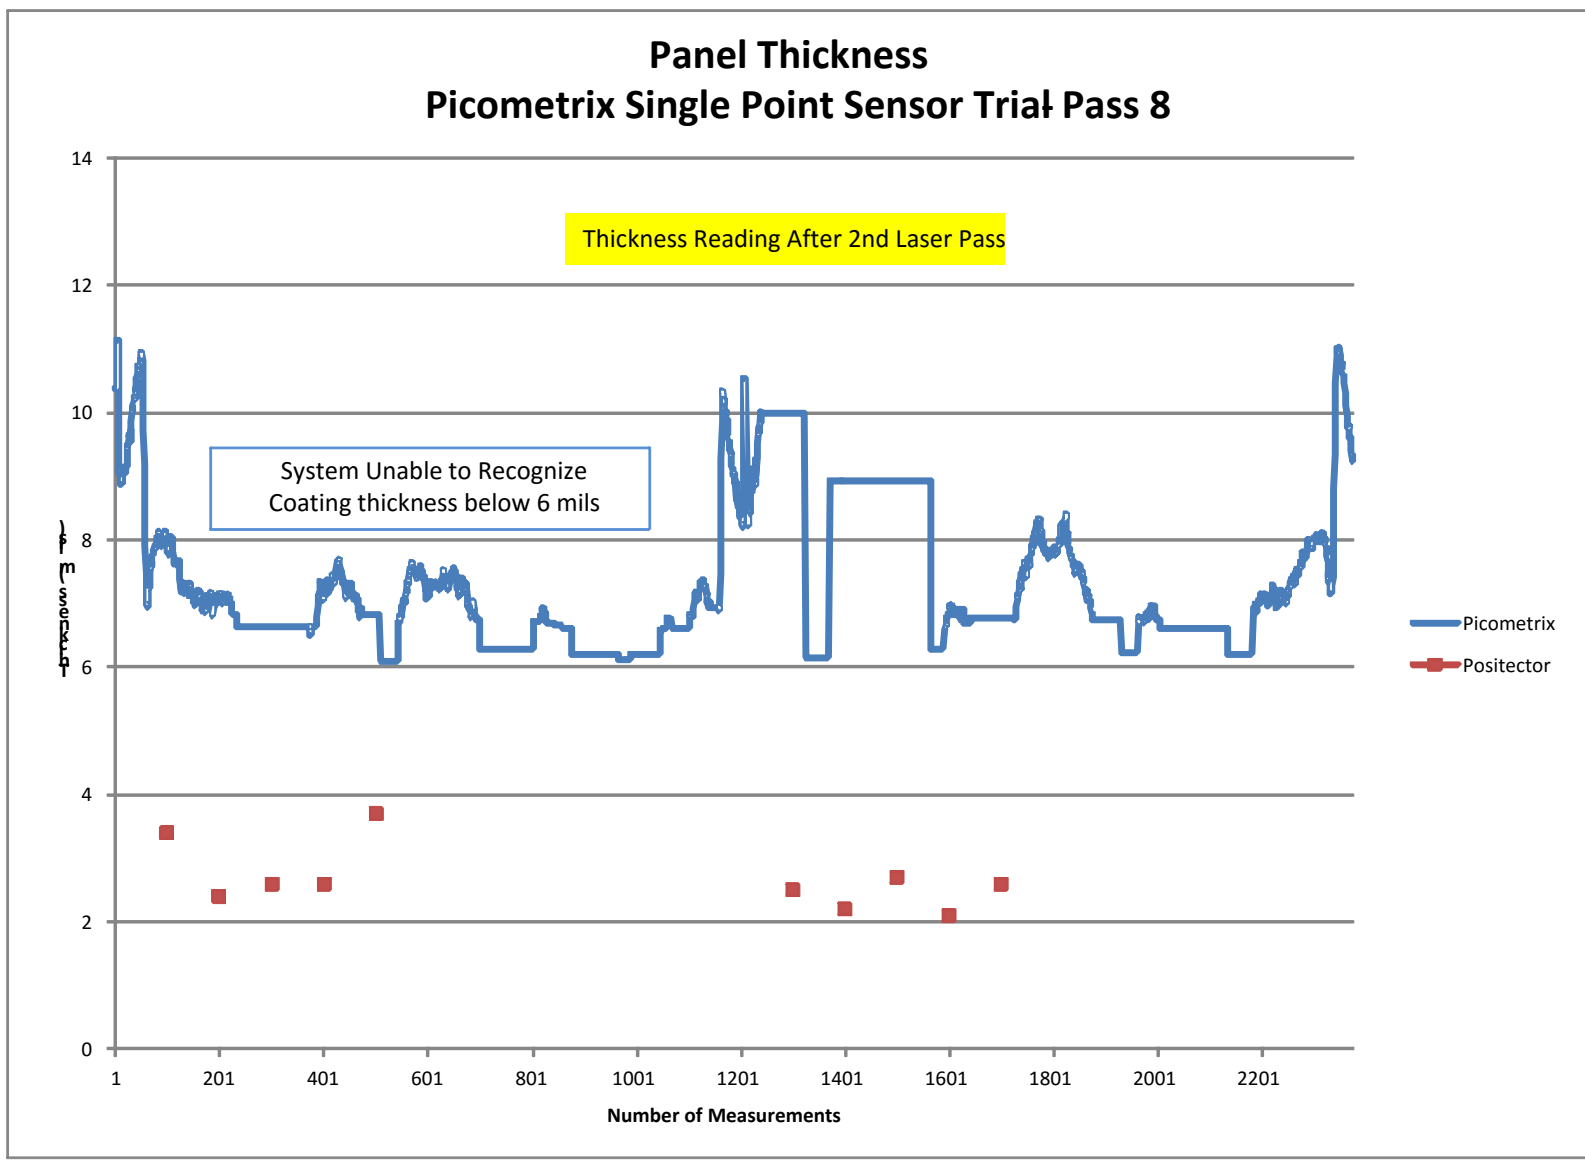
Figure 52. Environmental Tests with Single Point System – Trial #4 – Pass #1

Figure 53. Environmental Tests with Single Point System – Trial #4 – Pass #4

Figure 54. Environmental Tests with Single Point System – Trial #4 – Pass #8

Why is some of the data missing? It was concluded later that for single point measurements, anything less than approximately 4 mils of coating thickness does not produce a reflection of sufficient amplitude to be discernable from the large reflection created by the aluminum substrate, when this close (close because of thin remaining coating thickness). Mr. Duling indicated that there are some improvements and tradeoffs that can be made to the system to improve upon this minimum coating thickness measurement limit. A few improvements mentioned include better antenna design, better signal to noise ratio on the receiver, and some transceiver optics design changes. The optic design changes may cause other deficiencies, so Picometrix will discuss these engineering tradeoffs in their feasibility testing report.
