AFRL-RX-WP-TR-2017-0275

**Sub-Task Order 11: High Speed, Substrate Safe Specialty Coating Laser
Stripping: Project: WP-2146**

Alan Fletcher and Michelle Barga

**22 JUNE 2015
FINAL REPORT**

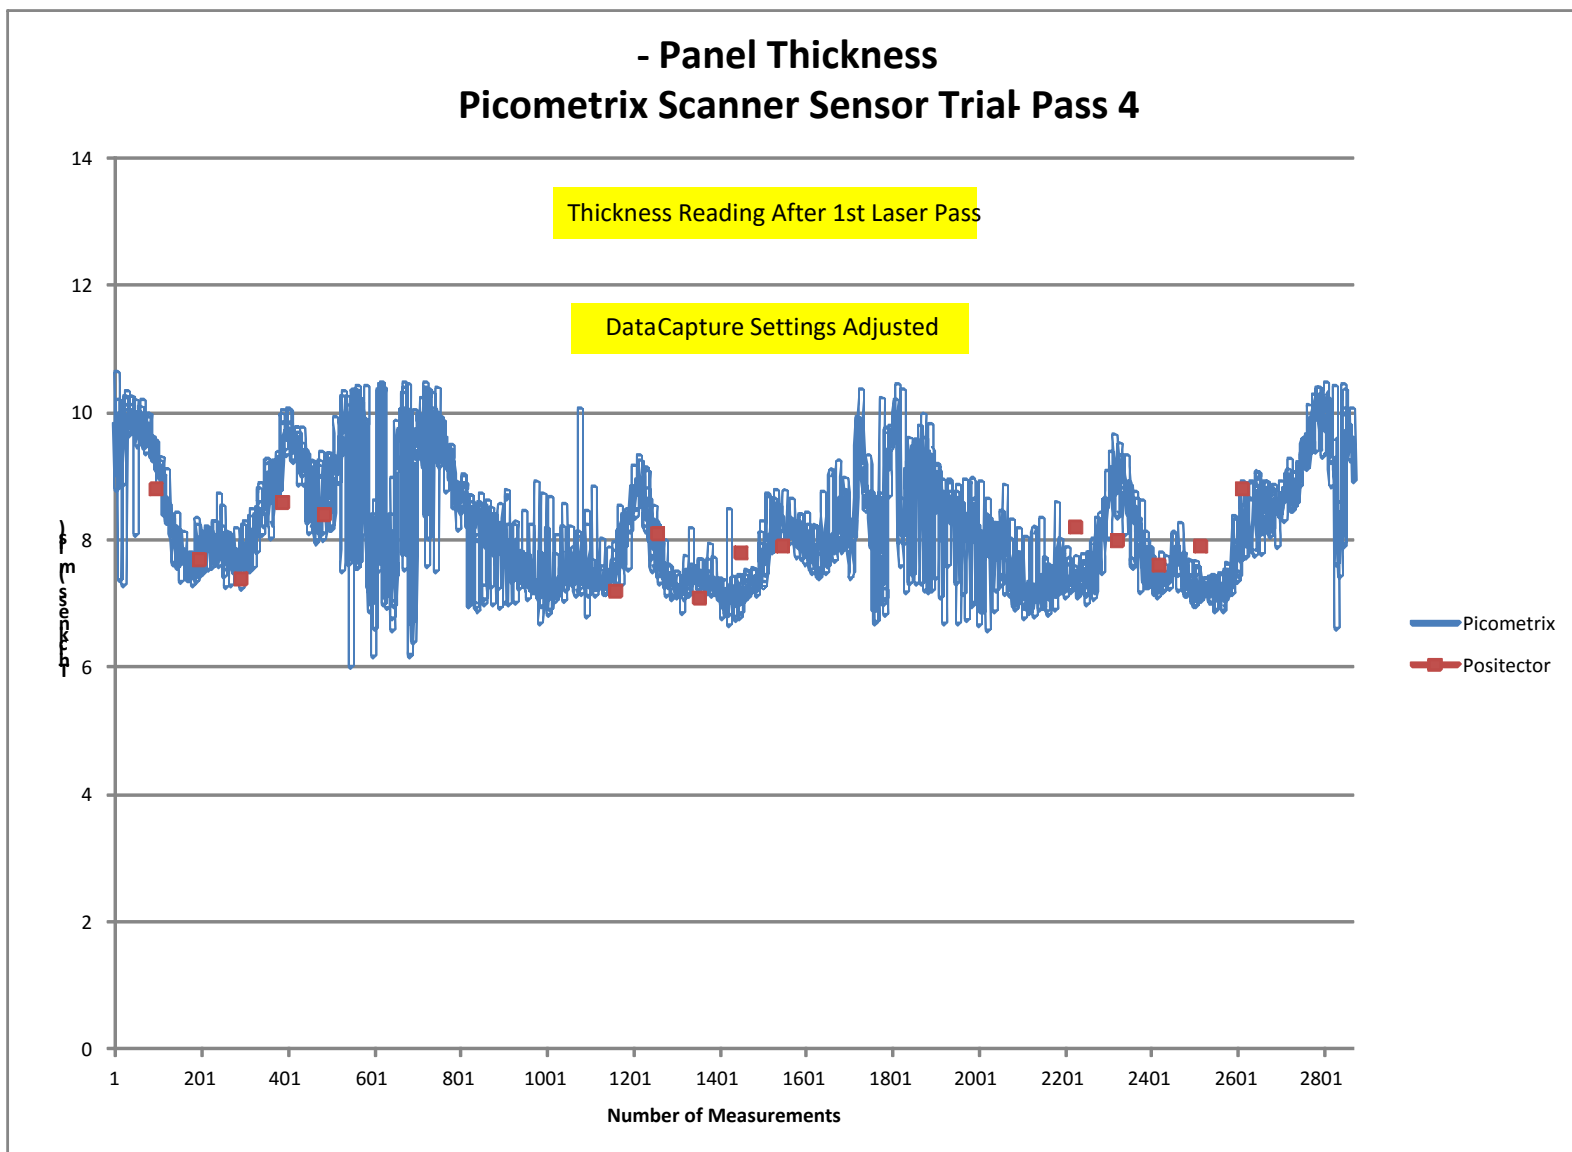
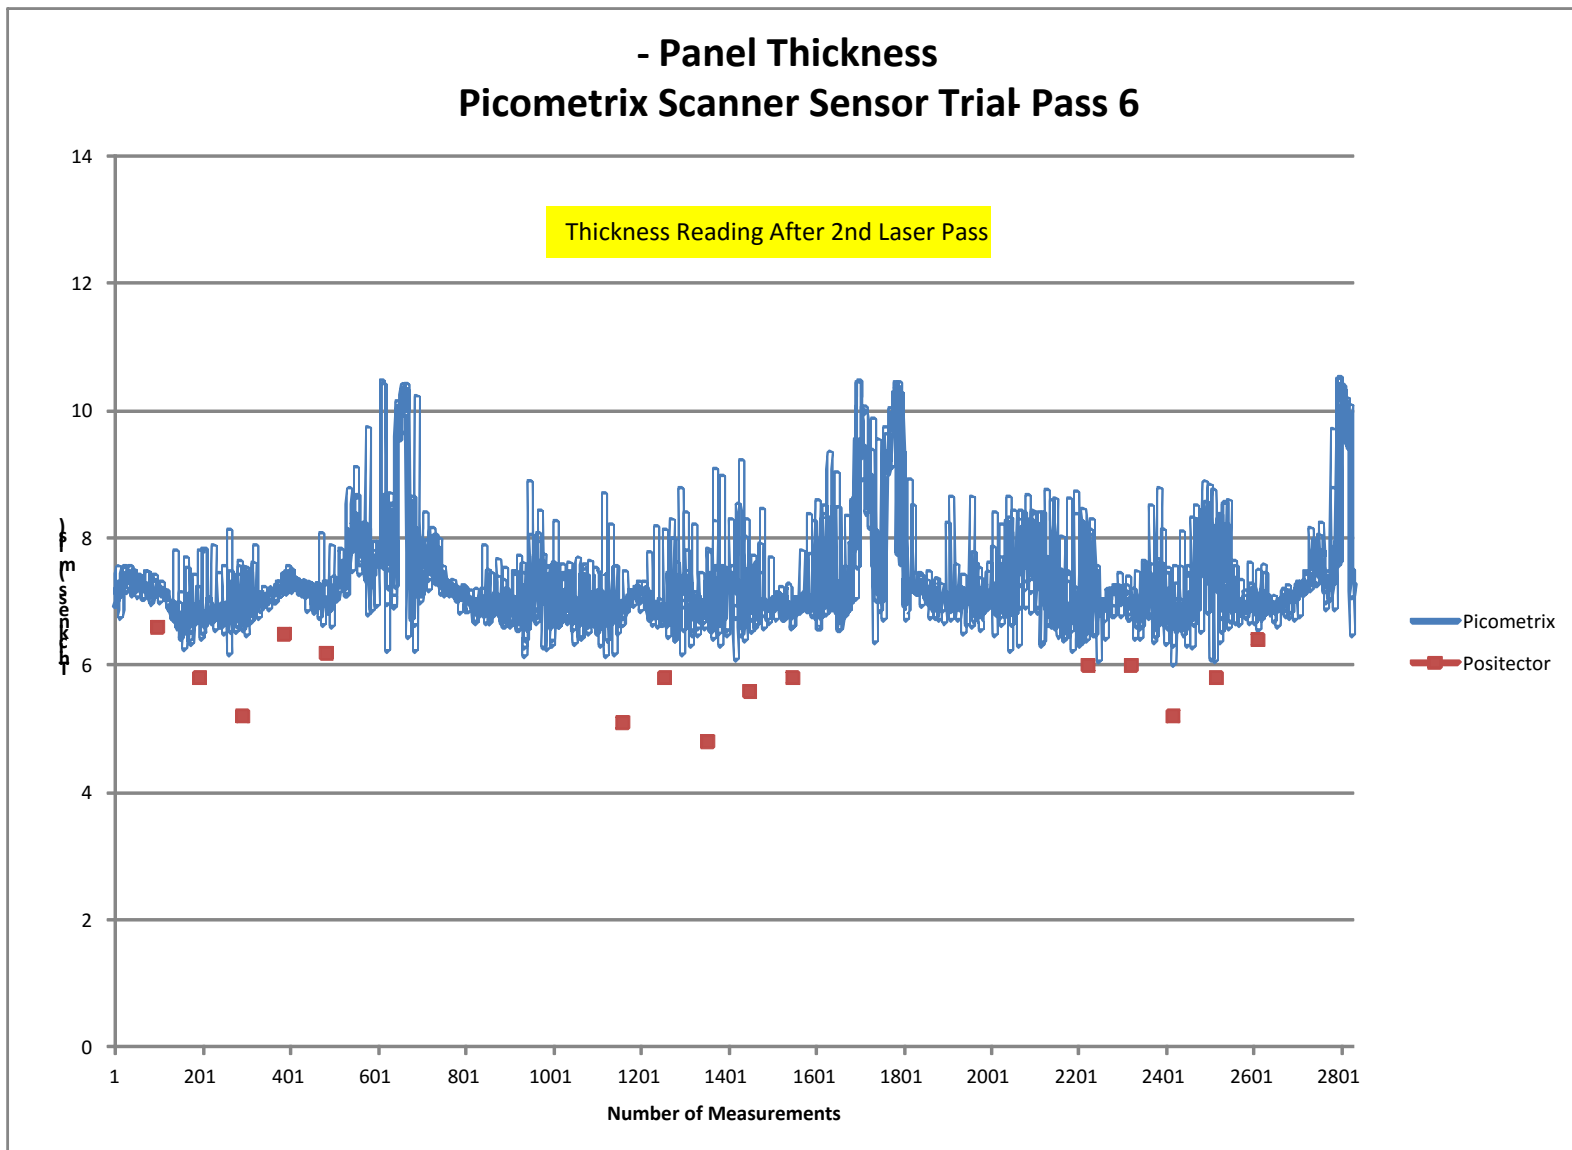
Figure 56. Environmental Tests with Scanner System – Trial #4 – Pass #1

Figure 57. Environmental Tests with Scanner System – Trial #4 – Pass #3

Figure 58. Environmental Tests with Scanner System – Trial #4 – Pass #4

Figure 59. Environmental Tests with Scanner System – Trial #4 – Pass #6

Figure 60. Environmental Tests with Scanner System – Trial #4 – Pass #8

Used an multi-coating panel (panel ID: Fiber-AL-2A-APC(DEFT)-1-Practice 43) for these tests. The scanner was running at 5 Hz. Recorded real-time data at 100 Hz. Multiple passes of data were recorded before and between ablation passes. Laser ablation appeared to have no effect on the thickness sensor operation, but as was seen with the single point sensor, when the coating became too thin, it lost the ability to take thickness measurements. Whereas the single point sensor stopped reading at about 4 mils of paint, the scanner stopped reading between 6 and 7 mils. Also found that as the correct reflection receded, the software was using another one, which inadvertently caused the thickness readings to go back up. Concluded that for scanner measurements, anything less than approximately 6 to 7 mils of coating thickness does not produce a reflection of sufficient amplitude to be discernable from the large reflection created by the aluminum substrate, when this close (close because of thin remaining coating thickness). A few improvements mentioned include better antenna design, higher antenna drive power, better signal to noise ratio on the receiver, and some transceiver optics design changes. The optic design changes may cause other deficiencies, so Picometrix will discuss these engineering tradeoffs in their feasibility testing report.

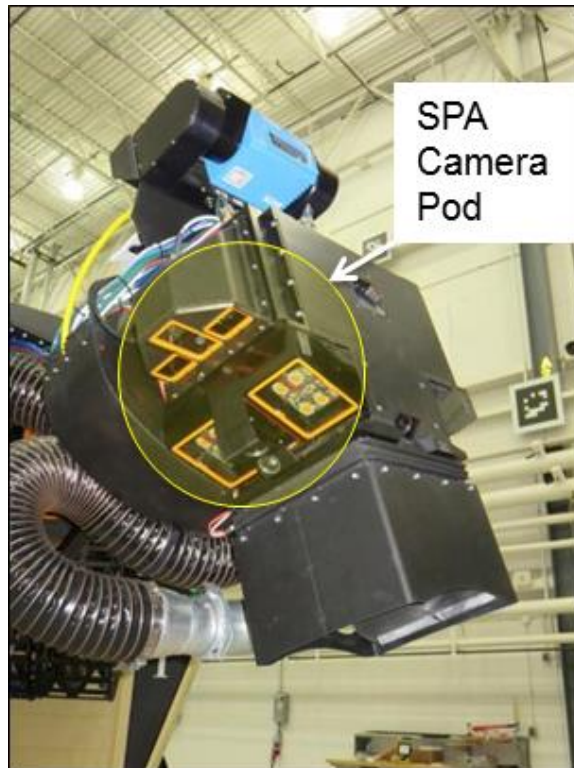
Figure 61. SPA Camera Pod on ARLCRS

The SPA sensor system is a color recognition sensor system that discriminates coatings prior to laser ablation by analyzing camera imagery with computer vision and machine learning techniques. The primary purpose of the SPA is to provide a classification and confidence level of the aircraft surface model. To accomplish this, multiple cameras, each with a different filter, and light emitting diode lights are used in a flexible design configuration, as shown in Figure 61, to allow the discrimination of surface coatings and substrate. The SPA system is a software-based system whose flexibility allows for adaption of new coating classes using machine-learning algorithms.

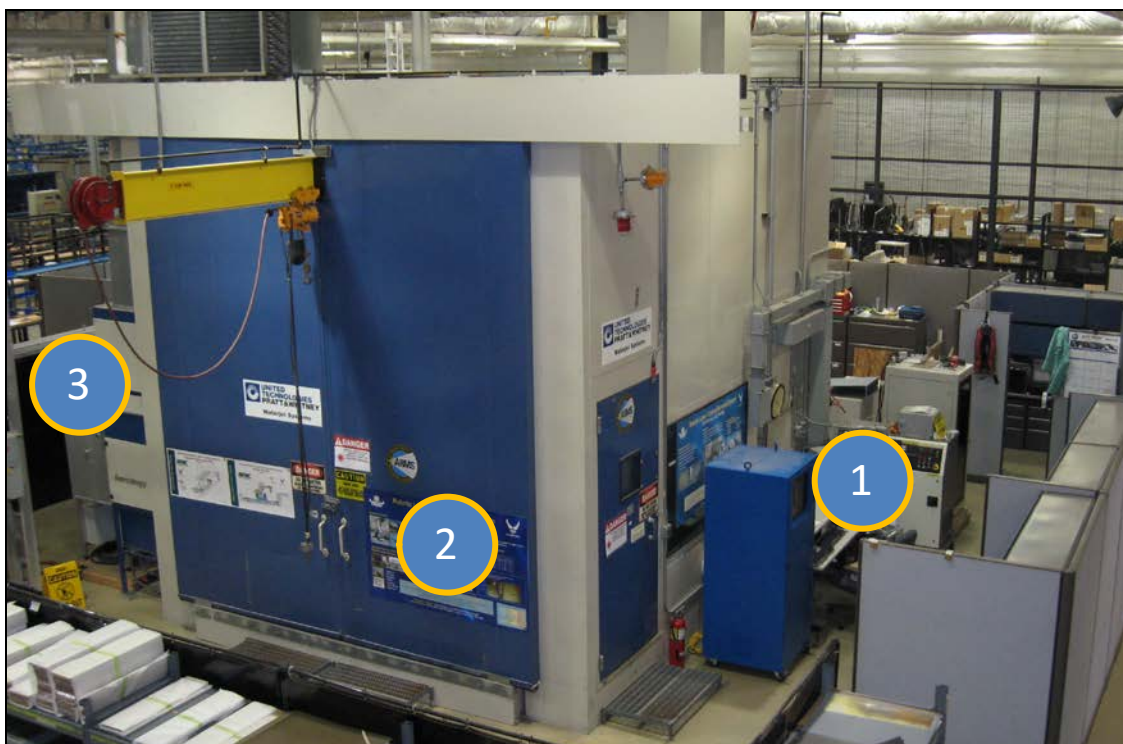
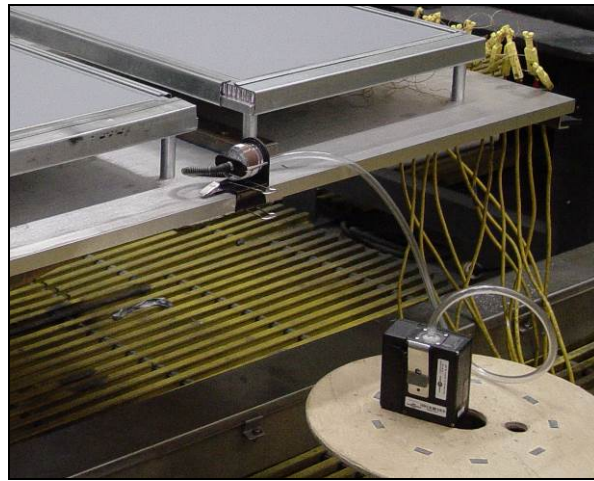
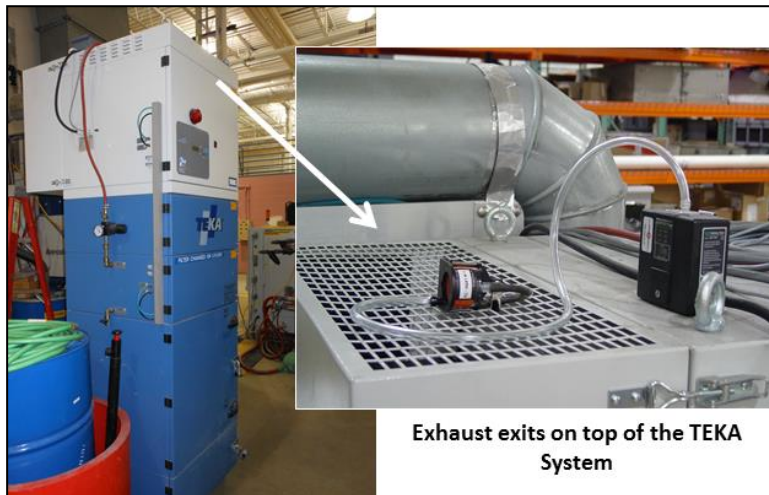
The air sampling was performed at three locations: (1) the fiber laser operator station, (2) inside the laser stripping cell (adjacent to the process) and (3) at the exhaust vent of the TEKA system, as shown in Figures 63 – 66.

Figure 63. Placement of Air Sampling Pumps

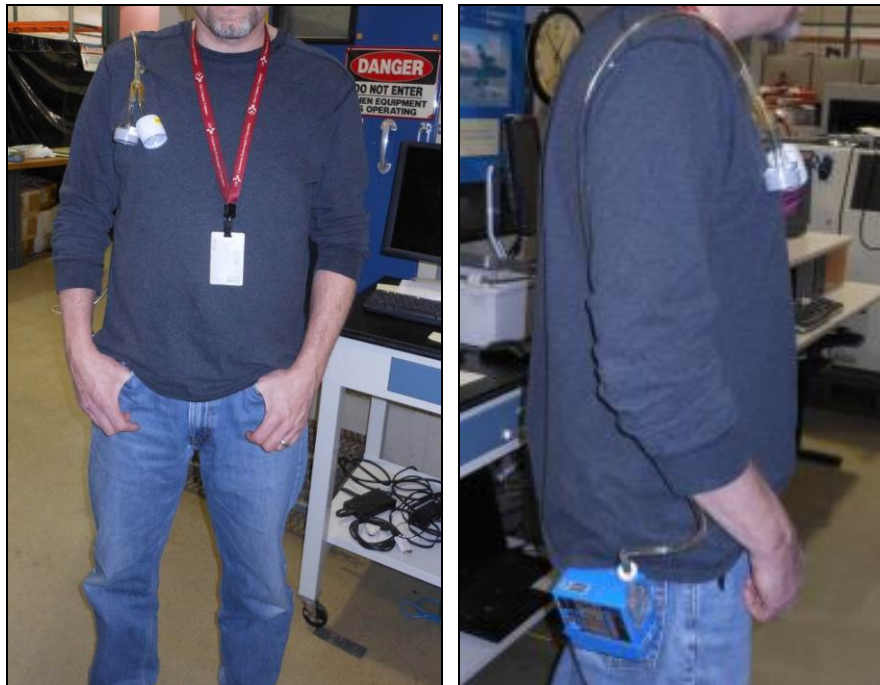
Figure 68. Air Sampling Pump Set-Up Inside Laser Test Cell

Figure 69. Air Sampling Pump Set-Up at TEKA System Exhaust

Figure 70. Personal Air Sample Located in the Operator's Breathing Zone

An additional personal air sample was taken at the conclusion of the laser stripping operation to determine operator's exposure to chromium and hexavalent chromium when entering the test cell. The sampling pump on the operator collected for 22 minutes while the individual was in the test cell.
