ARL-TR-8169 • Sep 2017

Verification and Demonstration for Transition of Nonhexavalent Chromium, Low-Volatile Organic Compound (VOC) Alternative Technologies to Replace DOD-P-15328 Wash Primer for Multimetall Applications

by John Kelley, Thomas Considine, Thomas Braswell, and Alicia Farrell

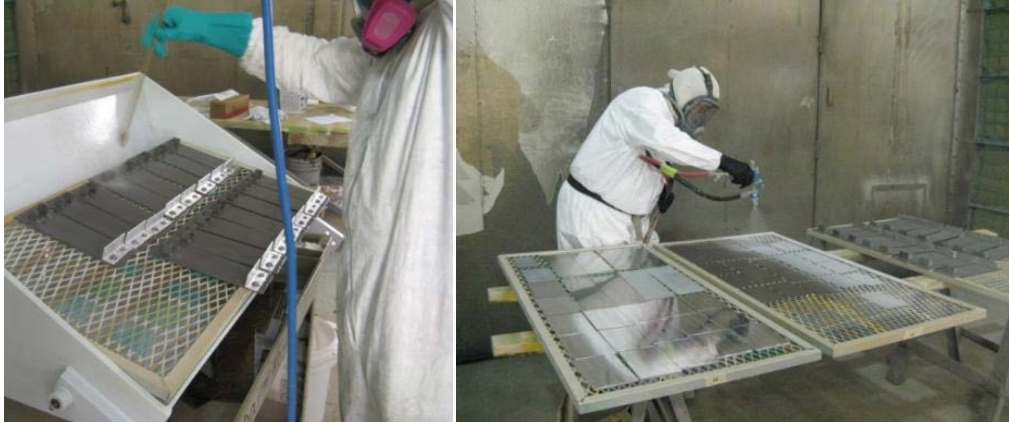
Fig. 2 Pretreatment application (left) and coating application at ATC (right)

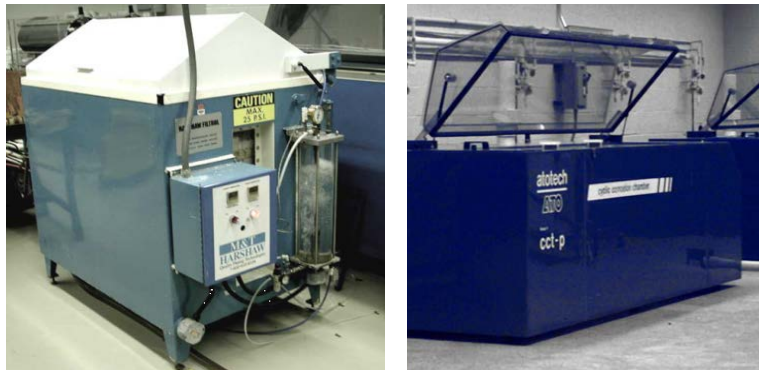
Fig. 6 The chamber used to conduct the neutral salt fog ASTM B117 (left) and the chamber used to conduct GM9540P tests (right)

The ASTM B117 neutral salt fog conditions are 95 °F with saturated humidity and atomized fog of 5% sodium chloride (NaCl) solution. The GM 9540P test consists of the 18 separate stages that are listed in Table 6 and includes the following intervals: saltwater spray, humidity, drying, ambient, and heated drying. The standard 0.9% NaCl, 0.1% CaCl₂, 0.25% NaHCO₃ test solution was used. The cyclic chamber was verified with standard steel mass loss coupons as described in the GM 9540P test specification. The salt fog chambers were verified using temperature, pH, and deposition rate measurements as per ASTM B117.

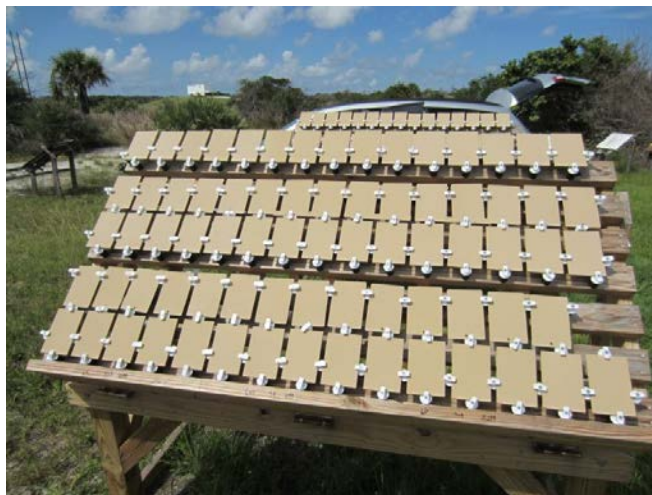
Fig. 8 Example of racks on CCAFS/TACOM outdoor exposure site

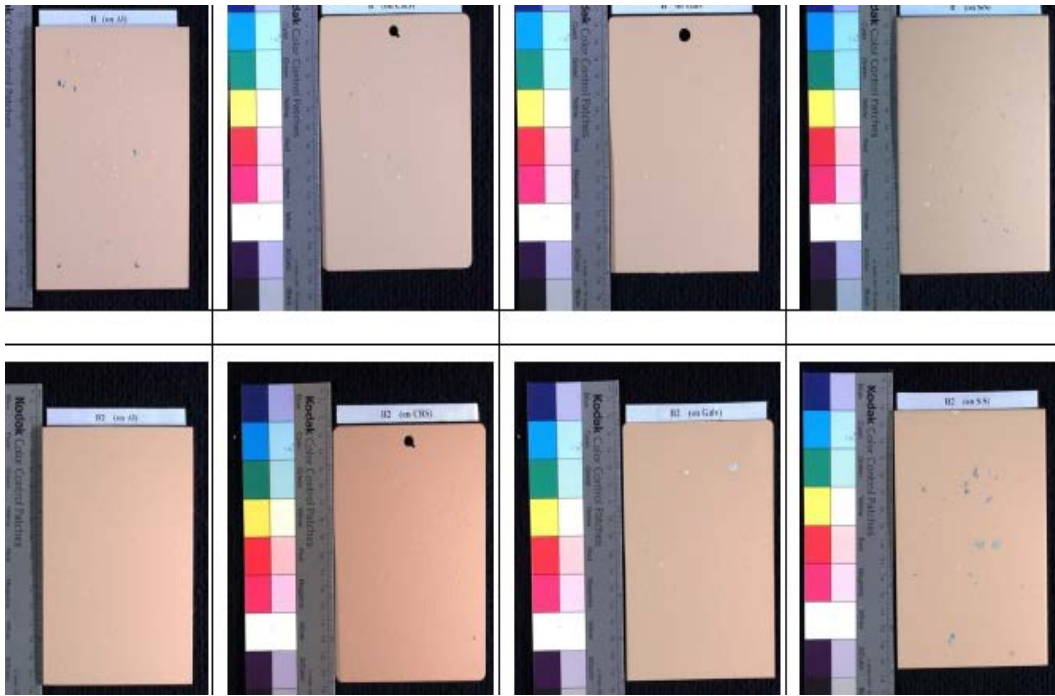
Fig. 9 Bonderite M-NT-7400 on (from L to R) aluminum, cold-rolled, galvanized, and stainless steel (53030 top, 53022 bottom)

Figures 9–12 show the results of the SAE J400 test panels after testing. Although the ratings quantitatively determine whether the pretreatments met or did not meet the success criteria, Figs. 9–12 show the performance qualitatively. Ecosil 5-1 and the Bonderite M-NT-7400 were 2 of the most resistant to chipping along with the Oxsilan 9810/2 (not shown). These alternatives compare very well to the baseline wash primer in Fig. 11. In fact, quantitatively, one could deduce the alternatives were better at resisting chipping. In contrast, Fig. 12 shows the poor performance of the Picklex with all primers and substrates. The chip resistance is particularly important for ground vehicles to prevent damage to the CARC system.

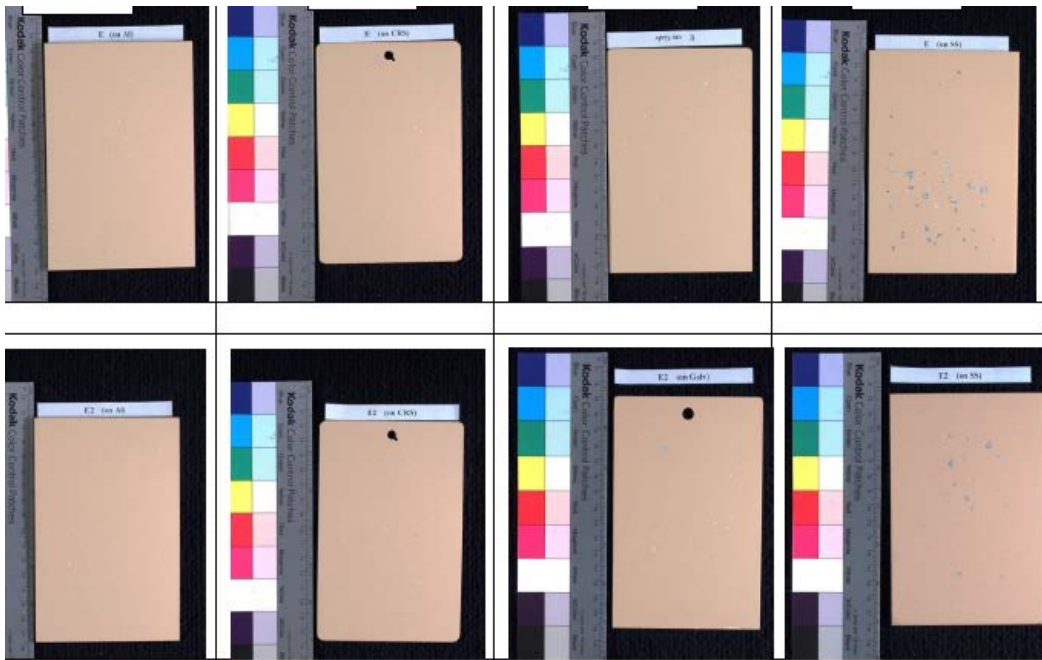
Fig. 10 Ecosil 5-1 on (from L to R) aluminum, cold-rolled, galvanized, and stainless steel (53030 top, 53022 bottom)

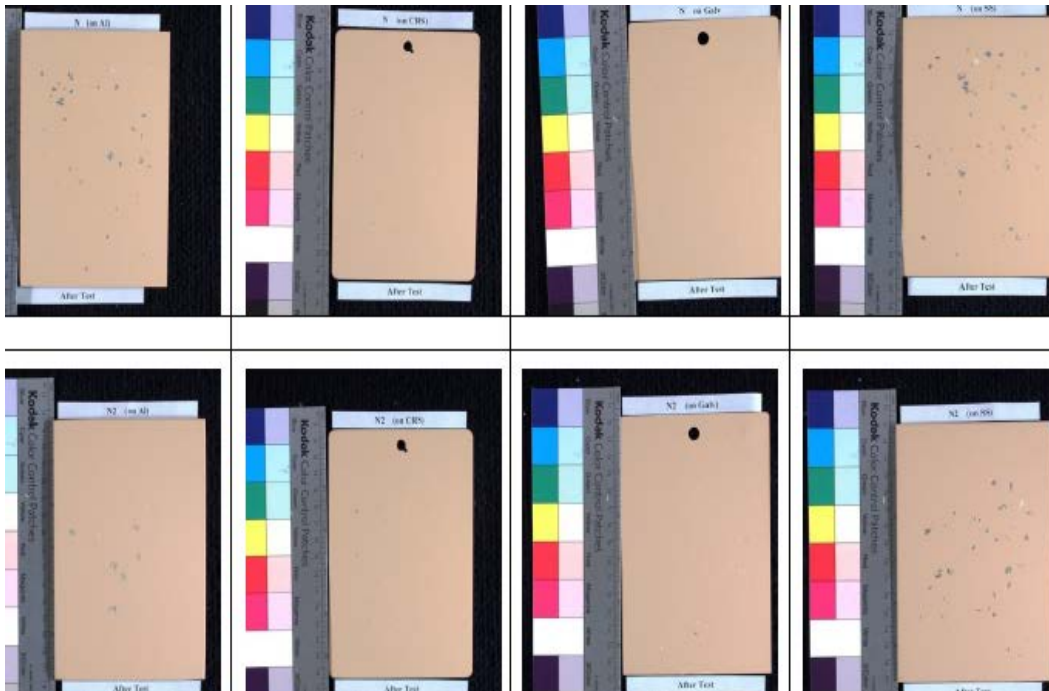
Fig. 11 DOD-P-15328 wash primer on (from L to R) aluminum, cold-rolled, galvanized, and stainless steel (53030 top, 53022 bottom)

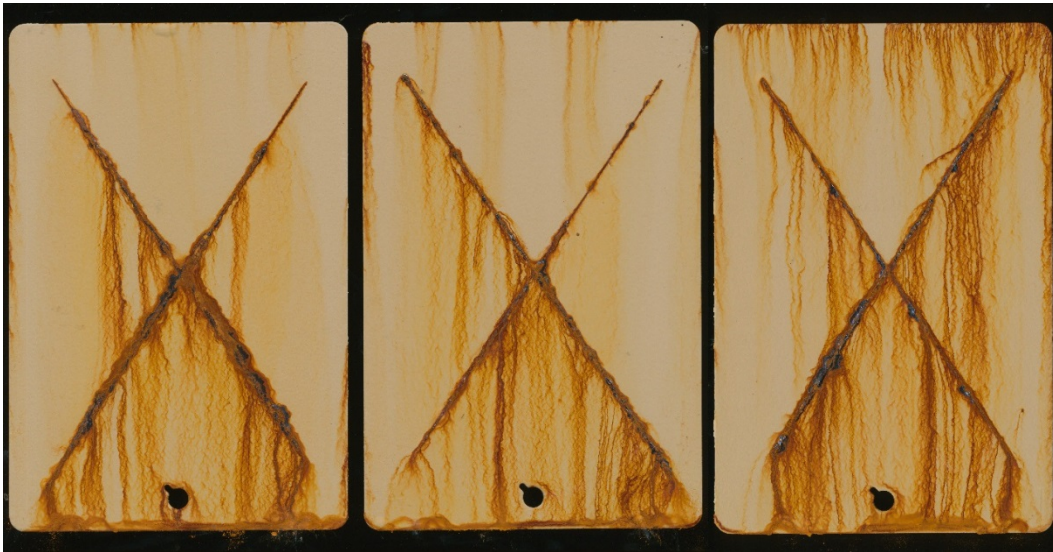
Fig. 13 Bonderite M-NT-7400 rated a 6 on steel panels with MIL-DTL-53030 at 1008 h

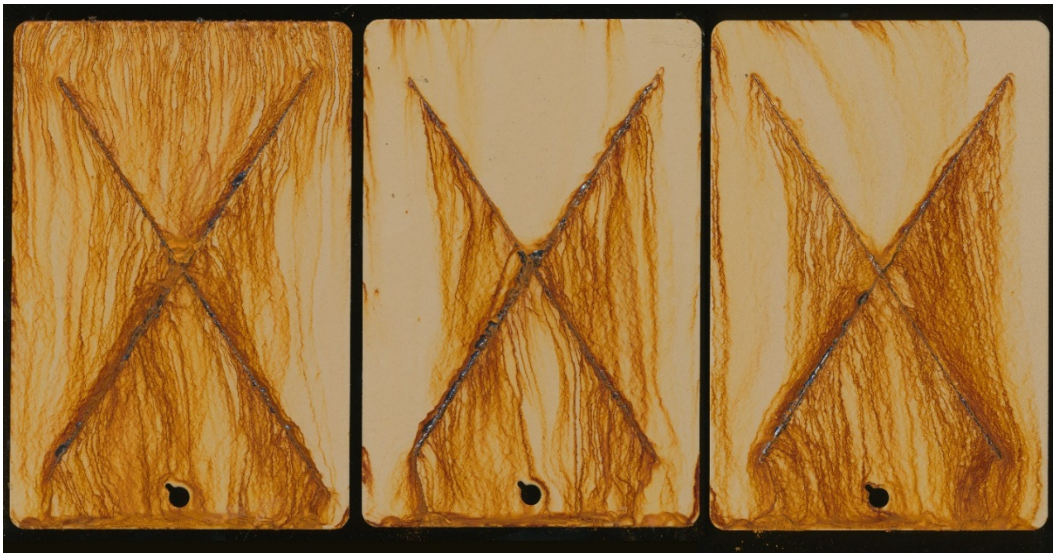
Fig. 14 DOD-P-15328 rated a 6.2 on steel panels with MIL-DTL-53030 at 1008 h

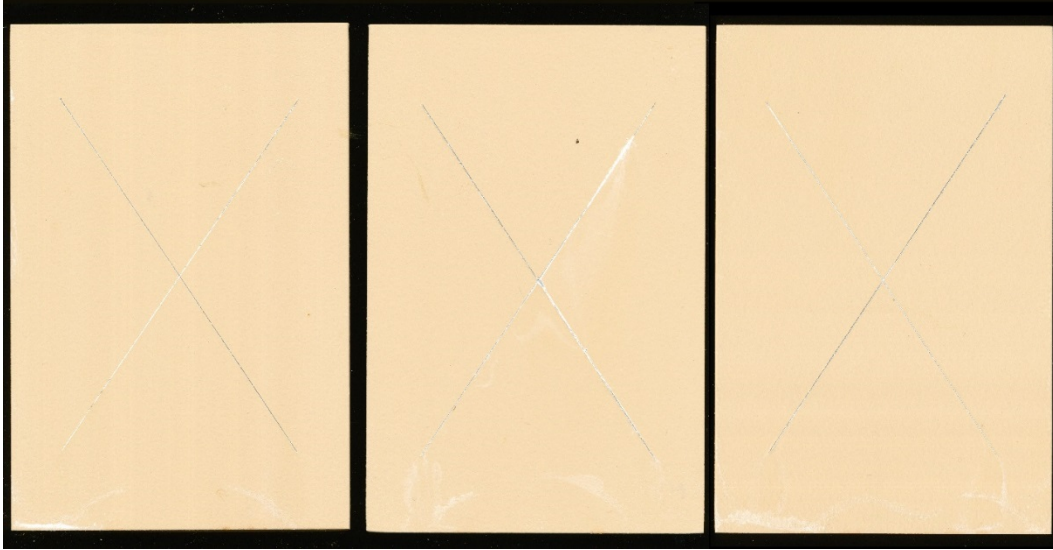
Fig. 15 Bonderite M-NT-7400 rated a 9 on Al panels with MIL-DTL-53030 at 1000 h

Figures 15 and 16 are photographs of MIL-DTL-53030 panel sets through 1008 h. At 1008 h, both the ratings and photographs show that the Bonderite M-NT-7400 compares very well with the baseline wash primer on steel and aluminum. The Picklex shown in Fig. 17 rated 0.0, and along with AC-10, showed early catastrophic failures starting after 72 h.

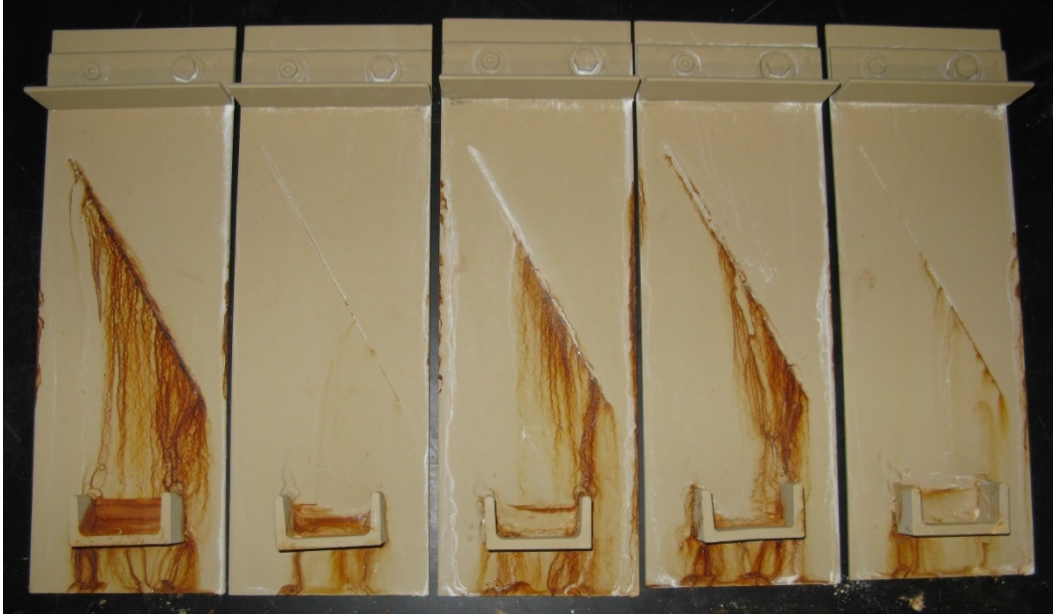
Fig. 18 Bonderite M-NT-7400 on multimetal panels with MIL-DTL-53022 after 1008 h

An example of the performance of Bonderite M-NT-7400 versus the baseline wash primer can be seen in Figs. 18 and 19. Although the success criteria were met after 336 h of ASTM B117 exposure, these photographs were taken after 1008 h. Despite the Bonderite M-NT-7400 samples showing significantly more staining and edge corrosion, there is less undercutting at the scribe on average than the wash primer. The chromate in the wash primer is clearly affecting the appearance of rust staining as seen here and on the other alternatives. The coating adhesion provided by the Bonderite M-NT-7400 resists the undercutting better than the wash primer.

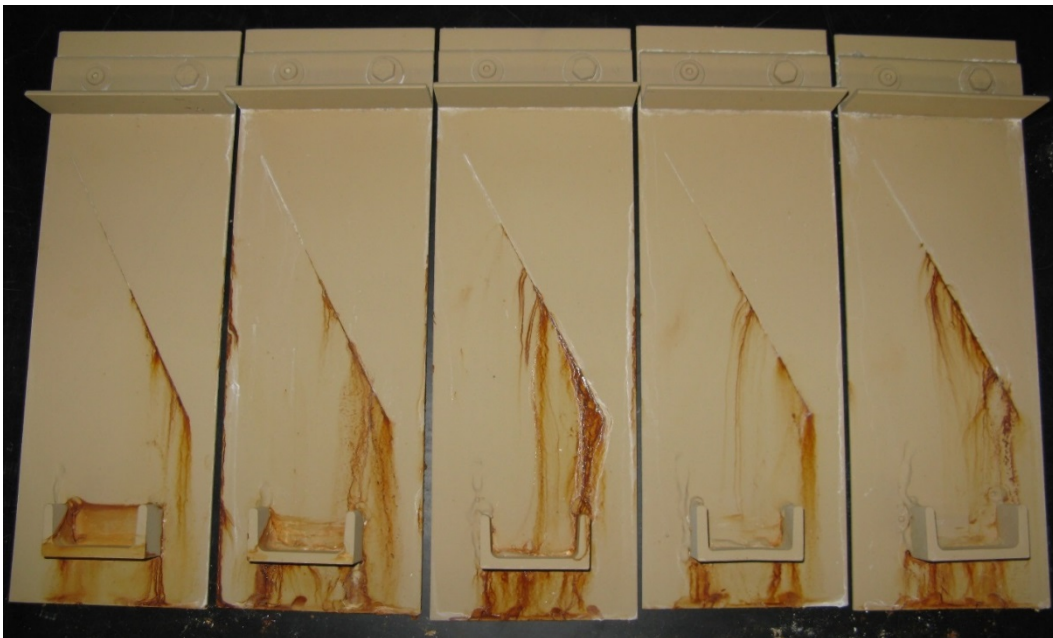
Fig. 19 DOD-P-15328 on multimetal panels with MIL-DTL-53022 after 1008 h

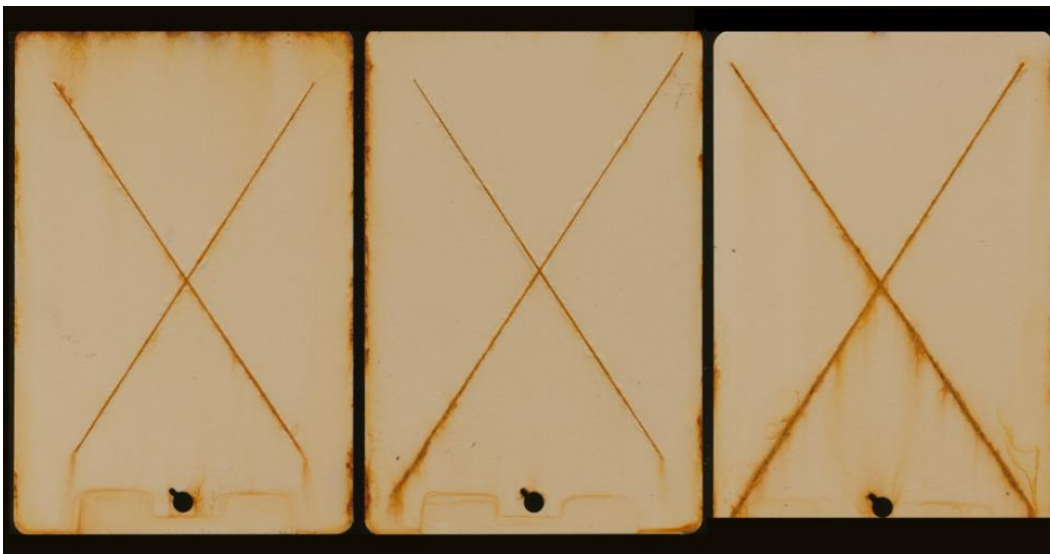
Fig. 21 Bonderite M-NT-7400 on CRS primed with MIL-DTL-53030 after 80 cycles

Figures 20–25 illustrate the performance of the 2 alternatives that met the success criteria for GM9540P relative to the baseline wash primer. After the panels were exposed to 80 cycles and subsequently scraped, it is difficult to discern any difference in performance.

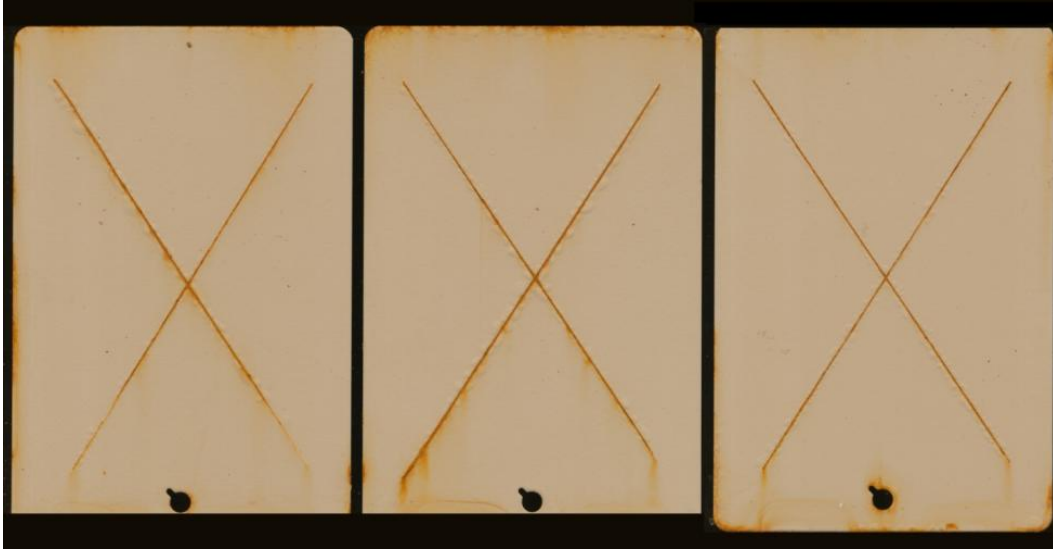
Fig. 22 Ecosil 5-1 on CRS primed with MIL-DTL-53022 after 80 cycles

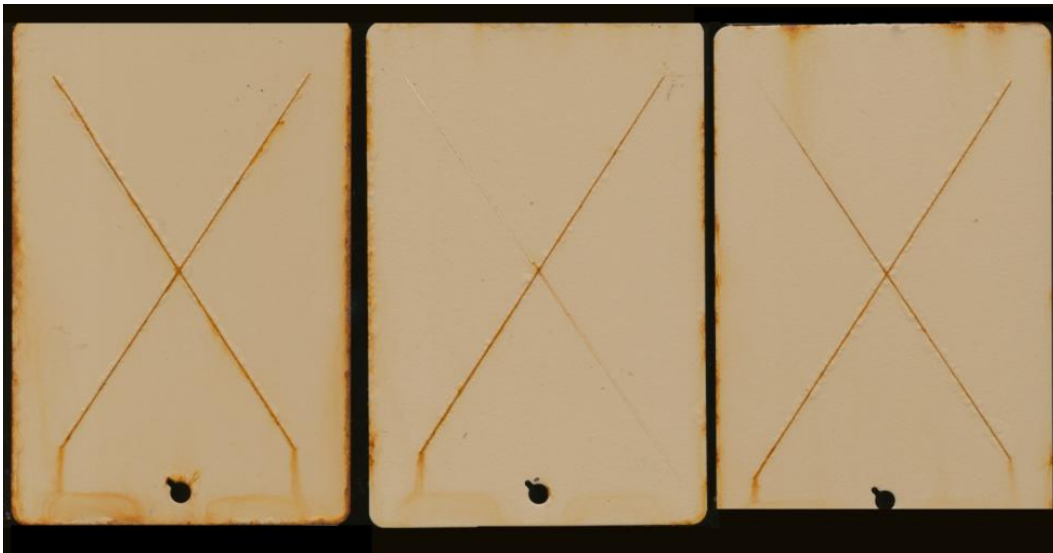
Fig. 23 Ecosil 5-1 on CRS primed with MIL-DTL-53030 after 80 cycles

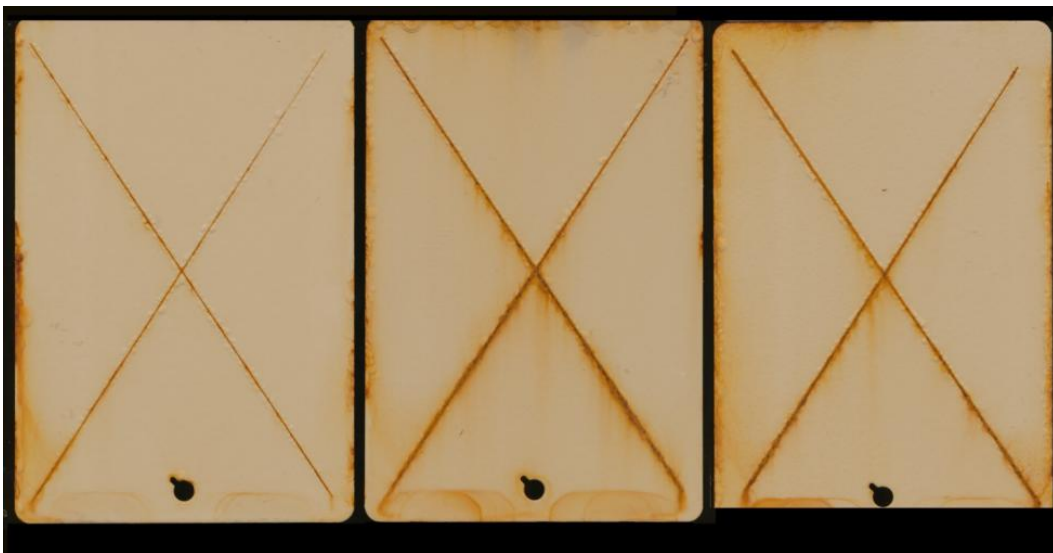
Fig. 25 DOD-P-15328 on CRS primed with MIL-DTL-53022 after 80 cycles

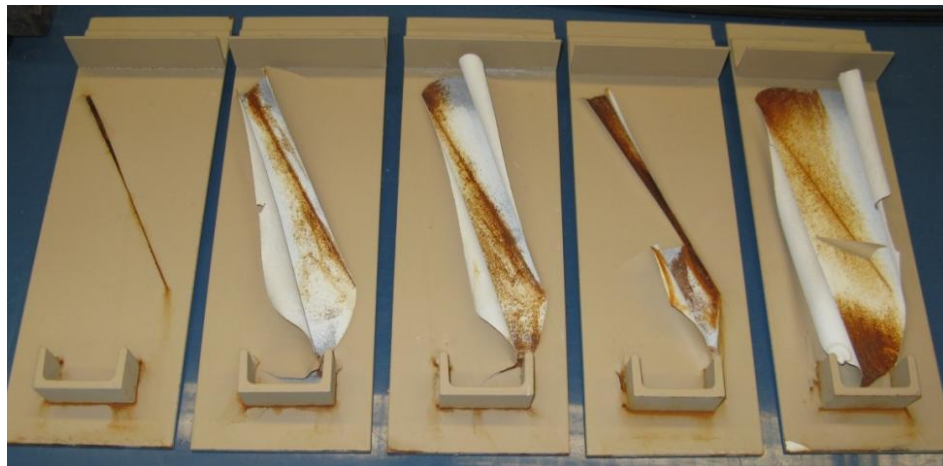
Fig. 32 NCP nonchromate wash primer multimetal panels delaminating after 3 cycles

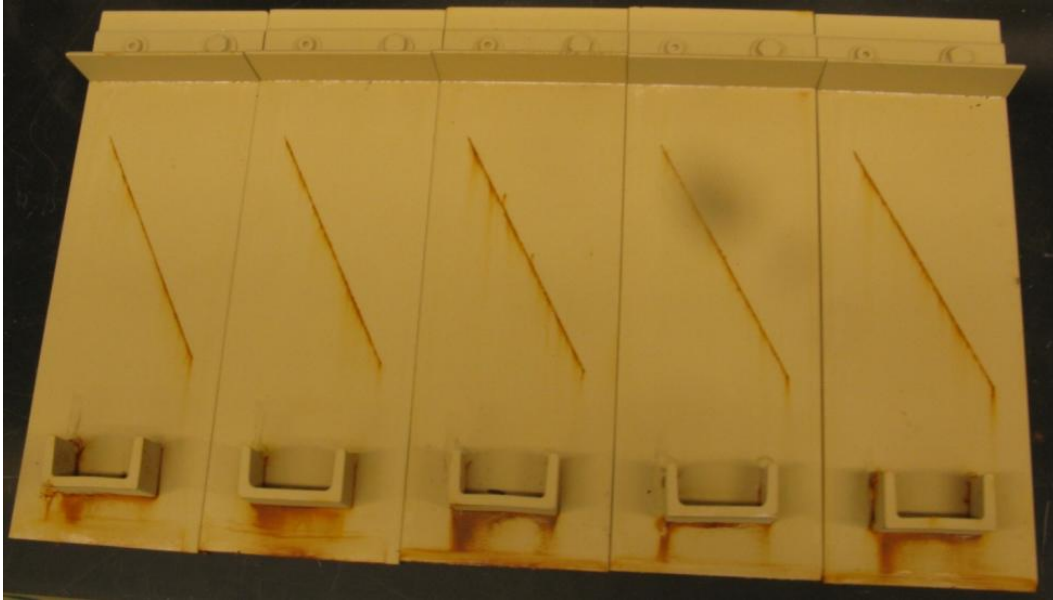
Fig. 34 Bonderite M-NT-7400 on multimetal panels primed with MIL-DTL-53030 after 80 cycles

Figures 33–38 show the multimetal galvanic test specimen after 80 cycles. One can clearly see the superior corrosion protection provided by the MIL-DTL-53030 type IV versus the MIL-DTL-53022 type II primer. Examining only the MIL-DTL-53022 type II specimens, it is evident that there is less blistering along the scribes of the Bonderite M-NT-7400 specimens than on the baseline wash primer or the Ecosil 5-1 specimens. However, there is noticeably more delamination at the aluminum “L” bracket for Bonderite M-NT-7400 and Ecosil 5-1 than is seen on the baseline wash primer. Note that the MIL-DTL-53030 shows no delamination at the aluminum angle bracket.

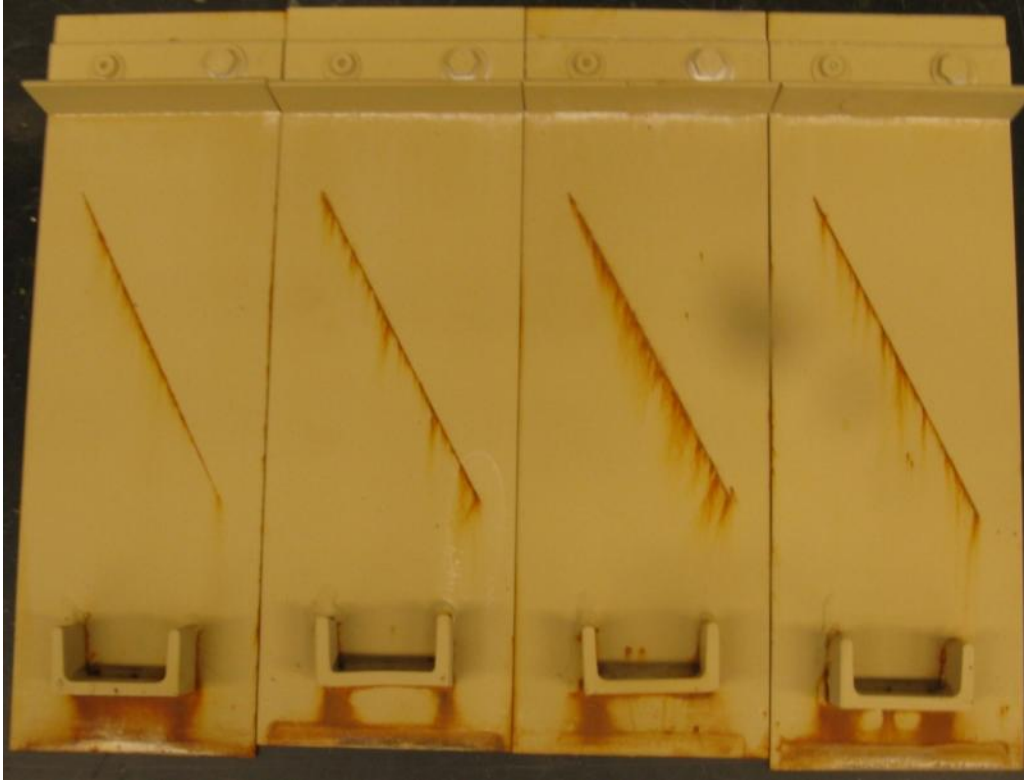
Fig. 36 Ecosil 5-1 on multimetals panel primed with MIL-DTL-53030 after 80 cycles

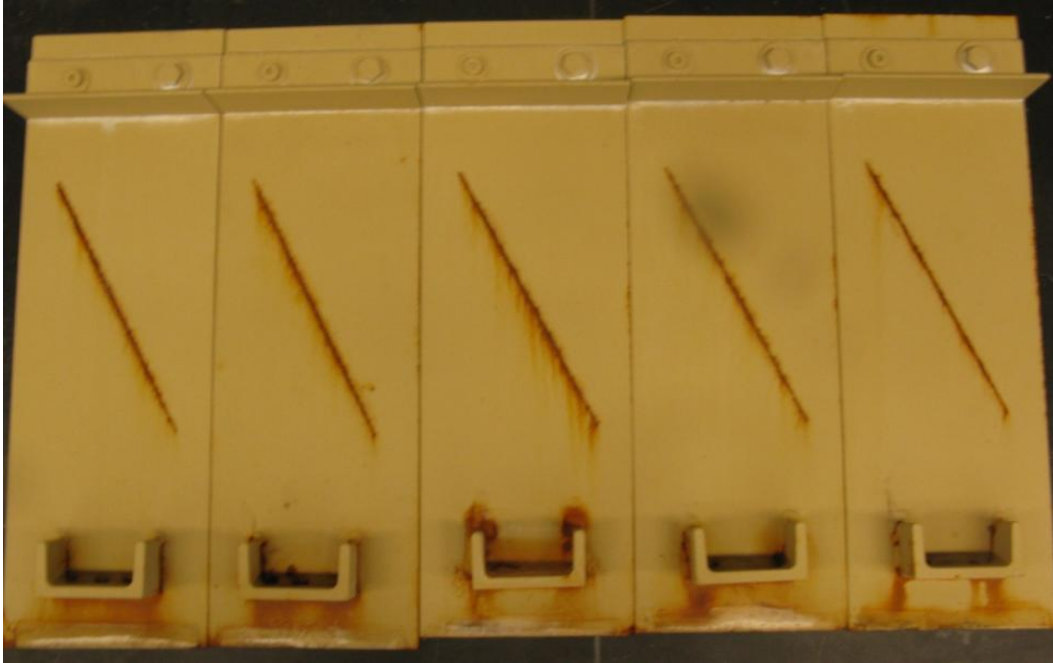
Fig. 38 DOD-P-15328 on multimetal panels primed with MIL-DTL-53030 after 80 cycles

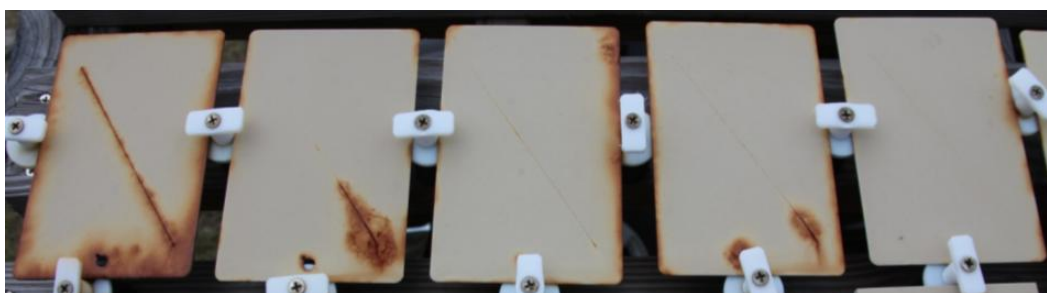
Fig. 39 Bonderite M-NT-7400 on CRS primed with MIL-DTL-53022 after 2 years

Figures 39–42 are presented as a visual comparison of the Bonderite M-NT-7400 versus the baseline wash primer on CRS test panels. These panels do not have an abrasive blasted profile and are a relatively smooth milled finish. Bonderite M-NT-7400 had markedly better performance than the baseline with MIL-DTL-53022. Although performance was also better with MIL-DTL-53030, there is far more undercutting of the coating along the scribe on the baseline wash primer samples.

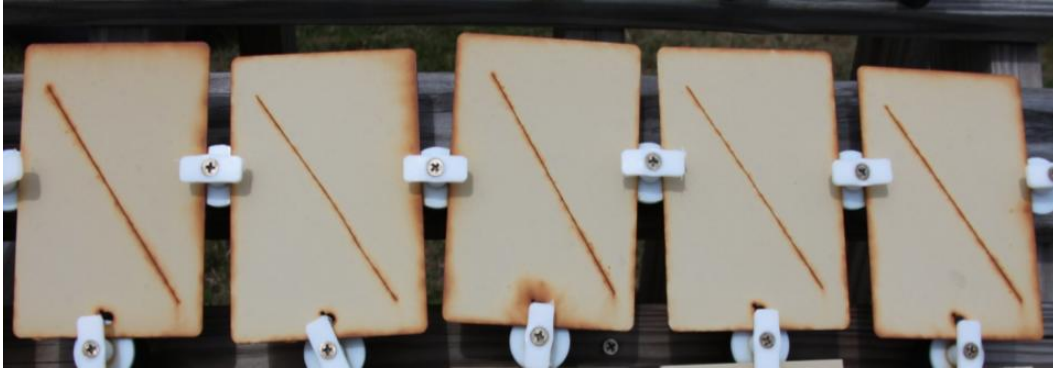
Fig. 40 Bonderite M-NT-7400 on CRS primed with MIL-DTL-53030 after 2 years

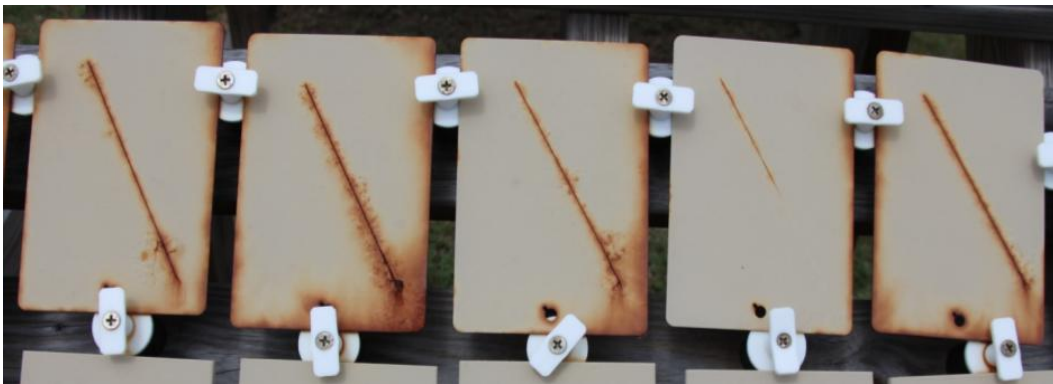
Fig. 41 DOD-P-15328 on CRS primed with MIL-DTL-53022 after 2 years

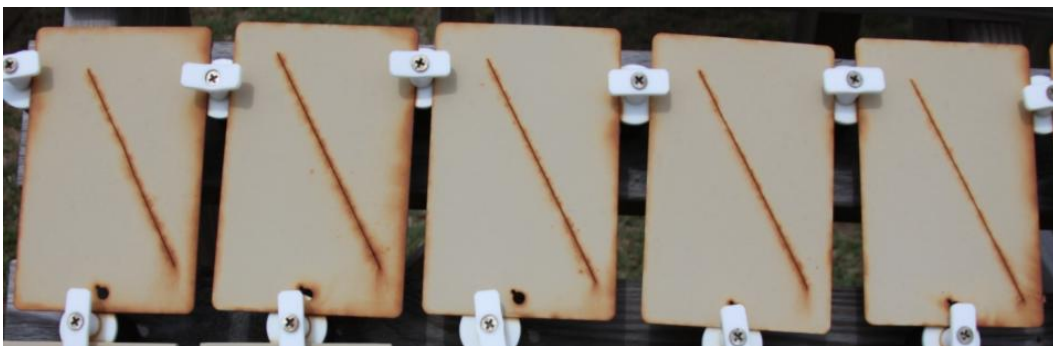
Fig. 42 DOD-P-15328 on CRS primed with MIL-DTL-53030 after 2 years

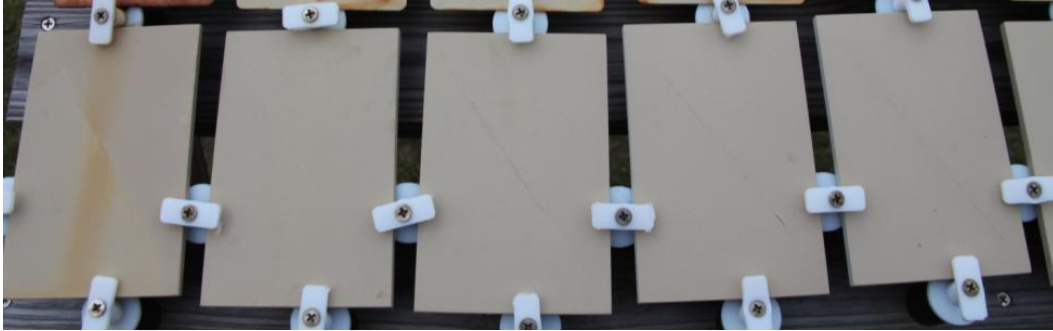
Fig. 44 Bonderite M-NT-7400 on aluminum primed with MIL-DTL-53022 after 2 years

Figures 44–47 are presented as a visual comparison of the Bonderite M-NT-7400 versus the baseline wash primer on aluminum test panels. Small areas along the scribe were detected with the recital and measured to arrive at the ratings. However, no significant difference can be discerned visually.

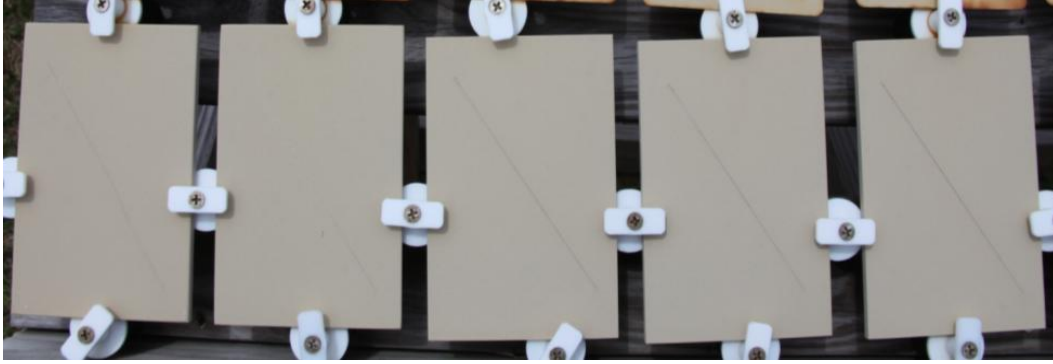
Fig. 47 DOD-P-15328 on aluminum primed with MIL-DTL-53030 after 2 years

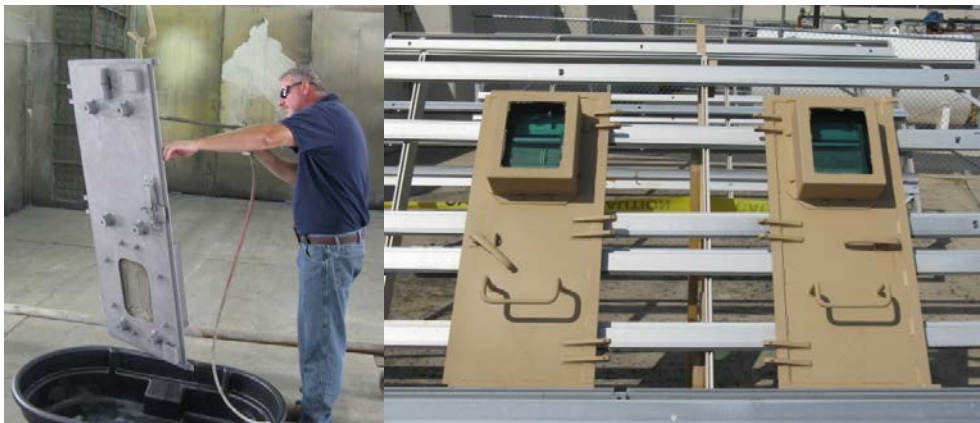
Fig. 48 MRAP door being treated with Oxsilan 9810/2 (left); painted doors on outdoor exposure racks at ARL (right)

After pretreatment is fully dry, the doors were primed and painted side-by-side with MIL-DTL-53022 type II primer and top-coated with MIL-DTL-53039. Once the CARC system was cured, the doors were transported to ARL's Rodman Laboratory, Building 4600, where they were placed outside on exposure test racks beginning in August of 2012 (Fig. 48). This outdoor exposure site lacks an individual weather station, so specific weather data were not collected. However, the corrosion rate is approximately 0.04 mpy. APG can provide weather data when requested.

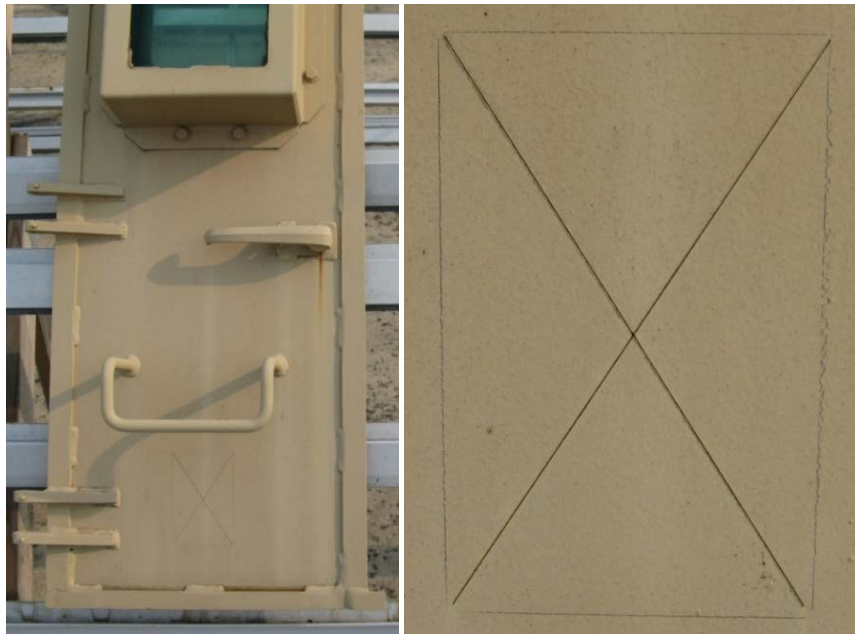
Fig. 49 MRAP door with Oxsilan 9810/2 after 2 years with close-up of scribed area

and 50 show the 2 MRAP doors after 2 years of outdoor exposure at APG. Understandably, APG is not as aggressive as Cape Canaveral; however, the relative performance of the Oxsilan 9810/2 versus the baseline wash primer can still be quantitatively measured. Table 21 lists the ASTM D1654 ratings over the past 2 years. There is no difference in the corrosion present on the doors or along the scribes so far. Exposure at APG will likely take longer for significant corrosion to occur.

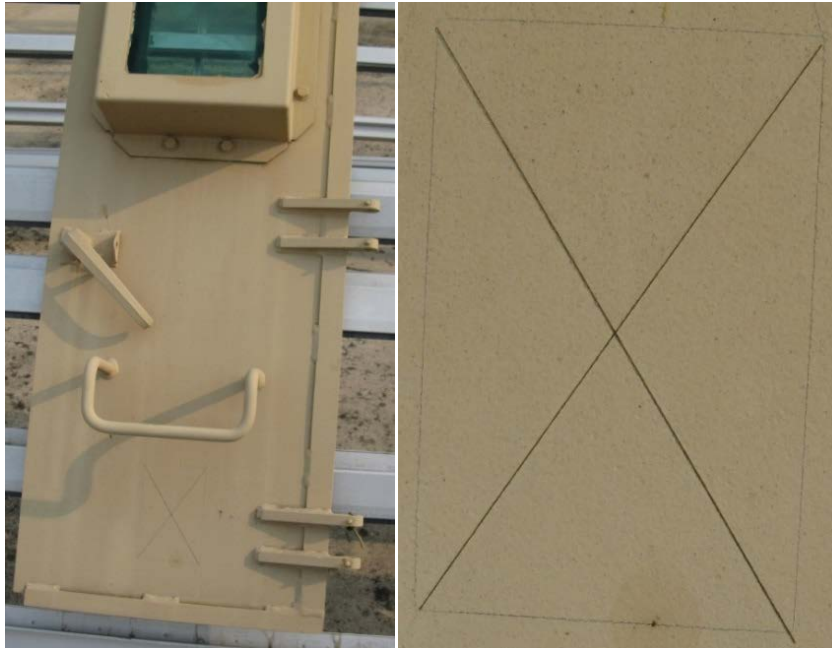
Fig. 50 MRAP door with DOD-P-15328 WP after 2 years with close-up of scribed area

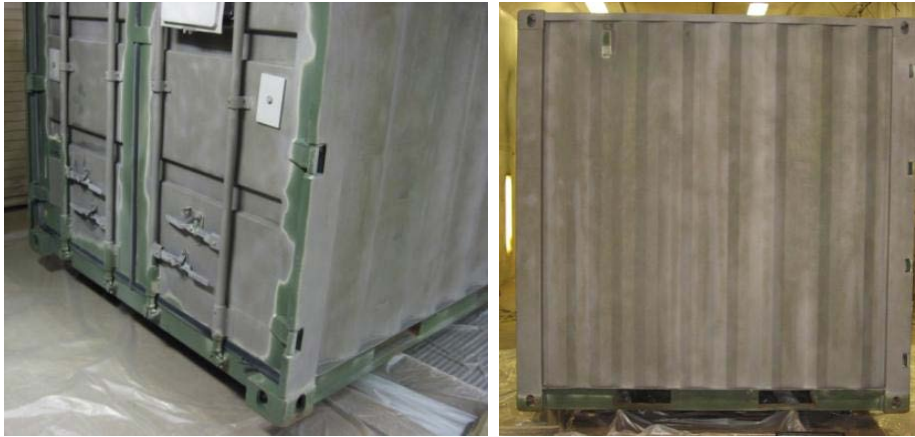
Fig. 51 Abrasive blasted tricon before (left) and after (right) Bonderite M-NT 7400

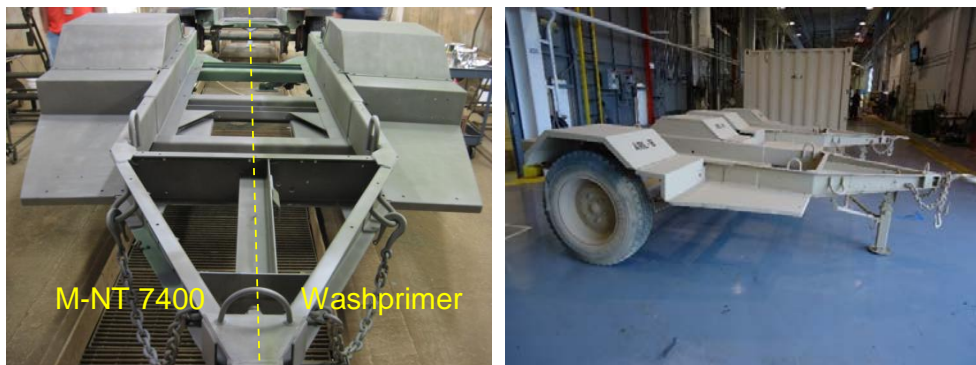
Fig. 52 M200A1 trailer with split pretreatments (left) and with full CARC system (right)

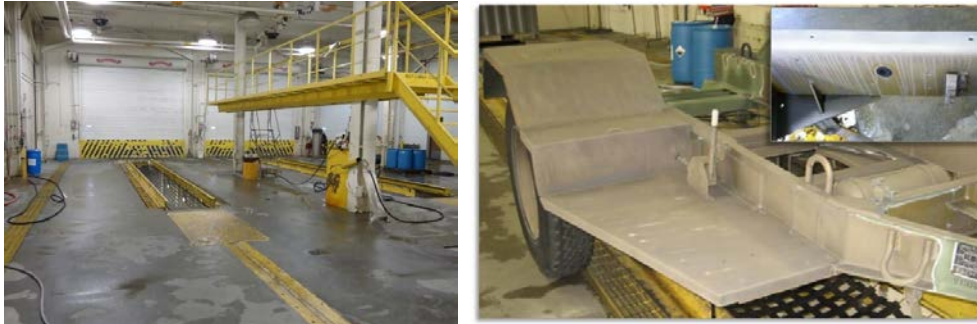
Fig. 53 Wash bay at LEAD (left) and M200A1 trailer (right) treated with Oxsilan 9810/2 showing what appears to be slight flash rust in some areas

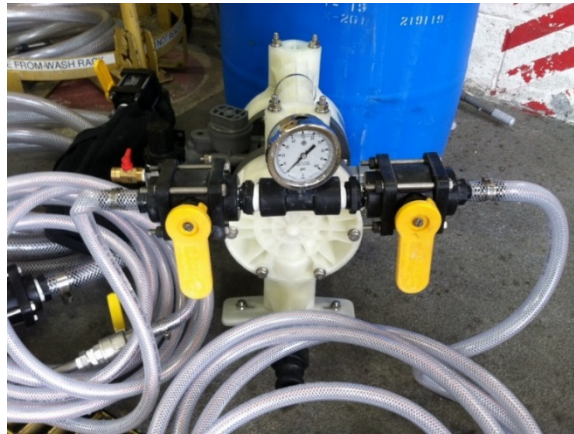
Fig. 54 GPM pump provided by Chemetall for application of Oxsilan 9810/2

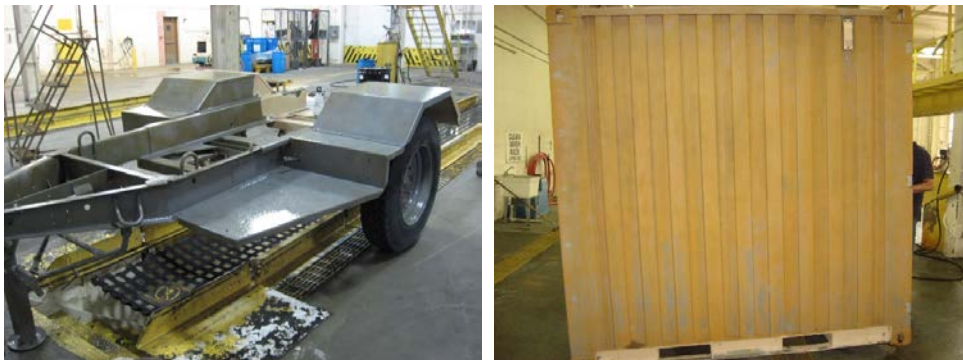
Fig. 56 M200A1 trailer during treatment (left) and container dry following treatment (right) with PPG 11-TGL-27

This product was provided by PPG in place of the previously tested Zircobond 4200. PPG indicated that the 11-TGL-27 was a reformulation of the 4200 specifically geared toward spray application. The 11-TGL-27 was provided ready-to-use by PPG and was agitated prior to application using a squirrel cage mixer attached to a portable drill. Application was performed using a standard HVLP spray gun. A 5-min dwell time was required before an initial post-rinse using the facility tap water, followed by a final post-rinse in DI water (provided by PPG). The assets were blown dry with shop air, with particular attention given to the areas susceptible to puddling. As the assets dried, evidence of flash rusting was observed, which can be seen in Fig. 56. Figure 57 shows the results of a tape pull test on the treated M200A1 trailer. LEAD personnel continued to paint the assets; however, it was decided that if the pretreatment appears to be causing flash rust, the demonstration would be considered a failure and no further observations would be made. Regardless of the performance results of the PPG 11-TGL-27, it would be difficult to persuade a user to adopt a process that leaves even an appearance of flash rusting to the degree that was observed here.

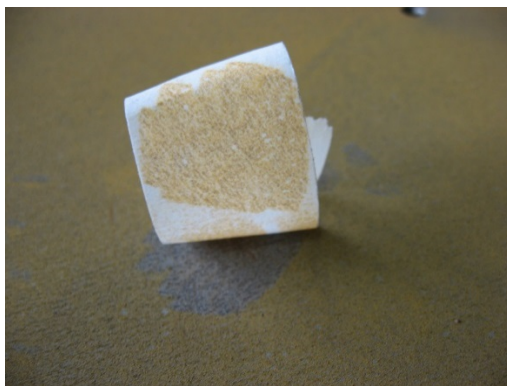
Fig. 57 Result of masking tape pull on dried PPG 11-TGL-27 treated assets

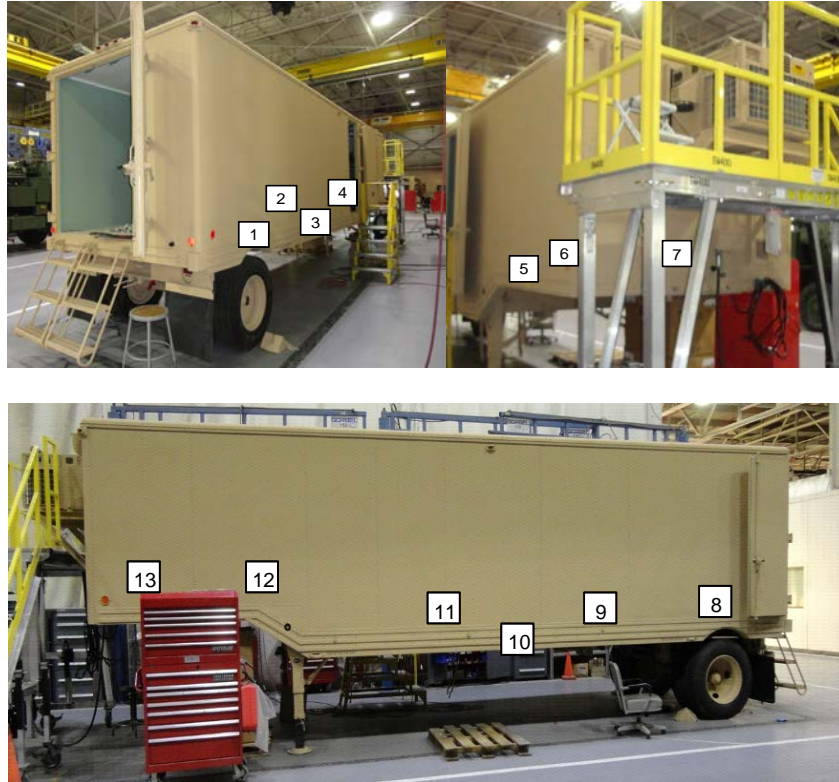
Fig. 63 The M373A2 trailer pretreated with baseline DOD-P-15328 wash primer and complete CARC system. The numbers indicate where adhesion tests were performed.
