DEMONSTRATION REPORT

Underwater Advanced Time-Domain Electromagnetic System

ESTCP Project MR-201313

Mr. Steve Saville
CH2M

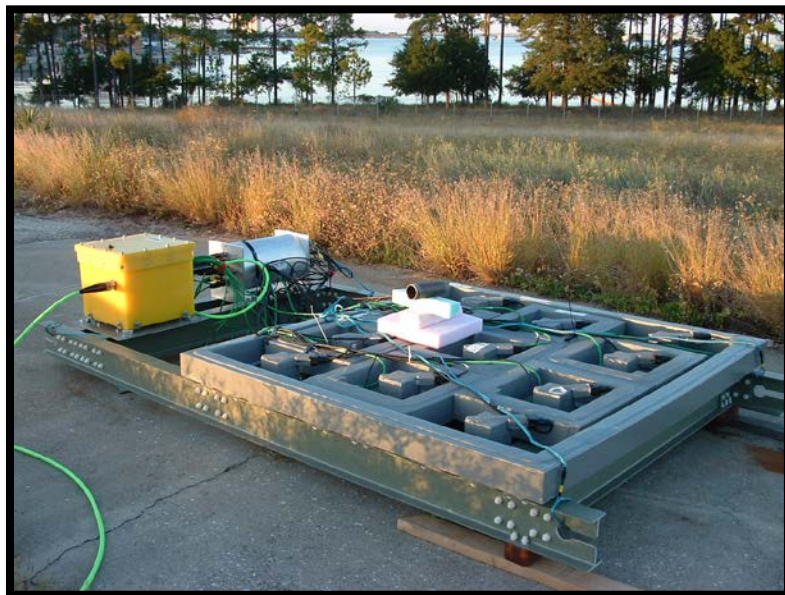
Figure 2. Photograph of Underwater Advanced Time-Domain Electromagnetic System

The system designed and constructed under this project has been described in detail in prior documents, titled *Modeling for Underwater Advanced Time-Domain Electromagnetic System* (June, 2014), *Underwater Advanced Time-Domain Electromagnetic System Design* (July, 2015), and in the *Underwater Advanced Time-Domain Electromagnetic System Evaluation Plan* (October, 2016). A diagram of the system, as tested, is provided as **Figure 1**. A photograph of the system is provided as **Figure 2**.

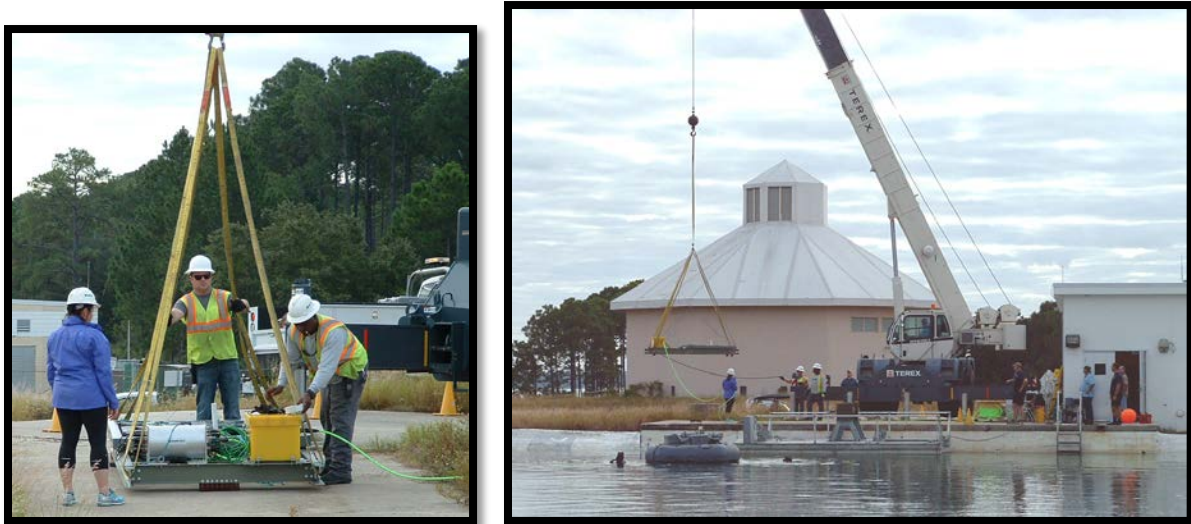
NSWCPCD provided a crane (see **Figure 5**), operator, and riggers for deployment of the system into and out of the pond, an inner-tube shallow water lift system with a 2500lb lift capacity crane (see **Figure 6**), and a team of divers to maneuver the inner-tube and the system.

Figure 5. Crane provided by NSWPCD for transfer of system from land into water.

The array was easily deployed into the pond using the crane and maneuvered in the water using the inner-tube shallow water lift system (donut) and winch. The divers provided some feedback with respect to modifications, such as handles on the frame, holes in the base of the system for visibility to the bottom, cable management, and improvements to the attachment mechanism for the ropes used to deploy the system with the crane and winch.

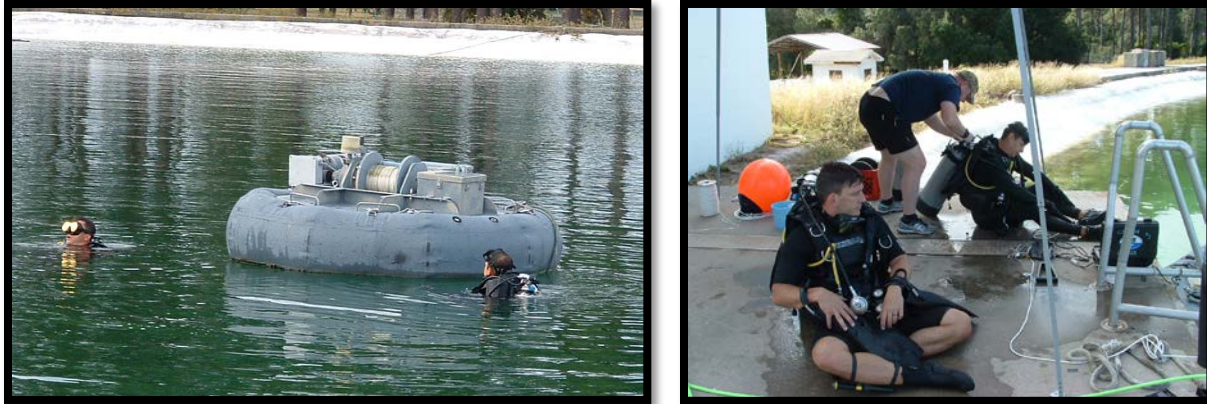
Figure 6. Inner-tube shallow water lift system and dive team for maneuvering system from within the water.

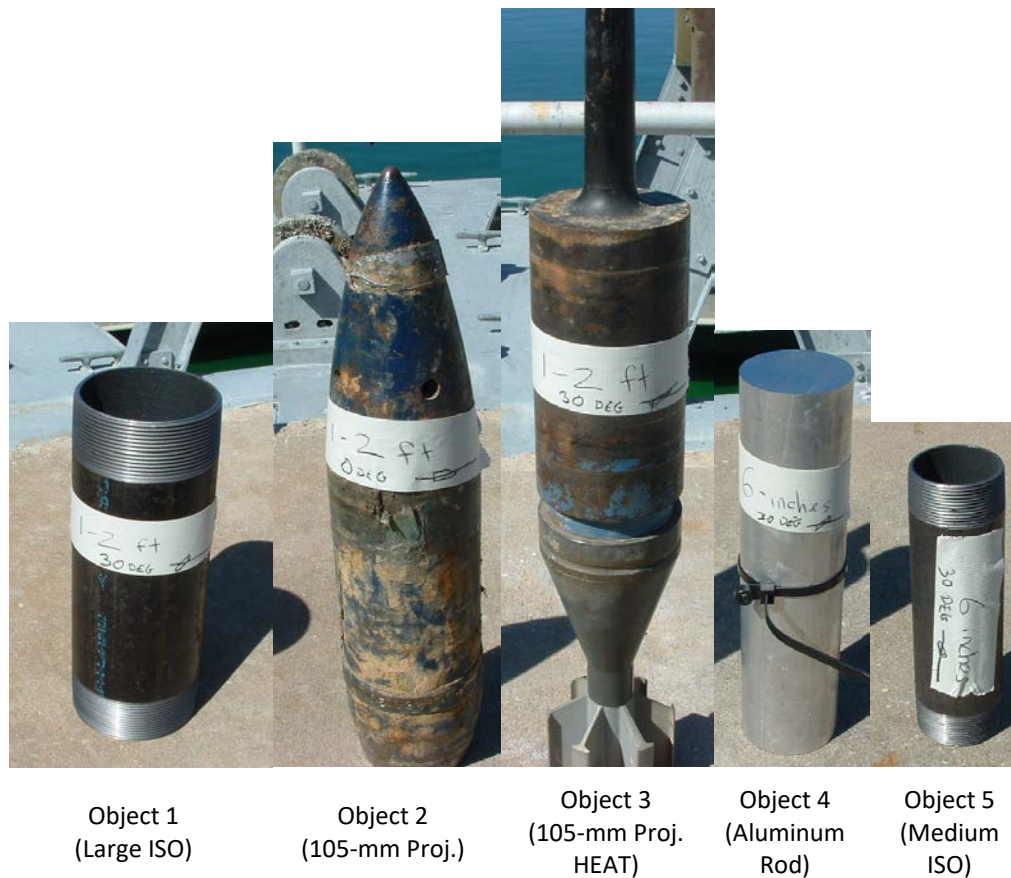
Figure 8. Photographs of test objects prior to burial. (Intended burial depths and orientations relative to the centerline of the test strip were marked on the objects.)

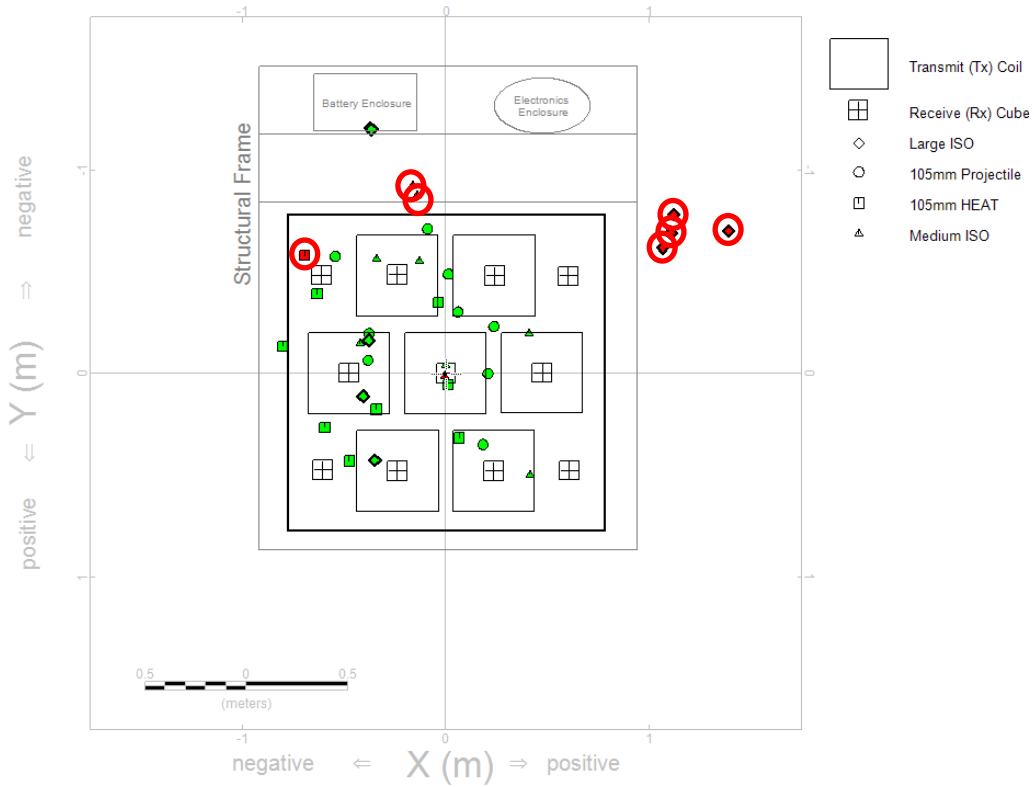
For the most part the measurements produced good fit quality and polarizabilities which were good matches to the library polarizabilities. The true target locations relative to the array are unknown; however, the board tests, discussed in the previous section, indicate an expected match of fit locations to within a few cm of the true target locations. To the extent that the fit locations reflect the actual target location, it appears that most of the time the array was positioned reasonably well over the target. With decent fit quality poor library matches typically occurred for targets outside the array footprint, as illustrated by **Figure 18**. The target locations in which the fit quality was okay but the match to the corresponding library item was less than 0.9, are circled on the figure. One of the medium ISO measurements (O5-6-1) did not converge to an acceptable fit using one or two dipole fit models and the library match failed; visual inspection of the data suggests that the array was not actually over the target and this is a bad

measurement. This measurement is represented by the red triangle at the center of the plot. Only two measurements (O1-3-1, O1-3-2) which fit to locations well outside the array footprint (near X = -0.4, Y = -1.2) had good (> 0.9) library matches. They are both measurements on the large ISO taken during the first sequence.

Figure 18. Buried target fit locations for ISOs and inert munitions. Green locations indicate >0.9 library match and red indicate <0.9. Circled locations indicate where the fit quality was good (>0.5) but the match to the corresponding library item was <0.9.
