FINAL REPORT

Rapid Assessment of Remedial Effectiveness and Rebound in Fractured Bedrock

ESTCP Project ER-201330

OCTOBER 2017

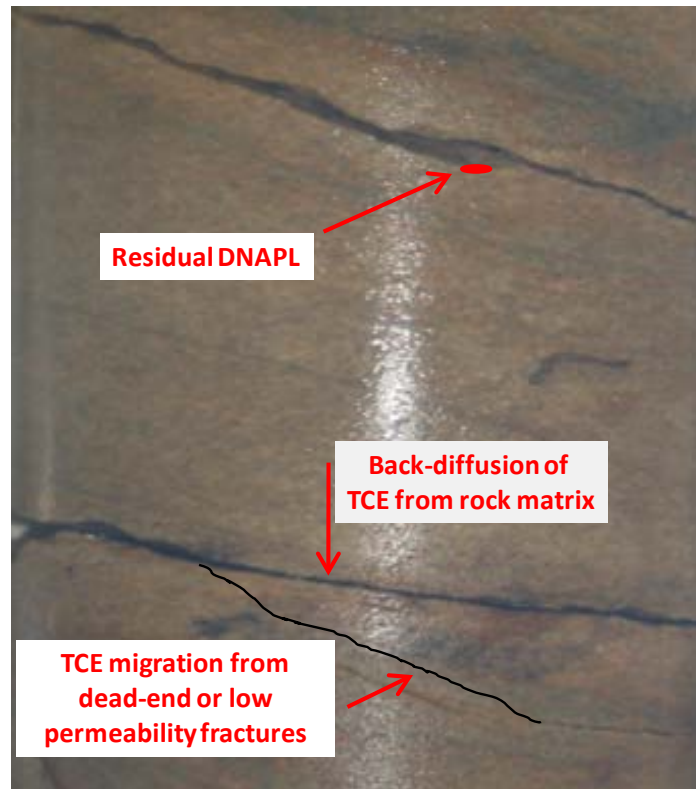
Figure 2.1. Illustration Showing Possible TCE Rebound Mechanisms in Fractured Bedrock.

There are many mechanisms that can contribute to contaminant rebound and sustained groundwater impacts in fractured bedrock aquifers. As illustrated in Figure 2.1 on the following page, these mechanisms include matrix back diffusion (Lipson et al., 2005; Sterling et al., 2005; West and Kueper, 2010), slow migration of contaminants from small or microfractures (USEPA, 2006), and/or the presence of DNAPL (Schaefer et al., 2012). For many sites, it is difficult to determine which of these mechanisms is responsible for the observed rebound (if rebound occurs), as the complexities associated with the flow field, aperture distribution, and contaminant distribution within the bedrock aquifer are difficult to quantify. Furthermore, many pilot tests are impacted from upgradient sources that migrate into the treatment area prior to evaluating rebound mechanisms, thereby preventing proper assessment of rebound during the post-injection period of the pilot test. The ability to isolate the treatment area to eliminate upgradient impacts would improve the ability to assess remedial effectiveness during pilot tests. However, approaches for comprehensively and cost effectively characterizing fractured bedrock aquifers to quantify these impacts have hitherto not been demonstrated.

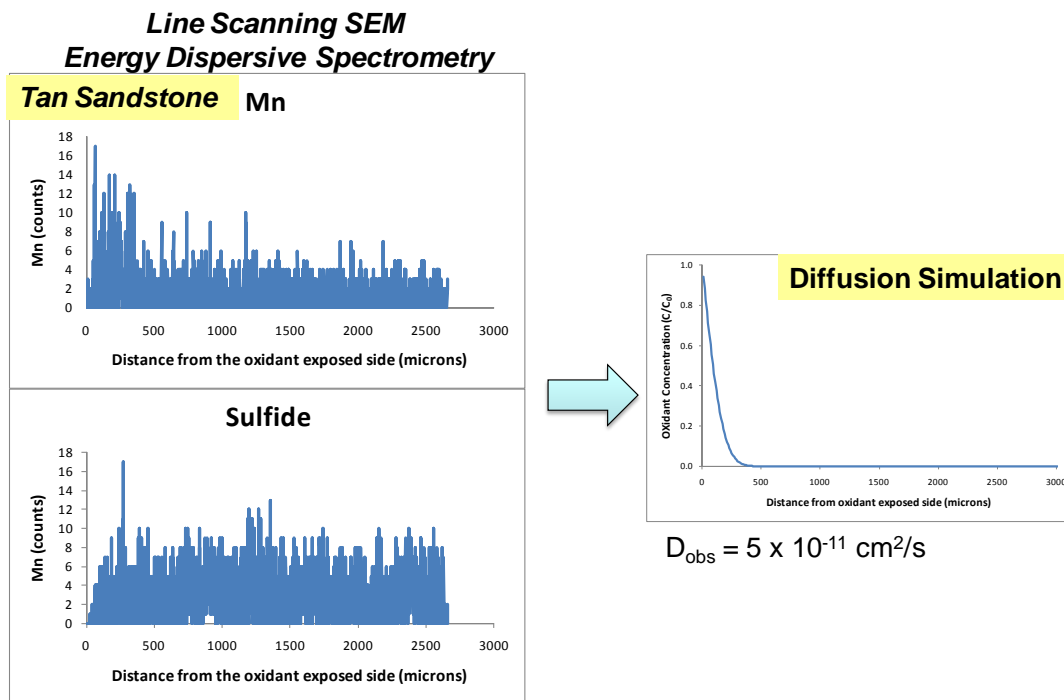
Figure 2.2. Diffusion of Permanganate into the Rock Matrix of a Tan Sandstone Collected from the Former Naval Air Warfare Center in Trenton, NJ (Huang et al., 2014).

Permanganate was in contact with the rock for 20 days. Line scanning SEM, which was able to show the diffusion profile via Mn deposition and sulfide depletion, showed that the oxidant migrated less than 400 microns into the rock. The observed diffusion coefficient was $5 \times 10^{-11} \text{ cm}^2/\text{s}$.

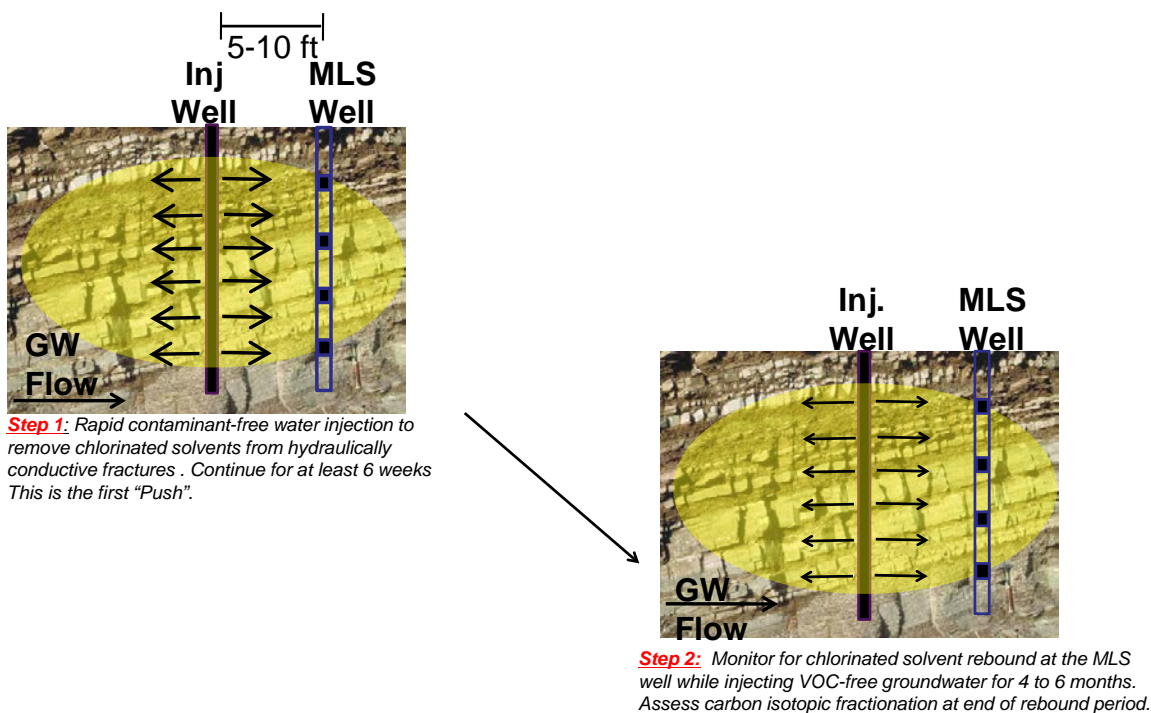
Figure 2.3. Conceptual Methodology for the Rapid Assessment Testing.

A conceptual diagram of the process is provided in Figure 2.3. The RA technique involves the use of two wells: a standard injection well and a multi-level sampling (MLS) well located approximately 5 to 10 feet downgradient of the injection well. In the first step of the test, either a chemical oxidant (e.g., permanganate) or uncontaminated water is injected into the injection well to rapidly remove PCE/TCE from the hydraulically conductive fractures. For the NAWC site, permanganate was used, where the permanganate was injected and allowed to incubate for several weeks prior to subsequent water injection to remove the permanganate. However, due to the difficulties associated with the oxidant, water flushing only was used in the subsequent test performed at CPP, as illustrated in Figure 2.3. This initial step of removing the chlorinated solvents from the hydraulically conductive fractures is the first injection phase of the test.

For simplicity of illustration, flow a simplified homogeneous flow regime is shown. The distance between the injection and MLS well may be increased depending upon the groundwater velocity, fracture connectivity, and fracture porosity. Initial efforts at NAWC employed the use of permanganate for step 1, where the permanganate was allowed to incubate in the fractures for several weeks prior to removal via water flushing.

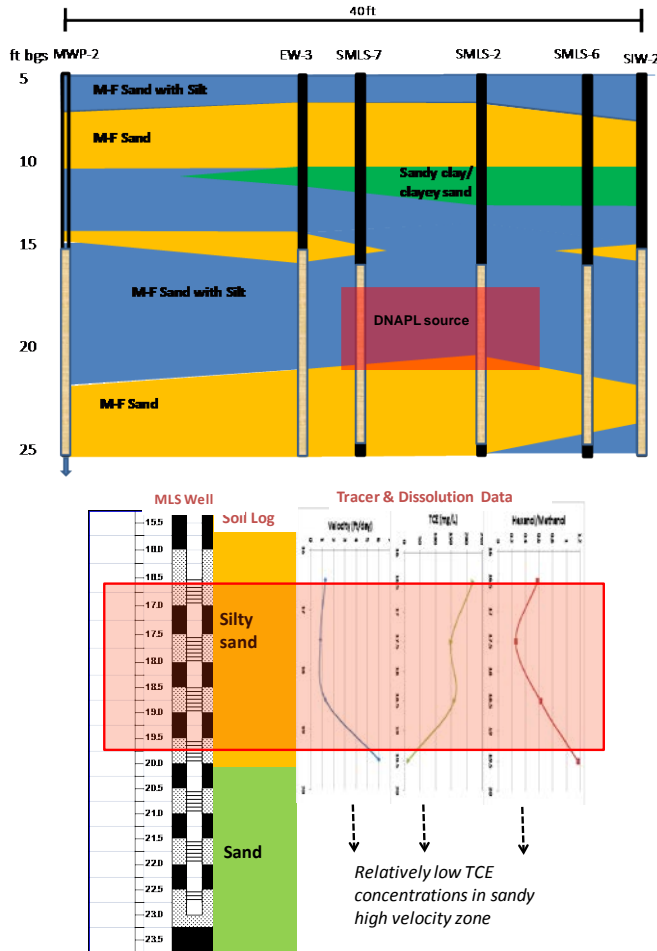
Conceptual cross section showing the TCE DNAPL source area at Alameda. Clean groundwater was recirculated through the system to enhance DNAPL dissolution using the injection and extraction wells that bounded the DNAPL source. Groundwater was passed through carbon to ensure that TCE-free groundwater was re-injected.

Using data from a single MLS well, along with results from conservative and partitioning tracer tests, a conceptual model for the system could be developed. DNAPL sources were located in the low flow zone, as indicated by tracer partitioning (low ratio of hexanol to methanol). Use of the MLS wells allowed the impacts of DNAPL dissolution on groundwater quality to be quantified, as VOC rebound was observed following recirculation.

Note that the use of the MLS well indicated that the groundwater velocity was much less, but the dissolved TCE concentrations were much greater, in the low permeability silty sand zone than in the underlying sand zone. The partitioning tracer test verified that DNAPL existed in the silty sand zone, which caused rebound in the sandy zone after the water flushing was completed. This work was performed with Professor Mike Annable as part of SERDP Project ER-1613.

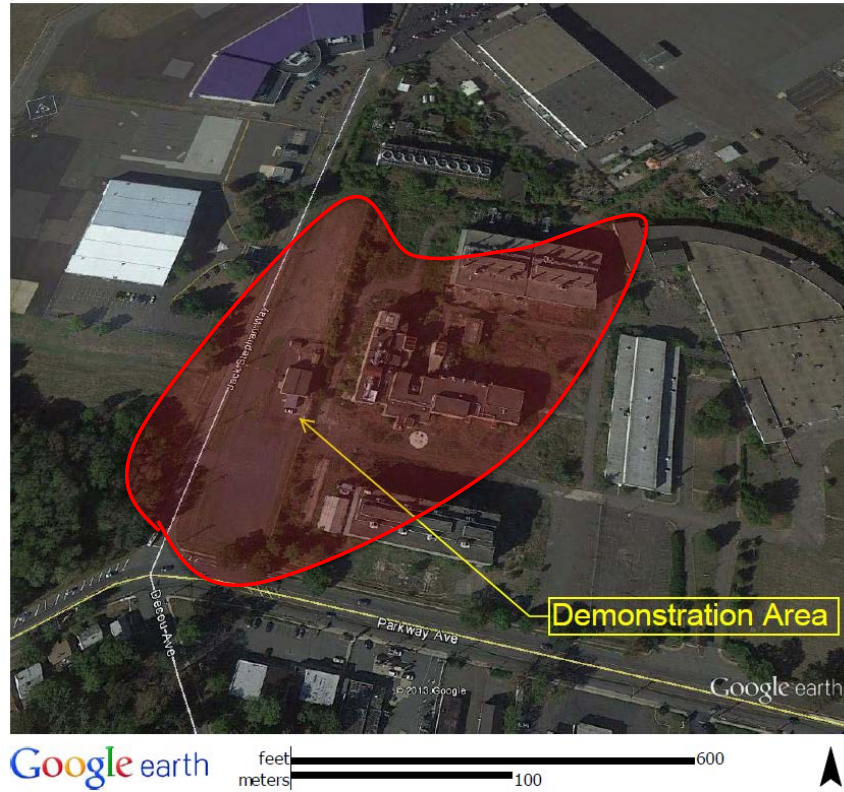
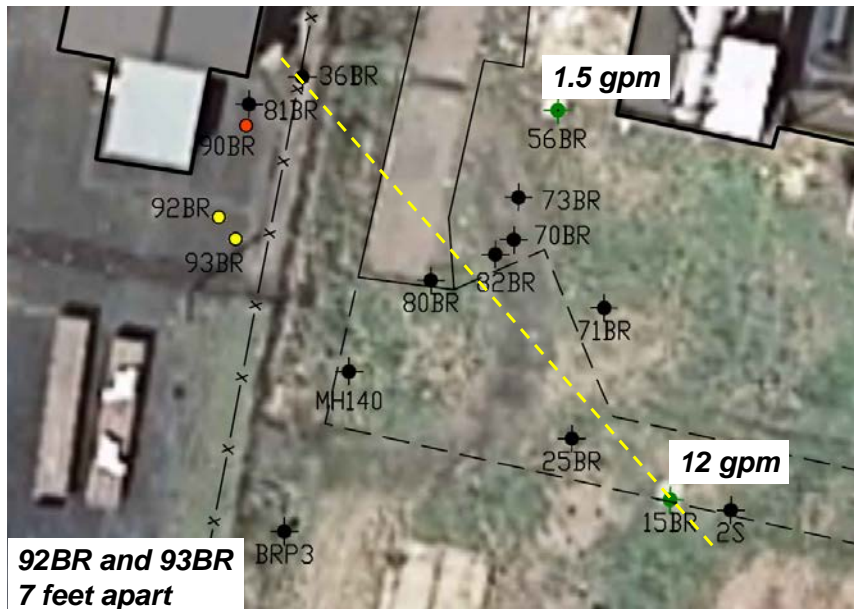
Figure 4.1. Demonstration Location at the NAWC Site.

The shaded area represents the bedrock TCE plume, where TCE is present at detectable concentrations (top). Demonstration wells (92BR and 93BR) and other local bedrock wells also are shown (bottom).

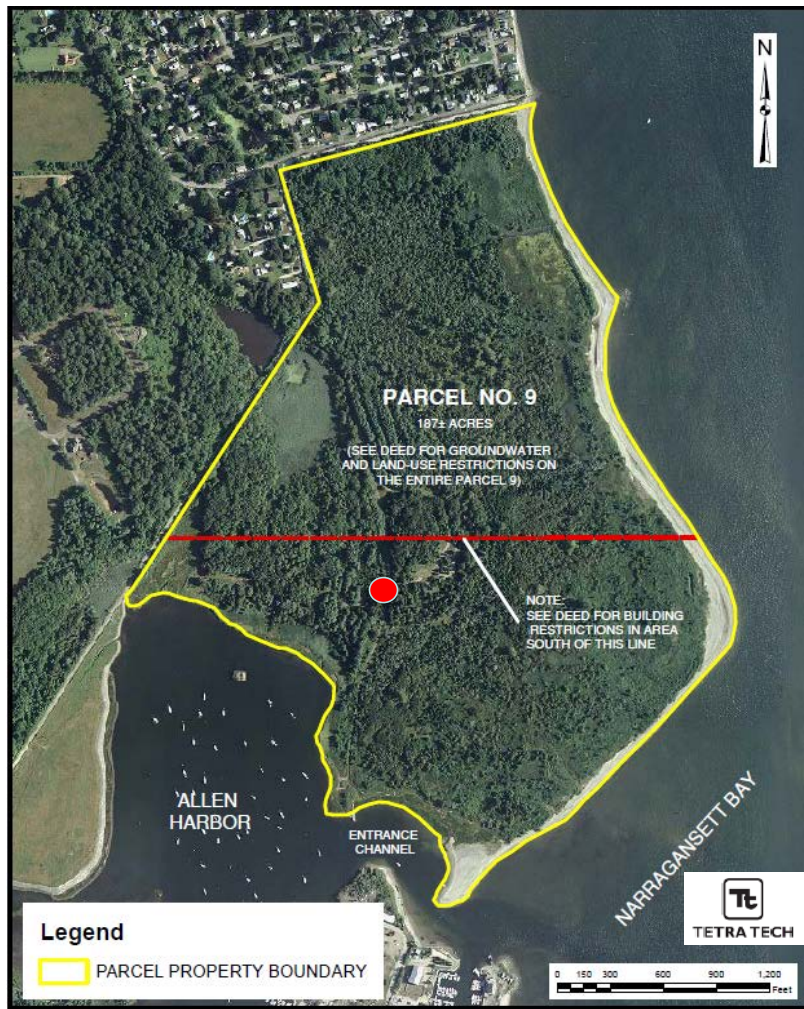
Figure 4.2. Demonstration Location at Calf Pasture Point.

The red dot shows the approximate location of the test wells.

The current remedy for the contaminated bedrock aquifer at Calf Pasture Point Site 07 is MNA. Thus, there were no remedial activities being performed in the portion of the site in which we performed the demonstration. The demonstration location is shown in Figures 4.2 and 4.3.

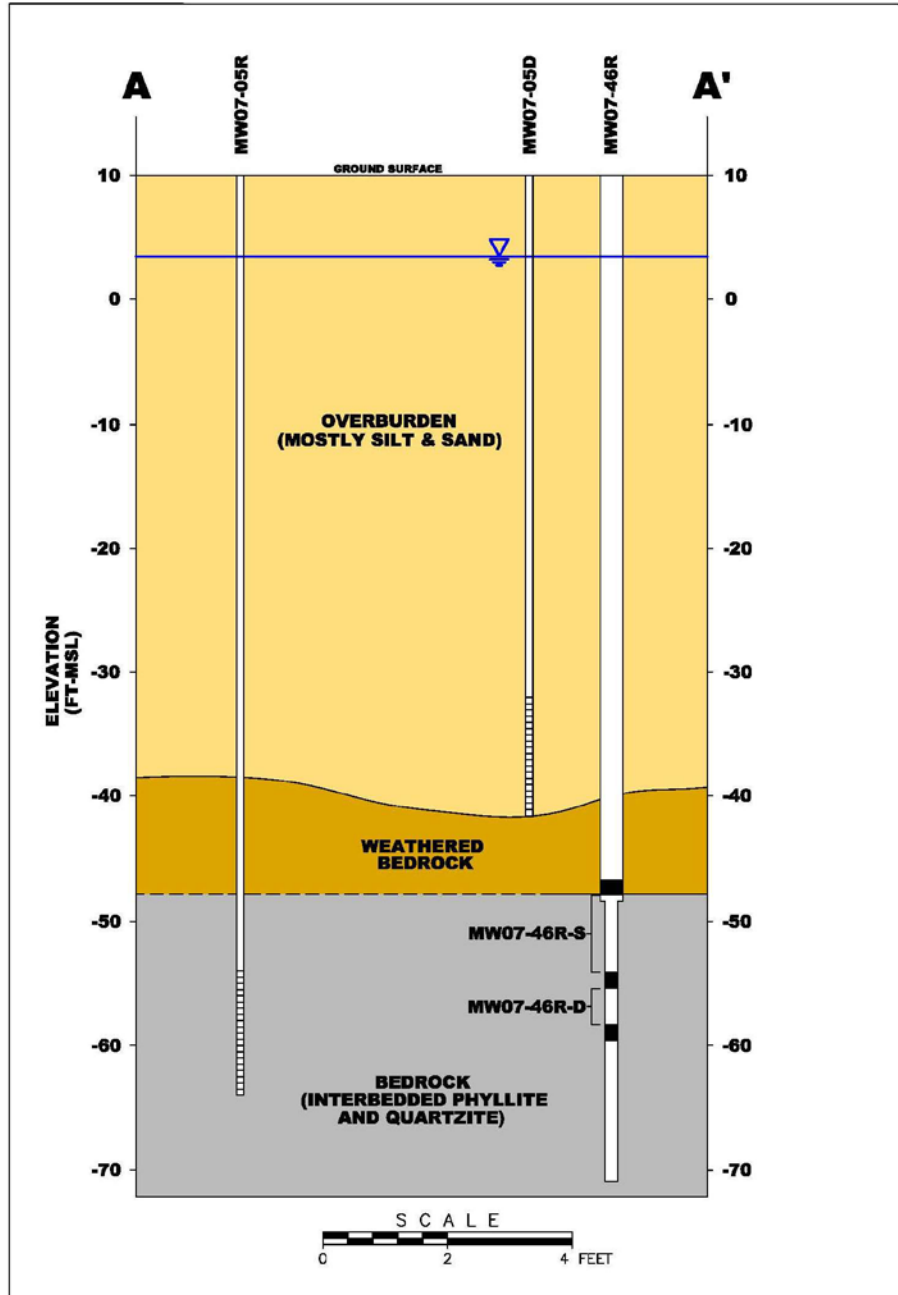
Figure 5.3. Generalized Geologic Cross Section of the CPP Demonstration Area.

The boring log for MW07-46R is provided in Appendix C, and indicates that the competent bedrock between 58.3 and 80.6 ft bgs consisted of interbedded quartzite and phyllite. A generalized geologic cross section of the demonstration area is provided in Figure 5.3. Visual logging of the rock core indicated that several water bearing fractures were located between 58.3 and 63 ft bgs. Very few fractures were noted between 63 and 80.6 ft bgs; the absence of mineral staining on the fractures in this deeper interval suggested that the fractures may not be water-bearing.

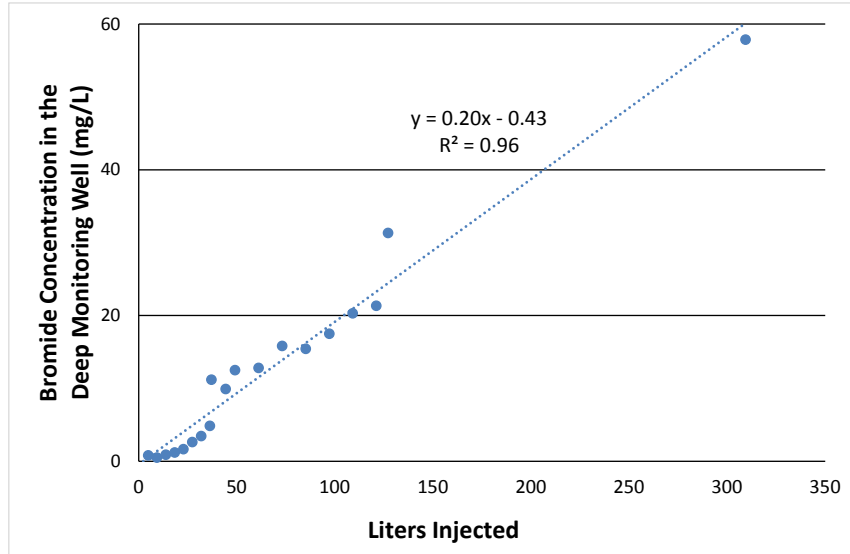
Figure 5.4. Increases in Bromide Concentration in the Deep Interval of MW07-46R as a Function of Volume Injected into MW07-05R.

Bromide data for the shallow and deep intervals for MW07-46R are provided in Figure 5.4. No measurable bromide was observed in the shallow, indicating that no significant flow path (despite observing a hydraulic connection during the short term pumping tests) exists between the injection well (MW07-05R) and the shallow interval of MW07-46R.

The dashed line shows the linear regression to the data.

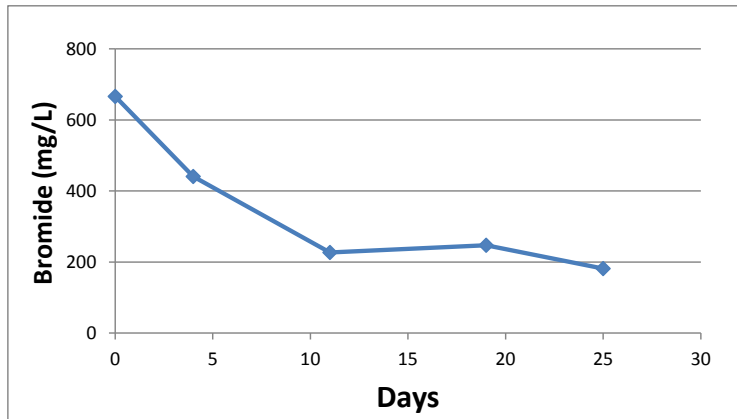
Figure 5.5. Results from the Borehole Dilution Testing Performed in the Injection Well (MW07-05R).

A 250 mL solution containing 8.9 grams of NaBr was added to the 11-foot interval below the packer to achieve a target bromide tracer concentration in the water column of 500 mg/L. Immediately following the addition of the sodium bromide tracer, water was recirculated within the well using the dedicated bladder pump installed below the packer to facilitate tracer mixing throughout the 11-ft interval. This was accomplished by pumping groundwater from near the top of the interval up to the ground surface. The water was continuously re-injected back through the packer to the top of the packer interval. Approximately 5.5 gallons (3 isolated interval volumes) was recirculated to sufficiently mix the bromide tracer within the interval. Bromide samples were collected from MW07-05R after recirculation (time=0), and on days 4, 11, 19 and 25. As with the tracer testing detailed in Section 5.2.6, samples were collected by recirculating ~600 mL (1.2 pump and tubing volumes) of water from the dedicated sample pump, to the surface, and back into the sampling interval to minimize the removal of groundwater from the expected small fracture volume between the injection and monitoring well. Approximately 10 mL of sample were collected for laboratory analysis at the end of each 600 mL recirculation. These data are presented in Figure 5.5.

The rate of decay of bromide from the injection well provides an estimate of the Darcy velocity. The Darcy velocity is calculated as follows (Pitrak et al., 2007; Nordqvist et al., 2008):

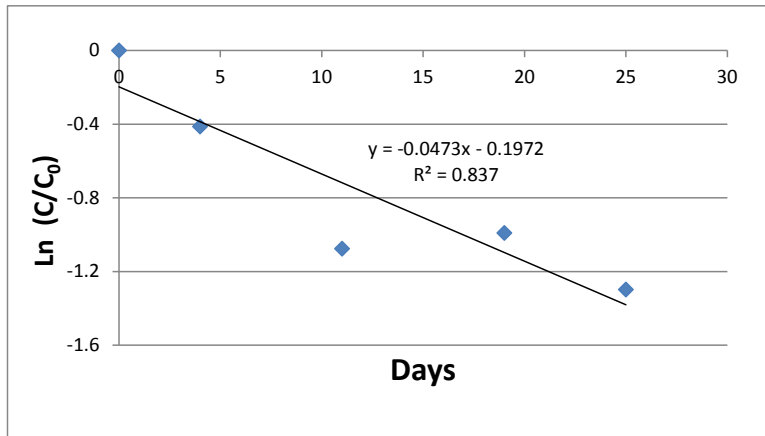
Figure 5.6. Linear Regression of the Bromide Data from the Borehole Dilution Test Performed at MW07-05R.

The bromide data are plotted in the form of Eq. 4 to facilitate determination of the ambient water flow rate into the borehole via linear regression. The linear regression to the data is represented by the solid line.

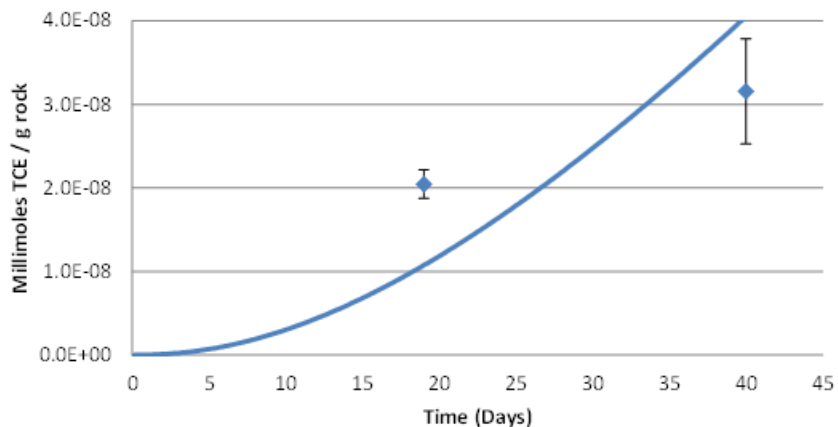
Figure 5.7. Abiotic Dechlorination of TCE in the Bench Scale Batch Testing.

Results of the abiotic batch dechlorination testing showed that abiotic dechlorination transformation products ethane and propane were generated in the TCE-spiked vials, consistent with previous abiotic testing in bedrock (Schaefer et al., 2013, 2015). Results plotted as total millimoles of TCE per g rock transformed are provided in Figure 5.7. Using a trial-and-error approach to estimate (within a factor of 2) the first-order TCE transformation rate constant via application of a coupled diffusion and first-order TCE transformation model (Schaefer et al., 2013) yield a rate constant of $2.7 \times 10^{-8} \text{ s}^{-1}$.

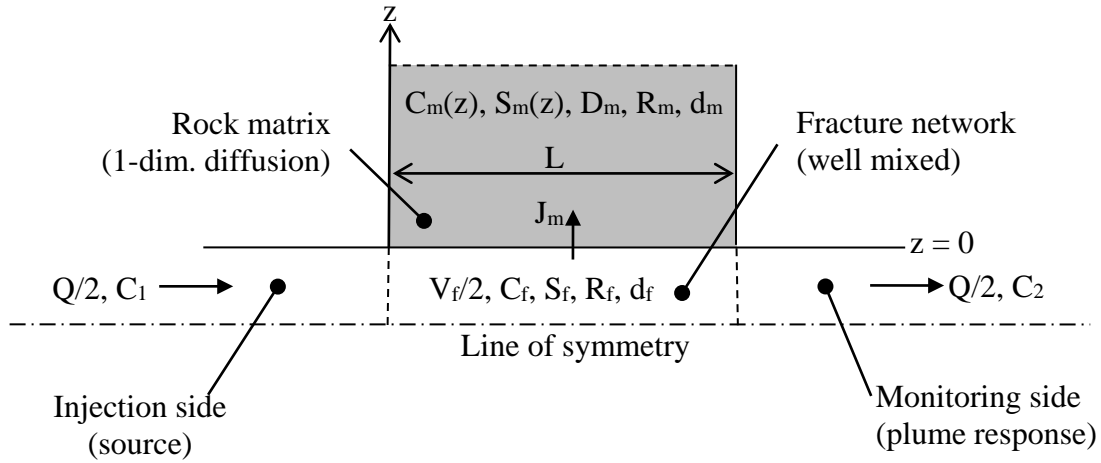
Figure 5.8. Conceptual Model of Transport by Fracture Flow Coupled with Matrix Diffusion (showing upper half of symmetric problem).

As illustrated in Figure 5.8, the model considers a well mixed fracture network of volume V_f [L^3] conveying a volumetric groundwater flow Q [L^3/T] entering from the left (injection well side) with aqueous contaminant source concentration C_1 [M/L^3] and leaving on the right (monitoring well side) with contaminant plume concentration C_2 [M/L^3]. In the rock matrix extending, there is no flow, but there is diffusive one-dimensional transport with diffusion coefficient D_m [L^2/T]. At the fracture-matrix interface of length L and located at $z = 0$ a diffusive mass flux J_m [M/T] occurs, which is taken positive for transport into the matrix. The dissolved contaminant concentrations in the fracture and the matrix are denoted by C_f [M/L^3] and C_m [M/L^3], respectively. The corresponding linearly and instantaneously sorbed contaminant masses per unit fracture or matrix pore volume are denoted by S_f and S_m [M/L^3]. Note that $C_f(t)$ and $S_f(t)$ are functions of time t [T] only, whereas $C_m(z,t)$ and $S_m(z,t)$ are functions of both z and t . Finally, retardation factors (defined as the total contaminant mass in the dissolved and sorbed phases, divided by the dissolved contaminant mass) are denoted by R_f [-] and R_m [-], respectively. First order degradation rates of contaminants in fracture and matrix are denoted by d_f [$1/T$] and d_m [$1/T$]. Note that d_f is applied to the dissolved phase, while d_m is applied to the sorbed phase (in contact with reactive rock material). For dimensional consistency, a transverse width (perpendicular to the plane shown in Figure 5.8) of the model was adopted as W [L]. As discussed in Section 5.2, 3 fractures are present connecting the injection well to the monitoring well, so the overall contaminant and water flux into the monitoring side well are multiplied by 3 in the model. It is noted that, due to the low value of D_m coupled with the value of d_m , model results shown that contaminant (TCE) migration into the rock matrix is very limited (< 3 cm), and thus assuming an infinite medium in the z direction for the rock matrix was shown to be a reasonable assumption.

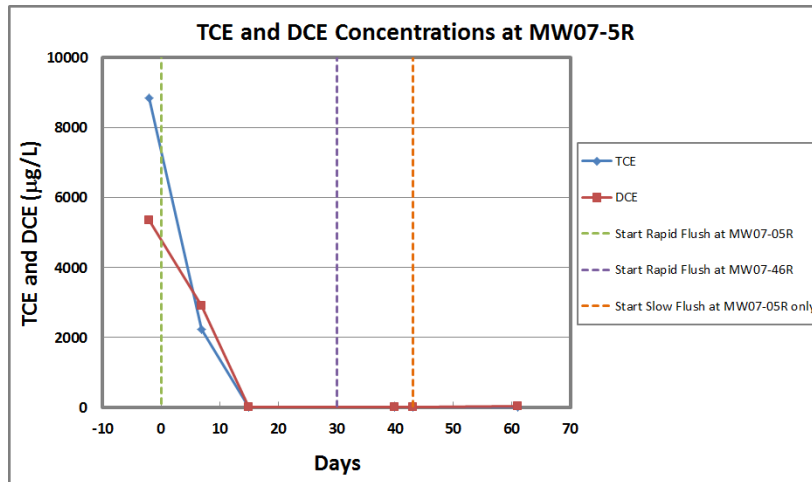
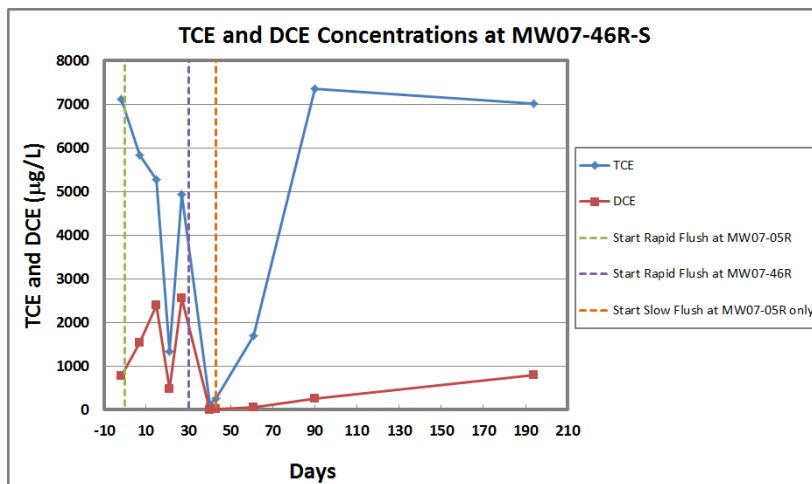
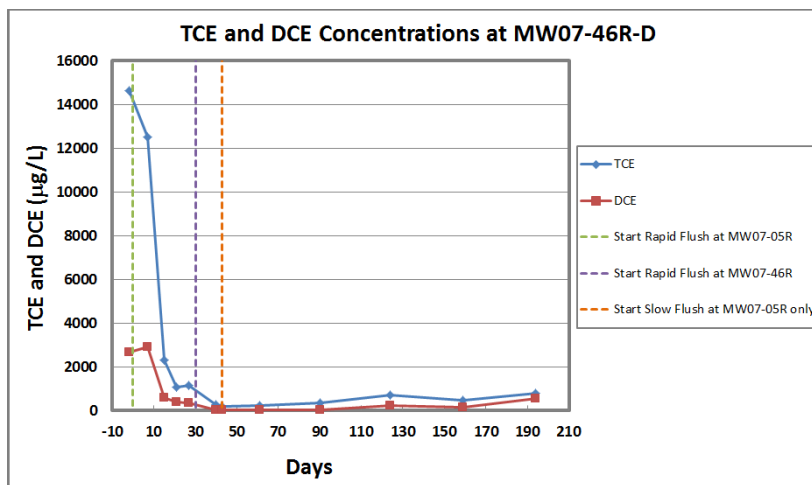
Figure 5.10. TCE and DCE Concentrations Measured Throughout the RA Demonstration.

Results of the rapid flushing are summarized in Figure 5.10 below. Rapid flushing was initiated on April 5, 2016 and terminated on May 19, 2016. The rapid flushing was effective in removing >90% of the cVOCs in both the shallow and deep monitoring locations (approximately 98.6% of the TCE was removed in the deep monitoring interval). However, the shallow monitoring location only showed substantial cVOC removal after water was injected directly into the monitoring interval. This result was not unexpected, as the tracer testing showed that the injection well and shallow monitoring interval were poorly connected. As described in Section 5.8.3, evaluation of rebound was therefore limited to the deep interval.

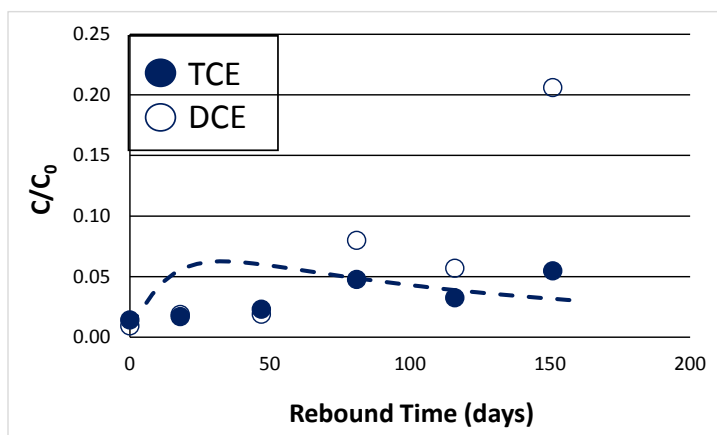
Figure 5.11. Increases of TCE and DCE Relative to their Baseline (prior to rapid flushing) Levels during Rebound at MW07-46R-D.

Increases in TCE and DCE relative to baseline (Table 5.6) plotted as a function of time are shown in Figure 5.11. Results show that TCE and DCE concentrations increased with time, indicating that there was a persistent contaminant mass present between the demonstration wells that was not removed during the rapid flushing.

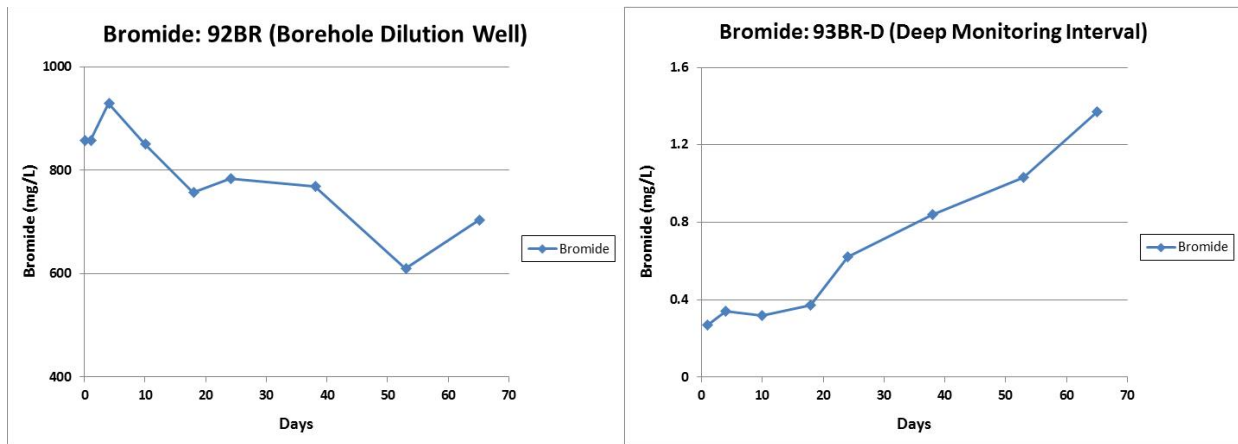
Figure 2: Bromide Concentrations in the Injection Well (Panel A) and MLS Well Deep Interval Well (Panel B) during the Passive Phase of Borehole Dilution/Tracer Testing.

In order to verify connectivity between the wells and to better estimate the effective fracture porosity, pumping was performed within the shallow and deep intervals of the monitoring well using the dedicated sampling pumps installed in those intervals. The deep monitoring well interval was pumped at approximately 75 mL/min for approximately 11 hours, and the shallow monitoring well interval was pumped at increasing steps between 75 mL/min and 450 mL/min for approximately 35 hours. Pumping was performed during the day, and discontinued at the end of each work day. Bromide samples were collected every 20 to 60 minutes to determine the time of breakthrough, and to develop a bromide curve for estimating effective fracture porosity. During this groundwater extraction phase, bromide concentrations in the injection well showed a steady decrease from 704 mg/L to 273 mg/L (**Figure 3**). The deep monitoring interval showed a steady increase and flattening of bromide concentrations at approximately 15 mg/L, while the shallow monitoring well interval showed a relatively steady increase and flattening of bromide concentrations at approximately 0.7 mg/L (**Figure 3**). Results from the deep interval confirmed that the flow path from the injection well to the MLS well was sufficient for the demonstration. The very low bromide levels measured in the shallow zone suggested that the majority of the flow into this shallow zone was not emanating along the flow path connected to the bromide tracer.

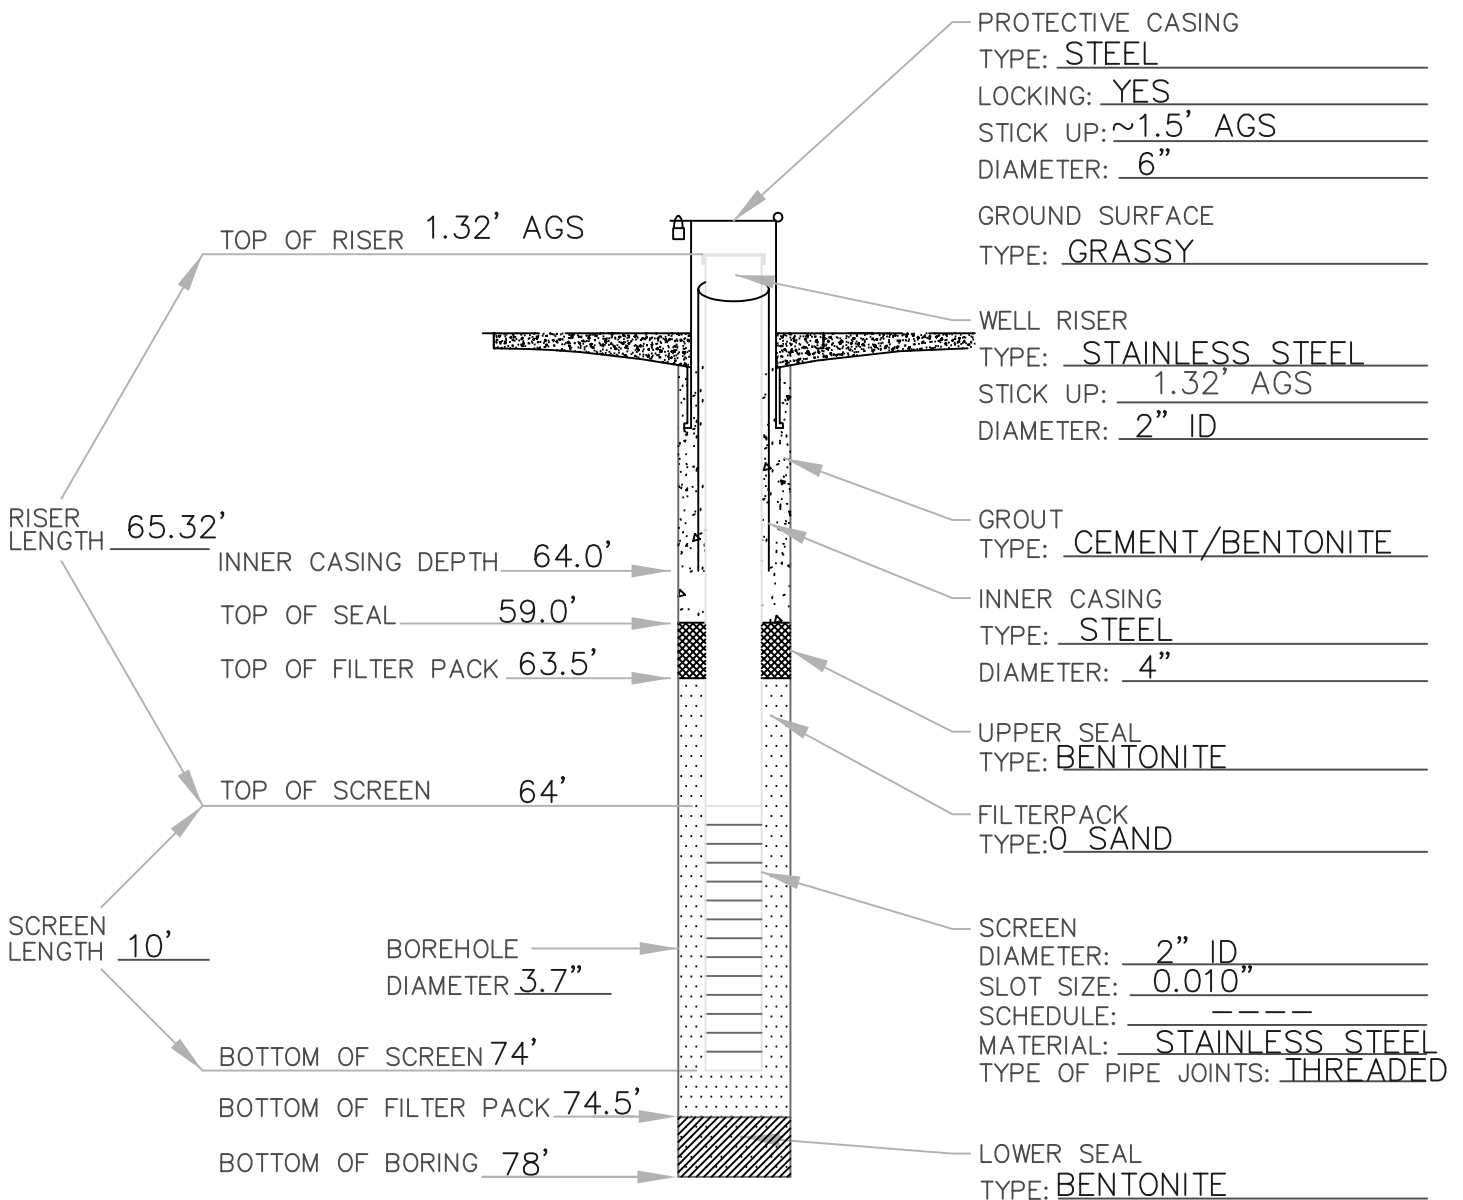
MONITORING WELL CONSTRUCTION
(ALL DEPTH MEASUREMENTS IN FT. BELOW GROUND SURFACE)

CLIENT/SITE NAME: NORDIV, NAVFAC NCBC DAVISVILLE, SITE 07, PHASE III RI	
DATE INSTALLED: 8/24/95	PROJECT No. 29600.32
ELEVATION OF GROUND SURFACE: 10.3' MSL ELEVATION TOP OF WELL RISER: 11.62' MSL	COORDINATES: N: 197588.42 E: 524597.83
DEPTH TO WATER: 7.88' (BELOW TOP OF RISER) DATE/TIME 12/1/96 1220	EA INSPECTOR: J. SHAPIRO
DRILLING METHOD & DEPTH: 6" FLUSH-JOINT CASING WITH 5.875" ROLLERBIT TO 64'/ HX-CORE 64'-77.5'

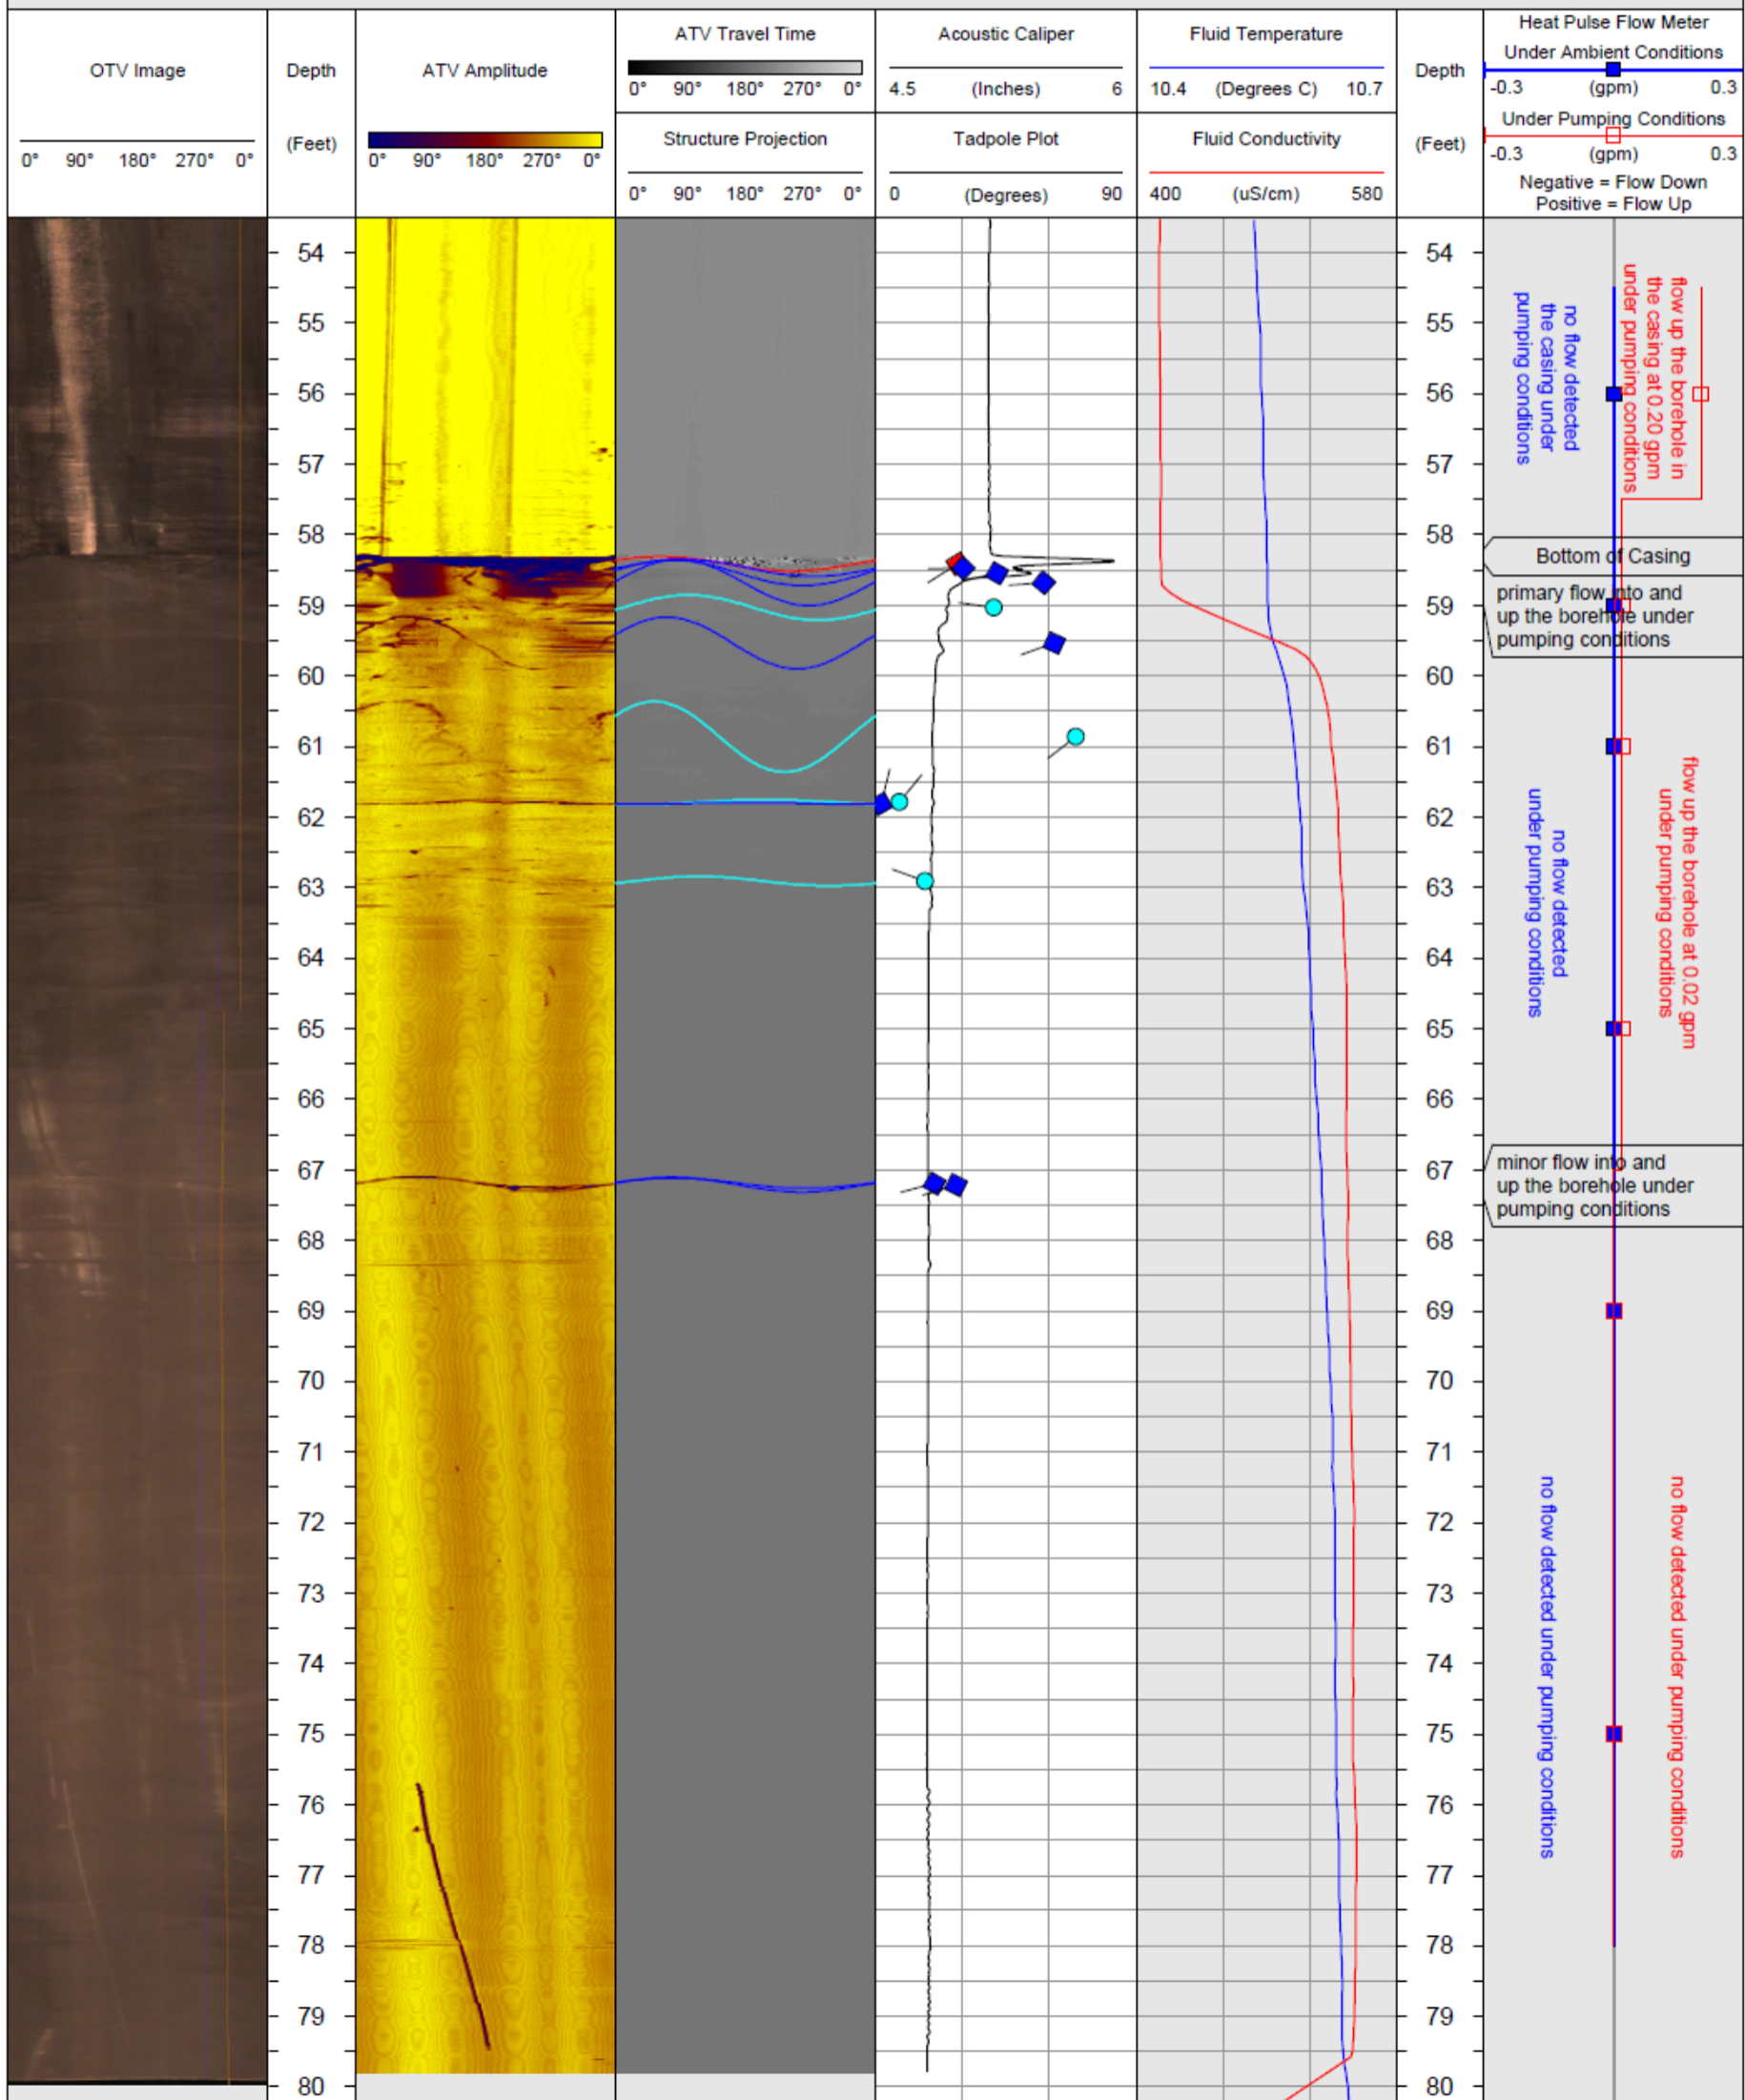
PT-BRMW-1 - Borehole Geophysical Logs

NOTE: Flow was not detected with the heat pulse flow meter under ambient conditions.

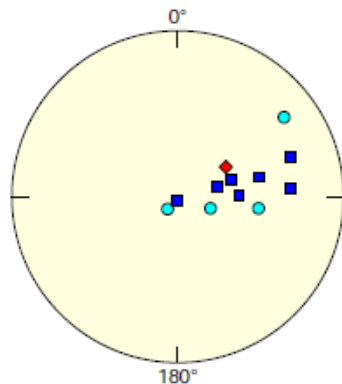
Schmidt Plot - LH - Bedrock Structures

Stereogram - Lower Hemisphere
of Fractures

Counts	Dip[deg]	Azi[deg]
Mean	12	33.66	269.18
◆	1	28.23	237.95
■	7	34.57	267.42
●	4	33.49	287.51

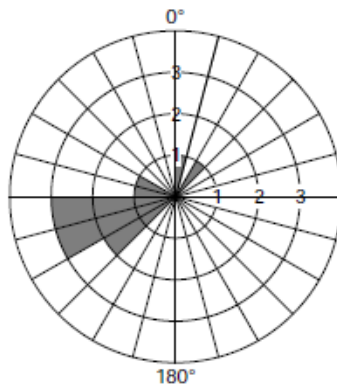
Azimuth - Absolute (Count)

Dip Azimuth Rose Diagram
of Fractures

Counts:	12.00
Mean:	269.18
Std.Dev.:	47.30
Min:	13.88
Max:	290.10

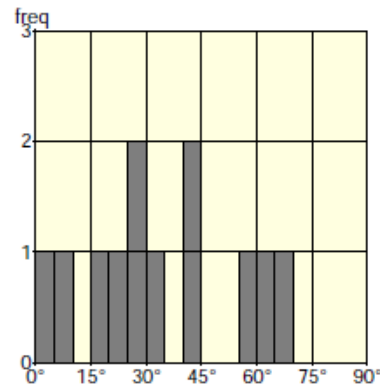
Dip Histogram (Count)

Dip Angle Histogram
of Fractures

Counts:	12.00
Mean:	33.66
Std.Dev.:	20.37
Min:	1.87
Max:	69.04

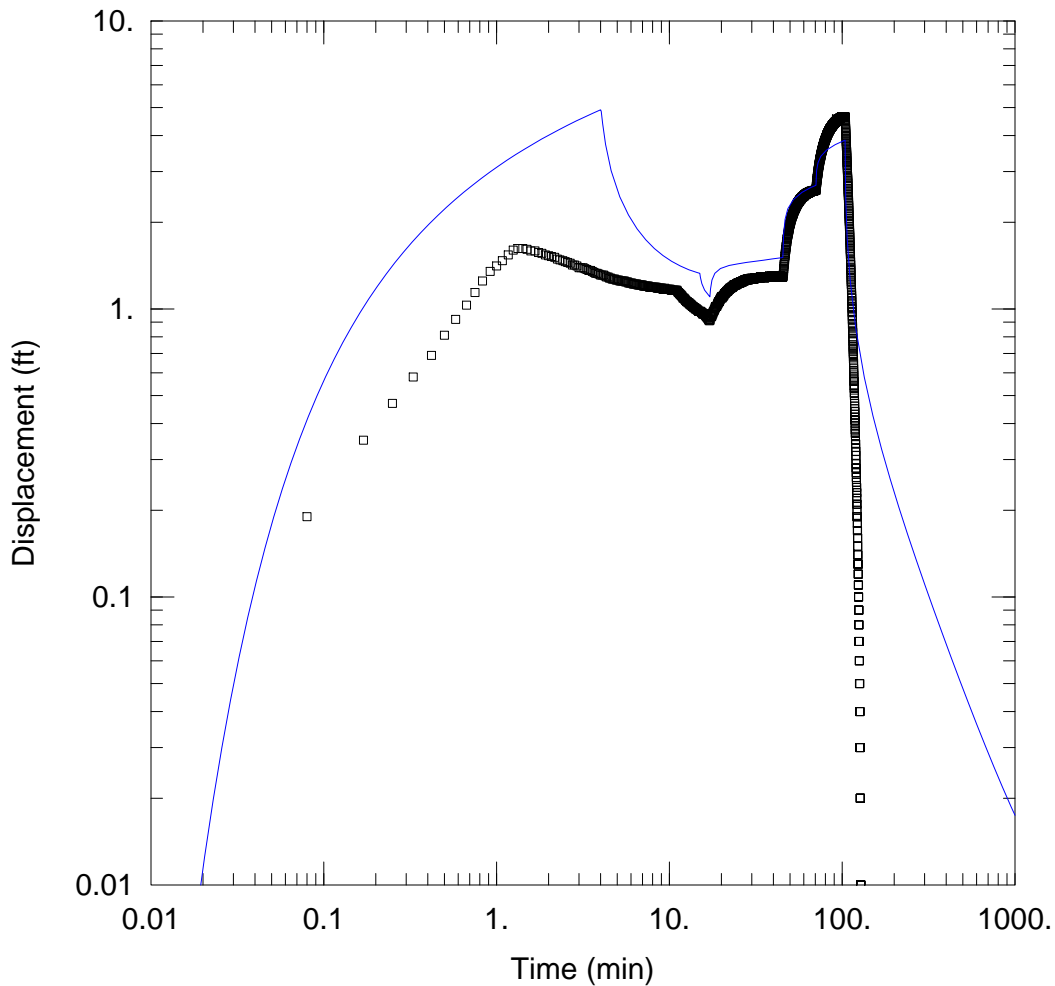
TEST #1: RESPONSE AT MW07-46R 58.3'-64.7' BGS TO PUMPING AT MW07-46R 58.3'-64.7'

Aquifer Model: Confined Solution Method: Theis
 $T = 56.93 \text{ ft}^2/\text{day}$ $S = 0.27$
 $Kz/Kr = 0.9926$ $b = 22.2 \text{ ft}$

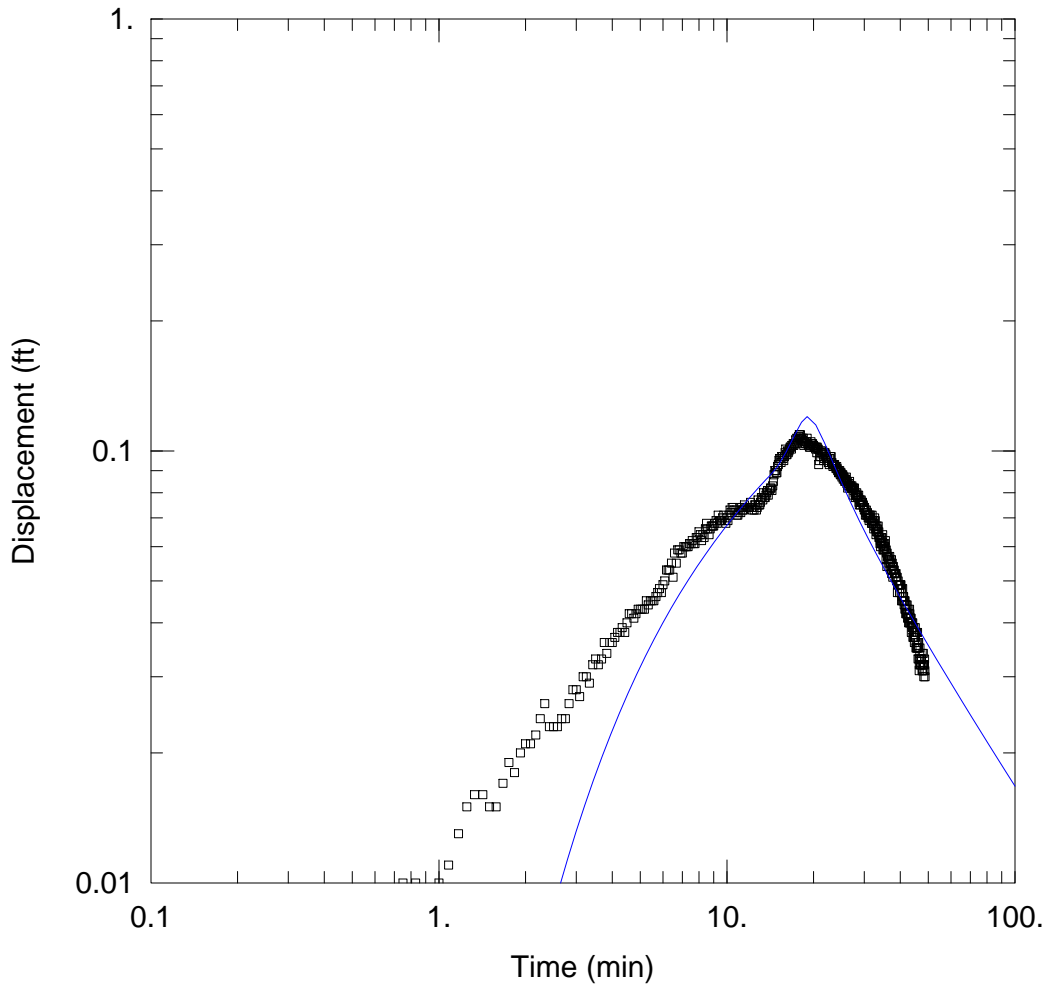
TEST5: RESPONSE AT MW07-46R 65'-69" BGS TO PUMPING AT MW07-05R 64'-74' BGS

Data Set: C:\...\Test5 Response at MW07-46R 65-69', Pumped well MW07-05R Thisis Hantush Confined aqt
 Date: 11/05/15 Time: 13:38:21
