FINAL REPORT

Rapid Assessment of Remedial Effectiveness and Rebound in Fractured Bedrock

ESTCP Project ER-201330

OCTOBER 2017

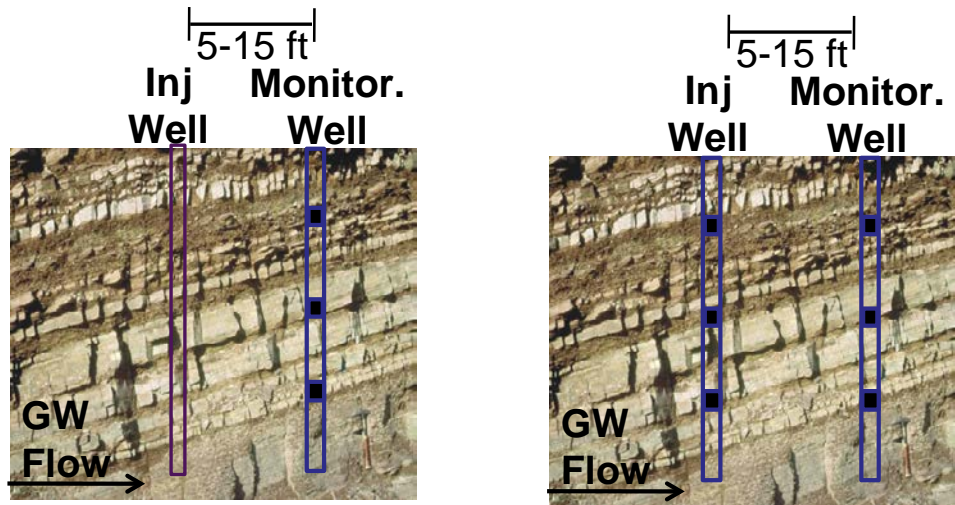
Figure 1. The injection well can be configured such that the open borehole injection interval spans the interval of the multi-level monitoring well (left), or the injection well can be configure as a multi-level injection well (right).

Using the isolated fracture intervals, hydraulic testing should be performed for each target interval. Short term pump or drawdown testing should be used to estimate the hydraulic conductivity within each interval, and to confirm a hydraulic connection between the injection and monitoring well intervals. A borehole dilution test is needed in the injection well across the entire injection interval. The injection interval of the injection well can be a single zone extending across the multiple discrete intervals of the monitoring well, or multiple injection intervals corresponding to fracture zones in the monitoring well (see Figure 1 below). This information is used to determine the ambient flow into the injection well, and ultimately the injection rate needed to provide the hydraulic control needed during the slow injection (rebound) phase of the RA testing (Section IV). Borehole sampling should be performed to limit the volume of water removed from the borehole via strategies such as in-well recirculation of fluids.
