# ESTCP Cost and Performance Report

(ER-201330)

## Rapid Assessment of Remedial Effectiveness and Rebound in Fractured Bedrock

August 2017

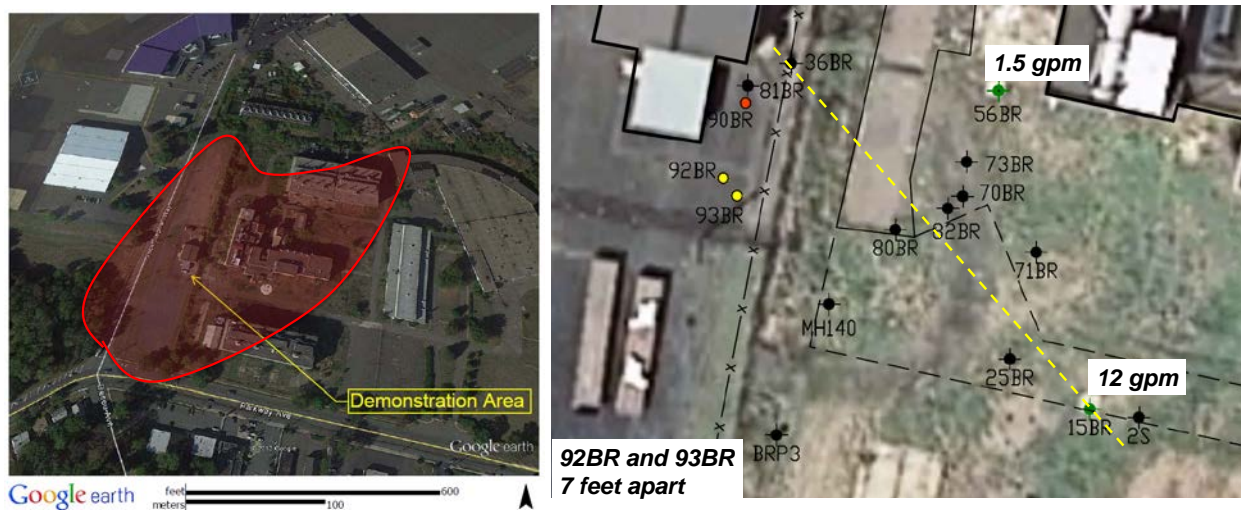
**Figure 4.1. Demonstration Location at the NAWC Site.**

*The shaded area represents the bedrock TCE plume, where TCE is present at detectable concentrations (left). Demonstration wells (92BR and 93BR) and other local bedrock wells also are shown (right).*

The NAWC, shown in Figure 4.1, is located in West Trenton, New Jersey. The approximately 67-acre site, used as a jet-engine test facility beginning in the 1950s, was decommissioned in 1998 ([http://nj.usgs.gov/nawc/site\\_description.html](http://nj.usgs.gov/nawc/site_description.html)). Past activities at the site lead to the release of TCE, jet fuel, and other chemicals into the subsurface. Portions of the site have been sold to commercial developers, but the majority of the site remains undeveloped.

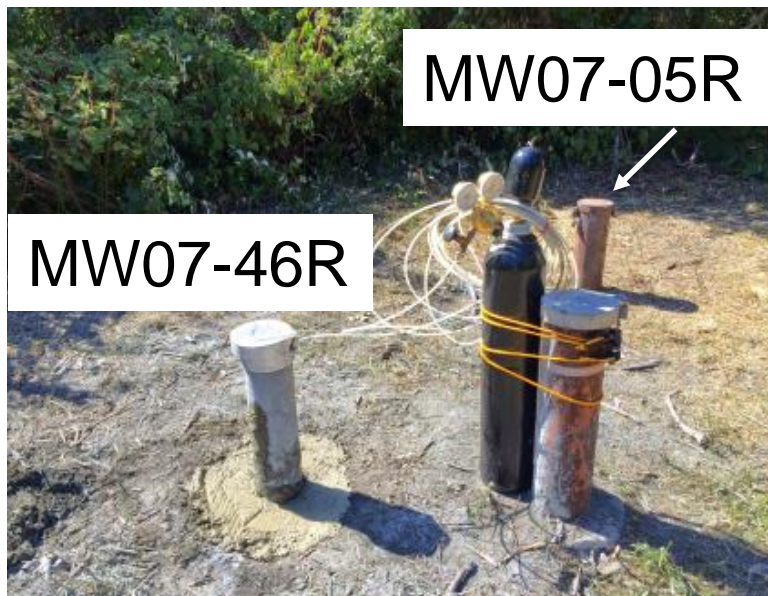
**Figure 5.2.** Newly Installed Well MW07-46R Shown in Proximity to Existing Well MW07-05R.

Characterization activities included drilling and coring one borehole located approximately eight feet downgradient from existing bedrock well MW07-05R. The newly installed open-borehole well was designated MW07-46R, and its location is shown in Figures 5.1 and 5.2.

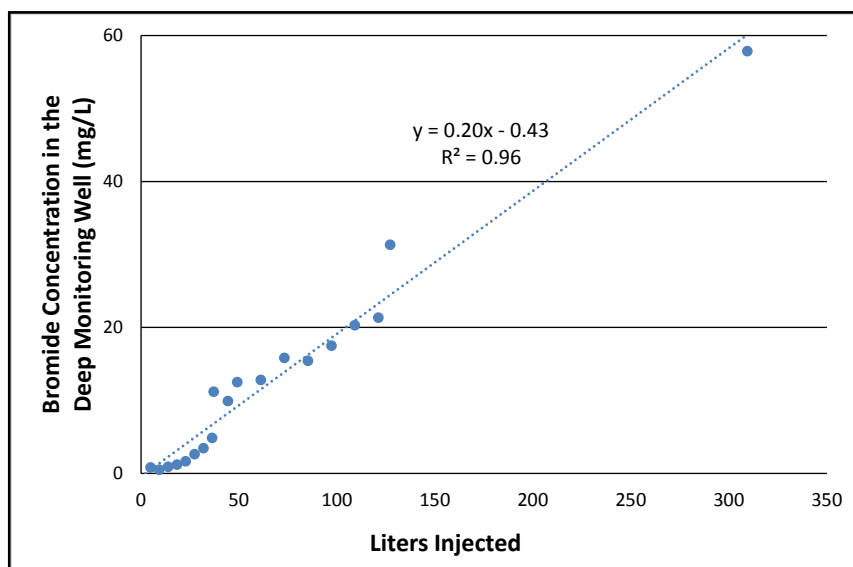
**Figure 5.4. Increases in Bromide Concentration in the Deep Interval of MW07-46R as a Function of Volume Injected into MW07-05R.**

*The dashed line shows the linear regression to the data.*

Bromide data for the shallow and deep intervals for MW07-46R are provided in Figure 5.4. No measurable bromide was observed in the shallow, indicating that no significant flow path (despite observing a hydraulic connection during the short-term pumping tests) exists between the injection well (MW07-05R) and the shallow interval of MW07-46R.

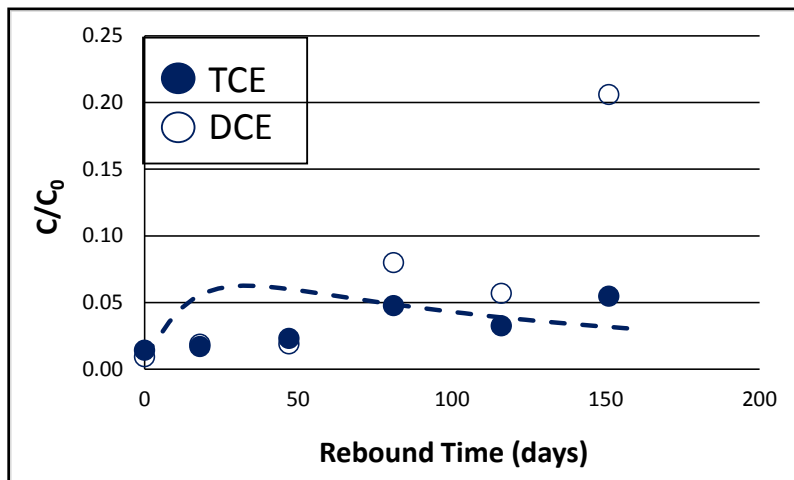
**Figure 5.8. Increases of TCE and DCE Relative to their Baseline (prior to rapid flushing) Levels during Rebound at MW07-46R-D.**

*The dashed line represents the TCE model prediction.*

Increases in TCE and DCE relative to baseline (Table 5.5) plotted as a function of time are shown in Figure 5.8. Results show that TCE and DCE concentrations increased with time, indicating that there was a persistent contaminant mass present between the demonstration wells that was not removed during the rapid flushing.

In addition to the CSIA data, the diffusion model (Section 5.6.1) serves as another line of evidence that the observed rebound is due to matrix back-diffusion. As shown in Figure 5.8, the model provides a generally reasonable prediction of the observed TCE rebound.

Based on the increase in DCE to TCE ratio observed during rebound, approximately 20% (on average) of the TCE that back-diffused was transformed to DCE. Thus the TCE plotted in Figure 5.8 would be approximately 20% greater in absence of biotic transformation to DCE. This increase in the DCE to TCE ratio may have also been due, in part, to the fact that DCE abiotic dechlorination likely is less than that of TCE (Lee and Batchelor, 2002).

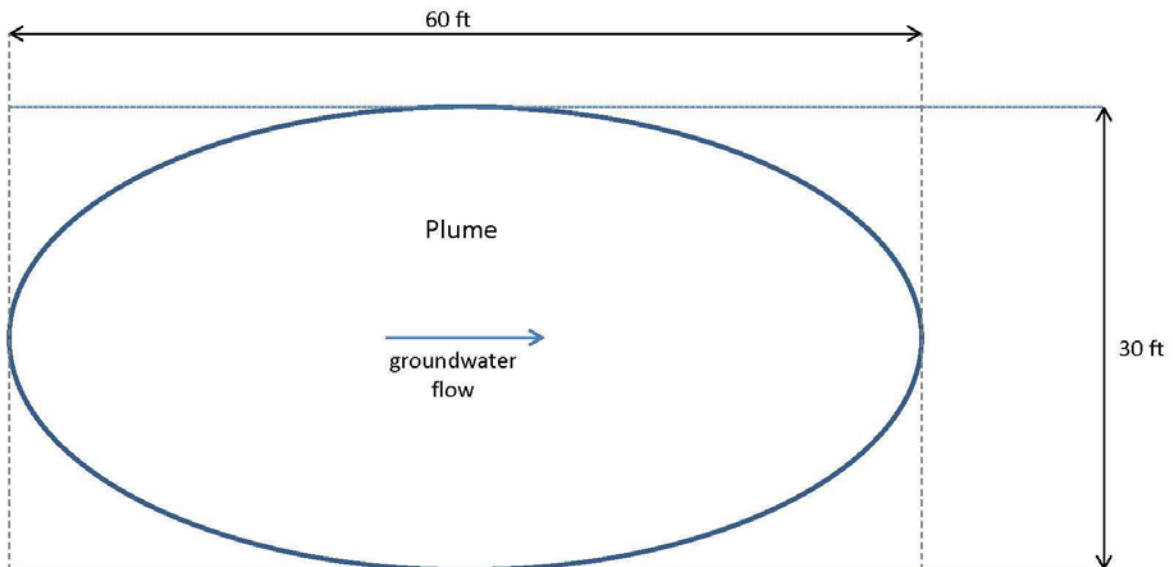
**Figure 7.1. Base Plume Characteristics**

The base case presented in Krug et al. (2009) is modified as a template for the cost analysis of the above technologies/approaches. The base case presents a situation where a bedrock aquifer contains a dissolved TCE source area extending to 75 ft bgs and is 60 ft long and 30 ft wide, perpendicular to groundwater flow (Figure 7.1). The specific base case site characteristics, including aquifer characteristics and design parameters for each of the remedial assessment approaches analyzed, are summarized in Table 7.2.
