***Project - LTPC Phase II: Modification of Hentzen  
(Crosslink) Powder Coatings 6191-61003 for Enhanced  
protection to UV and MIC***

# Report on Technical Order 35-1-3 Review and Recommendations

Prepared by:  
Battelle  
505 King Avenue  
Columbus, Ohio 43201

6 June, 2018

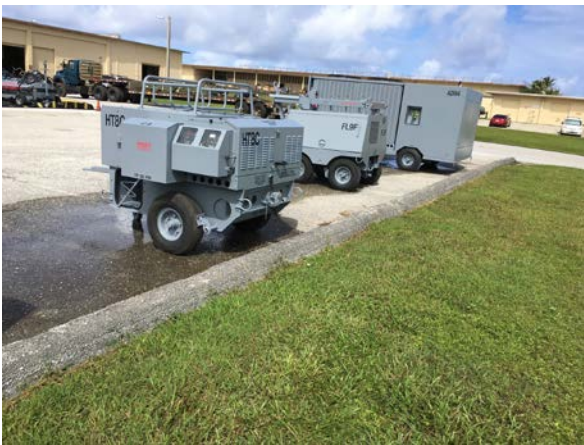
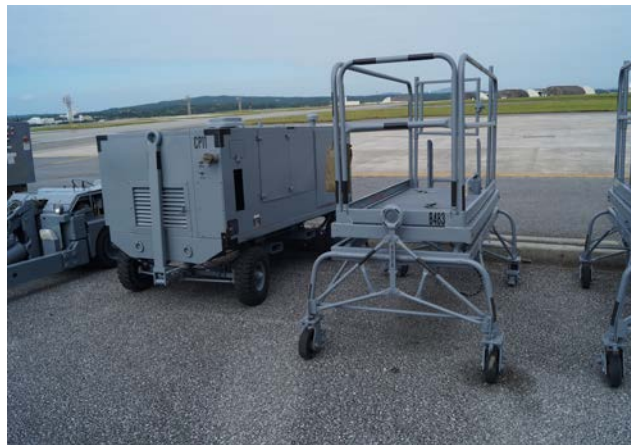
**Figure 1 Observed storage of SE at PACAF locations**

AGE stored at Andersen AFB

AGE stored at Kadena AB

The storage of support equipment (SE) or AGE in this manner allowed for intense UV exposure as well as no protection from other environmental conditions such as water, snow, ice, heat, dirt, smog, humidity, grime and salts. While UV exposure could slow the advancement of MIC as it is known to be an excellent disinfectant in industrial processes, it is also known to cause significant damage to coatings. Exposure to

UV radiation over time can have detrimental effects on the polyurethane coating applied to SE to protect it from corrosion. Once the coatings start to degrade, microorganisms can invade the SE and obtain protection from direct UV; MIC then also becomes an issue.

The TO does not provide similar specific guidance for storage of AGE located in other regions. The guidance provided in section 7.2.4 could be implemented across PACAF locations.

The Marine Corps CPAC program has had marked success in the storage of their ground assets in several types of structures to limit the UV and weathering exposure. Many times, these structures will include dehumidification units to maintain controlled humidity for corrosion prevention. These structures could be brick and mortar maintenance bays, interim relocatable tension fabric shelters, or T- shelters with awnings.

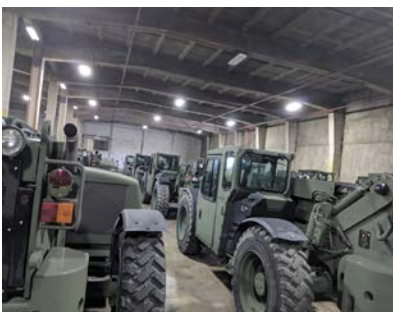
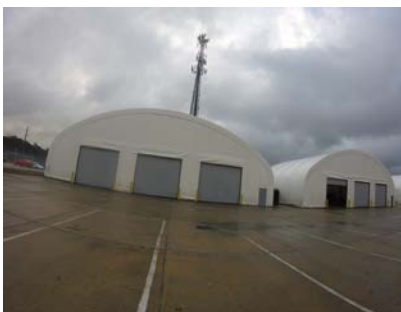
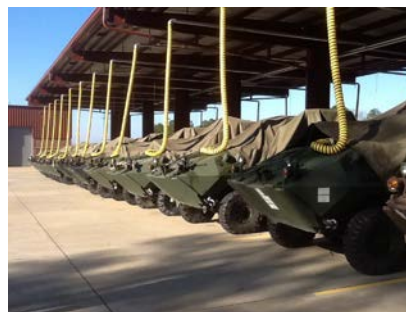
**Figure 2 Examples of various storage structures used by Marine Corps for ground assets**

Permanent Structure

Tension Fabric Shelter

Open Shelters

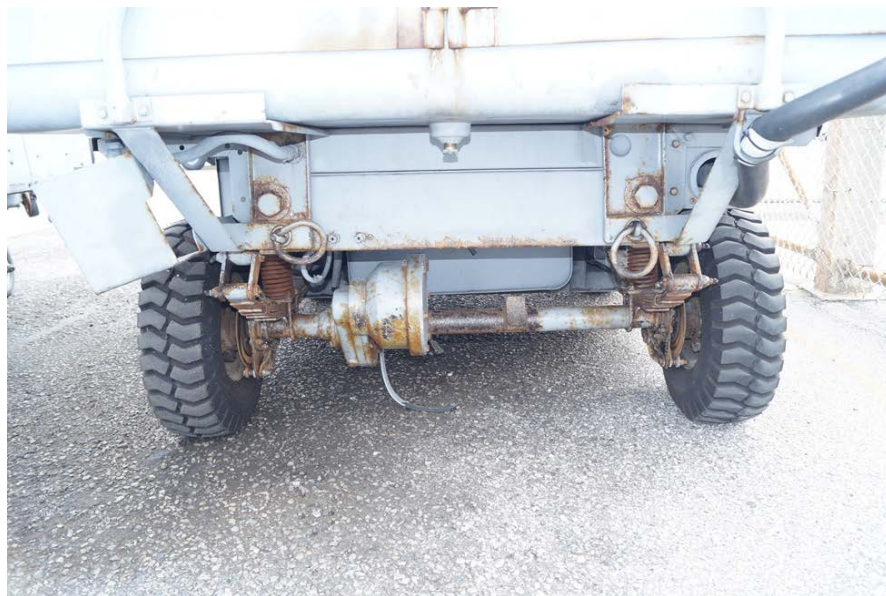
Section 3.22 of TO 35-1-3 refers to undercoating of SE but very little detail is discussed, or definitive guidance provided in regard to undercoating of SE. However, much of the observed corrosion was seen on the undercarriage of the support equipment. Debris such as rocks tend to chip the coating under the equipment making it more susceptible to corrosion. Hard flexible coating protecting these areas could be very beneficial in increasing the life span due to corrosion of SE. The corrosion repair facilities at Kadena and Gunsan do not apply undercoating to the SE whereas, the contractor (Milspray Technologies LLC) operated corrosion repair facility at Andersen AFB has recently acquired approval to apply Tectyl 2423, a low Volatile Organic Content (VOC), air dry, high solids, emulsion coating as an undercoating to the SE and has started undercoat application.

**Figure 3 Undercarriage corrosion observed at Kadena AB**

Most AGE/SE observed during visit to the three PACAF locations was stored/parked on open lots with blacktop extending on vegetation. Grass clippings are regularly deposited on the undercarriage creating potential for MIC. Given the above understanding of how the MIC causing bacteria and fungi reproduce, the Air Force could consider including guidance on parking of equipment stored on open lots to not extend over the surrounding green spaces. Additional guidance could include a requirement that a 4 to 6 feet perimeter surrounding the storage lots be formed with gravel or other benign material void of vegetation or areas requiring lawn mowing.

The Marine Corps CPAC program has had great success with the underbody coating Tectyl 2423, a low VOC, air dry, high solids, emulsion coating. It works well with both ferrous and non-ferrous metals with a single application. The cured film is hard and flexible. Milspray Technologies LLC is a primary provider of mobile corrosion repair services (MCRS) to the CPAC program which includes application of bed liner and undercarriage coatings.

Section 3.22 talks briefly about SE undercoating considerations. It is Battelle's belief that an undercoating program could be very beneficial for the longevity of AGE. More details as to how flights can get their AGE undercoated should be included.
