**HEADQUARTERS
AIR FORCE SAFETY CENTER**

**Boeing Michigan Aeronautical
Research Center (BOMARC), Final
Remedial Action Report for Site
RW-01, McGuire AFB, N.J.**

17 May 2010

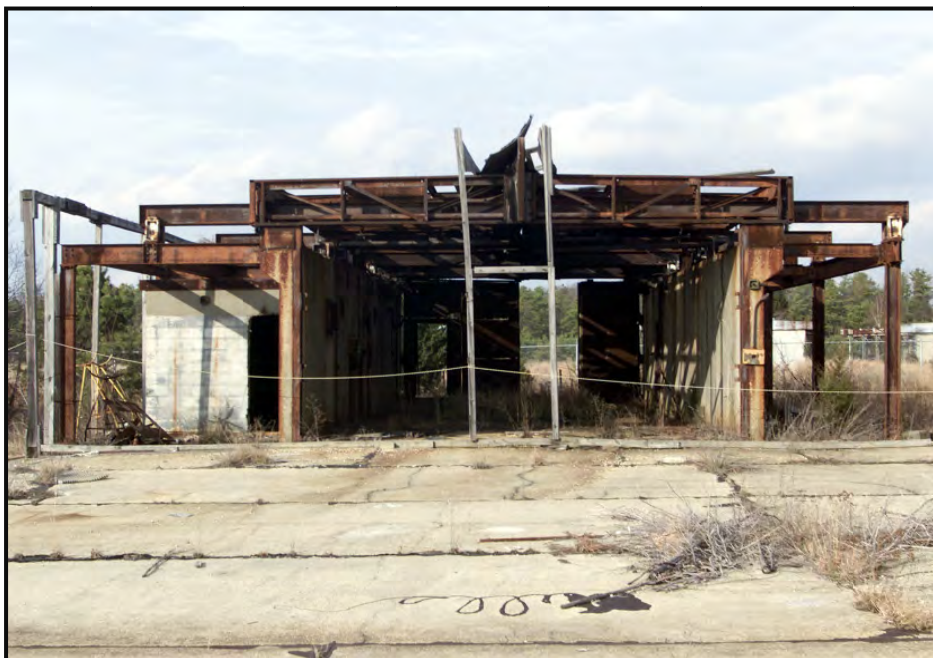
On 7 June 1960, an explosion in a helium tank took place in Shelter 204 (Figure ES) causing a fire in a nuclear-tipped, liquid-fueled BOMARC missile at McGuire Air Force Base, N.J. The fire burned uninhibited for approximately 30 minutes. Fire-fighting activities were conducted for 15 hours using water as a suppressant. As a result, materials from the shelter flowed under the front shelter doors, down the asphalt apron and street between the row of shelters, and into the drainage ditch leading outside the site boundary fence. The primary material of concern is weapons grade plutonium (WGP), fissile material from the nuclear warhead. It was estimated that 300 g of WGP was not recovered from the initial accident response actions, which, in a dioxide chemical form, is about one fluid ounce. Initial surveys conducted shortly after the accident indicated that the water associated with the fire-fighting activities was responsible for the primary distribution of contaminants. While a wind from the north to northeast was present during the initial stages of the fire, evidence from the Remedial Investigation/Feasibility Study (RI/FS) and the Final Status Survey Report (conducted for secondary impacted areas) did not support any significant airborne transport. Though translocation of shelter contaminants was largely attributed to fire-fighting water (and later storm water run-offs), activities during the accident response and those post-accident (i.e., foot and vehicle traffic) were believed to be responsible for some cross-contamination of material, estimated at less than 0.1 % of the total residual. In 1972, the site ceased operational use. Since then, a number of radiological investigations were accomplished to assess the integrity of asphalt and concrete engineering controls

Figure ES. Shelter 204.

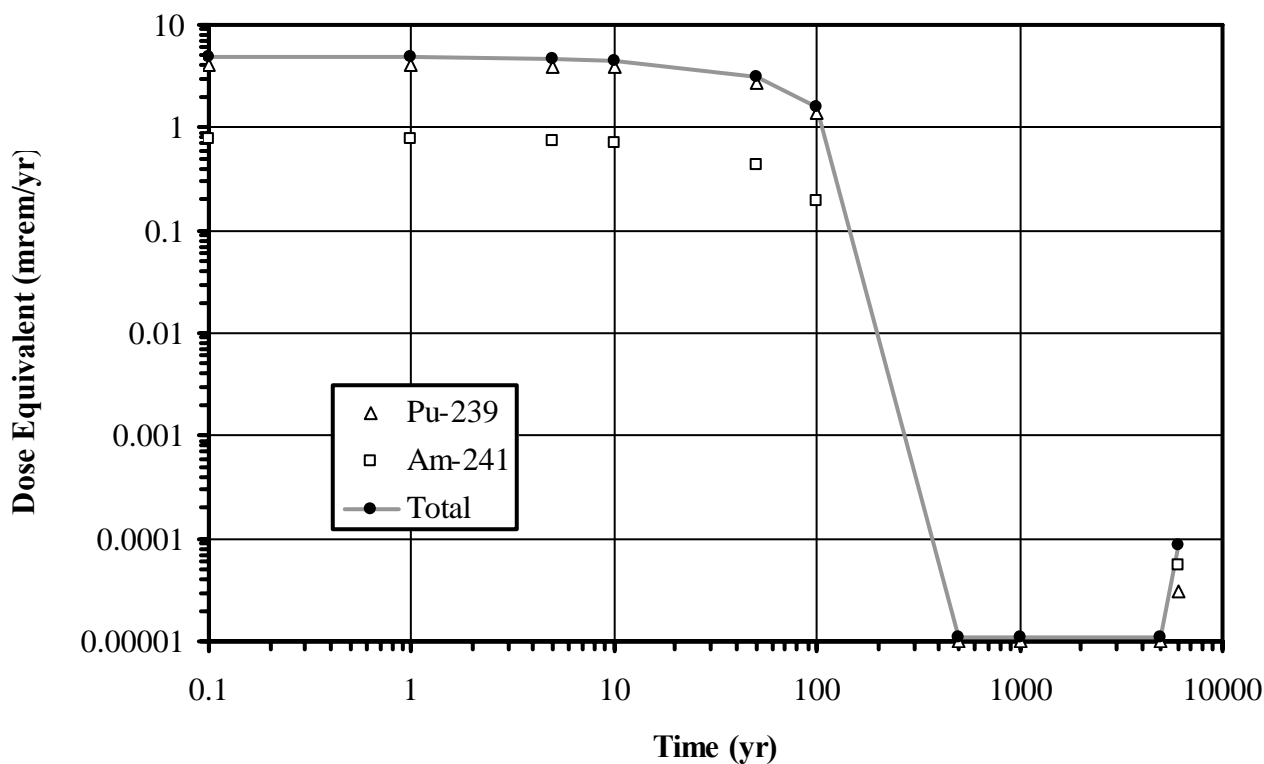
Figure 2-1. RESRAD Dose Summary Over Time [Data from RI/FS, Appendix J, Earth Tech (1992)]. [Note: ^{241}Am Modified for $^{239+240}\text{Pu}$ to ^{241}Am Ratio of 5.4, and Average $^{239+240}\text{Pu}$ Concentration of 8 pCi/g].

^{239}Pu was 4.8 mrem/yr. This level was deemed to be approximately equivalent to 4 mrem/yr, the post-remedial action goal. From the plot, projected dose equivalents are predominantly from ^{239}Pu , at a fraction almost equivalent to the fraction of total α -activity of the two isotopes combined. Among the modeled exposure routes, the inhalation route comprised about 76 % of the total dose equivalent, with the majority of the balance to soil ingestion (see Figure 2.2). Dose equivalent from plant consumption was a small modeled contributor, and external radiation an extremely small fraction, but primarily from ^{241}Am . Water-dependent pathways did not contribute significant dose equivalent for any time period considered by the model. However, from Figure 2.1, at about 6000 years, a very small dose equivalent from water-dependent pathways is projected, which is predominantly from ^{241}Am .

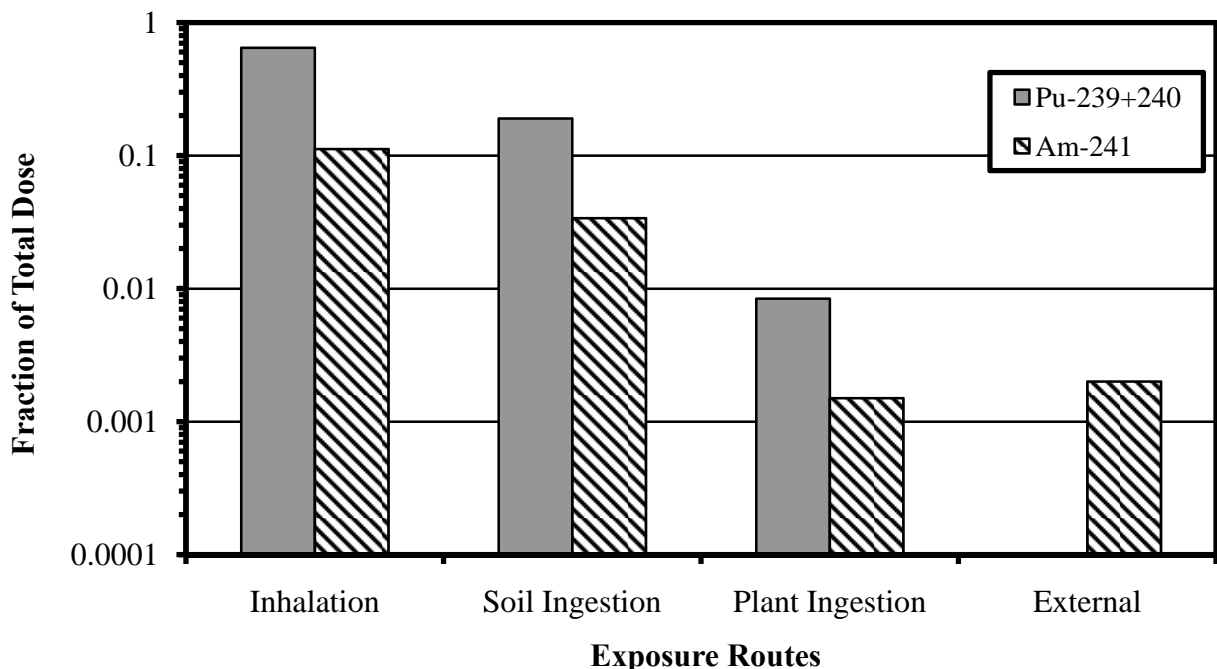
Figure 2-2. RESRAD Exposure Route Summary for $t = 0$ [Data from RI/FS, Appendix J, Earth Tech (1992)]. [Note: ^{241}Am Modified for $^{239+240}\text{Pu}$ to ^{241}Am Ratio of 5.4].

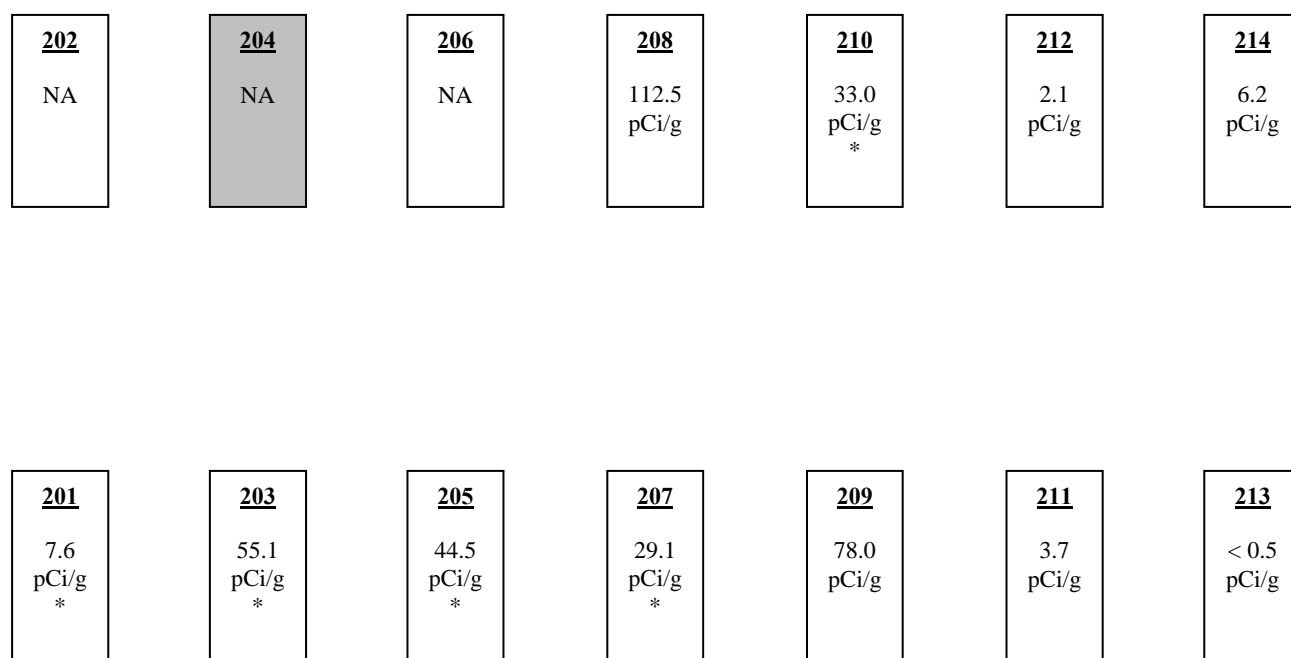
Figure 5-1. Shelter Configuration with $^{239+240}\text{Pu}$ Activity Concentrations in Floor Debris of Main Shelters from First Debris Removal During 2007 Survey; [* Not Including Discrete Particles Removed, Data from Rademacher *et al.* (2009)].

Table D-7 contains a summary of debris γ -spectroscopy sampling findings. Gray-highlighted cells are for samples with $^{239+240}\text{Pu}$ activity concentrations greater than the DCGL_w of 8 pCi/g. The concentrations ranged from below the decision level for the method to 112.5 pCi/g. In general, the concentrations were greatest in those shelters with close proximity and lower for other at greater distance, with the highest in rank order: 208 (112.5 pCi/g), 209 (78.0 pCi/g), 203 (55.1 pCi/g), 205 (44.5 pCi/g), and 210 (33.0 pCi/g). Figure 5-1 provides a diagram of these shelters and respective concentrations from Table D-7. These concentrations would be somewhat different if discrete particle removals had been included. For example, in shelter 205, the debris contained 210 nCi $^{239+240}\text{Pu}$, while the discrete particle removed prior to sweeping and sampling had an estimated activity of 290 nCi, 58 % of the total debris activity. Only one of the equipment rooms, shelter 203, had debris greater than 8 pCi/g. While floor debris was removed during survey preparation, the total activity compared to the soils criterion was considerably lower than the acceptable elevated measurement comparison for a 1 m² land area containing soil. Subsequently, if removed and added to soils adjacent to shelters under a demolition scenario, the radiological risks would be low.

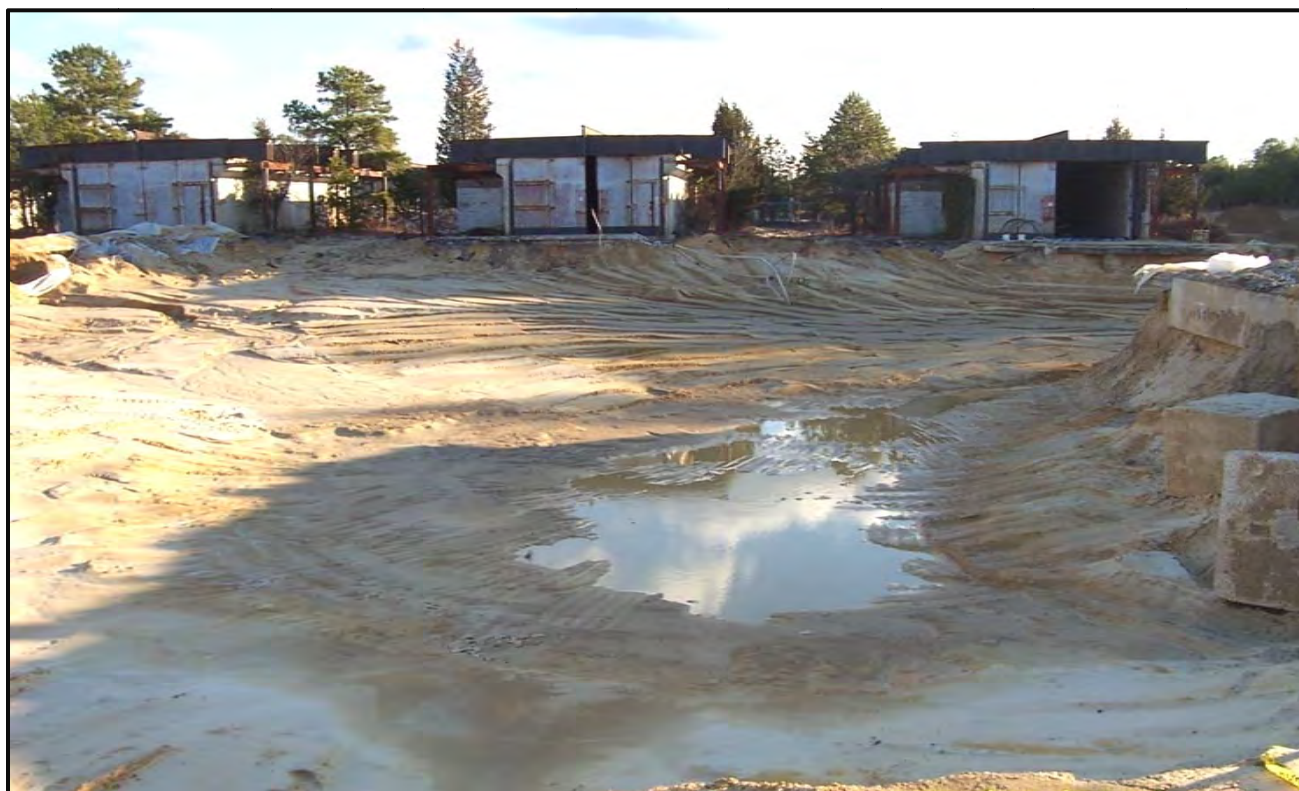
Figure 10-1. Primary Excavation Area between Shelters 201 – 205 and 202 – 206 (Duratek 2006).

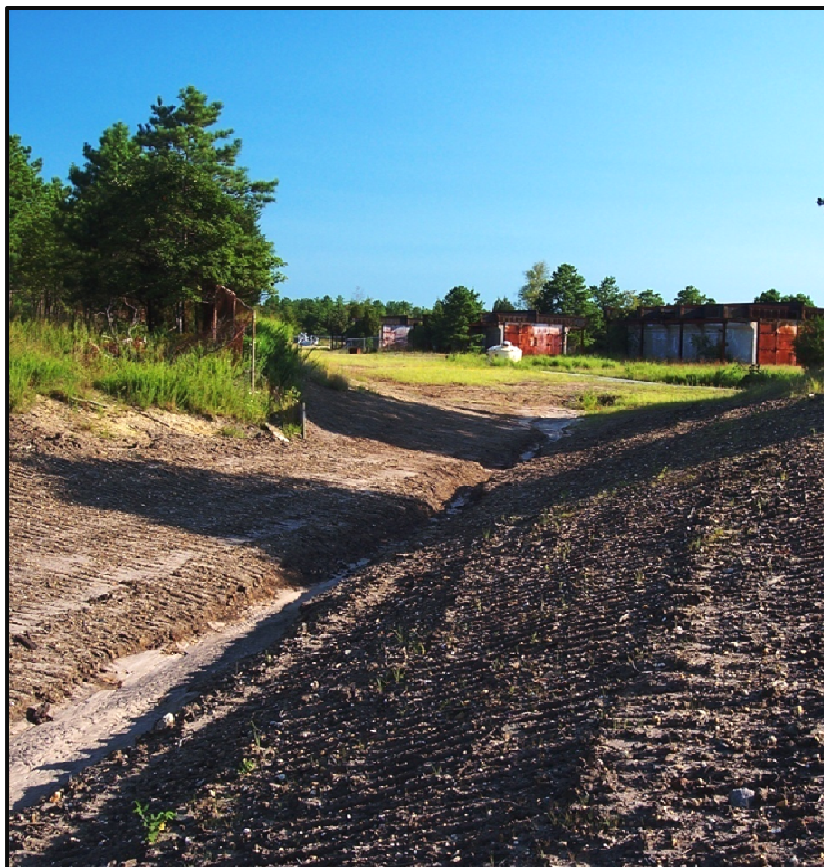
Figure 10-2. Restored Drainage Ditch Area.

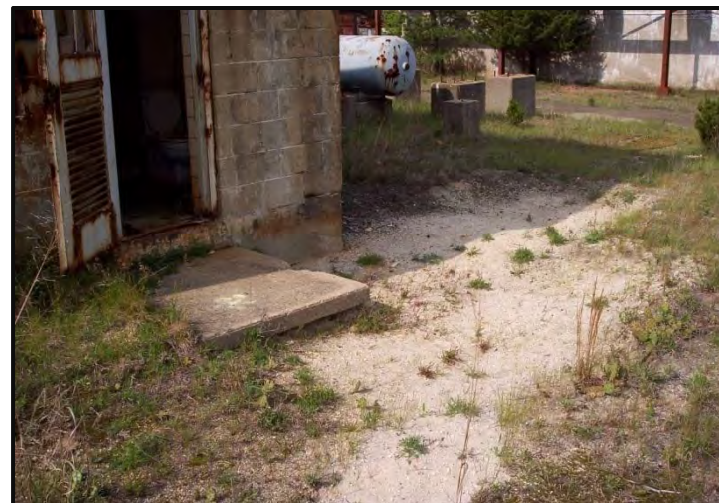
Figure 10-3. Area Surrounding Concrete Pad Outside Restroom in Building 159, within Missile Area.

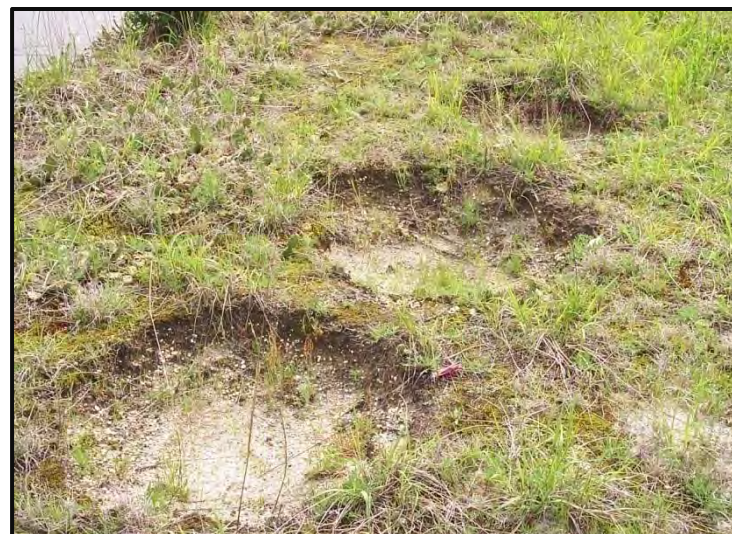
Figure 10-4. Restoration of Contaminated Soil, along Road.

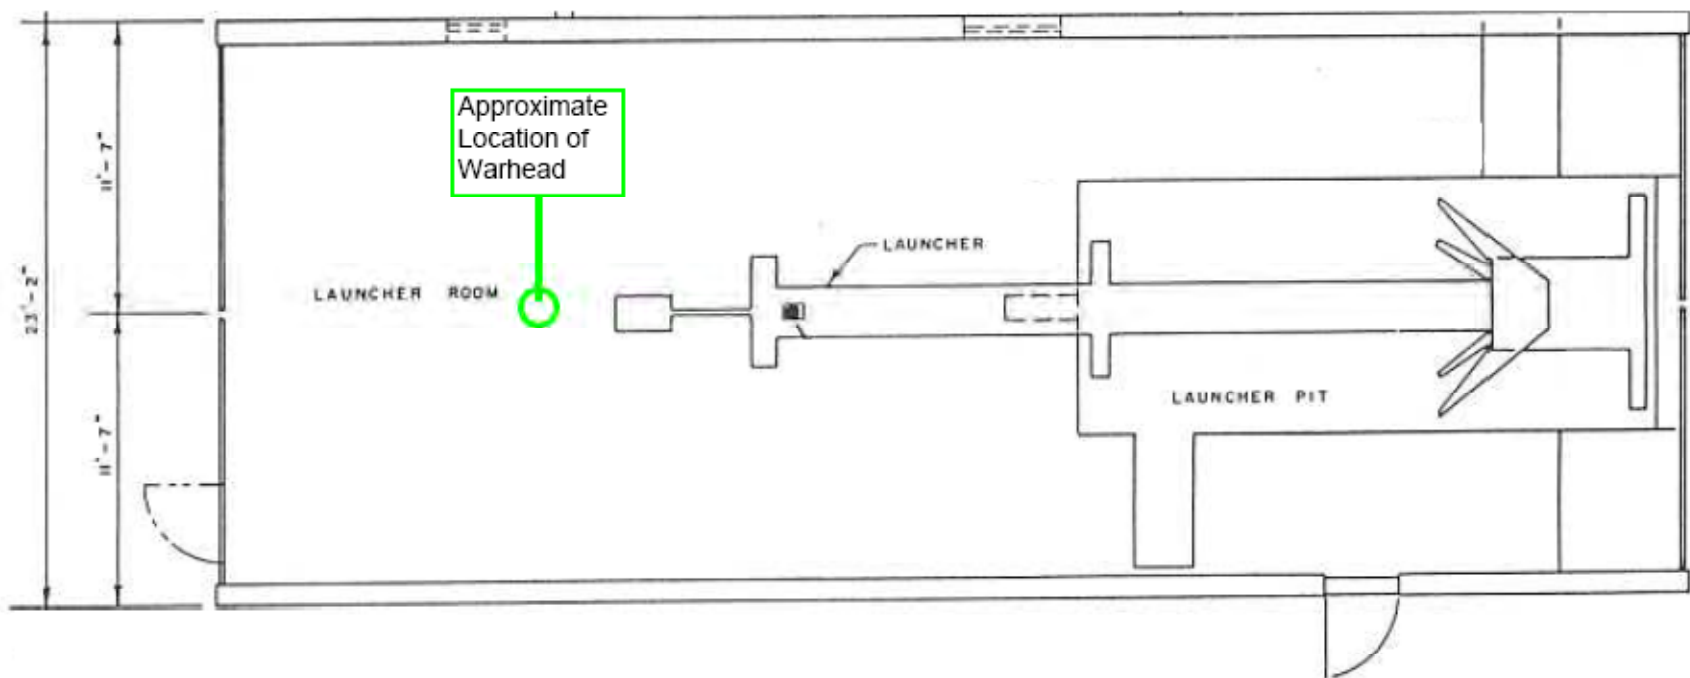
Figure A-3. Dimensions of Shelter Showing Simple Detail of Launcher Pit, Launcher, and Warhead Locations.

On 7 June 1960, at approximately 1500 hours, sensors in shelter 204 detected a fire, where a missile and warhead were in a war “ready” state. Based on an evaluation of the shelter post accident, officials determined that the fire was most likely initiated by the explosion of a pressurized helium tank which evidently caused the rupture of the 80-octane and JP-X fuel tanks. This allowed their fluids to flow into the 42-inch deep missile launcher pit where a substantial portion of the launcher mechanism was located. Within three to five minutes, a McGuire AFB fire-fighting crew responded, however, the fire was unabated for over 30 minutes because of the distance from the base to the site. While a small amount of carbon dioxide was applied to the fire, more than 30,000 gallons of water were applied throughout the initial response (with the fire hose wedged between the front two shelter doors). Approximately fifteen minutes into the fire, response personnel reported a muffled explosion associated with the ignition of high explosives in the weapon. [In this action, bright flashes of light are normally emitted, which are sometimes referred to as “arcing.”] However, according to an investigation conducted by Los Alamos Scientific Laboratory (LASL) weapons response team experts, the fuel fire initiated at the onset of the accident and produced the large black plume of smoke exhausted near the rear of the shelter (pit area), while the fire that ensued in the high explosive material of the warhead was separate in time and space [references in Crismon *et al.* (2001)]. Radiological material in the shelter was predominantly under the weapon with some contamination on the floor as expected from the large amounts of water used to mitigate the fire. However, contamination was not associated with the roof of the shelter or walls where the fuel fire had most violently exhausted in the initial stages of the accident. The LASL team reported that the center points of the two distinct fires were separated by about twenty feet, and the fuel fire was greatly diminished (or exhausted) by the time the fire in the high explosives liberated any plutonium. (See Figure A-3 for detail on the interior of the shelter.)

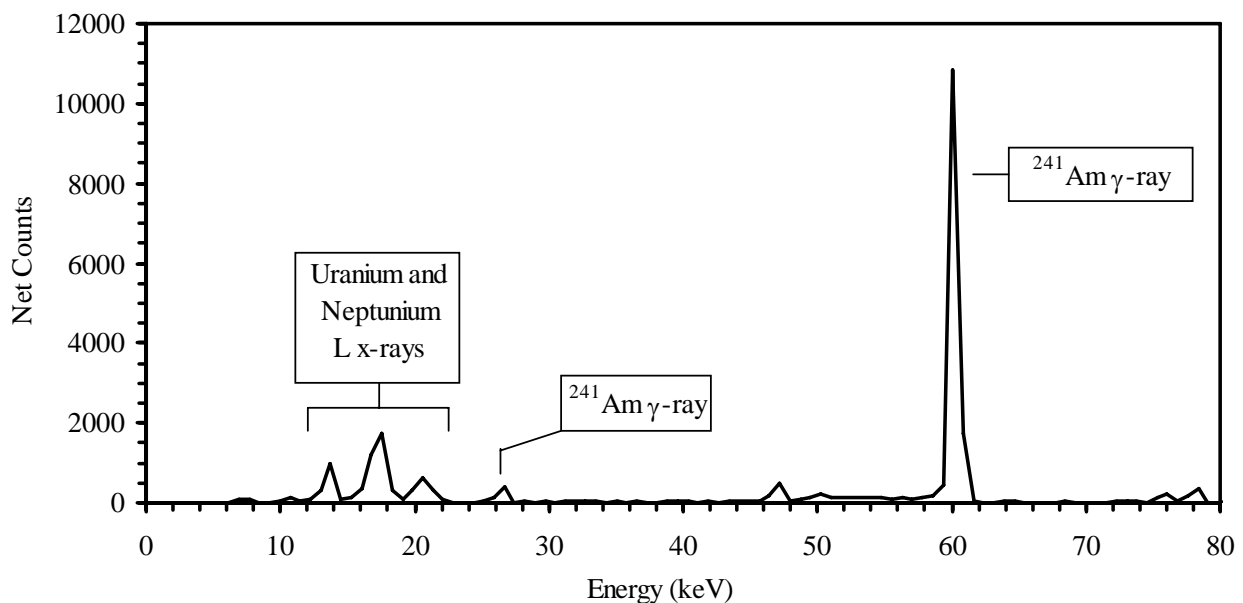
Figure A-5. Low-Energy Germanium Spectra for Discrete Particle Removed from a Shelter (Favret 2007).

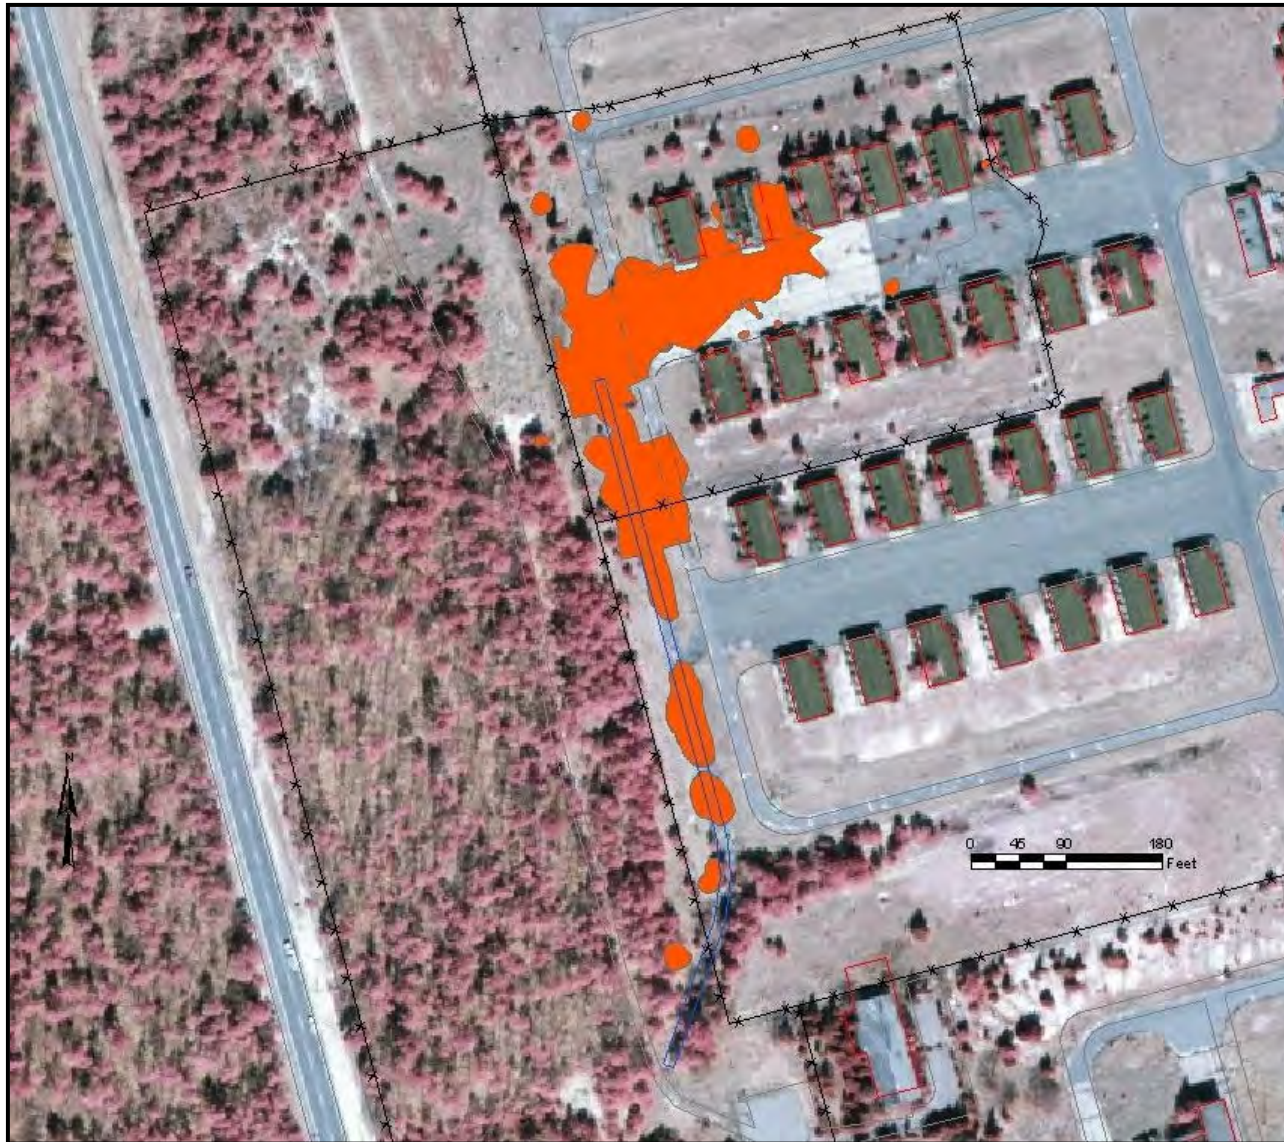
Figure A-13. 1996 Characterization Results (OHM 1996).

contaminated soil and debris at 8,661 yd³. The primary contaminated areas defined by the survey and shown in Figure A-13 closely corresponded to previous surveys.

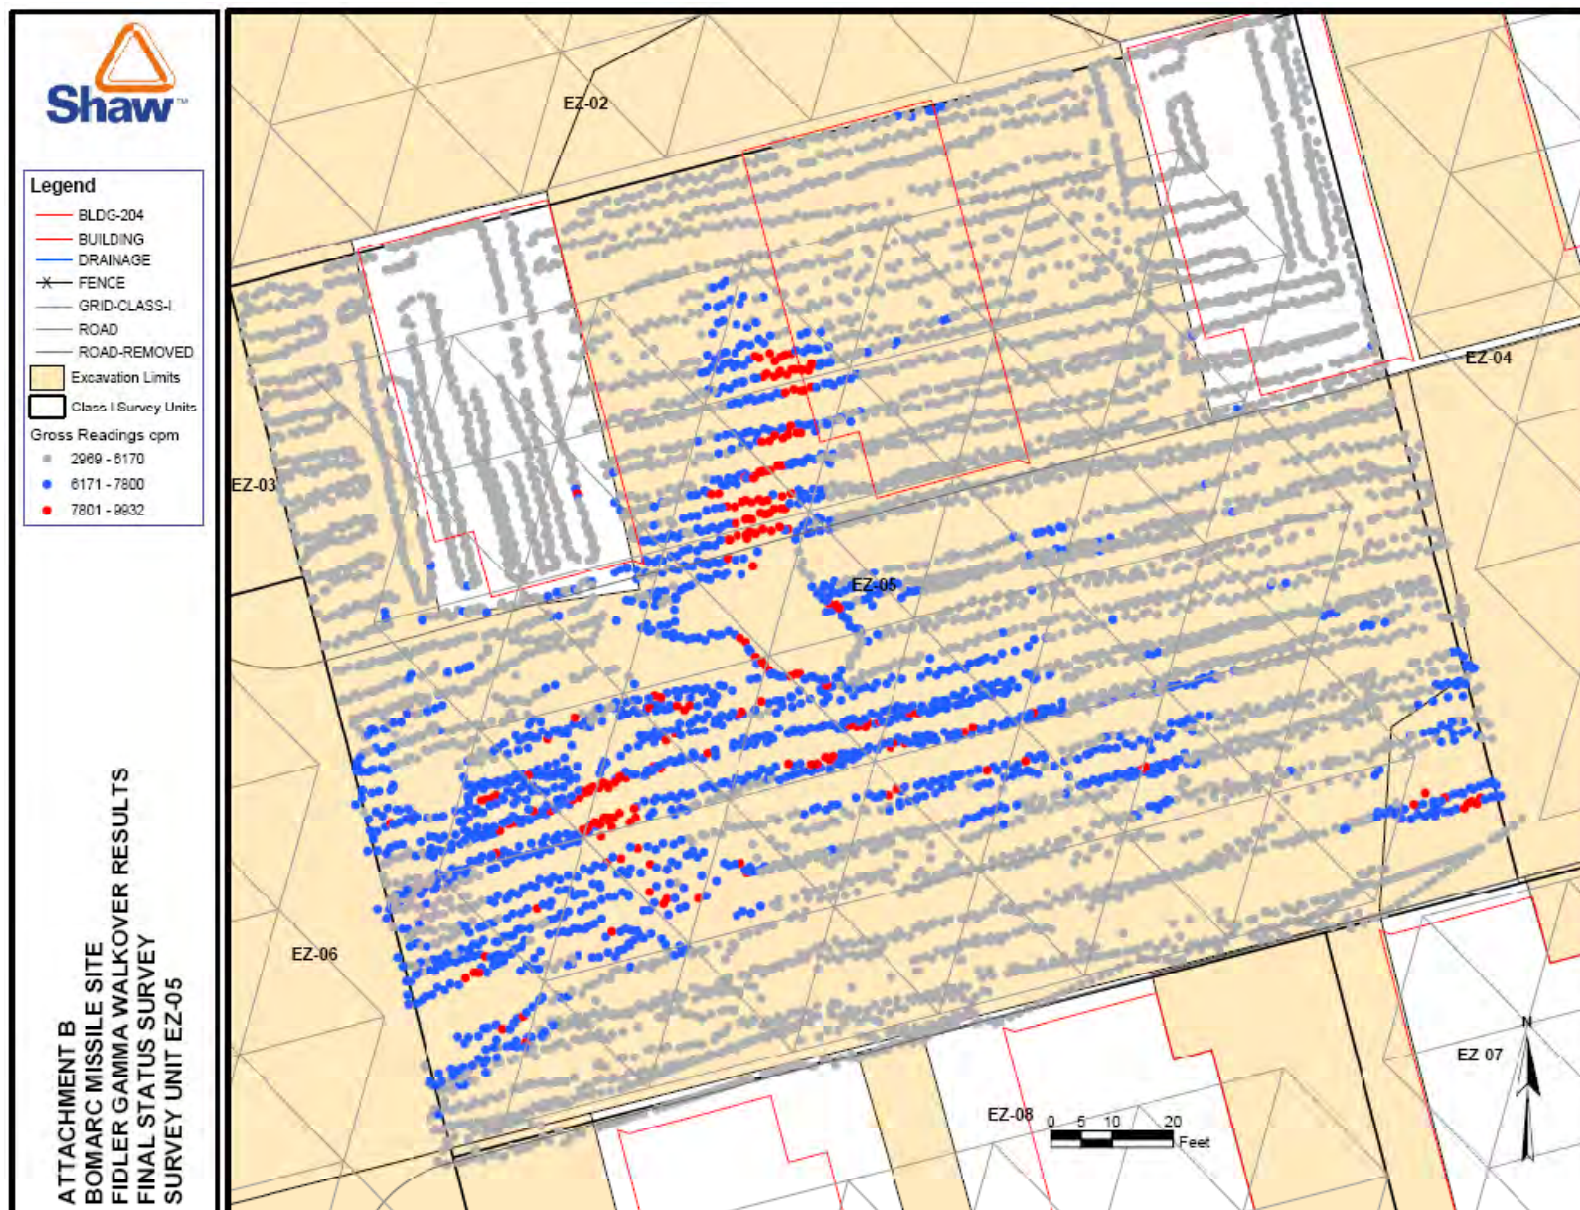
Figure B-6. Example FIDLER Scan Data for Survey Unit EZ-5 (Duratek 2005).

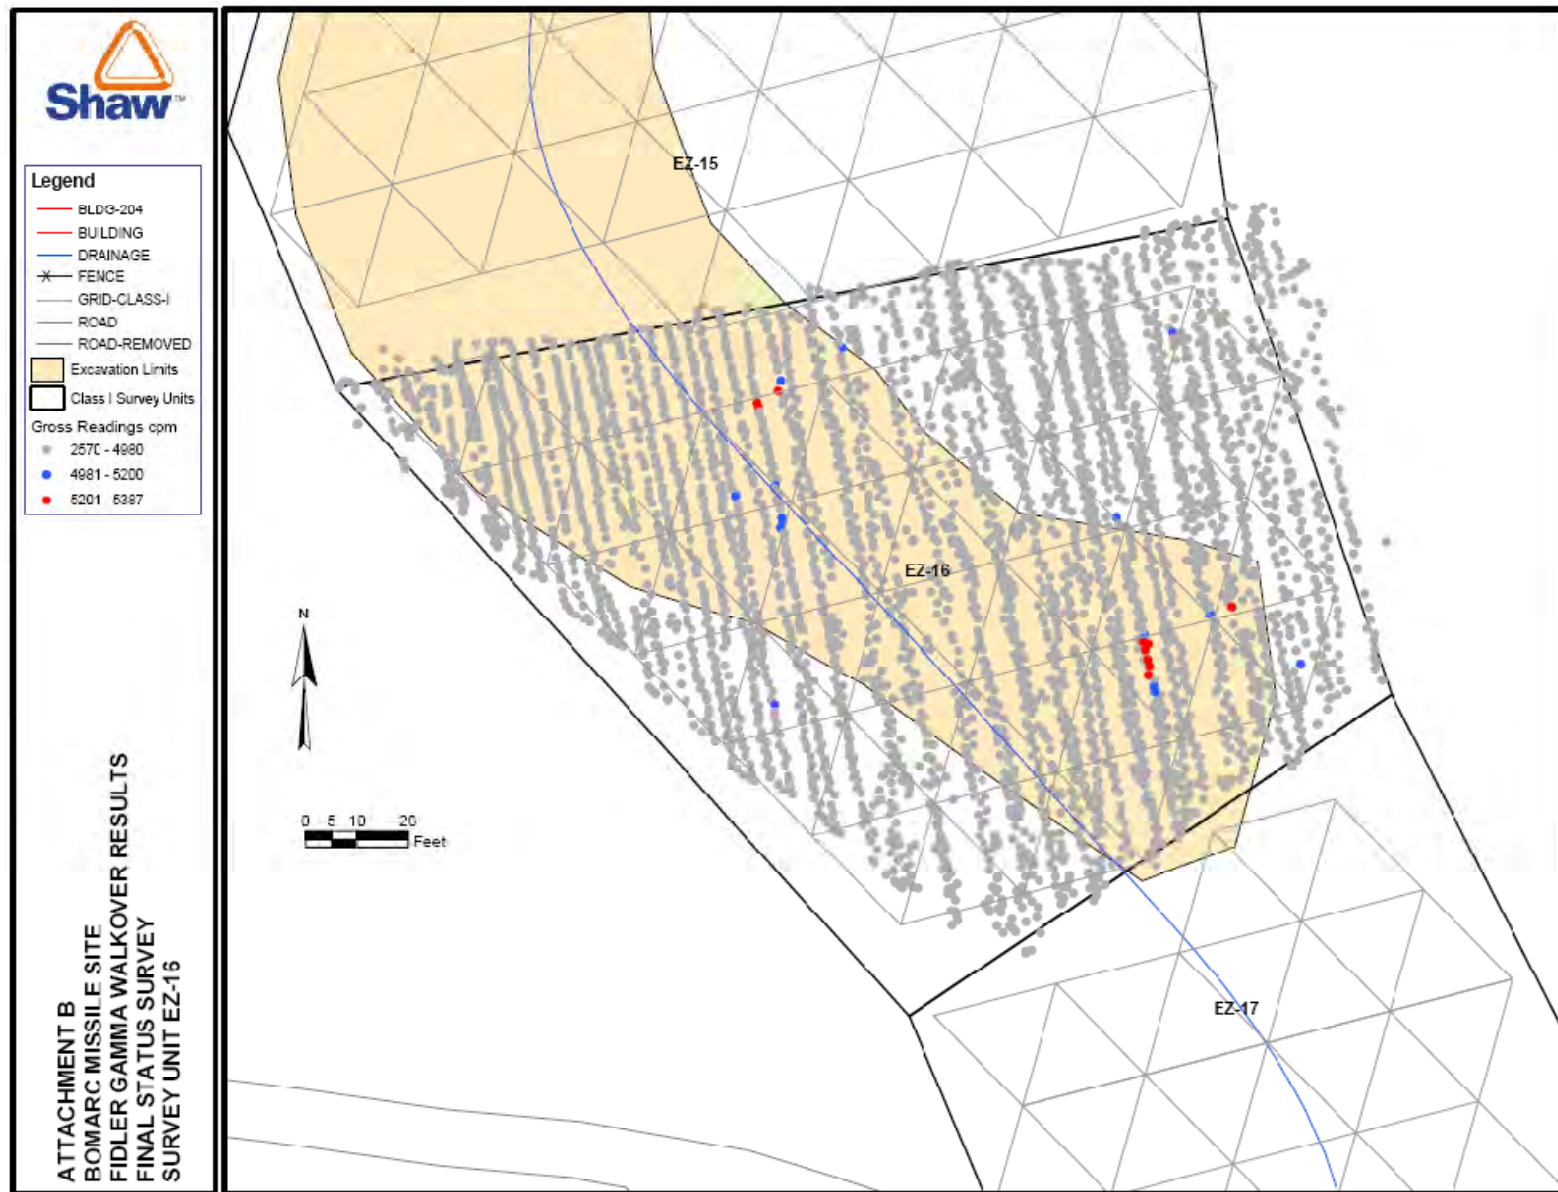
Figure B-7. Example FIDLER Scan Data for Survey Unit EZ-16 (Duratek 2005).

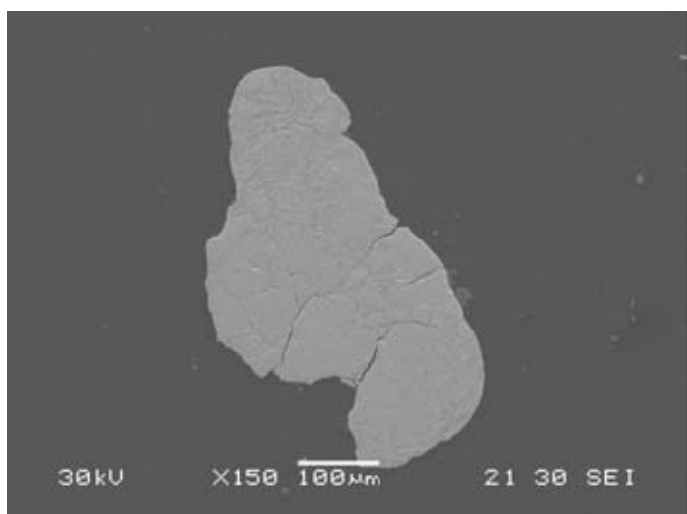
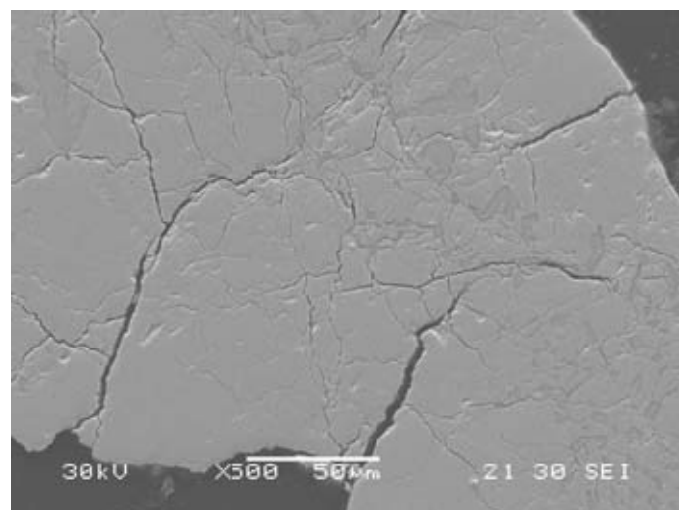
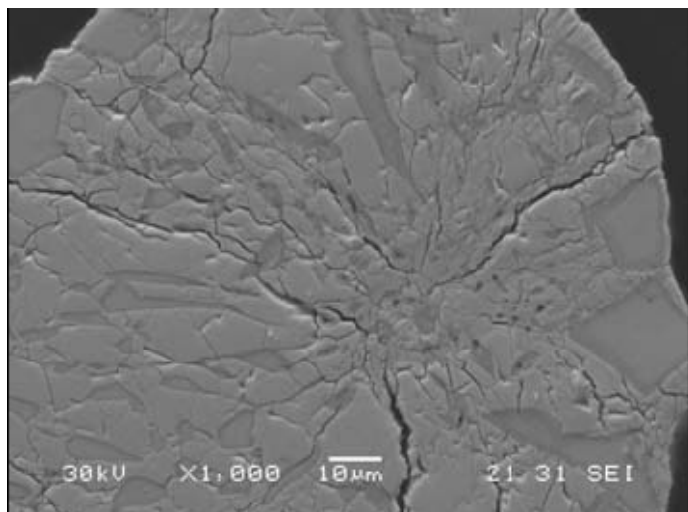
Figure C-4. Scanning Electron Microscopy (SEM) Image, 0.8 μCi $^{239+240}\text{Pu}$ Particle Evaluated by Radiochemistry Research Group, Harry Reid Center and Department of Chemistry, University of Nevada, Las Vegas, NV [Figure 13, Appendix E, (Cabrera 2006c)].

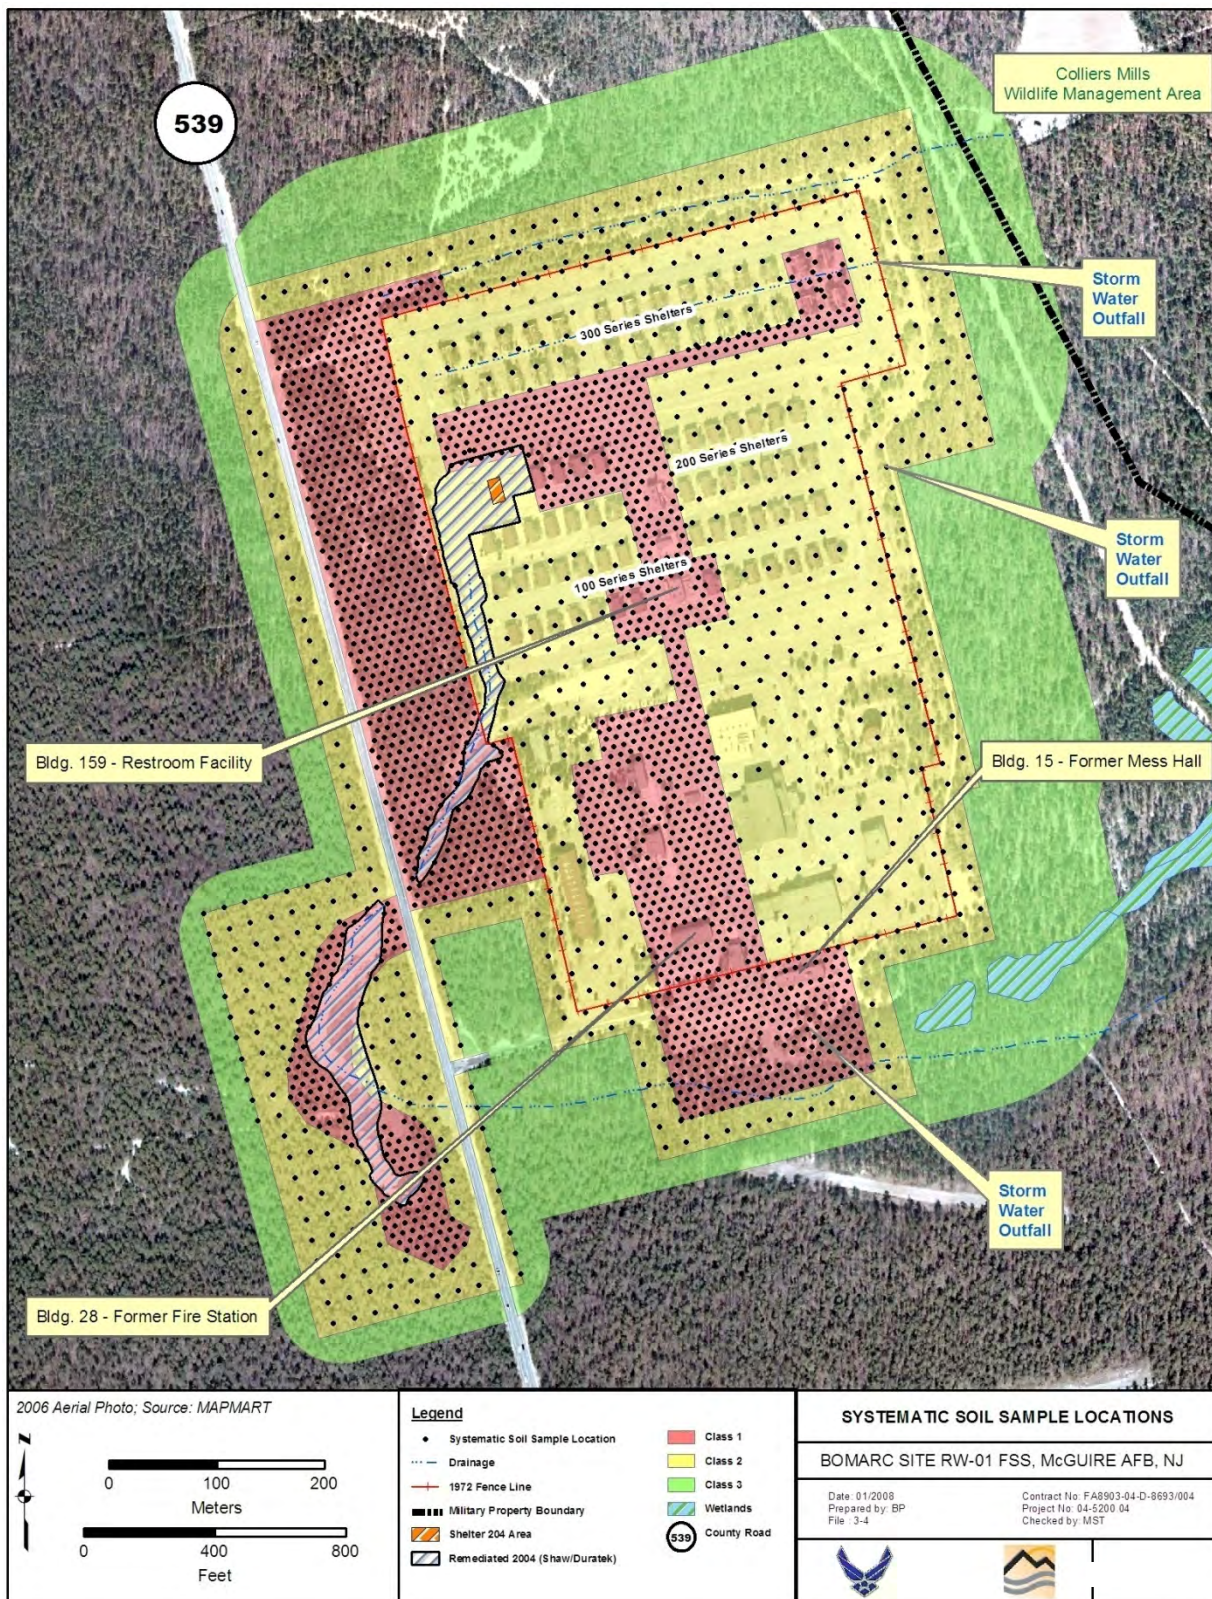
Figure C-15. Systematic Soil Sampling Locations Supporting Final Status Surveys in Secondary Areas (Cabrera 2008).

Figure C-15 shows systematic soil sampling locations in support of the final status survey. The class 1 areas had 1956 samples among 78 individual survey units. A summary of the results are contained in Table C-3. For the vast majority of the survey units, no remedial actions were accomplished based on an elevated systematic soil sampling result, but rather based on scanning survey results. The table contains average $^{230+240}\text{Pu}$ concentrations for each survey unit. Seven of the survey units (data highlighted in gray) had systematic sample(s) replacement, based on remedial efforts. The average concentrations in the survey units are based on pre-remedial action sampling, while the maximum concentrations listed reflect the value for pre-remedial and post-remedial action sampling. Among the systematic samples, the highest was 1000 pCi/g, and located in survey unit 43, in the vicinity of the 200-series shelter area. Figure C-16 shows individual survey unit locations. For survey unit 43, the pre-remedial action average $^{239+240}\text{Pu}$ activity concentration was 37 pCi/g, but was almost entirely influenced by the sample with the maximum activity. From the re-sampling of this area, the average net $^{239+240}\text{Pu}$ activity concentration among the samples was indistinguishable from background. Survey unit 43 was the only one with a pre-remedial action $^{239+240}\text{Pu}$ activity concentration greater than the DCG_{Lw} of 8 pCi/g. Eight-hundred twenty-three samples were collected in the class 2 survey unit. Only 14 of the samples were above the decision level of the method for ^{241}Am , with the sample with the maximum calculated $^{239+240}\text{Pu}$ at 5.1 pCi/g. All survey units passed the sign statistical test recommended by MARSSIM.

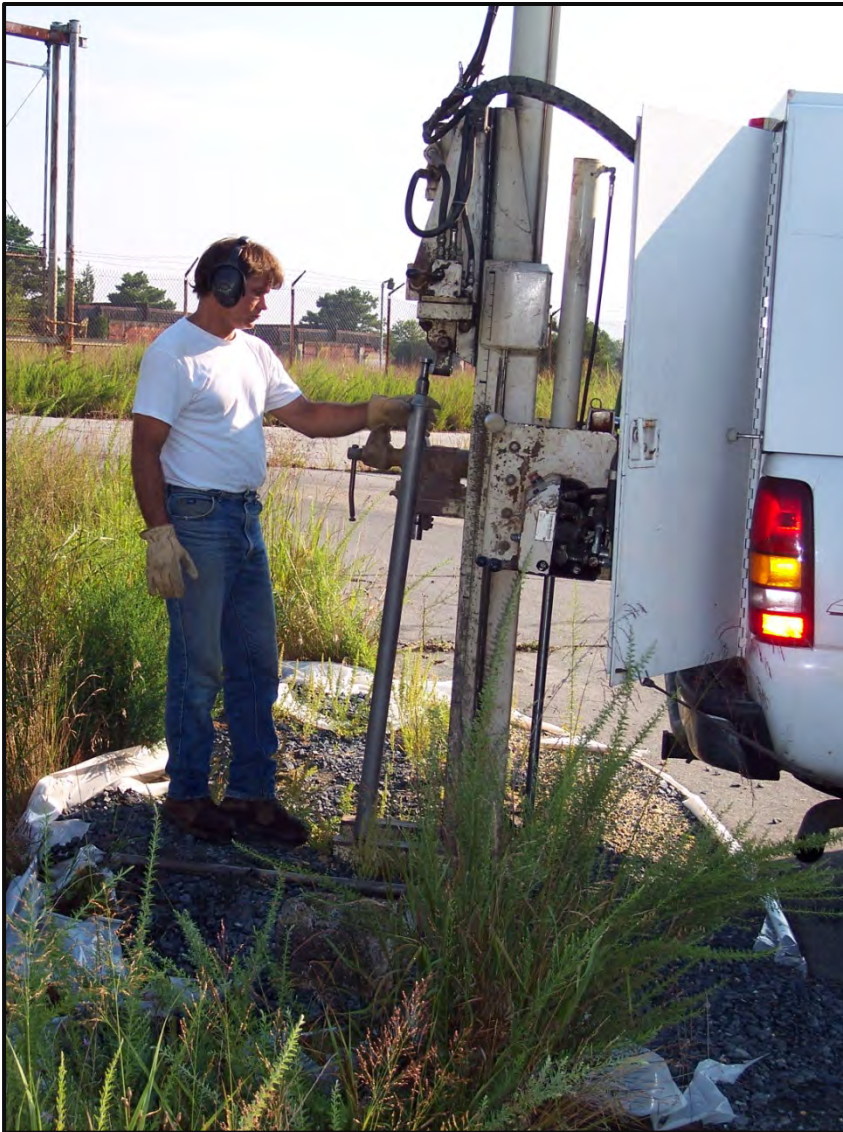
Figure C-19. Direct-Push Rig Sampling Location with Positive ^{241}Am Finding, Along Road Edge, South of Missile Area Entrance Gate.

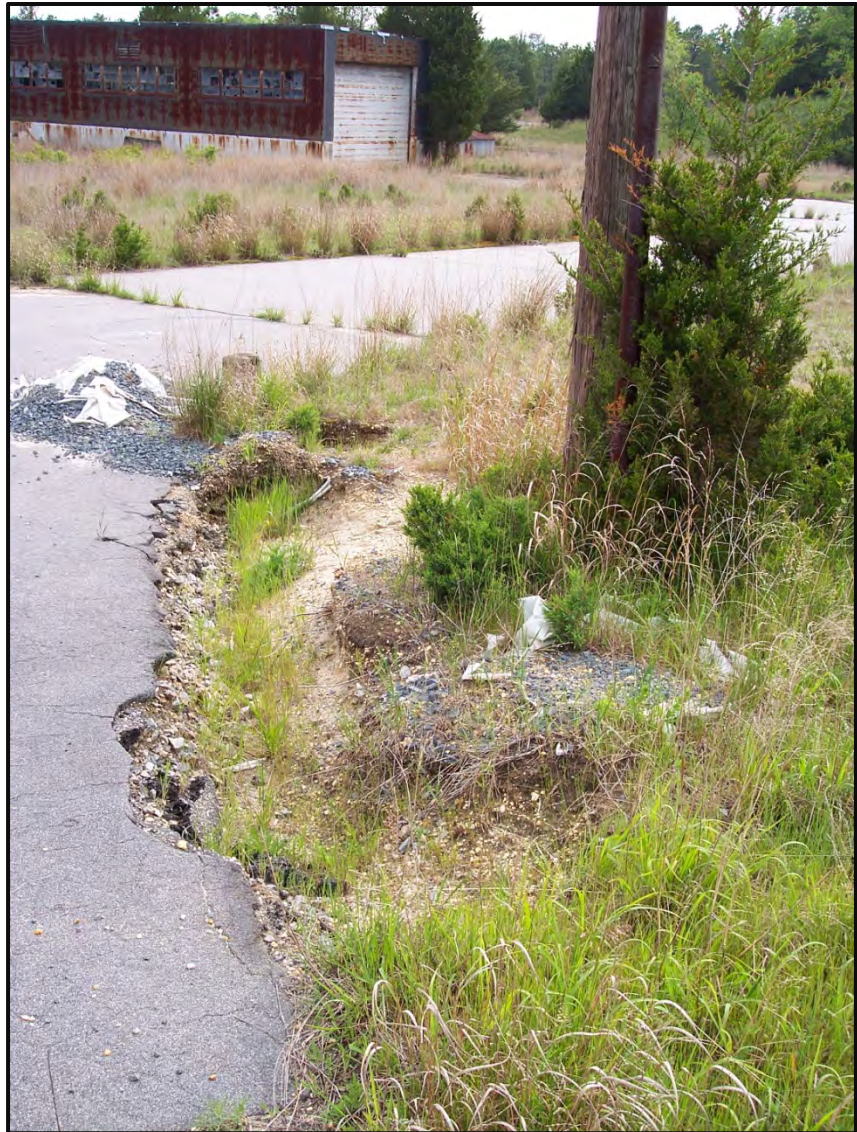
Figure C-20. Location Sampled in Figure C-19, Post Sampling and Remediation of Contaminated Soil, Just Along Edge of Road.

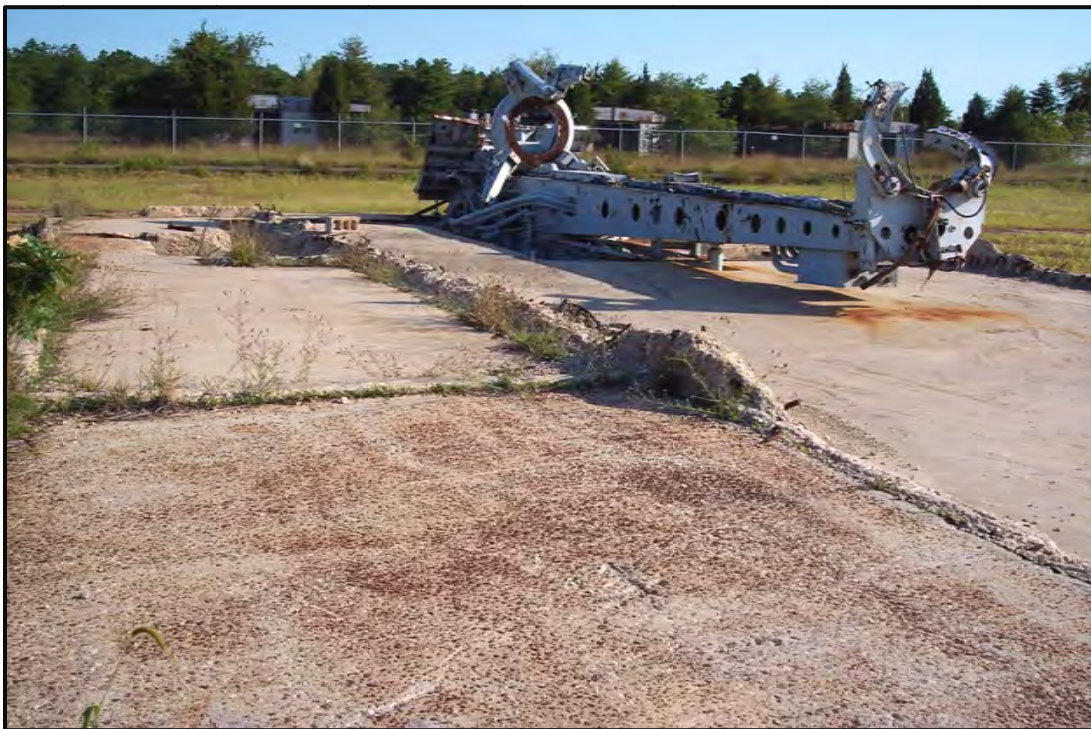
Figure D-4. Photograph of Residual Concrete Pads, Launchers, and Pits of Shelter 202.

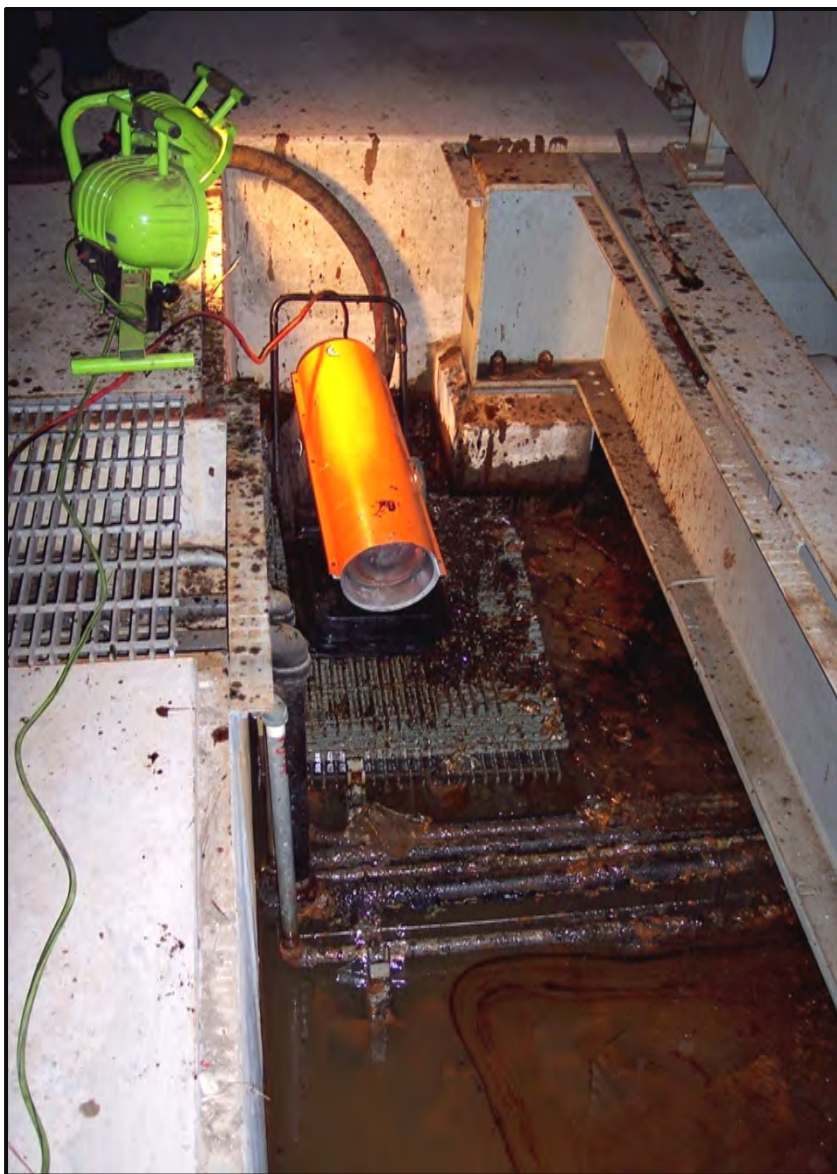
Figure E-1. Fluid Pumping from Pits.
