**HEADQUARTERS
AIR FORCE SAFETY CENTER**

**Boeing Michigan Aeronautical
Research Center (BOMARC), Final
Remedial Action Report for Site
RW-01, McGuire AFB, N.J.**

17 May 2010

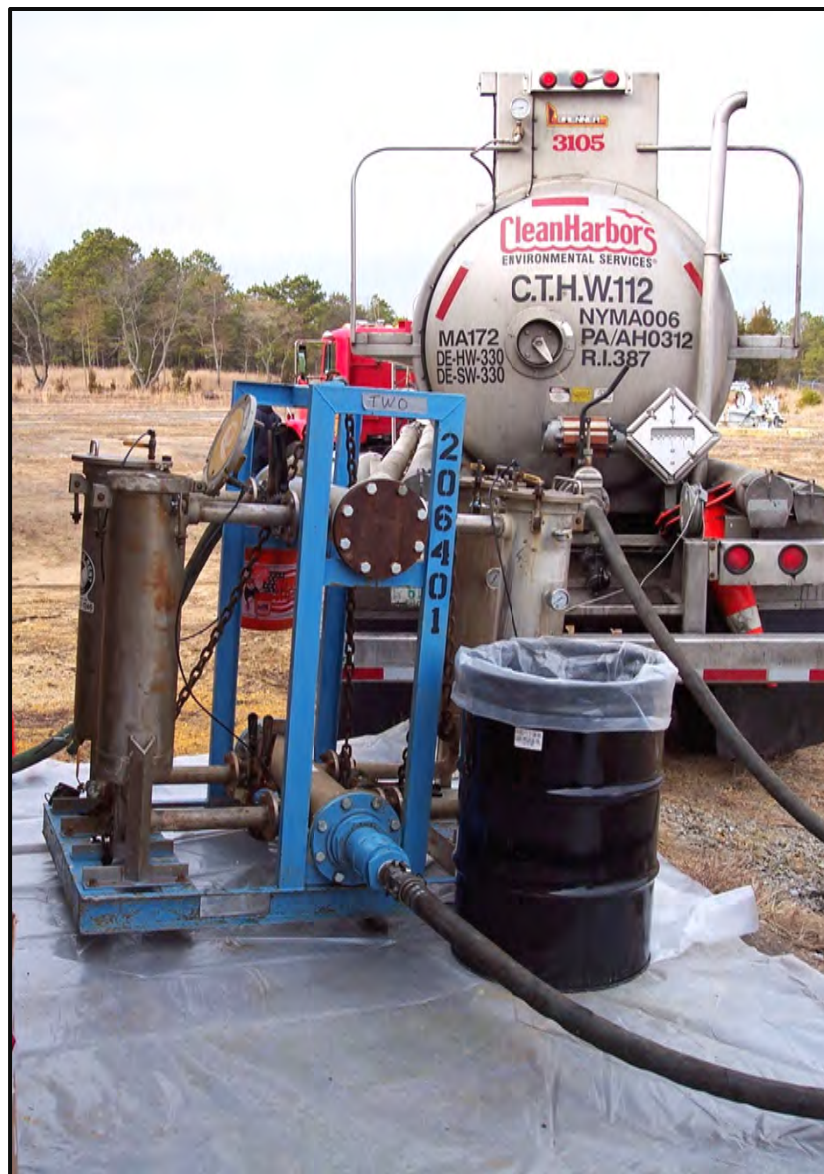
Figure E-2. Filtering and Storage of Pumped Fluids.

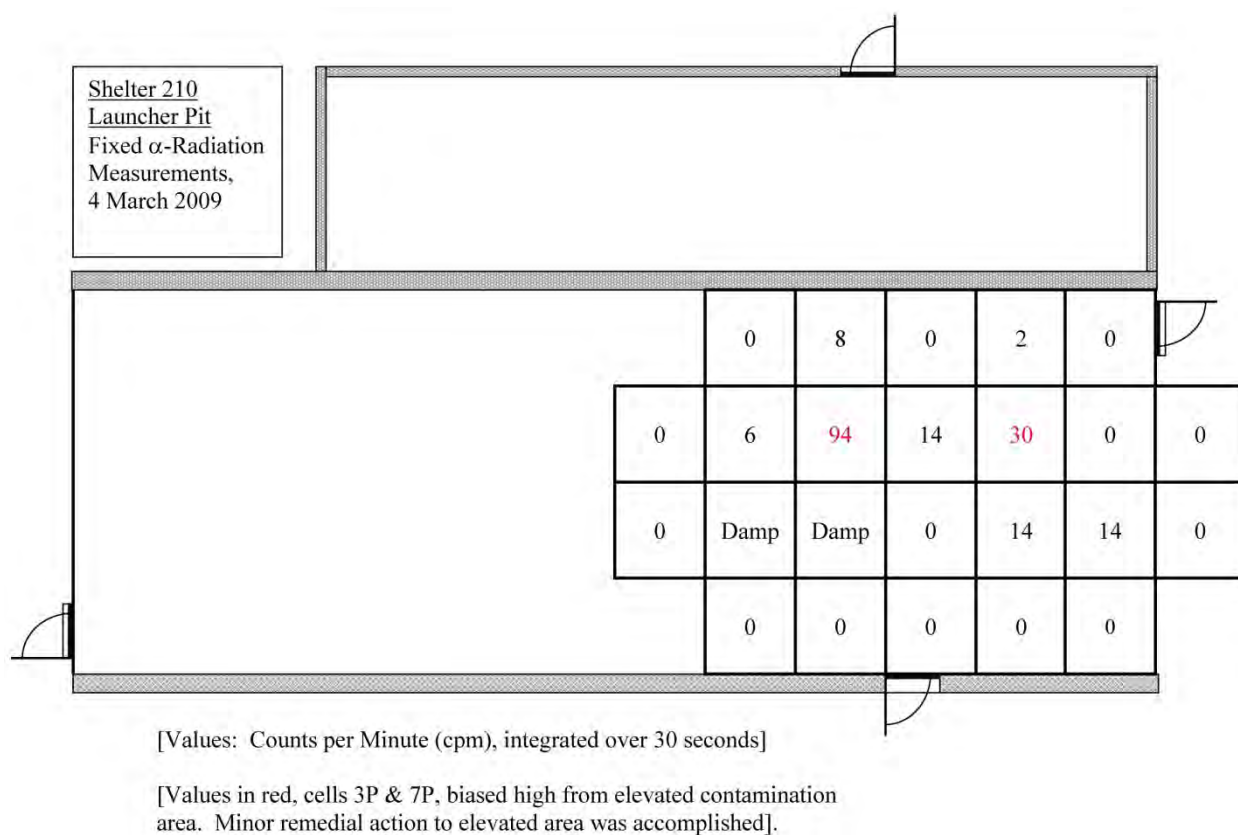
Figure E-3. Fixed α -Radiation Measurements in Launcher Pit of Shelter 210 [Appendix F, Rademacher *et al.* (2009)].

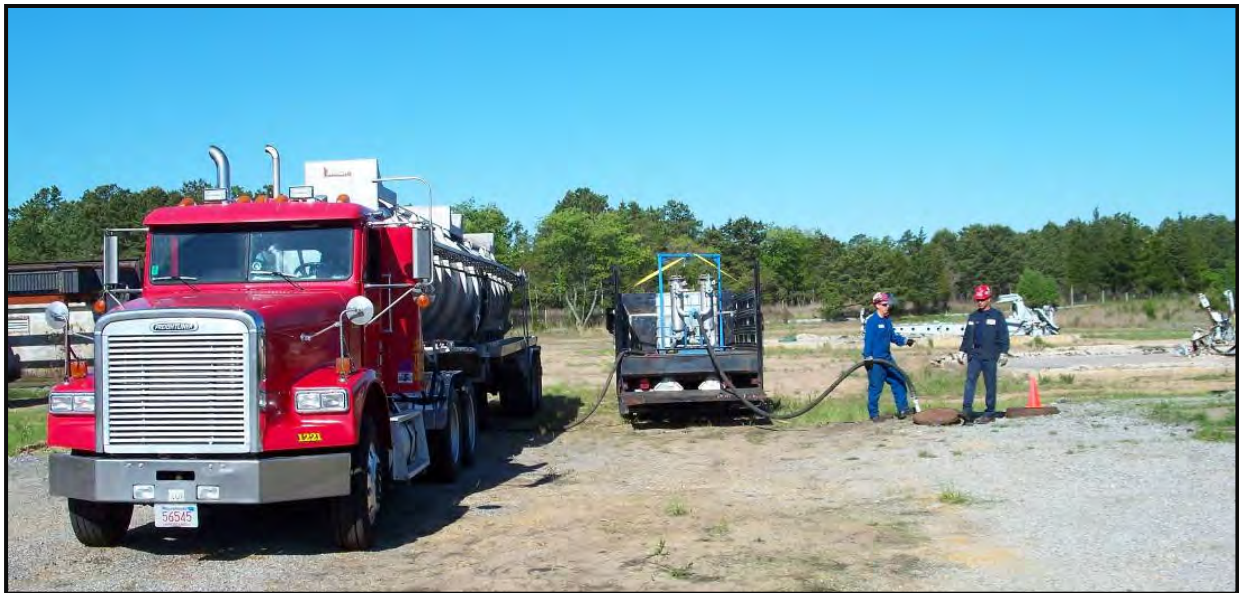
Figure E-4. Pumping and Filtering Water from Shelter 208 Power Bunker.

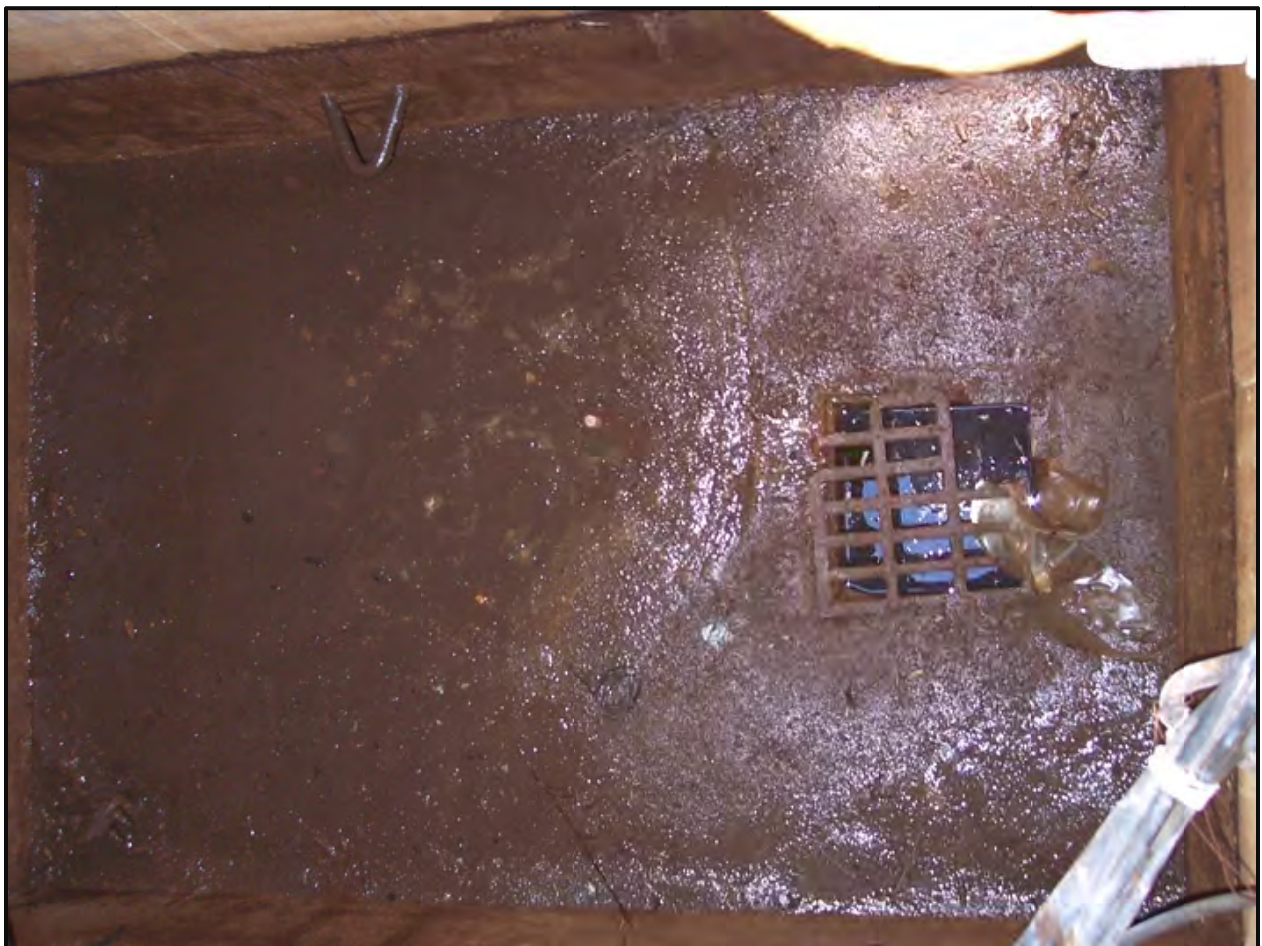
Figure E-5. Photo of Interior of Shelter 208 Power Bunker.

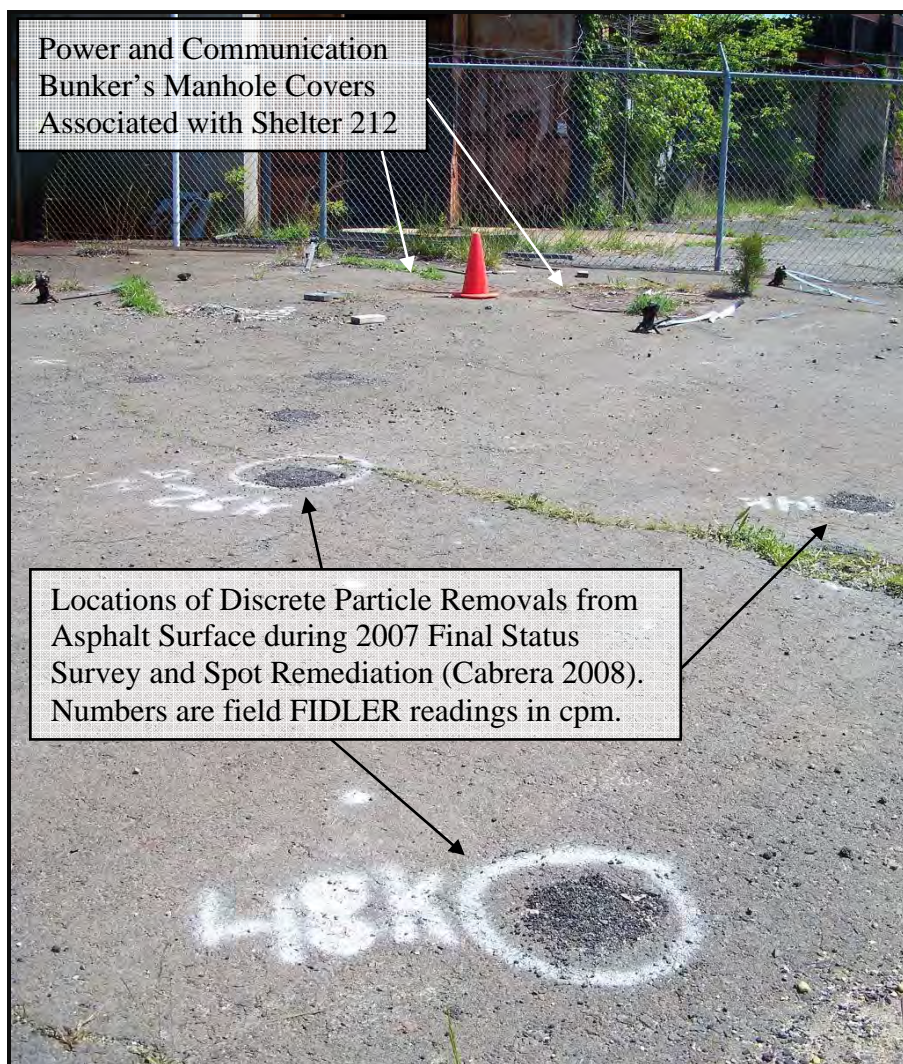
Figure E-7. Asphalt Area in Vicinity of Manhole Covers to Shelter 212 Communication and Power Bunkers (White Paint Identifies FIDLER Reading and Location of Discrete Particle Removals).

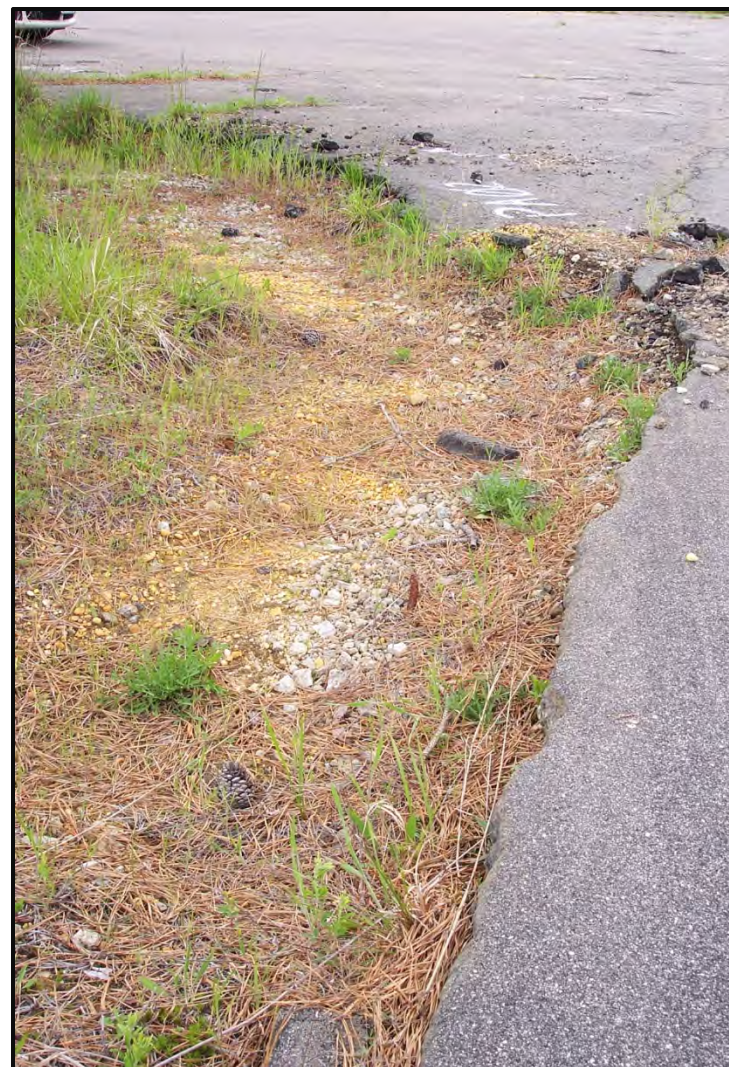
Figure E-8. Soil Contamination Removal Area Near Shelter 213 (Area 1 on Figure E-6).

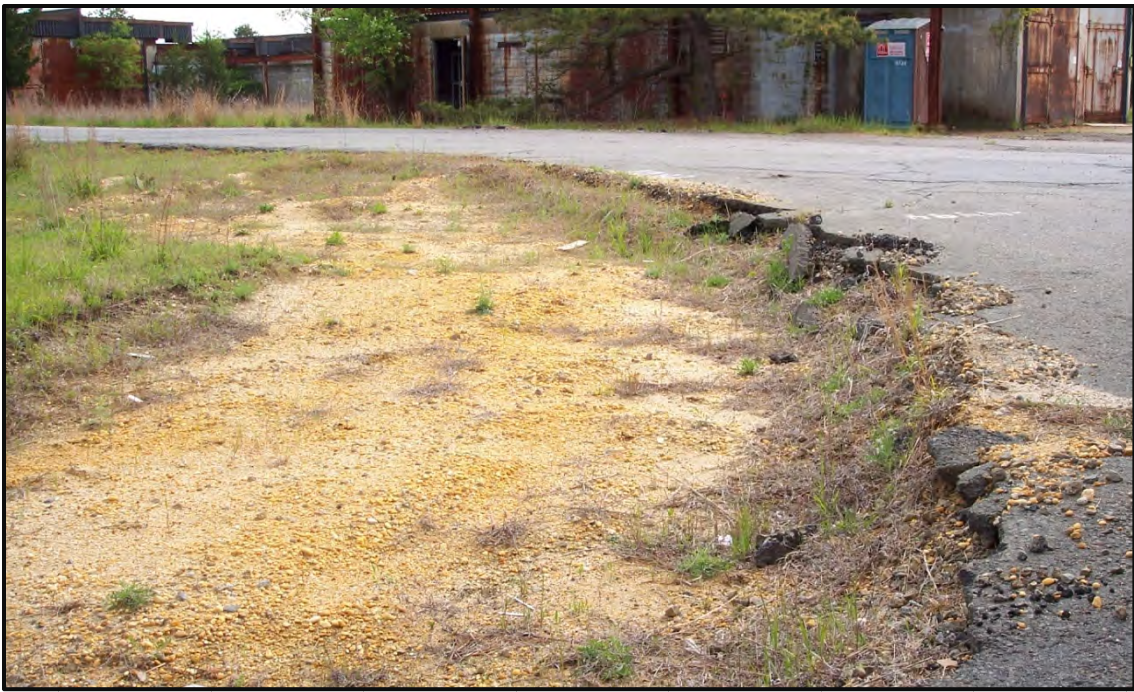
Figure E-9. Soil Contamination Removal Area Near Building 162 (Area 2 as Annotated on Figure E-7).

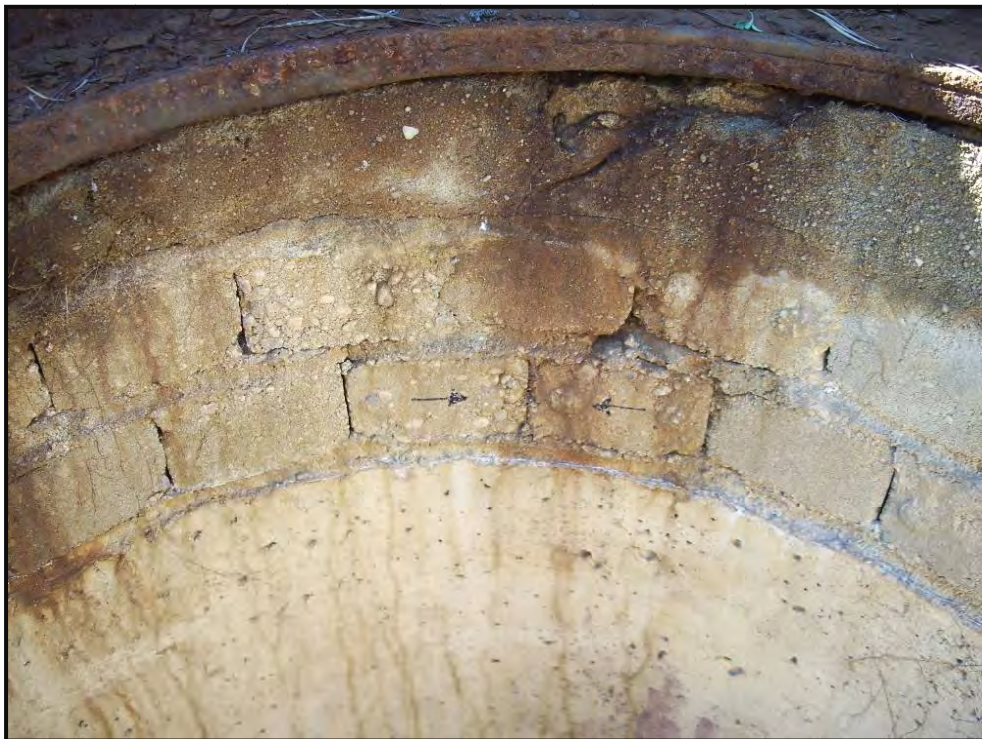
Figure E-10. Bulkhead to Shelter 216 Power Bunker (Arrows Indicate Location of α -Radiation Contamination on Grout).
