DoD Corrosion Prevention and Control Program

Rehabilitation of Deteriorated Wood Railroad Ties Using Inorganic Polymers

Final Report on Project F17-AR03

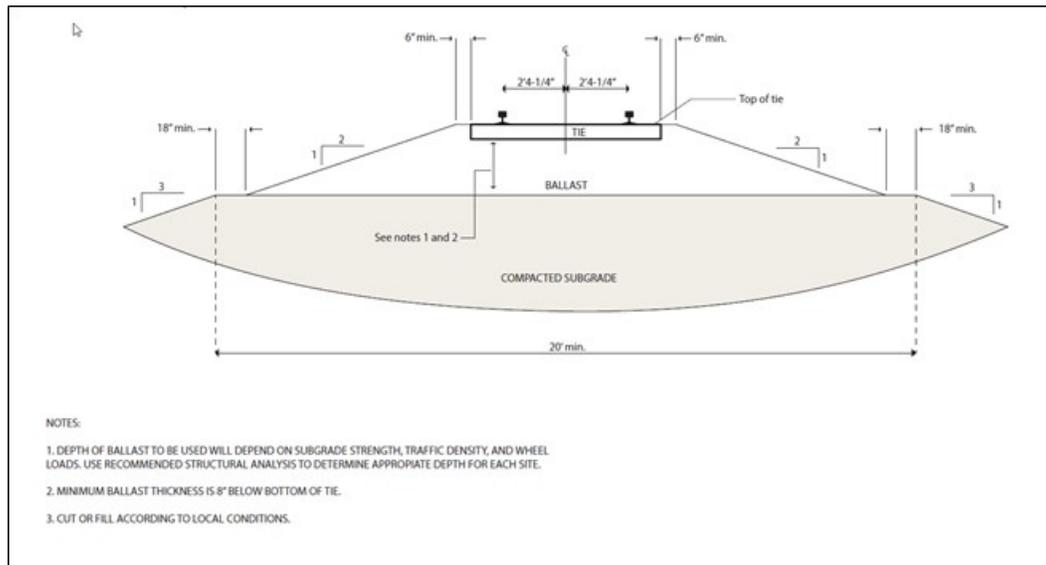
track modulus with the properties of individual track components such as the crossties. Railroad track carrying annual traffic volumes of 5 MGT (million gross tons) or lower is common at military installations. In such a use case, wood ties are more likely to fail from decay than from either mechanical wear or loss of spike-holding capability. The two common cross-sectional sizes for wood crossties are (1) 7 in. thick x 9 in. wide and (2) 6 in. thick x 8 in. wide. The 7 x 9 in. ties are recommended for areas with higher traffic volumes and wheel loads, as well as for use in turnouts and road crossings. Track ties are commonly produced in 8.5 ft or 9 ft lengths, and the 8.5 ft length is used for standard ties when most conveniently available. The typical cross section of track is shown in Figure 1.

Figure 1. Cross section of typical railroad track and foundations.

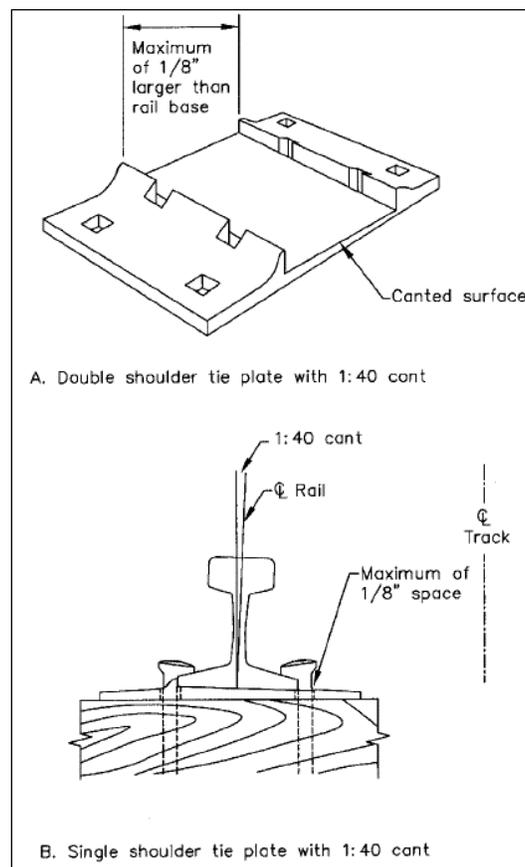
Another critical component of railroad track—tie plates—also varies in available length and width. Most sizes are suitable as long as the spike hole punching (or distance between the shoulders for double-shoulder plates) matches the width of the rail base. Either single- or double-shoulder tie plates can be used (see Figure 2). For double-shoulder tie plates, the distance between the shoulders will be at most 1/8 in. larger than the rail base width. On single-shoulder plates, the spike holes on the gage side (opposite the shoulder) must keep the inside face of the spike within 1/8 in. of the rail base when the opposite edge of the base is against the shoulder. Within a given length of track, tie plates of different lengths and widths may be used, and single-shoulder plates may be mixed with double-shoulder plates. However, plates with different cants (i.e., those with level rail

seats and those with a 1:40 slope) will not be mixed. Tie plates with a 1:40 cant are preferred.

Figure 2. Tie plates.

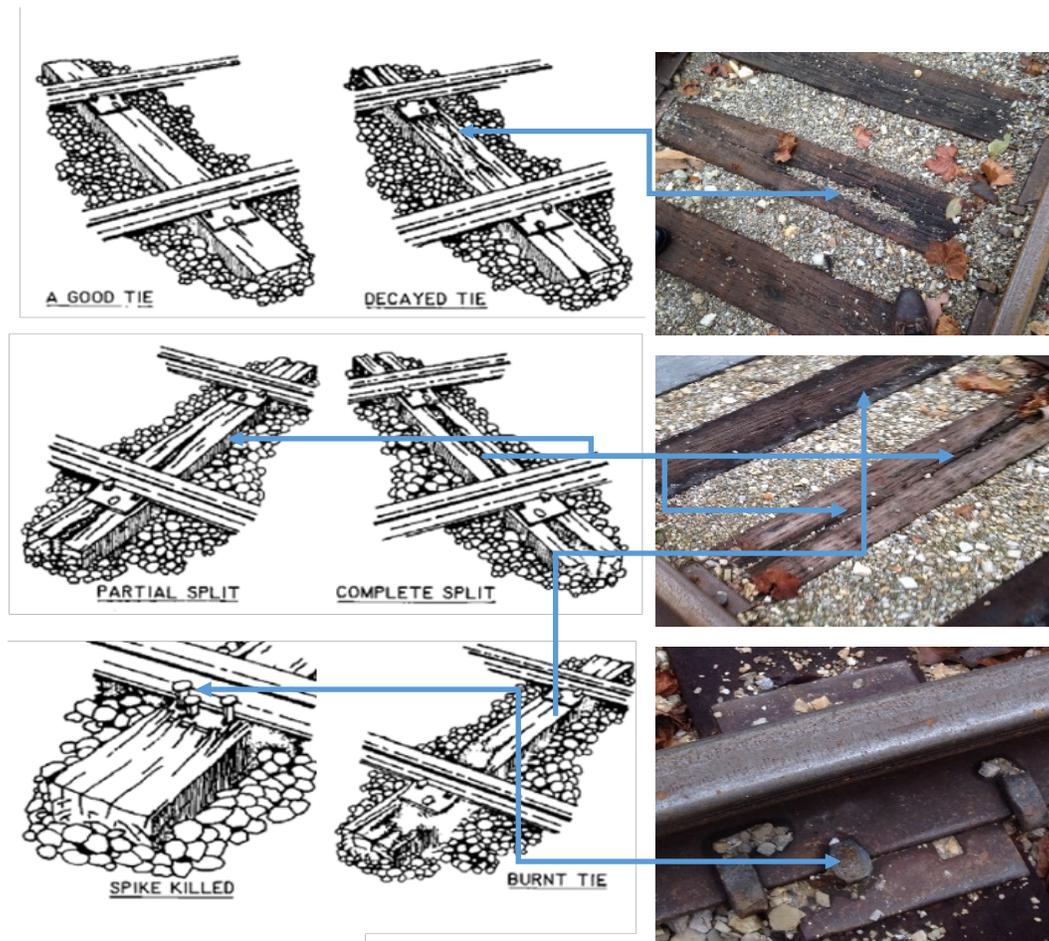
Modes of failure that could be reversed by using inorganic polymer repair-in-place techniques are shown in Figure 3.

Figure 3. AREMA failure modes that are treatable using in-place inorganic polymer application.

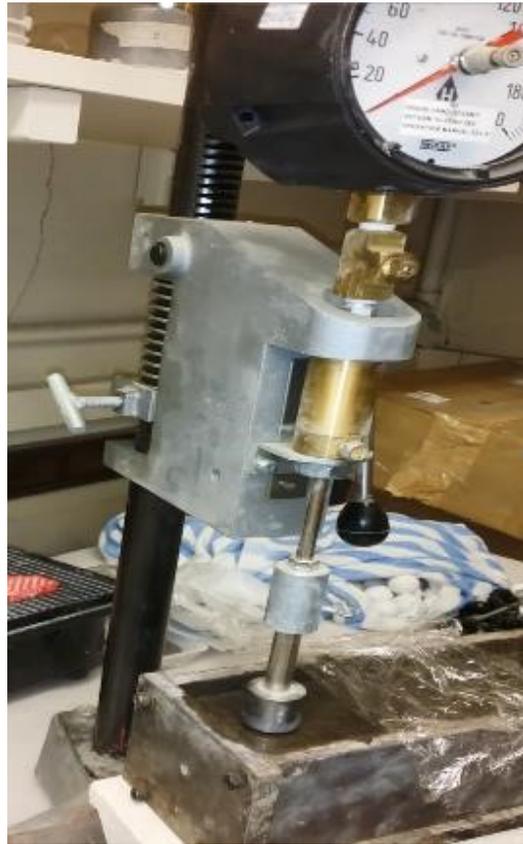
Setting time of binders was measured using ASTM C403 Proctor penetration resistance test. This test was originally developed for mortars sieved from concrete. Penetration tests measure gel strength. Based on previous studies that extended ASTM C403 to cements, initial set was empirically assigned when penetration resistance reached 2 MPa, and final set was assigned when penetration resistance reached 14 MPa. See Figure 5 for proctor test apparatus.

Figure 5. Proctor test apparatus.

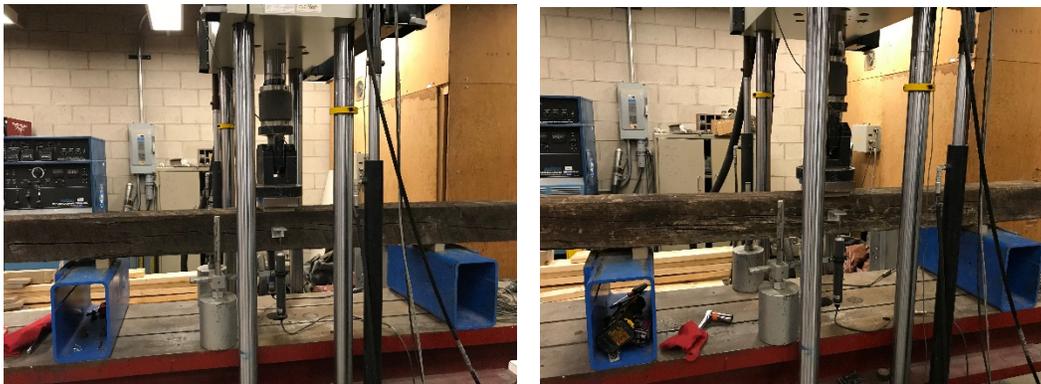
Damaged crossties were selected for rehabilitation using candidate inorganic polymer mixes. Structural strength of the rehabilitated ties was tested in accordance with ASTM C293. Figure 6 shows the three-point test setup with an undamaged crosstie (left) and a non-rehabilitated specimen taken from field service (right) mounted in the testing device.

Figure 6. New, undamaged tie (left) and aged tie without rehabilitation (right) were tested as baselines.

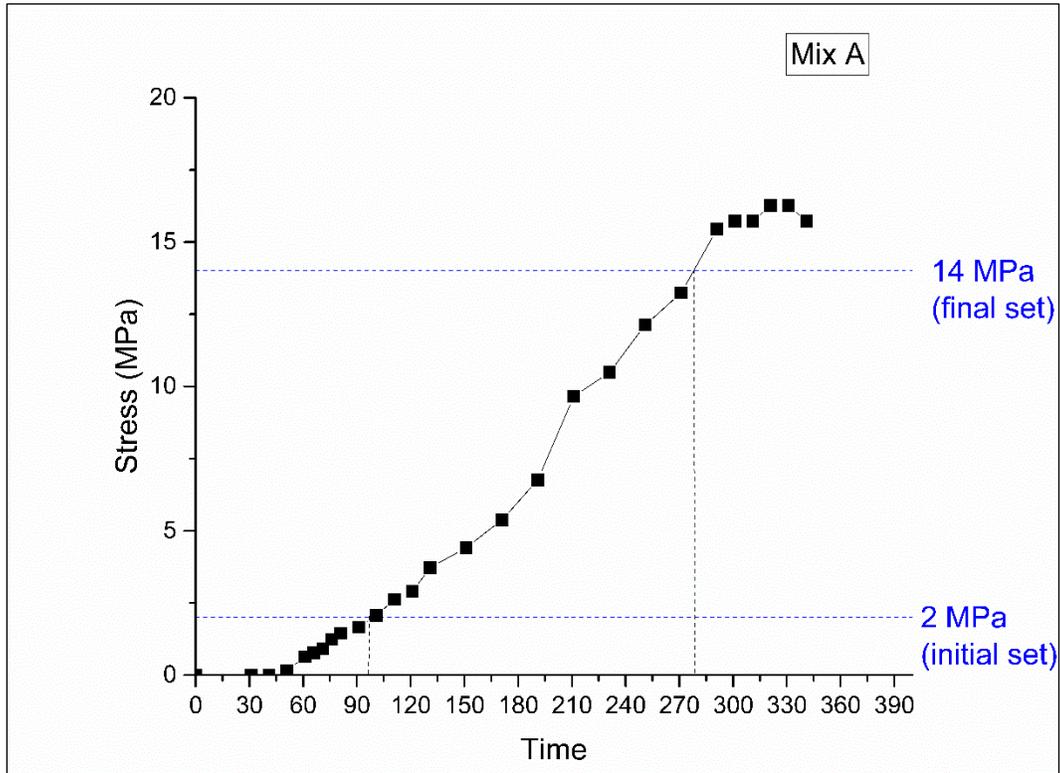
Penetration tests provide a better idea of how stiff the binder gets with time. Figure 7 plots penetration test results on Mix A, with initial set at 95 minutes and final set at 280 minutes. As shown in Figure 8, Mix B set at 125 minutes and achieved final set at 233 minutes. Figure 9, for Mix C, shows initial set at 60 minutes and final set at 270 minutes.

Figure 7. Penetration test of Mix A.

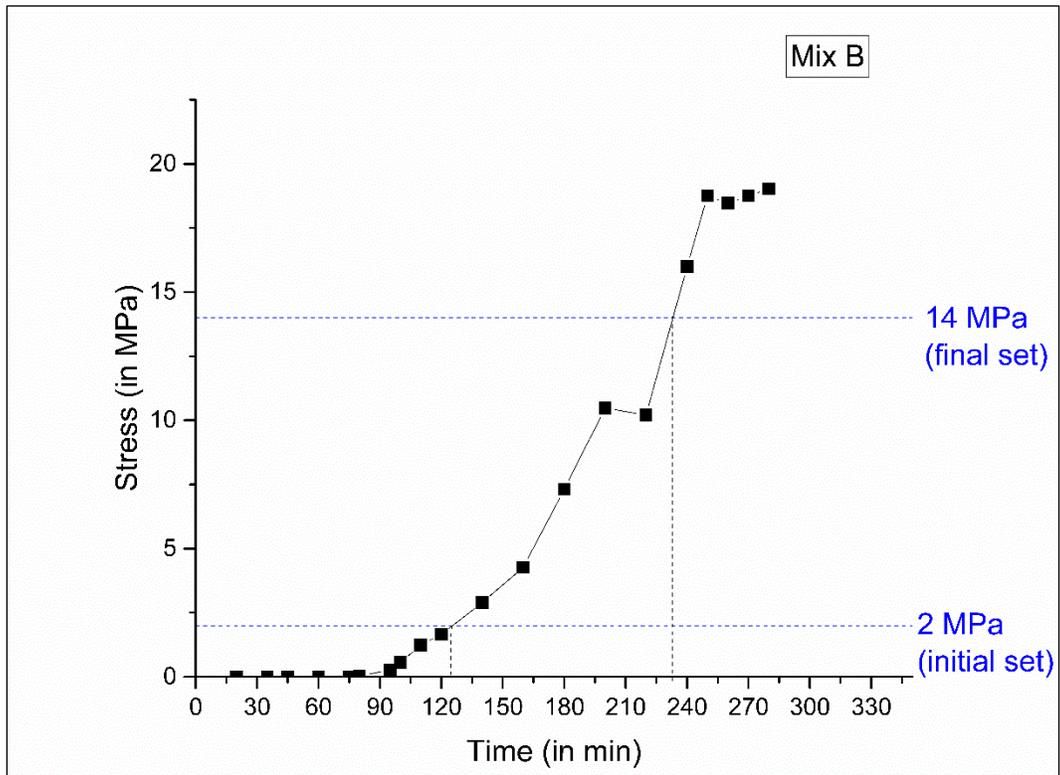
Figure 8. Penetration test of Mix B.

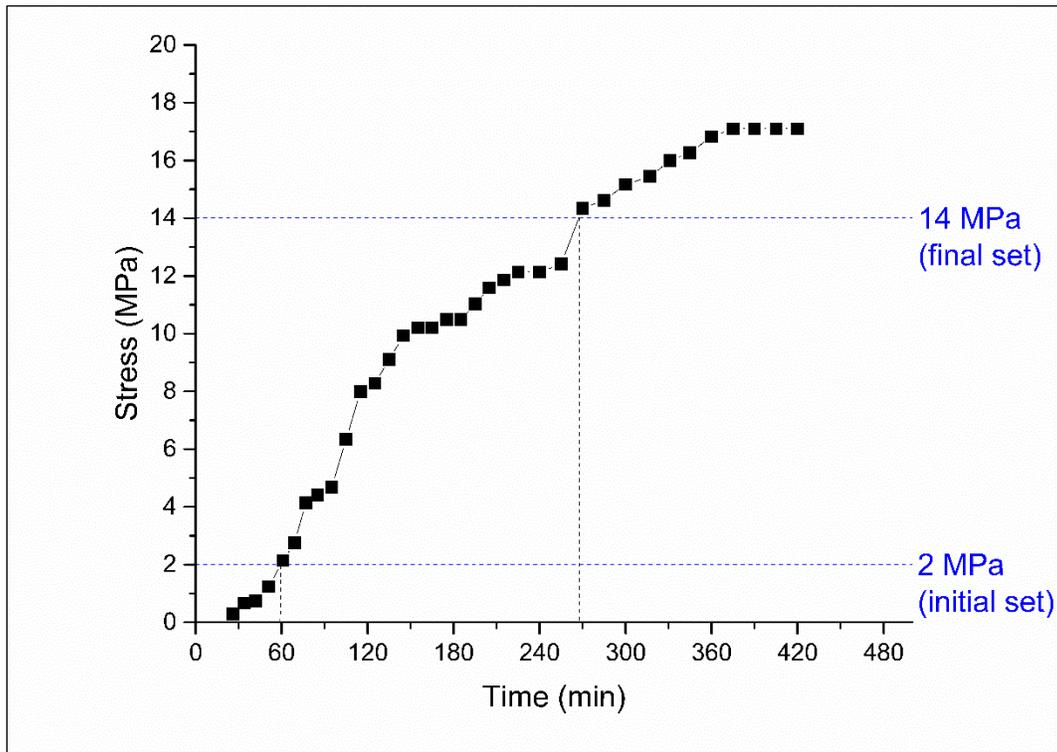
Figure 9. Penetration test of Mix C.

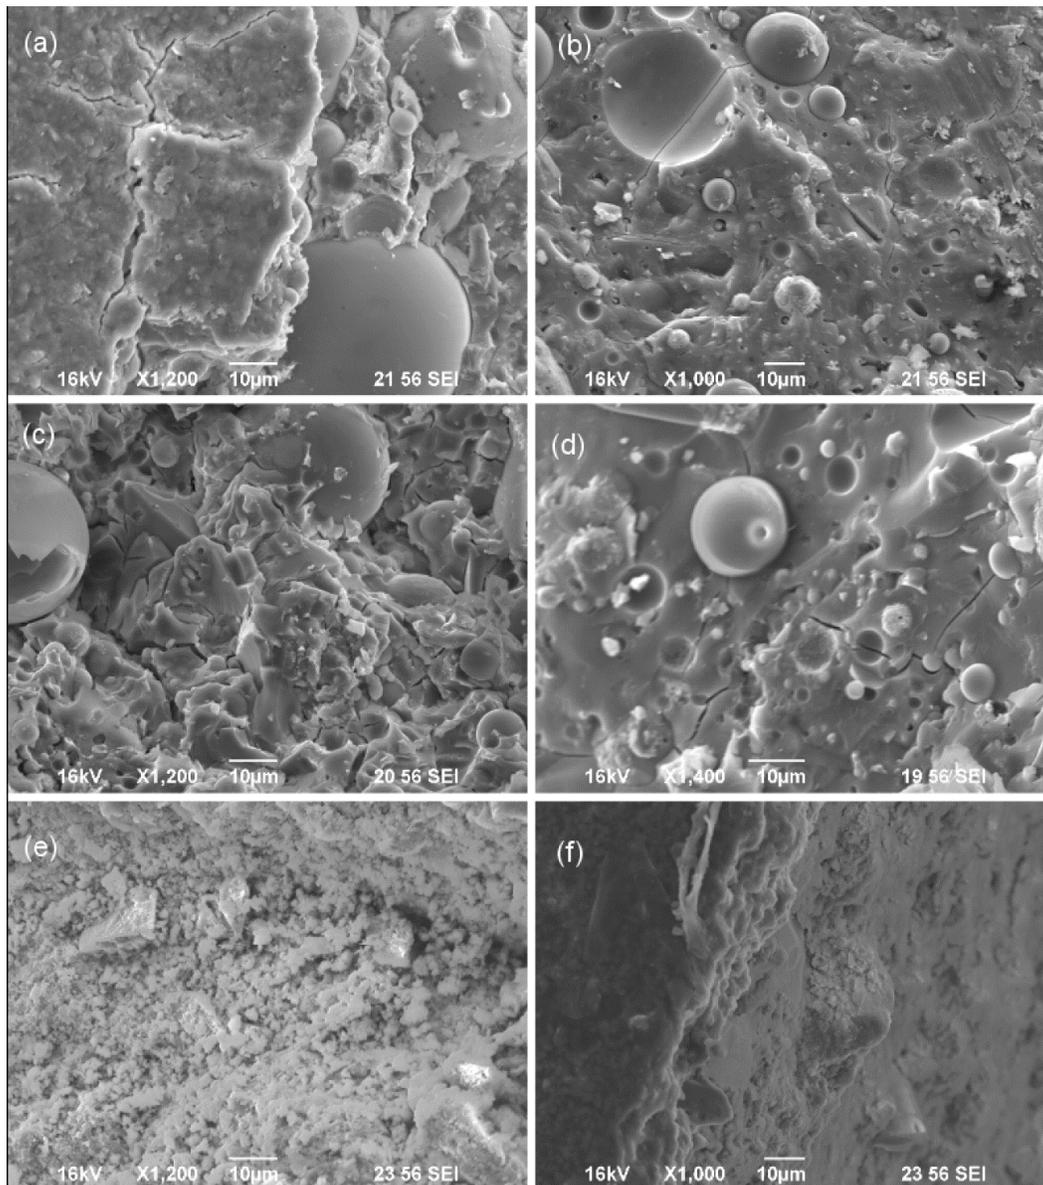
Figure 10. Binder microstructure of (a) Mix A at 3 days; (b) Mix A at 28 days; (c) Mix B at 3 days; (d) Mix B at 28 days; (e) Mix C at 3 days; and (f) Mix C at 28 days.

The microstructure of Mix B (Figure 10d) becomes more compact at 28 days. The microstructure of Mix C at 3 days shows some unreacted precursor (angular and platelet-like morphology) (Figure 10e) and some lumpy (cauliflower-like) precipitates (Figure 10f) that are generally observed in stoichiometric geopolymers. Microstructure becoming more compact with time correlates well with strength development over time.

231). The greater microstructural compaction imaged in Figure 10c may explain the faster and higher strength development of Mix B versus Mix A evident in the table.

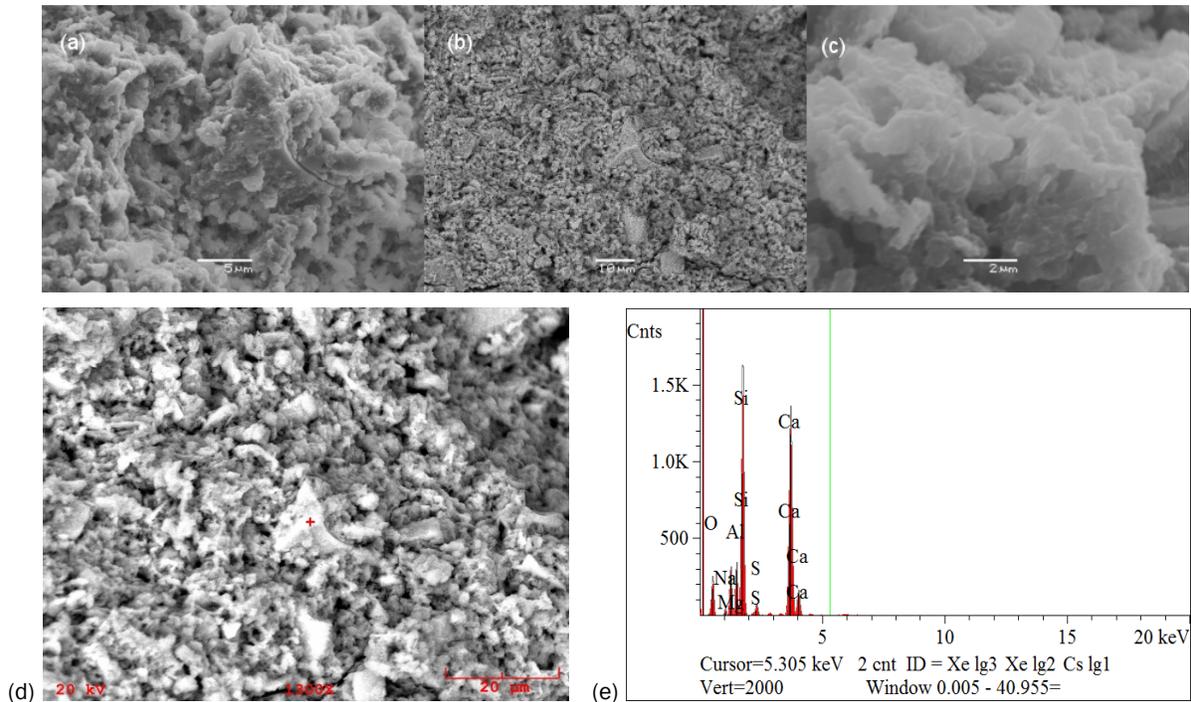
Figure 11 shows the microstructure of Mix C (Figure 11a), unreacted slag (Figure 11b), the reacted portion showing cauliflower-shaped geopolymer precipitates (Figure 11c), and proof that the unreacted angular particle is

slag through use of energy-dispersive spectrometry (EDS), which detected the presence of calcium (Ca) (Figure 11d and 11e).

Figure 11. (a) Microstructure of Mix 50 RT cured at 28 days, (b) unreacted slag at the center of the microstructure, (c) reacted portion showing cauliflower-shaped geopolymer precipitates, (d) unreacted angular particle identified as slag, and (e) plot of EDS data showing presence of Ca.

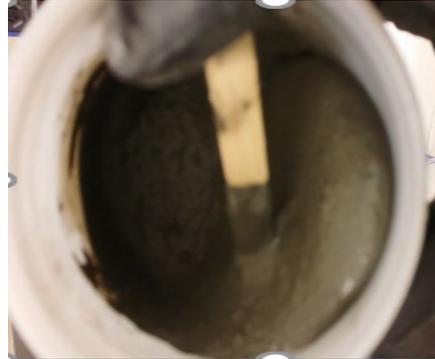
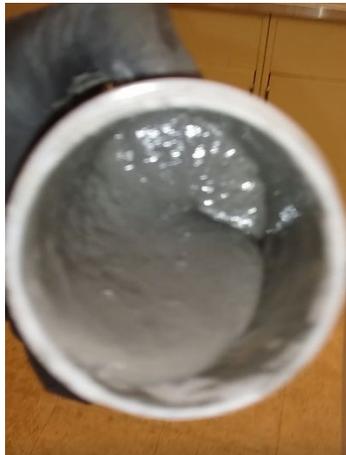
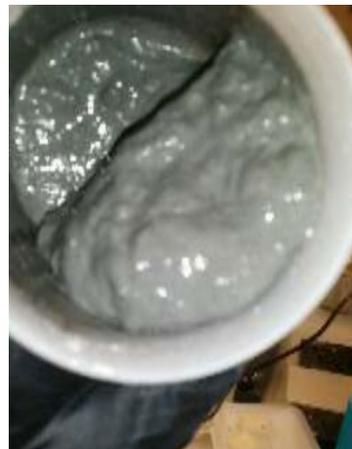
This testing task was executed at the University of Illinois Materials Testing Laboratory. Well-graded fine sand was brought to saturated surface dry (SSD) condition and then added to Mix A and Mix 49 B mortars in increments of 5 weight percent (wt%), and its flowability was empirically observed as shown in Figure 12. Sand was preferable to chamotte because sand is less expensive and more readily available. Also, because chamotte needs high-temperature processing, using it increases the mixture's overall carbon footprint. It was found that up to 53 wt% well-graded fine sand in SSD could be added to Mix B mortar and up to 30 wt% well-graded fine sand in SSD could be added to Mix A mortar. If the amount of sand exceeded this amount, then no flow could be observed without vibration. Excellent flow without vibration resulted when the amount of sand is 40 wt% in Mix B mortar and 25 wt% in Mix A mortar. The mortar mixtures could flow into small cracks in the railroad tie.

Figure 12. Various mixes shown during flowability observations. (a) Mix B binder; (b) Mix B with 40 wt% sand mortar; (c) Mix B with 20 wt% sand and 2.5 wt% basalt concrete; (d) Mix A binder (e) Mix A with 25 wt% sand mortar; and (f) Mix A with 15 wt% sand and 2.5 wt% basalt concrete.

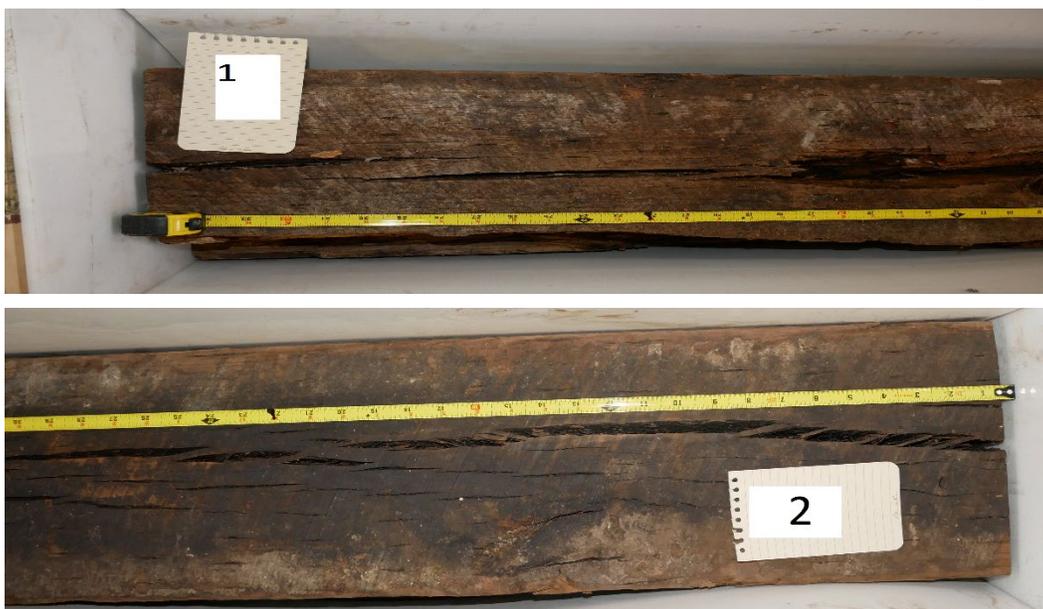
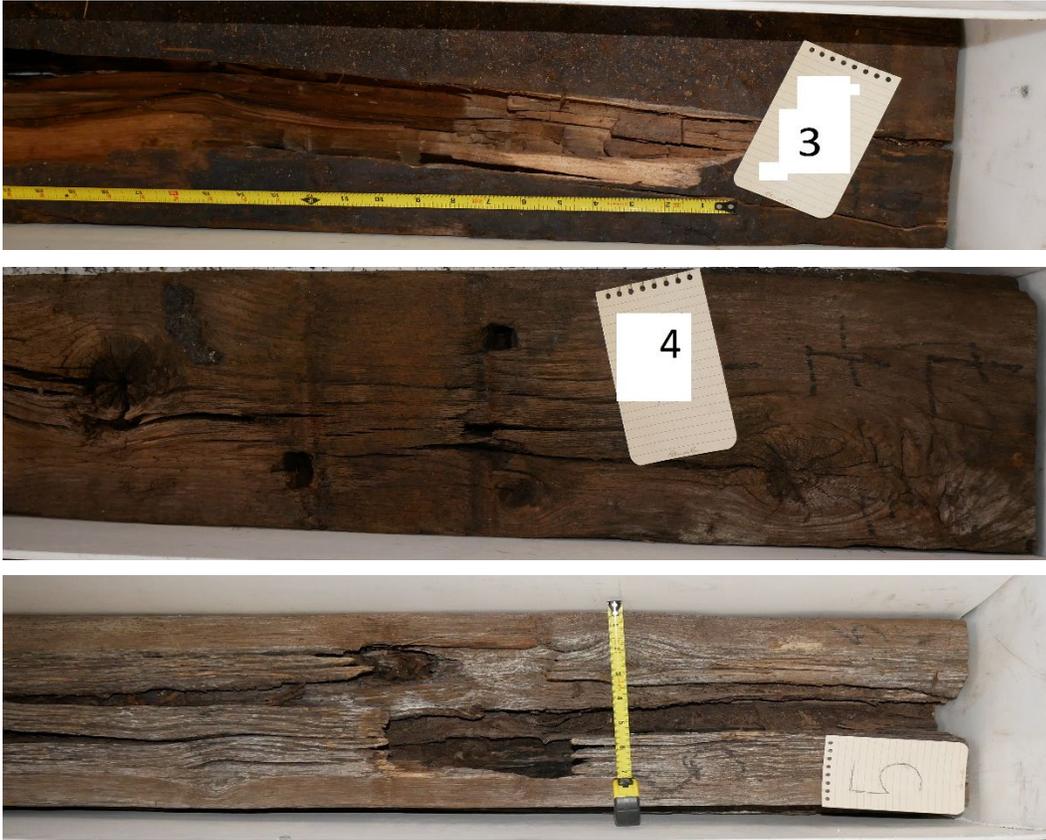
After the mix and reinforcement selection process had narrowed to two mixes with three different reinforcement schemes, five deteriorated ties were selected for testing. Ties were cut from a length of 8 ft, 6 in. to 8 ft in order to fit them inside the mold to hold them during pouring of geopolymer mixtures. The mold was constructed of wood nominal 2 x 4s with non-stick plastic lining and separators between each tie. Each tie was power washed and the interior cavities were cleared of debris caused by deterioration by using a water pressure washer and air blower. Photos of the specimens' condition are shown in Figure 14.

Figure 14. Damaged railroad ties before rehabilitation (continued to next page).

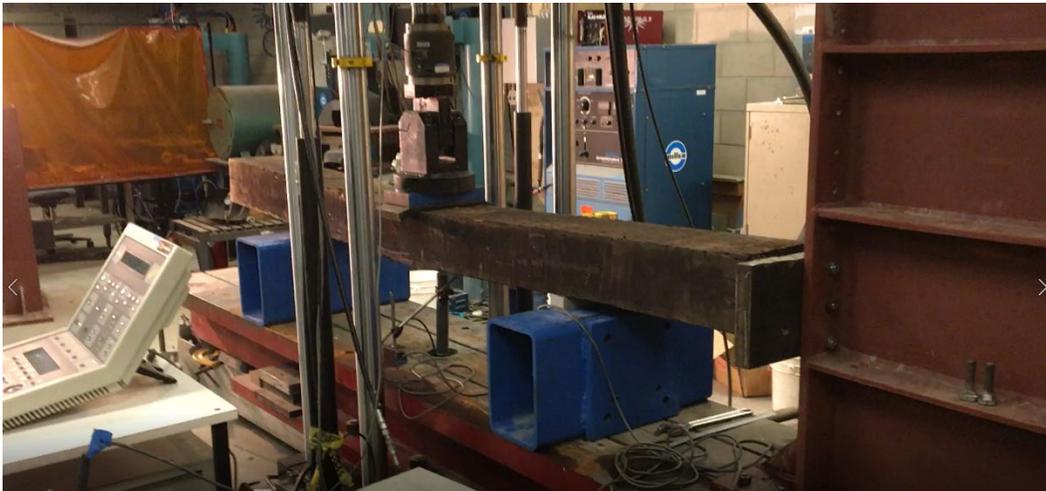
Figure 15 shows the deformation specimen subjected to vertical loading. The support points are modeled as roller connections to eliminate friction and achieve accurate load measurements.

Figure 15. Undamaged tie under vertical load.

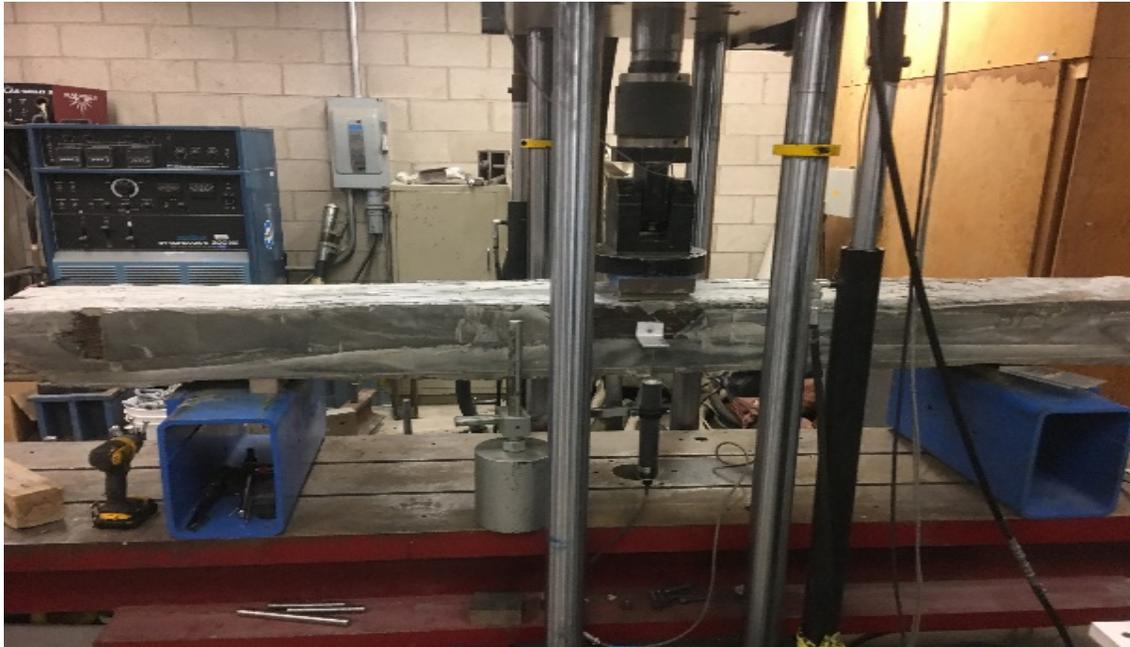
Figure 16 is the pretest position of rehabilitated tie #1, which was instrumented and ready for flexural testing.

Figure 16. Rehabilitated tie #1, before flexural testing.

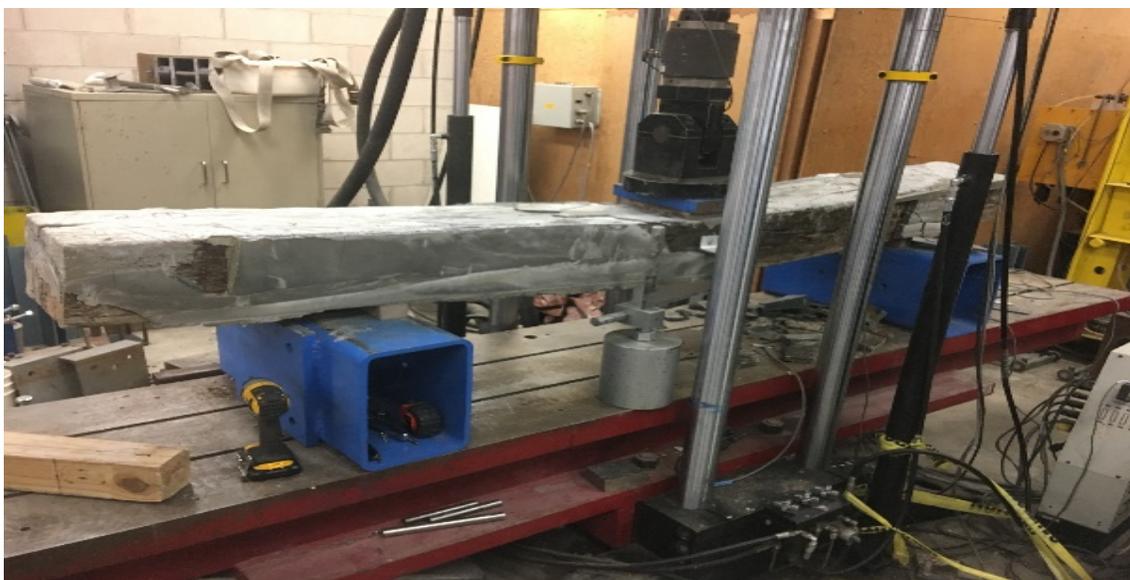
Figure 17 is a rehabilitated tie subjected to load near failure.

Figure 17. Rehabilitated tie #1 after flexural loading.

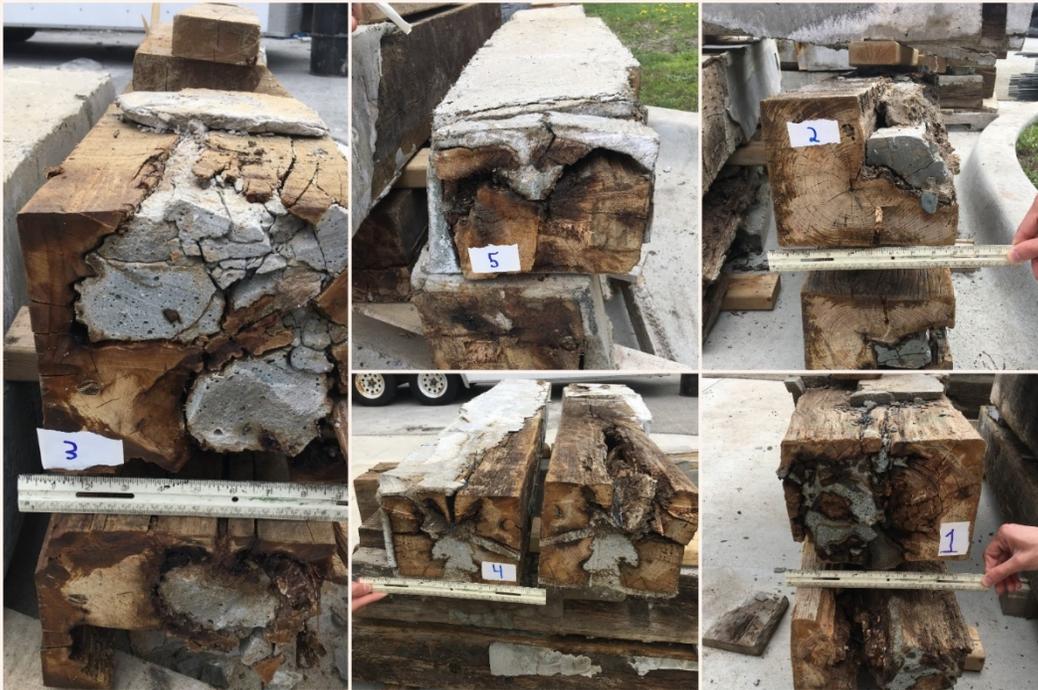
After testing all specimens in the manner above, each tie was cut at the center to determine how well the inorganic polymer had filled the void (Figure 18).

Figure 18. Cross section of post-tested tie #1-5 showing good penetration of inorganic polymer into wood.

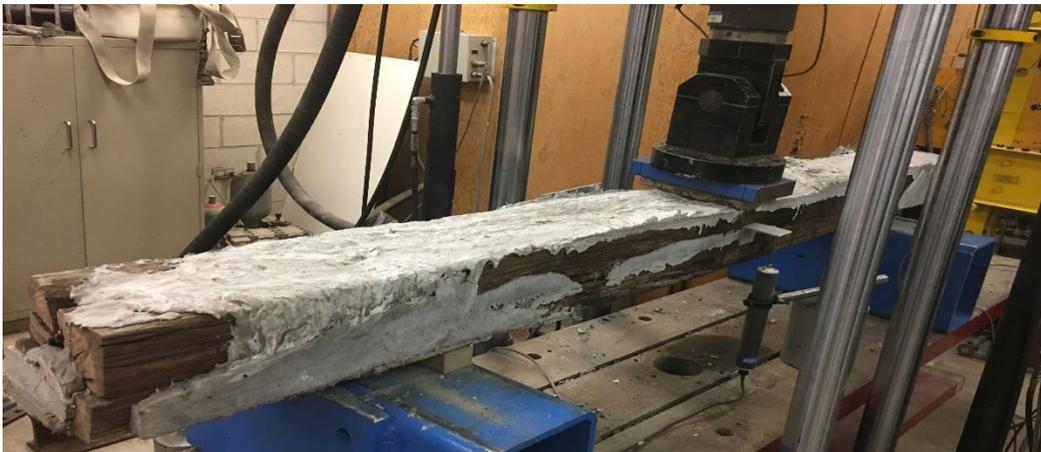
Figure 19 shows the pretest position of rehabilitated tie #2 that is instrumented and ready for flexural testing.

Figure 19. Rehabilitated tie #2 before flexural testing.

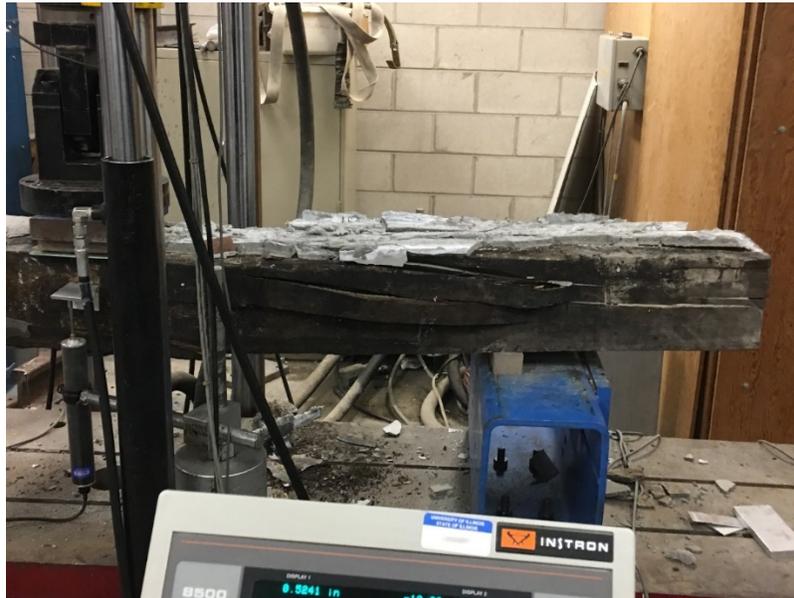
Figure 20 shows post-test condition of rehabilitated tie #2, with longitudinal failure planes clearly visible.

Figure 20. Rehabilitated tie #2 after flexural testing.

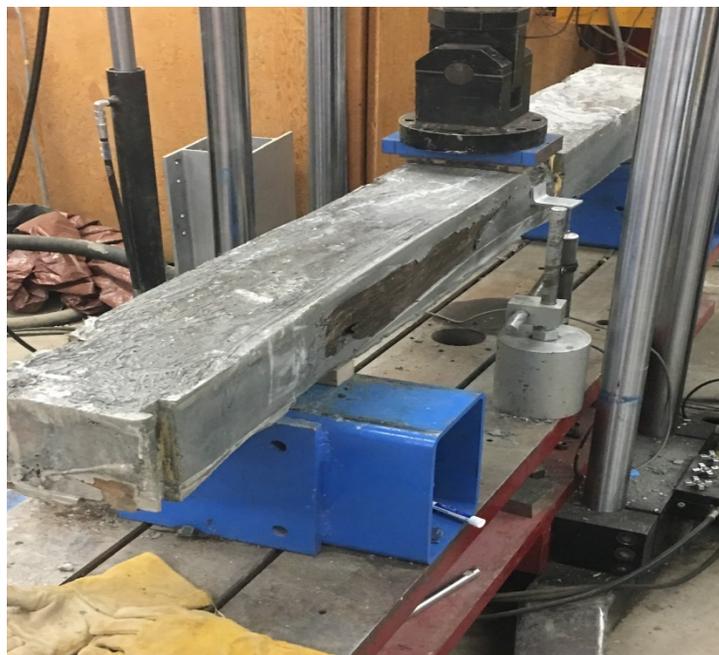
Figure 21 is a pretest position of rehabilitated tie #5 instrumented and ready for testing.

Figure 21. Rehabilitated tie #5 before testing

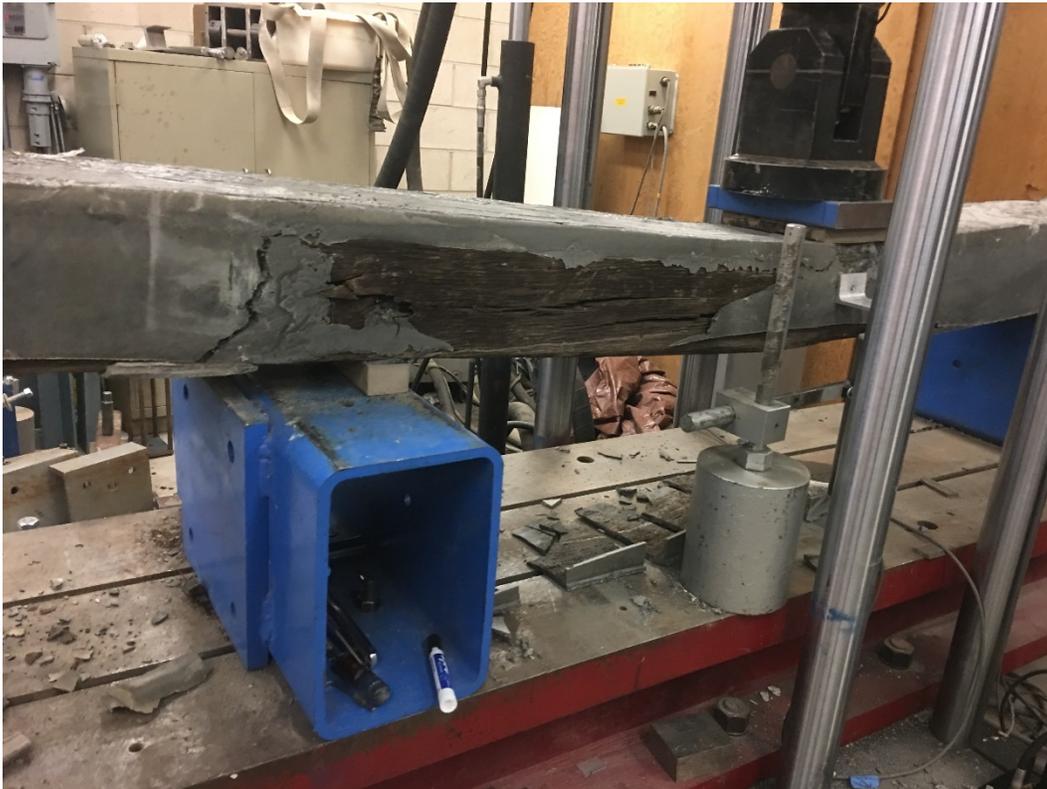
Figure 22 shows a deformation of rehabilitated tie #5 subjected to vertical load.

Figure 22. Rehabilitated tie #5 after vertical load testing.

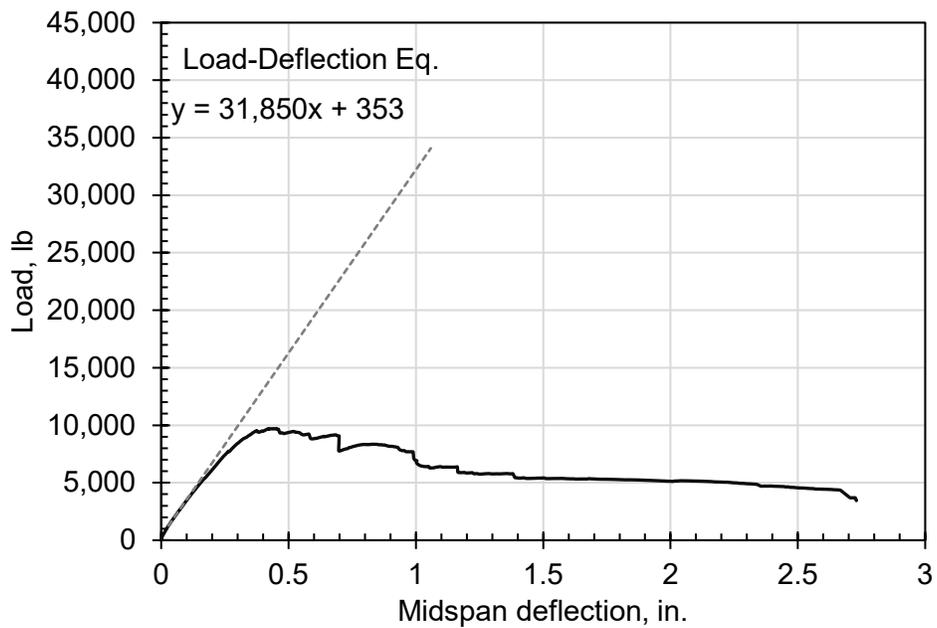
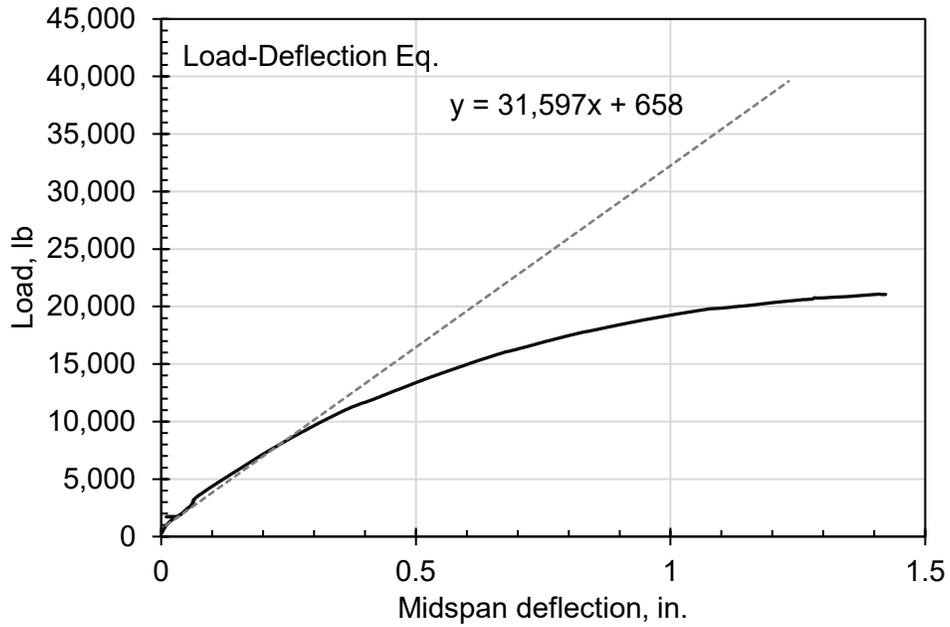
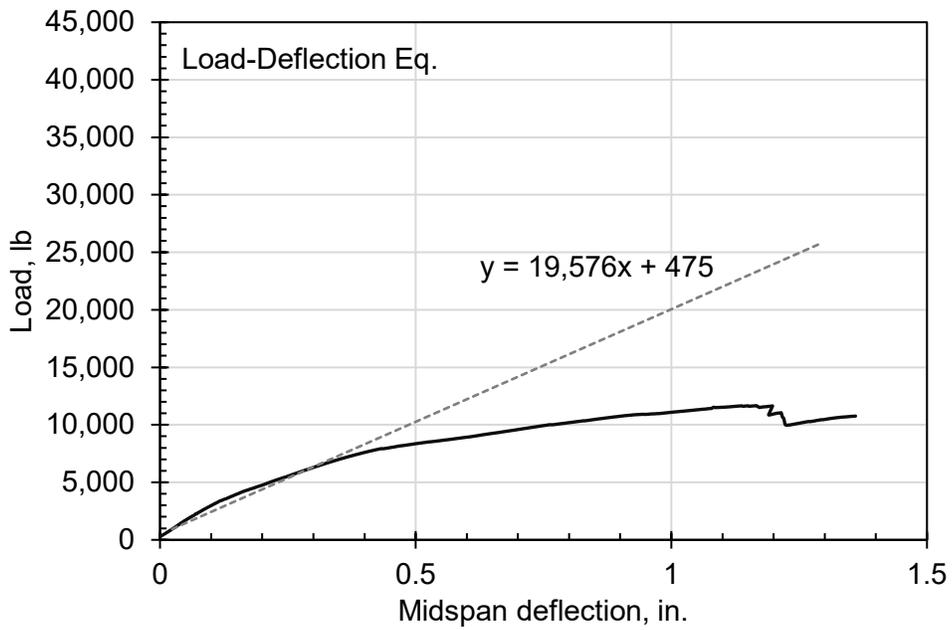
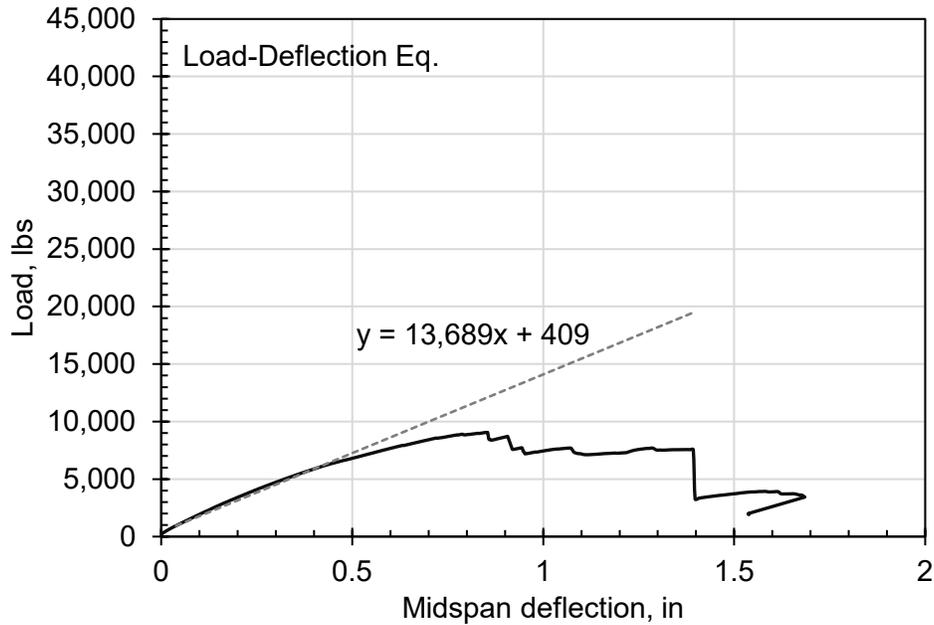
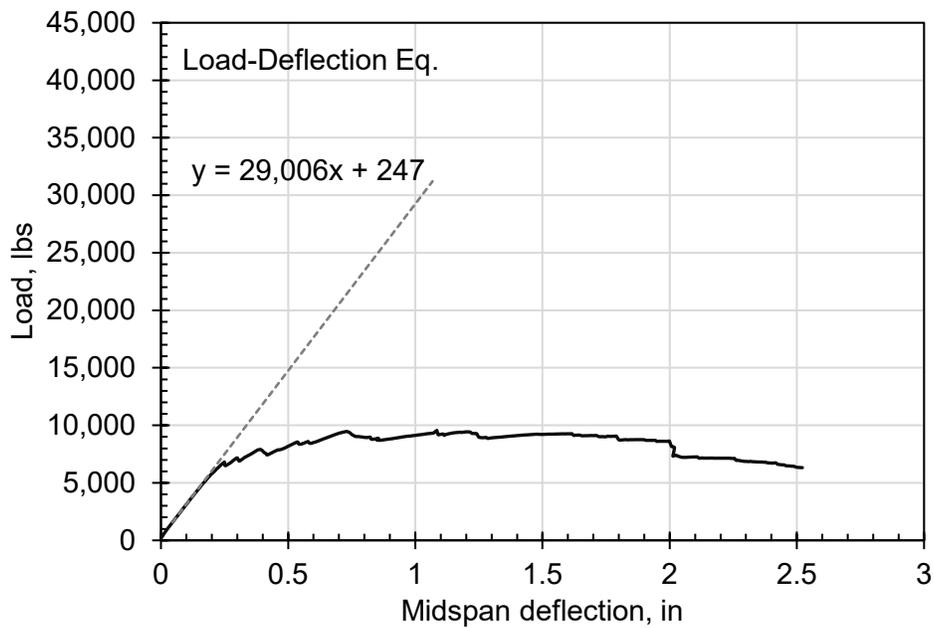
Figure 23–Figure 27 are load deflection curves for specimens #1–5. The x and y values represent the modulus of elasticity based on the measured data for each specimen.

Figure 23. Load-deflection of specimen #1.

Figure 24. Load-deflection of specimen #2.

Figure 25. Load-deflection of specimen #3.

Figure 26. Load-deflection of specimen #4.

Figure 27. Load-deflection of specimen #5.

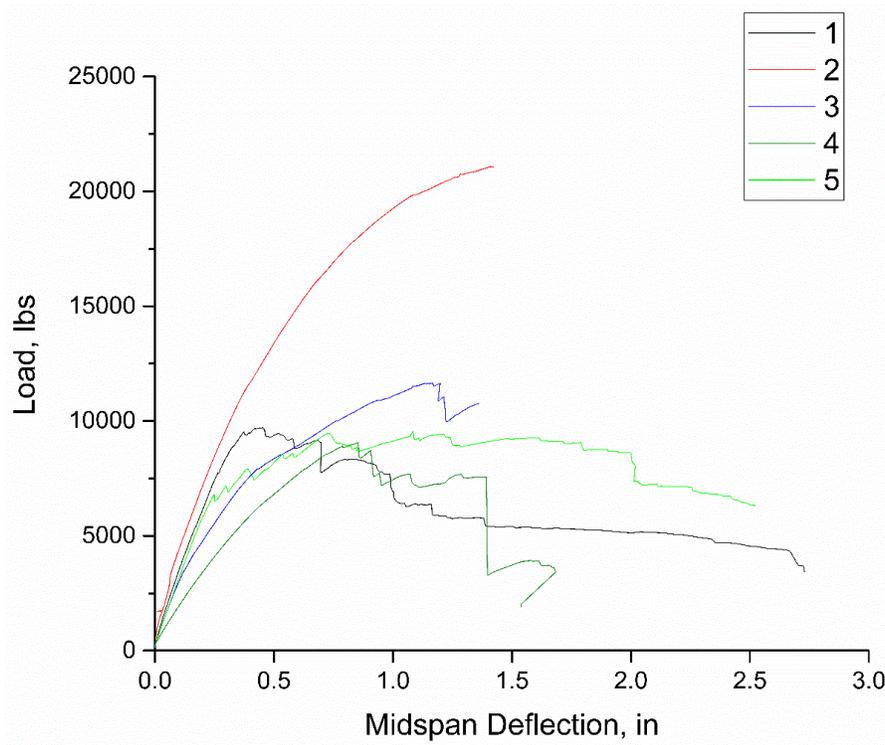
Figure 28 shows the load deflection curves of specimens 1–5. Figure 29 shows the load deflection curves of a new railroad tie and an aged but undamaged tie. Even without damage, older ties are expected to lose strength with time. The aged, undamaged tie was used as an average baseline to compare with rehabilitated ties.

Figure 28. Load vs deflection curves of rehabilitated ties #1-5.

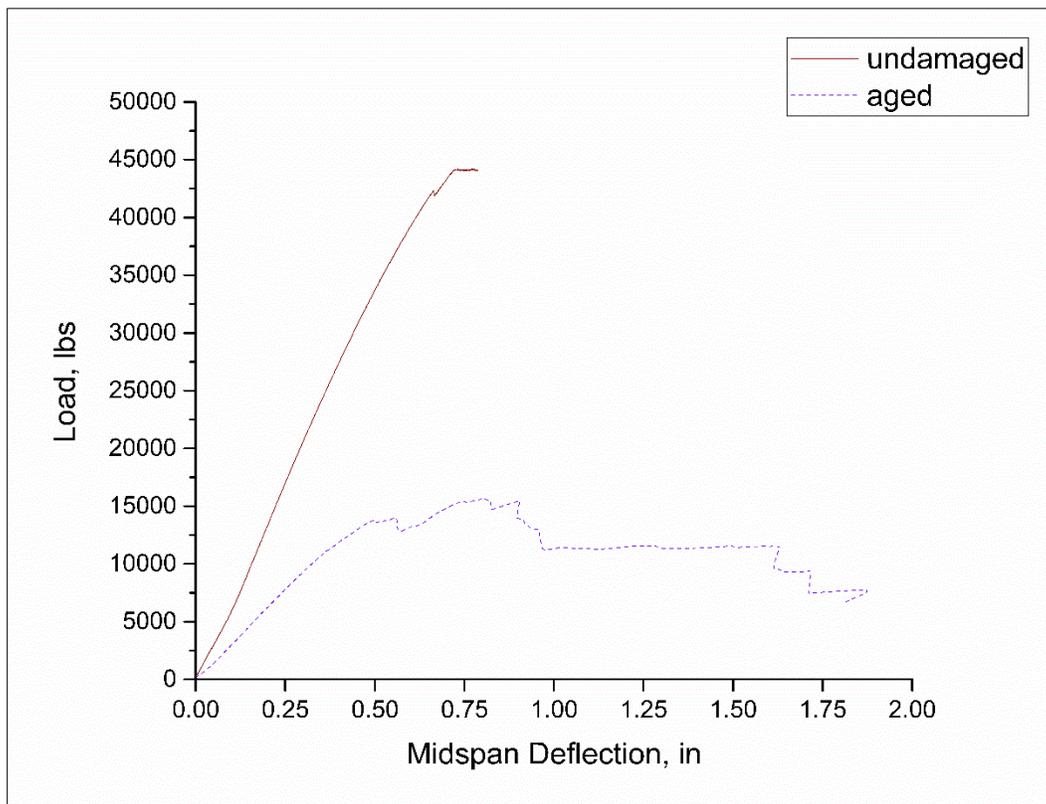
Figure 29. Load vs deflection curves of new and aged undamaged railroad ties.

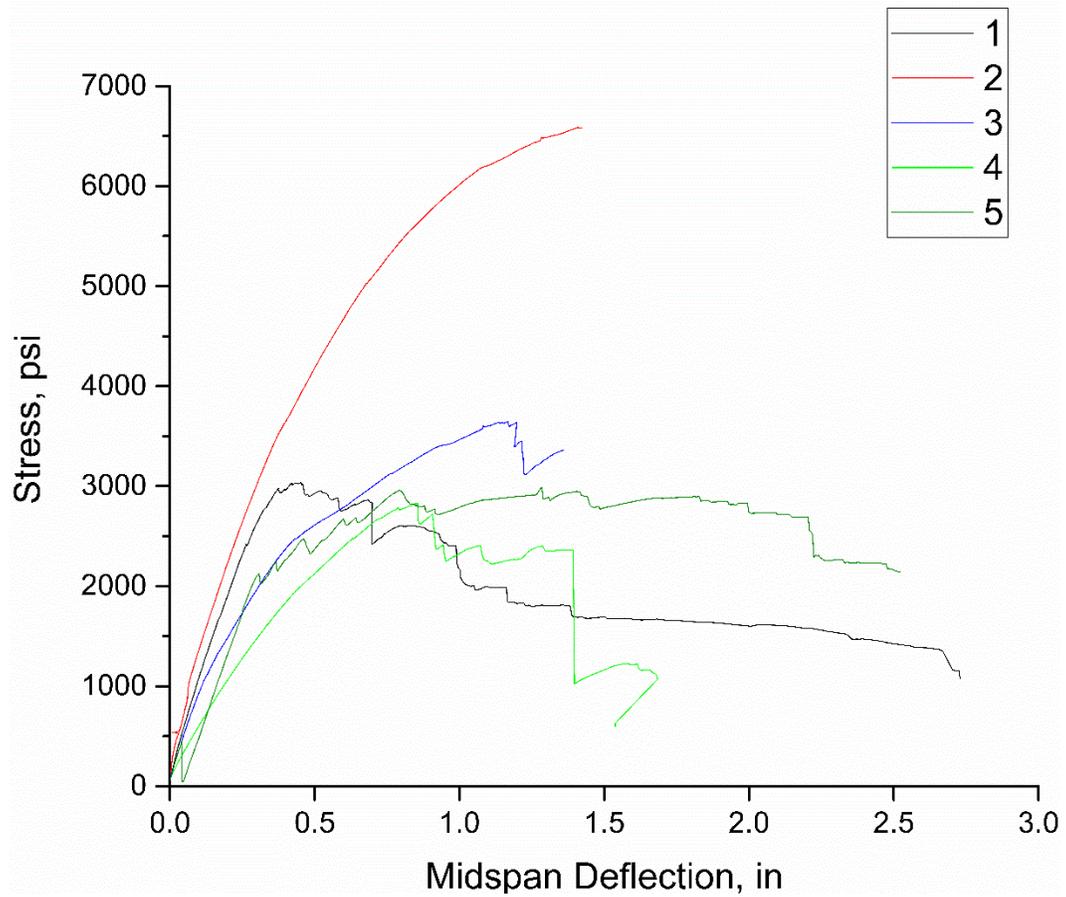
Figure 30 shows stress vs deflection curves of rehabilitated ties. Figure 31 shows stress vs deflection curves of new and aged, undamaged ties.

Figure 30. Stress vs deflection curves of rehabilitated ties #1-5.

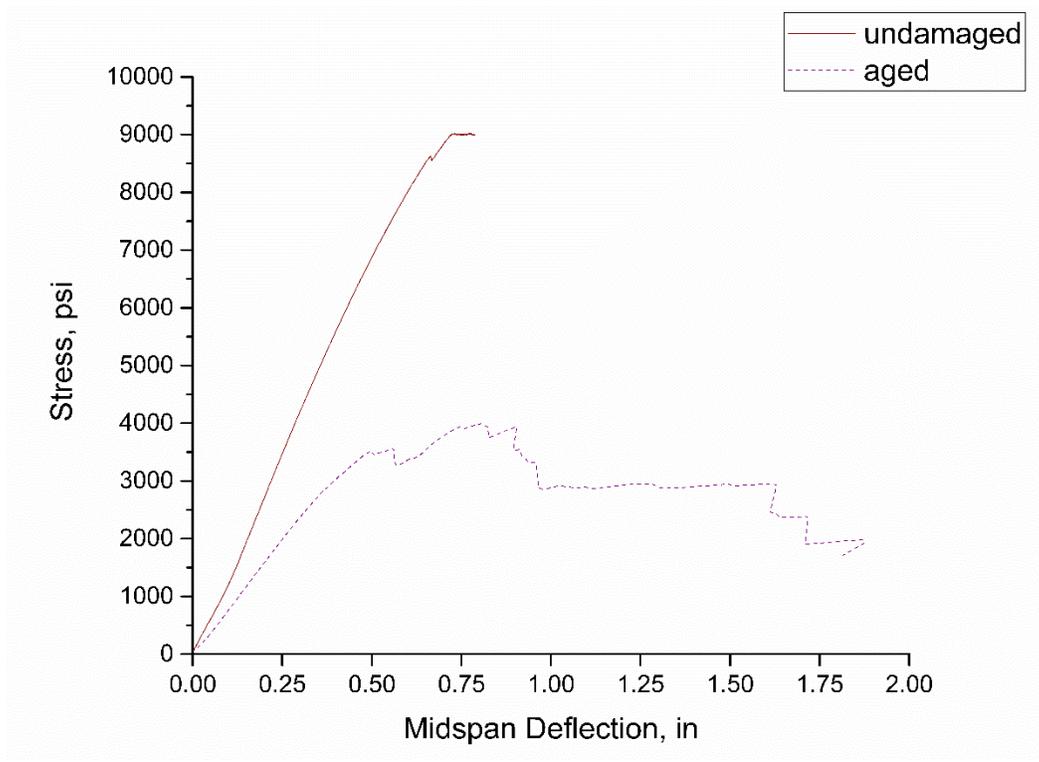
Figure 31. Stress vs deflection curves of damaged and undamaged railroad ties (only wood, no binder).
