LRAPP VERTICAL ARRAY

Westinghouse Research Laboratories

5 November 1973

REPORT DOCUMENTATION PAGE		READ INSTRUCTIONS BEFORE COMPLETING FORM																
1. REPORT NUMBER	2. GOVT ACCESSION NO.	3. RECIPIENT'S CATALOG NUMBER <b>AD/A-001130</b>																
4. TITLE (and Subtitle) <b>LRAPP VERTICAL ARRAY - PHASE III</b>		5. TYPE OF REPORT & PERIOD COVERED <b>Technical Report April 1 to August 30, 1973</b>																
7. AUTHOR(s) <b>C. H. Jones</b>		6. PERFORMING ORG. REPORT NUMBER <b>73-9M7-VERAY-R2</b>																
9. PERFORMING ORGANIZATION NAME AND ADDRESS <b>Westinghouse Electric Corporation Research &amp; Development Center Beulah Road, Pittsburgh, PA 15235</b>		8. CONTRACT OR GRANT NUMBER(s) <b>N00C14-72-C-0120</b>																
11. CONTROLLING OFFICE NAME AND ADDRESS <b>Procuring Contracting Officer Office of Naval Research Department of the Navy Arlington, VA 22217</b>		10. PROGRAM ELEMENT, PROJECT, TASK AREA & WORK UNIT NUMBERS <b>NR292-074/5-22-73 (469)</b>																
14. MONITORING AGENCY NAME & ADDRESS (if different from Controlling Office) <b>Commander, Defense Contract Administration Services District 1610-S Federal Building, 1000 Liberty Aven Pitt

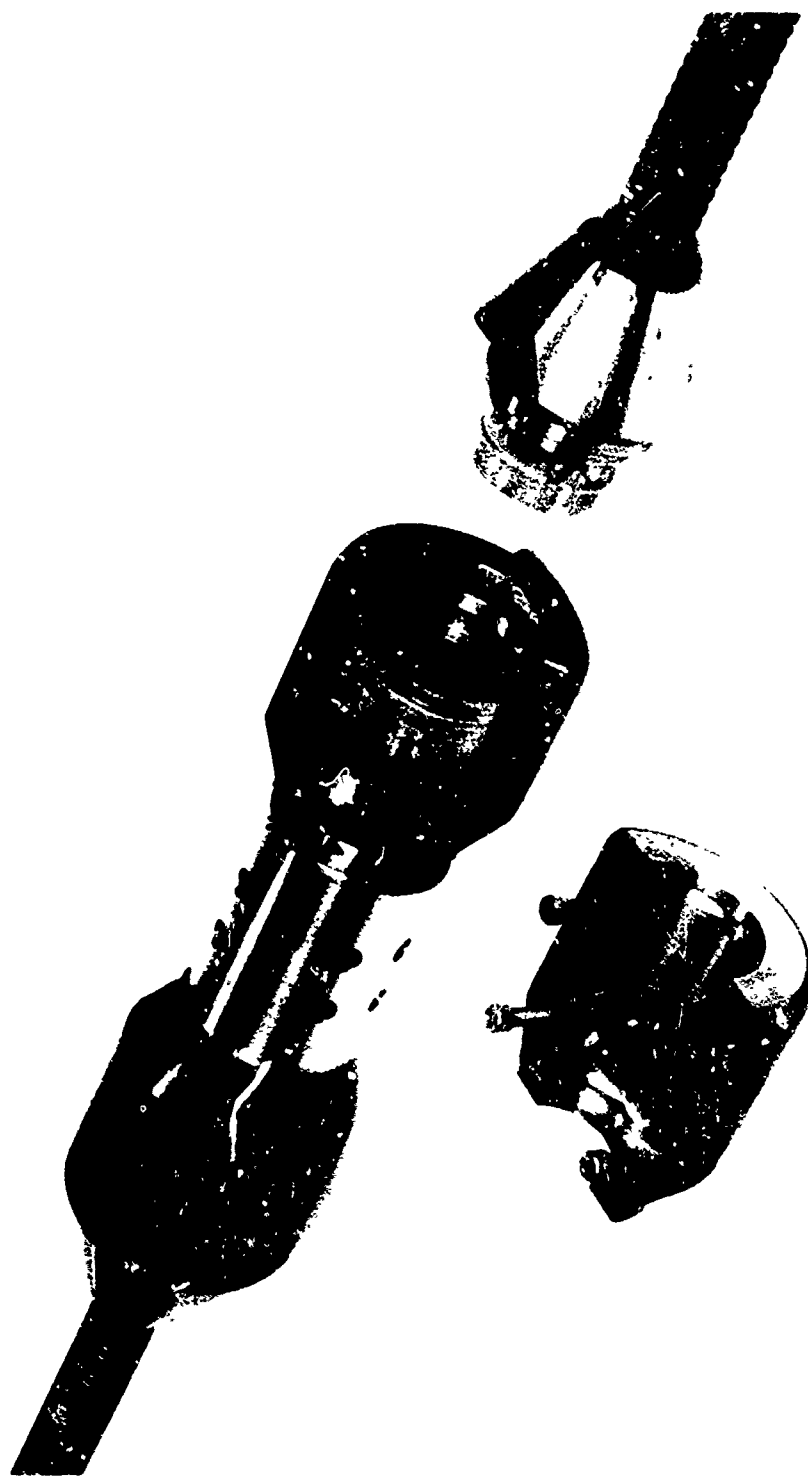
Fig. 3 - Hydrophone with Upper End Connected to a Cable and Lower End  
Disconnected to Show Potted Preampfier and Electrical Connector

Some of the potted preamplifiers attached to the hydrophones as illustrated in Fig. 3 behaved in an erratic way. Although the surfaces of all of the semiconductor elements were passivated before being potted in polyurethane the forces exerted during pressure cycling sometimes caused the gain of the amplifiers to drop to zero. Therefore, as a back-up effort, experiments were made with two new encapsulation methods. The first consisted of cutting off the lids of the transistor cans, attaching a Tygon tube filled with moisture-free castor oil. The second method consisted of sealing the units inside of a pressure tight aluminum cylinder. Figure 4 shows three transistors with oil-filled tubes attached. On the left is an aluminum capsule covered with black tape. Both types of encapsulation proved satisfactory under pressure cycling. The second method was chosen because it isolates the semiconductor assembly from any large pressure changes. Before being tested at the Naval Research Laboratory at Orlando, Florida, hydrophone-preamplifiers are pressure cycled 10 times to 55 MPa at 4°C. The pressure is increased linearly over a 15 minute period in order to avoid damaging the low noise input stage of the preamp.

A split metal cylinder is used to couple the cable to the hydrophone. Figure 3 shows half of such a cylinder in place around the male connector and the preamplifier and the other half removed. Before assembly the "O-ring" groove was coated with Dow Corning #4 Silicone Dielectric. The inside surface of the split coupler was coated with Lubriplate made by Fisk Bros. Refining Corp. to reduce corrosion and to make it easier to assemble the coupler. After the deployment it was found that on many of the hydrophones the split cylinder had pinched the polyurethane and caused the connector to leak. The inside diameter of the coupler will be increased to eliminate the pinching problem.

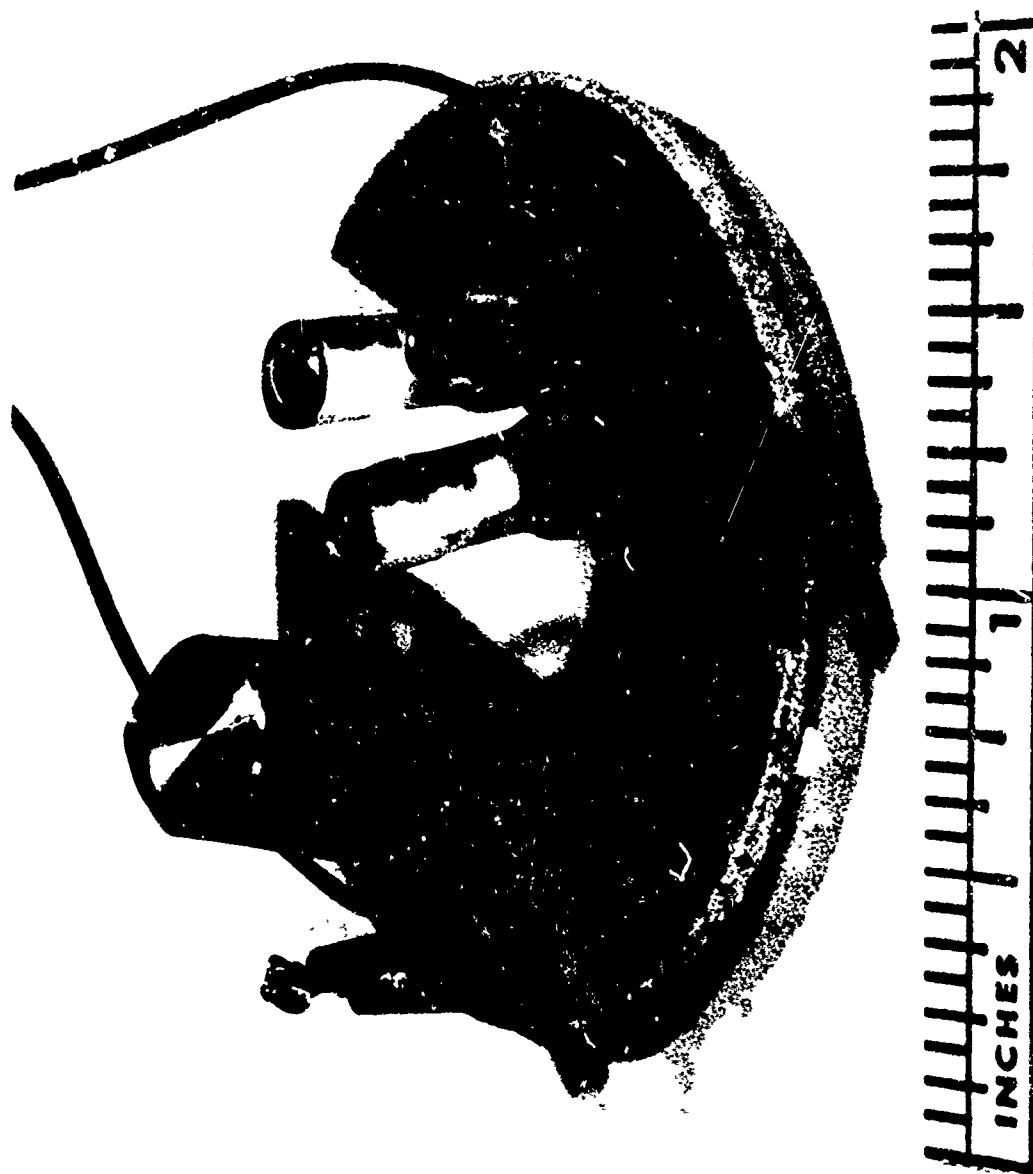
Fig. 4 - Preamplifier with Three Oil-Filled Transistor Cases and One Aluminum Pressure Capsule
