FATIGUE TESTING TECHNIQUES FOR EVALUATING THE EFFECTS OF ENVIRONMENT ON COMPOSITE MATERIALS

Michael D. Hanson

Army Air Mobility Research and Development
Laboratory
Fort Eustis, Virginia

October 1974

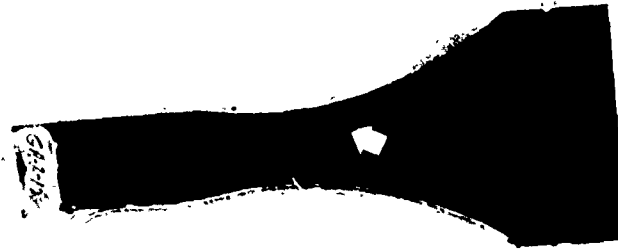
Figure 8. Delamination of graphite specimen.

Although only five specimens were tested, these five showed that the extreme laminae in a multilayered structure essentially fail before delamination and cracking occur. For example, the uppermost layer of specimen 3 was delaminated after 50,000 cycles. The same layer on specimen 4 was completely intact (by visual inspection) up to 1,300,000 cycles. Yet, at 100,000 cycles when static-deflection tests were made, the static deflection in each specimen had increased .18 cm from that at 0 cycles. In fact, specimen 4 failed earlier than specimen 3 (1.7 million cycles compared to 2 million). For this reason, observable damage was not used as a criterion for failure.

When delamination did occur and cracks appeared, all cracks were parallel to the lay of the fibers. It appeared that the failure was in the resin matrix. Fiber damage was not evident under a 20-power microscope.
