**AIRCREW RESTRAINT SYSTEM - DESIGN
CRITERIA EVALUATION**

Ultrasonics, Incorporated

**Army Air Mobility Research and Development
Laboratory**

February 1975

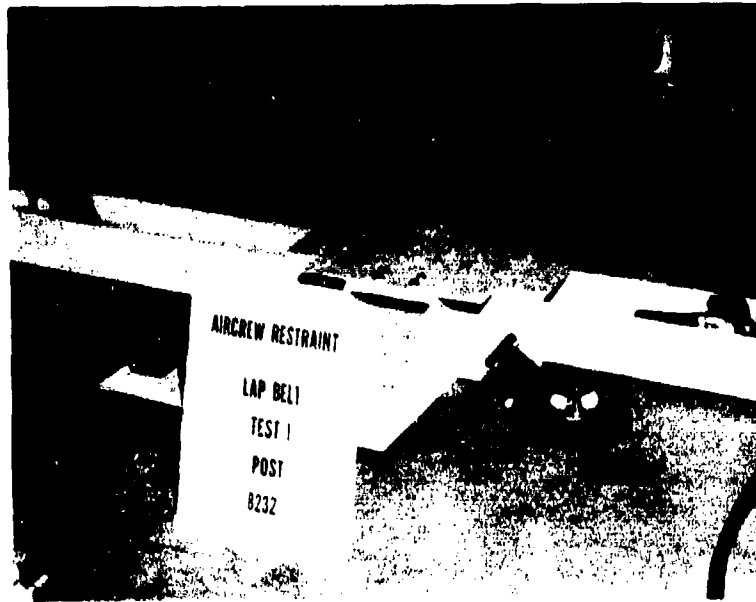
Figure 24. Lap Belt Assembly - Posttest.

The data from the lap belt assembly test, presented in Table 9, show that the assembly failed at 4,024 pounds, with an elongation of 3.54 inches at 4,000 pounds. The assembly failed when the left locking dog of the buckle was pulled through the buckle's side. When the buckle failed, its release mechanism was activated; then the buckle separated from the right side of the lap belt and, after being thrown into the air, ended up in the position shown in Figure 24.

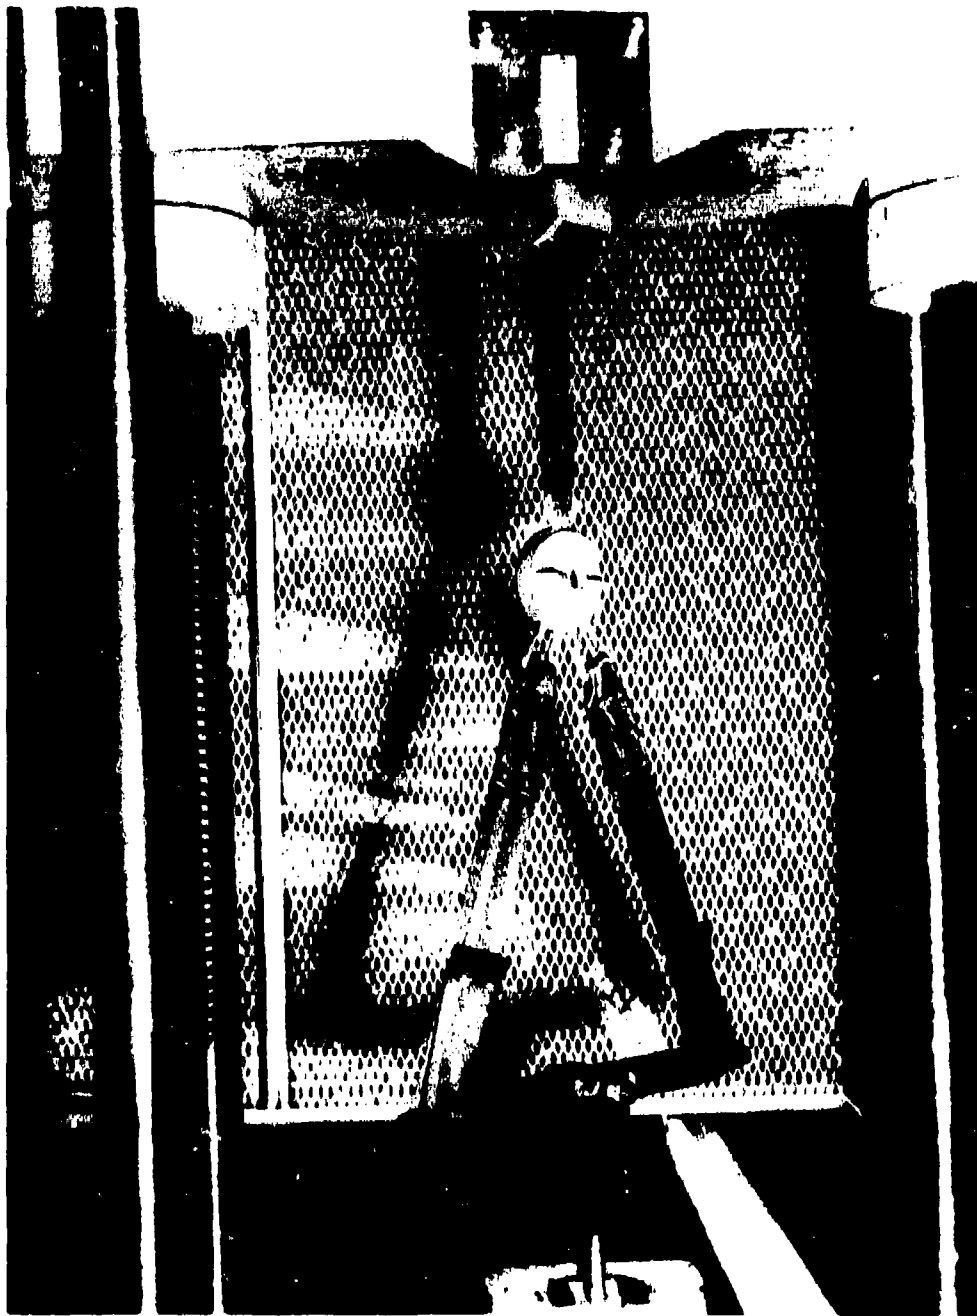
Figure 29. PSCo's Buckle Test Configuration - Tie-Down Connection.

The single-point release buckle was tested in two configurations: one, shown in Figure 28, was a straight pull to test the lap belt attachment; and the other, shown in Figure 29, was used to test the tie-down strap connection. The ultimate load for the lap belt attachment was 4,220 pounds. Two types of failures were observed. In one instance (see Figure 30), a restraining tab on the locking dog failed; in the other (see Figure 31), the locking dog and load plate failed simultaneously. The ultimate load was 2,935 pounds for the tie-down connection, which produced a webbing failure at the fitting. The ultimate strength and failure mechanism for each shoulder strap attachment were determined to be the same as the lap belt attachment because they have the same configuration.

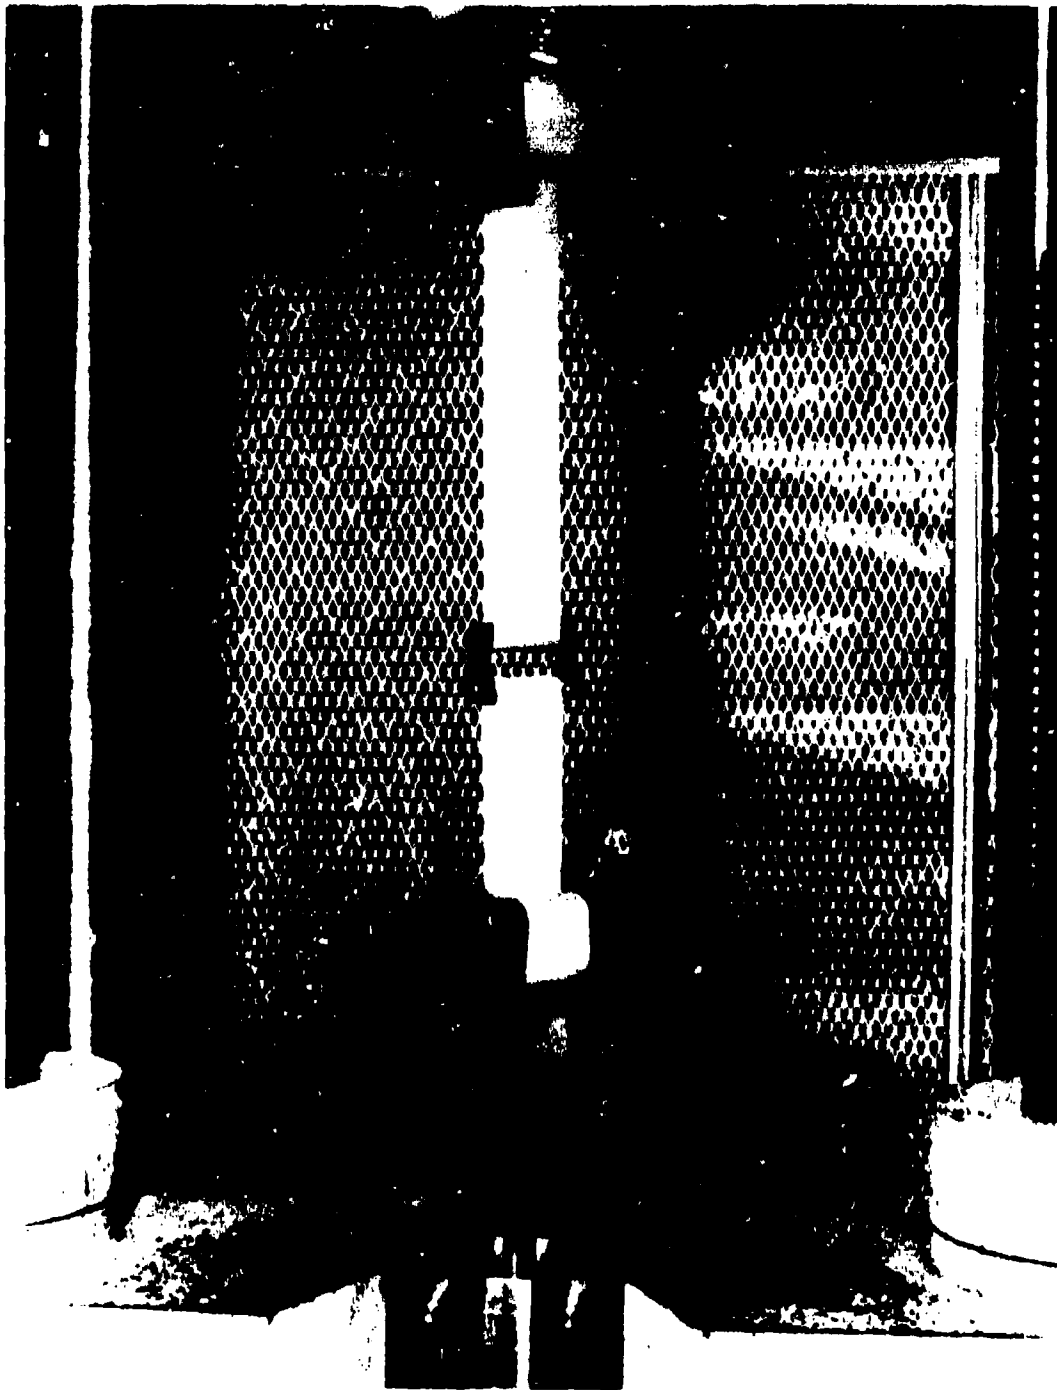
Figure 36. PSCo's Roller Fitting Test Configuration.

The roller fitting was tested, as shown in Figure 36, with high-strength webbing (MIL-W-25361, Type III). At 7,320 pounds, the webbing failed at the tester fitting, and the test was discontinued. The roller fitting was examined, and the only damage observed was a slight deformation in the roller frame. The deformation prevented the roller from rotating freely; however, it satisfactorily passed the test.

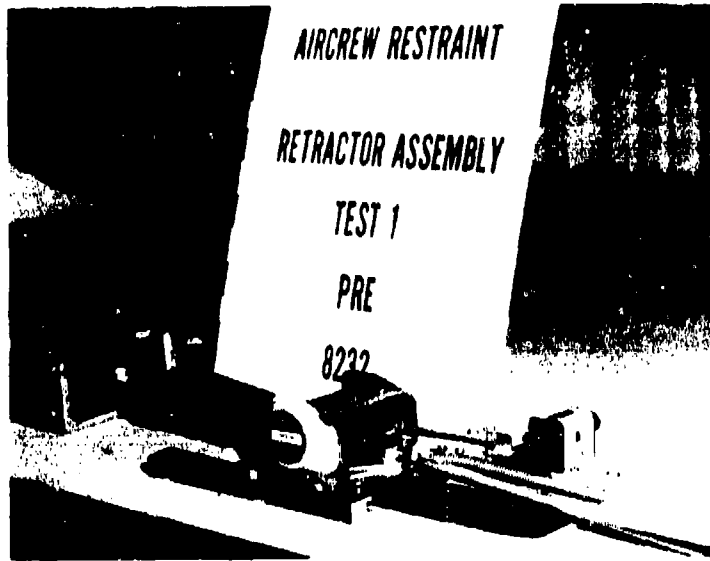
Figure 37. Retractor Mounting for Locking Test.

For the locking test, the retractor was mounted on the Functional Test Fixture (DSL603), with the retractor housing attached to the slide plate (DSL603-7) and the buckle fitting attached to the traveler base (DSL603-17), as shown in Figures 37 and 38. The test fixture was then energized, applying an extension load to the webbing and pulling it out of the retractor at an average rate of 20 ± 2 inches per second. After 12 inches of webbing had been extended, the motion was stopped by the test mechanism for 0.6 second to allow the retractor to lock. The extension load was then reapplied to the retractor, and, since it had locked, there was no further relative motion between the buckle fitting and the retractor housing. The retractor spring (DSL603-5) permitted the retractor housing to move forward so that the crank mechanism would continue to rotate and allow the webbing to rewind on the retractor. When the test fixture had reached its initial position, it was stopped again for 0.6 second to ensure that the retractor would be stabilized for the next locking cycle. This sequence was repeated automatically in 50-cycle increments until 1,000 tests had been performed. The test fixture was stopped after each 50 cycle period to ensure that heat generated within the retractor would not be a factor in the test results. For this test, two mechanical counters were used to monitor retractor locking. One counted the traveler base revolutions, and the other counted the slide plate strokes. If the retractor failed to lock during the cycle, the slide plate counter would indicate less than the traveler base counter, with the difference being the number of times the retractor failed to lock.

The only difficulty encountered during the retractor locking tests was that the relationship of the stopping cam to the crank mechanism changed slightly with each cycle. This change could be adjusted to some degree; but as the brake's temperature increased, additional adjustment was required. Therefore, an initial adjustment that would last for 50 cycles was made, and the crank mechanism was repositioned during the waiting period between each 50-cycle series of tests.

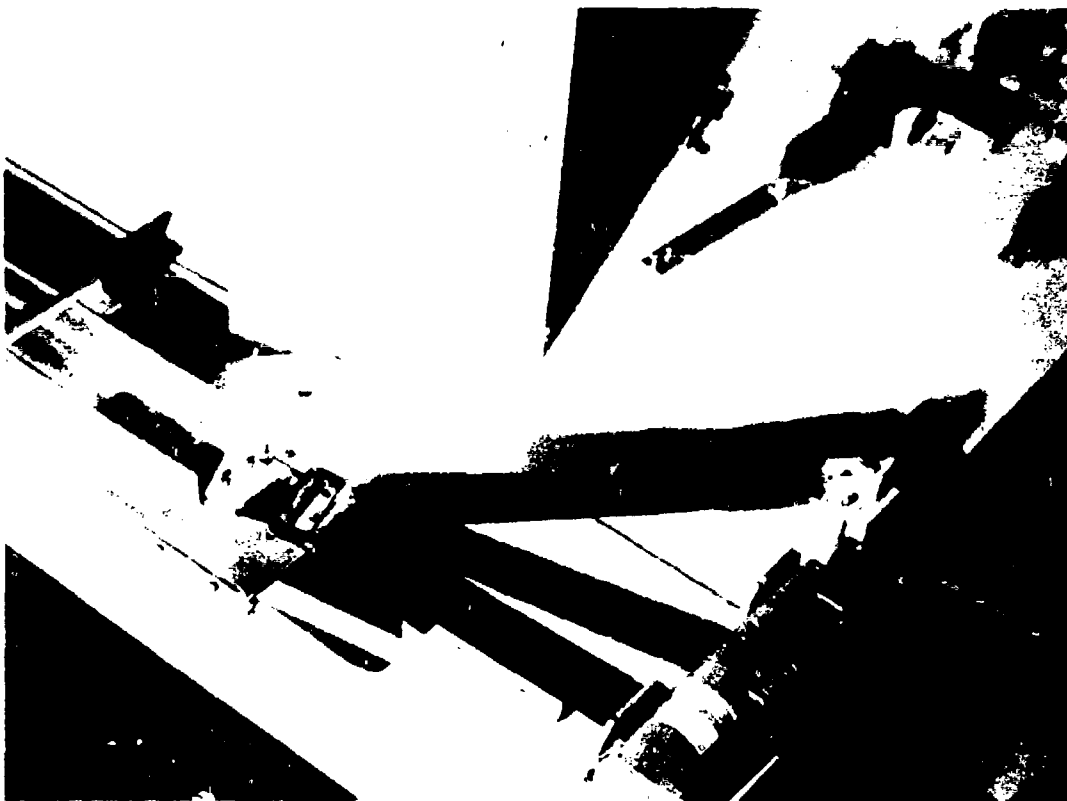
Figure 45. Roller Fitting Test Configuration.

During the test, neither noticeable wear of either the webbing or the roller fitting nor an increase in temperature was observed. However, the reflected strap did have a tendency to rub against one side of the roller fitting because of the take-off angle. This did not seem to produce any noticeable wear on either the webbing or the roller fitting. The roller fitting

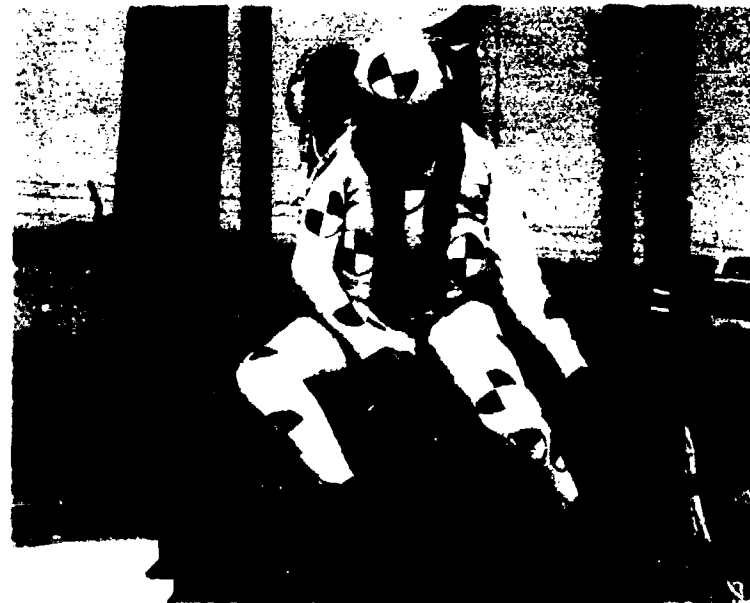
Figure 47. Initial and Final Positions - First Drop Test.

The configurations of the dummy and restraint system both before and after the first vertical impact are shown in Figure 47, while before and after photos of the first horizontal impact are shown in Figure 48. During each of the dynamic tests, the restraint system performed quite satisfactorily. There were no component failures, and from the final position of the dummy, it was apparent that the restraint system performed its primary function of keeping the occupant in the seat.

Examination of the data acquired in these tests indicated that higher than expected velocity changes were achieved, while the peak input decelerations were lower than anticipated. The peak deceleration measured in the drop tower test was 44G; in the sled test, 25G. The honeycomb stacks used for these two tests had been calibrated for peak decelerations of 48G and 30G, respectively. The velocity change measured during both tests was 55 fps, which was 5 fps greater than expected and provided

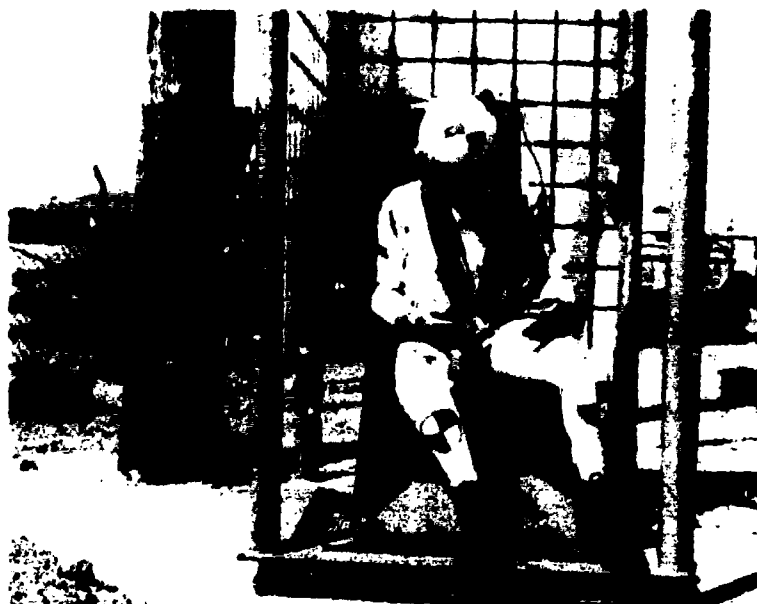
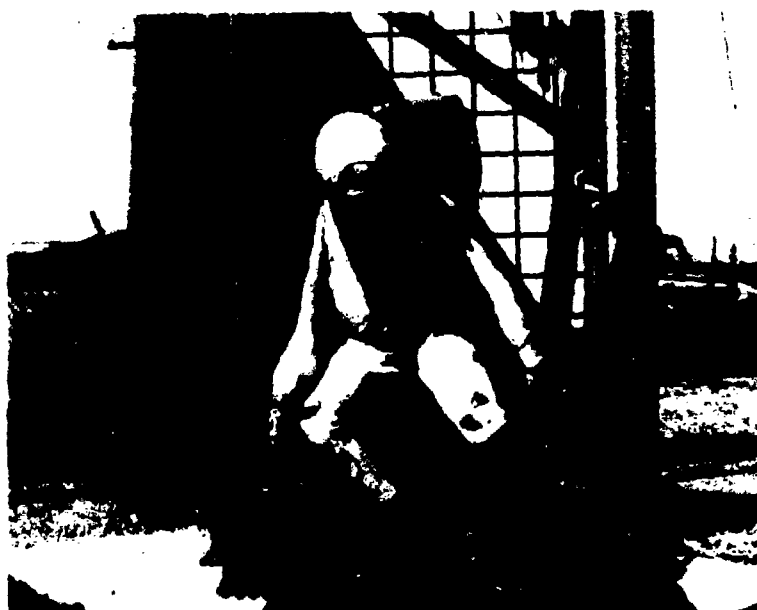
Figure 49. Initial and Final Positions - Second Drop Test.

In the second drop tower test, a peak input deceleration of 51.5G was measured (48G was required); however, the tie-down strap anchor broke at the webbing loop into two pieces during the impact. The initial and final positions of the dummy and restraint system for this test are presented in Figure 49. A preliminary inspection of the failure indicated that the fitting was bent forward and subsequently fractured due to the loading that it incurred through the tie-down strap as a result of the dummy's moving forward in the seat during impact.

The buckle was relatively undamaged, although operation of the handle was somewhat sluggish, and all of the fittings were deformed at their interface with the buckle's locking dogs. In addition, both lap belt fittings were noticeably bent inward, with the right lap belt fitting bent the furthest (about 25 degrees), and the left shoulder strap fitting slightly bent.

It should be emphasized that the failures occurred during full load retesting of once-tested restraint systems. Even though these systems are not designed for more than one loading, the results of the dynamic retests (Test Series #2) served to illustrate the potential weaknesses of the restraint system design, and to point up areas where design improvements could be made.
