construction
engineering
research
laboratory

TECHNICAL REPORT M-94
January 1976

STUDY OF ARTICULATED CONCRETE REVETMENT MATTRESS:
TEST AND ANALYSIS—RESULTS OF FY 1974 PROGRAM

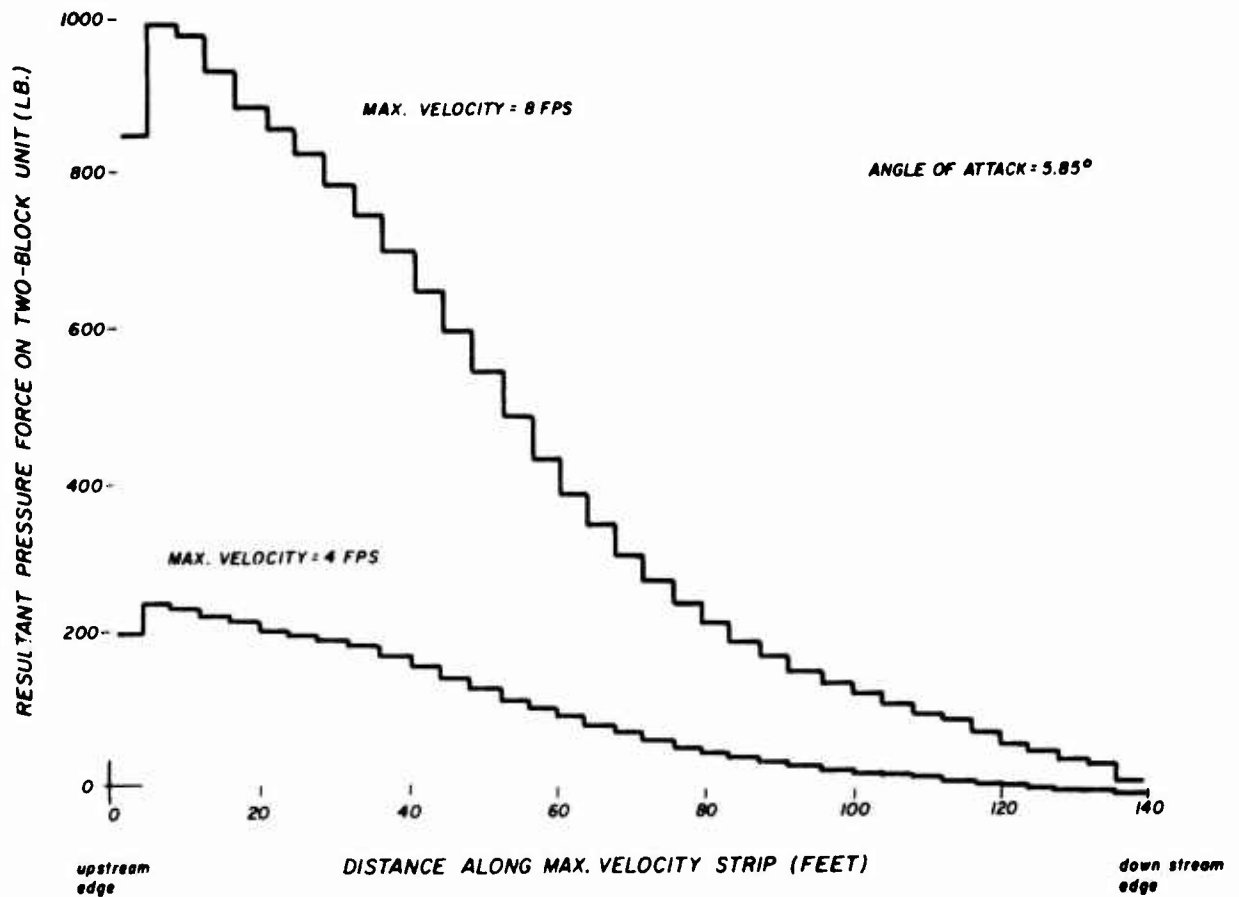
Figure 3. Pressure forces on two-block units along the strip of maximum velocity.

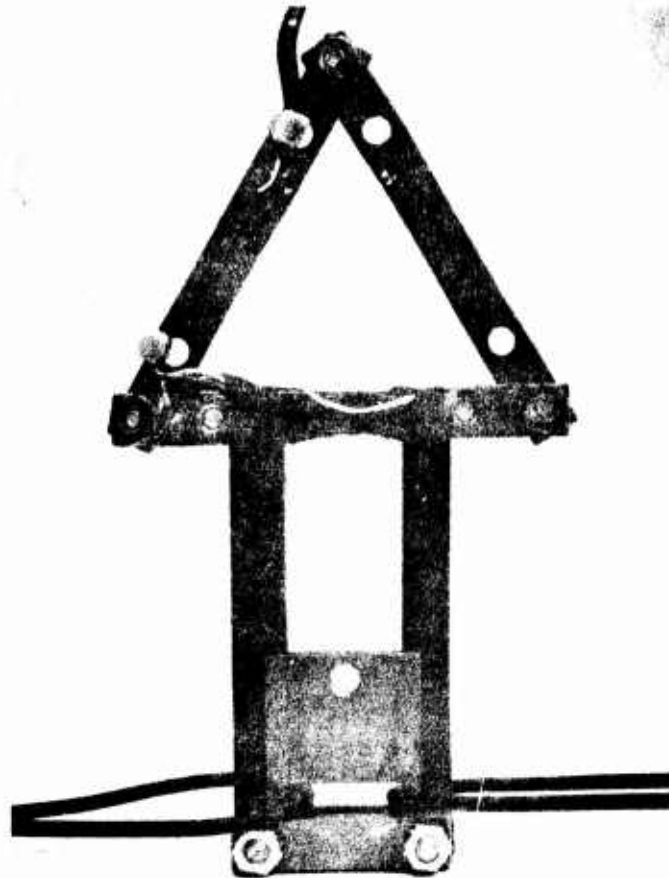
Figure 8. Mechanical gage modified to produce an electrical signal proportional to force.

blocks in the mid-section of squares, and mechanical gages modified to produce an output signal proportional to force (Figure 8). This instrumentation provided a continuous force-time history. These tests confirmed results of the electrical gage tests conducted at Burnside, LA in December 1972, which showed that the peak force occurred at the finger apron.

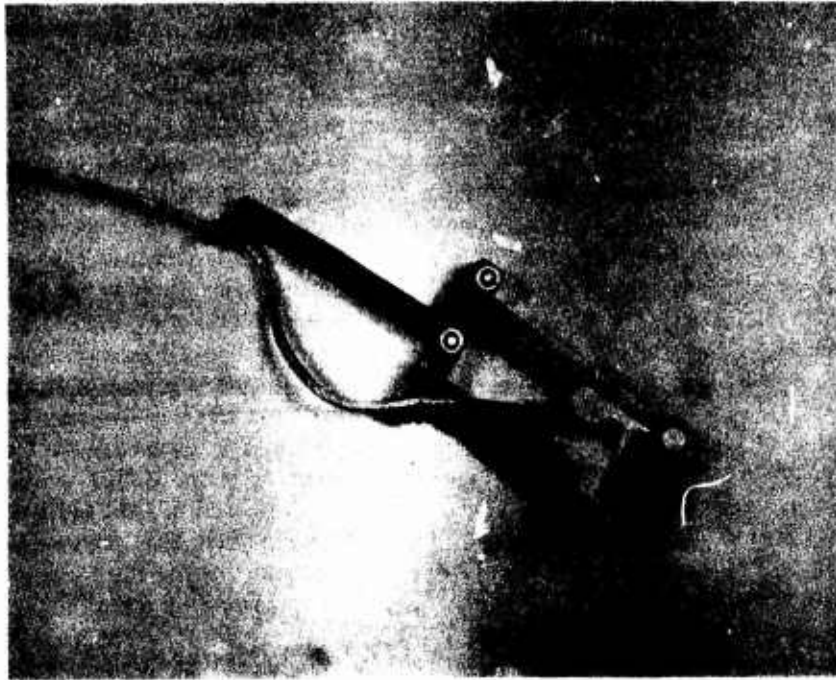
Figure B1. Longitudinal wire gage.

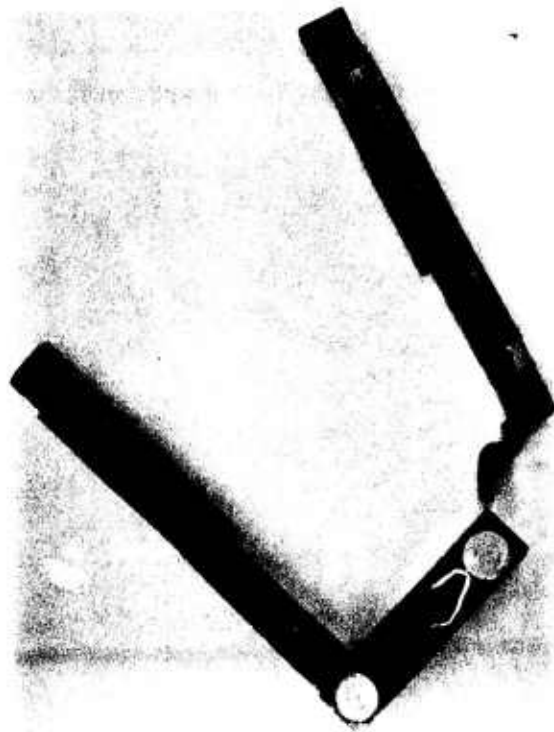
Figure B7. Gage frame failure at slotted section.
