TESTS OF OIL RECOVERY DEVICES IN

BROKEN ICE FIELDS

PHASE II

FINAL REPORT

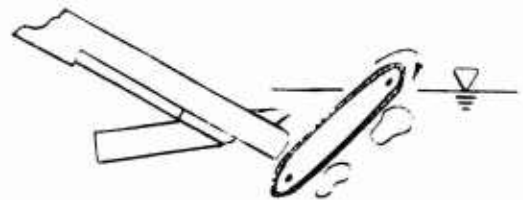
Concept P. Driven Mesh.

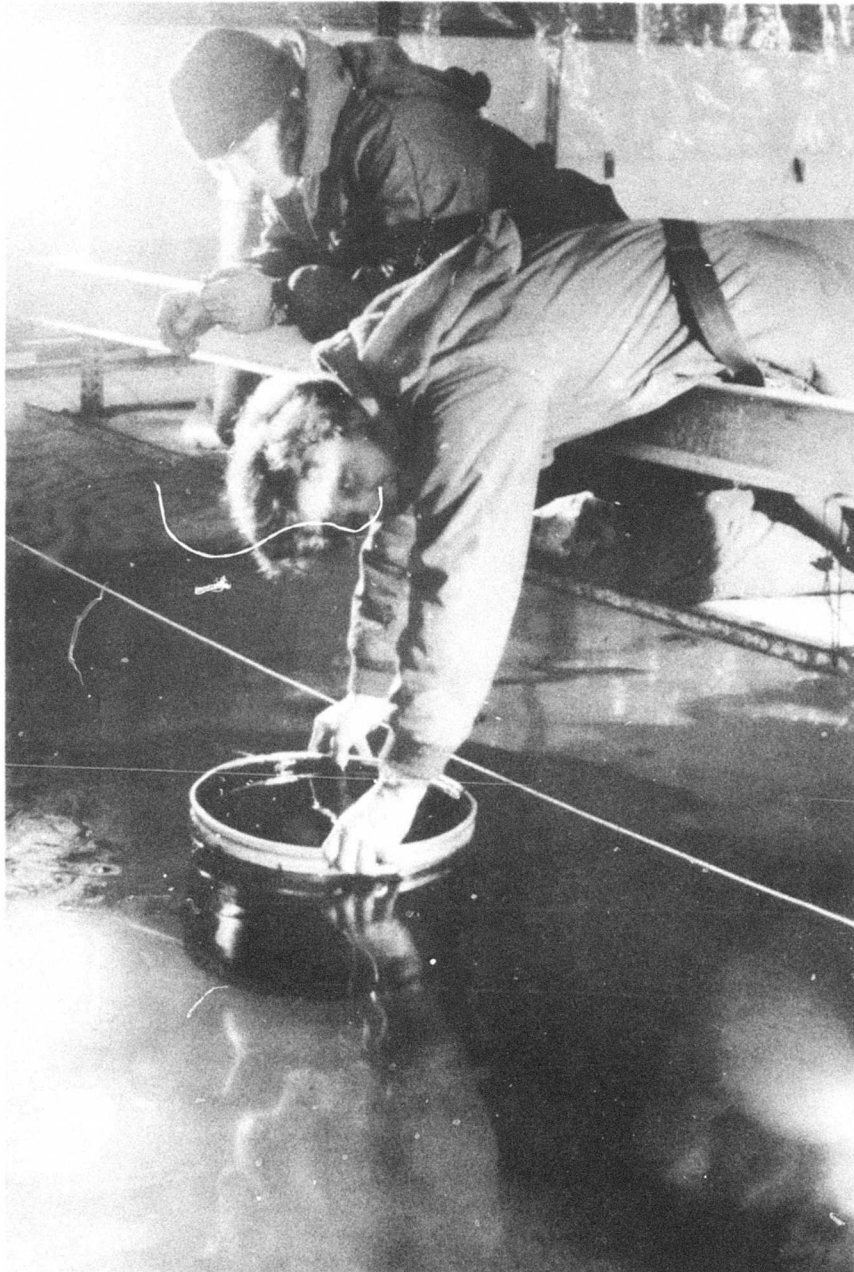
FIGURE 16. PHOTOGRAPH OF THE CRUDE OIL OPEN WATER SPREADING TEST JUST PRIOR TO RELEASE OF THE OIL .

The elimination of ice for the open water spreading test allowed the use of a simplified testing technique. The open water technique consisted of submerging a cylindrical container from which both the top and bottom had been removed into the water, adding oil to the inside of the container such that it was contained within it, and then slowly removing the container from the surface of the water thereby allowing the oil to spread. Figure 16 is a photograph of the crude oil open water spreading test taken just prior to release of the oil by lifting the container which has an open top and bottom. Figure 17 is a photograph of the resulting oil slick taken moments after the container had been removed. Apparently some slight horizontal velocity was imparted to the oil slick as the container was removed, since Figure 17 shows the oil slick approaching the side wall of the basin. It is interesting to note that shortly after this photograph was taken, the slick literally bounced off the side wall without wetting the wall surface and returned toward the middle of the basin. The bulk of the spreading action occurred very quickly, with the area of the slick increasing only a very slight amount over an extended period of time after the initial spreading took place. The average equilibrium thickness of this crude oil slick in cold open water was measured as 0.73 cm, excluding the edges of the slick. The thickness, at the edges, of course, diminished. Figure 18 is a photograph of the edge of the slick after a period of time, showing the thinning of the slick at the boundaries and the effect of the volatiles coming off the surface of the slick.

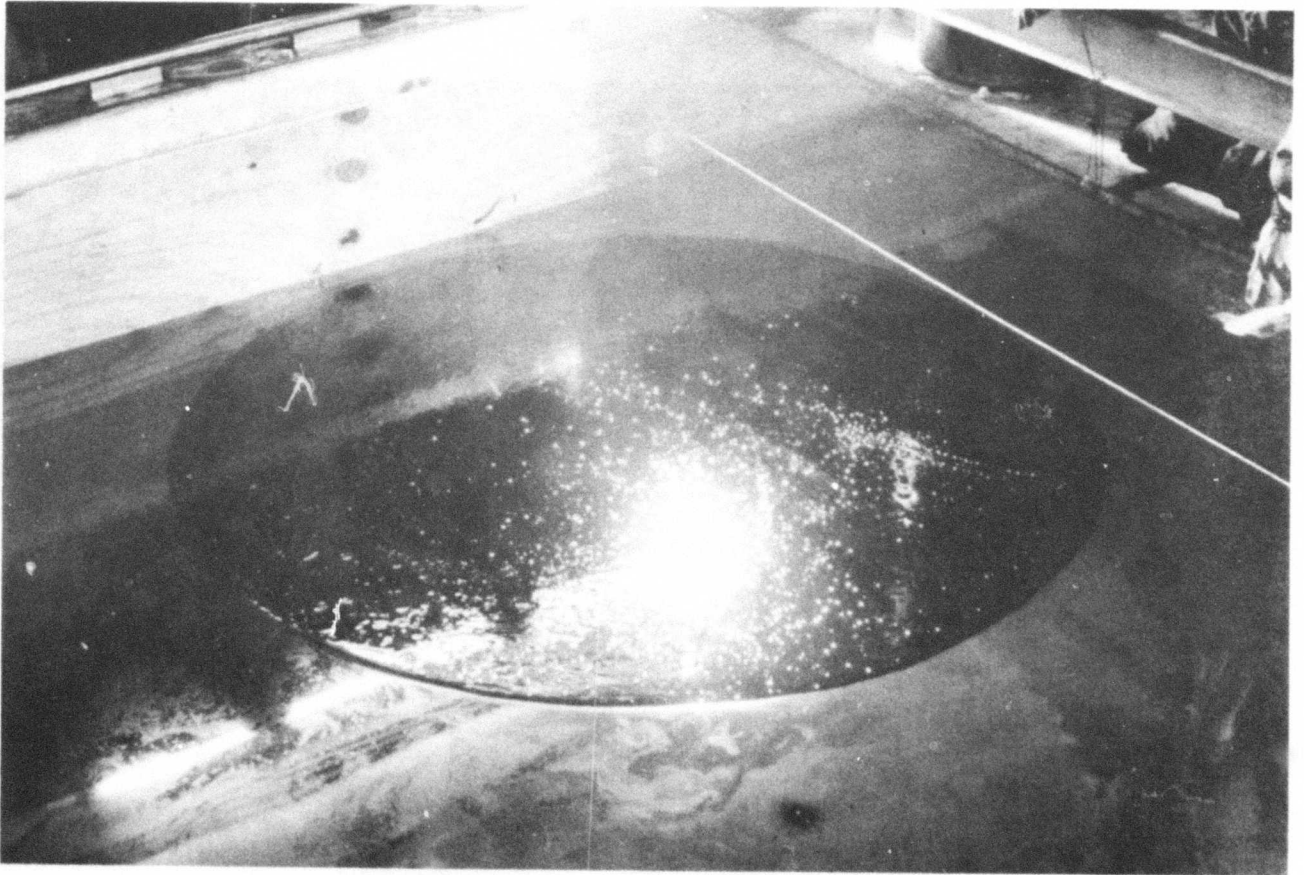
FIGURE 17. PHOTOGRAPH OF THE CRUDE OIL OPEN WATER SPREADING TEST TAKEN MOMENTS AFTER RELEASE OF THE OIL.

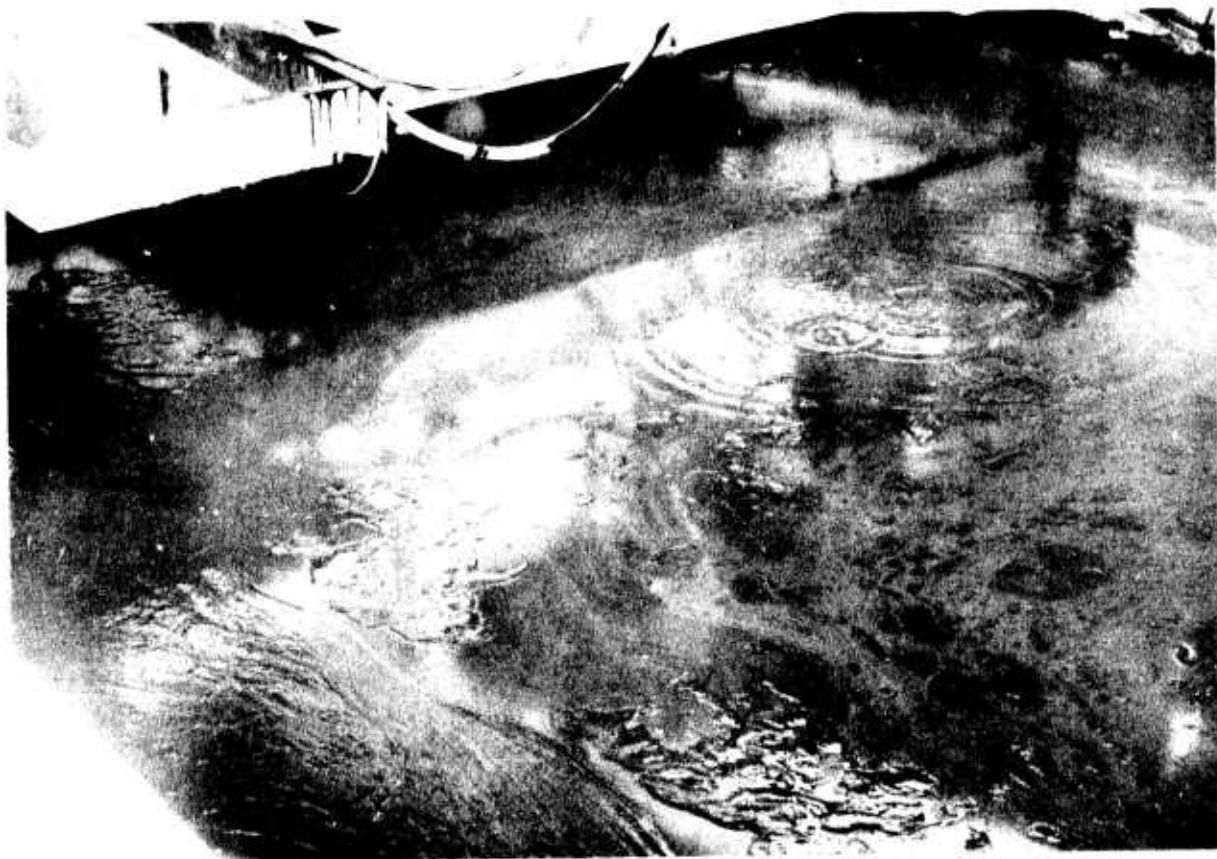
FIGURE 20. PHOTOGRAPH OF THE CLEAR WATER SWATH LEFT IN THE 1.27 CM THICK SLICK OF CRUDE OIL IN OPEN WATER AFTER PASSAGE OF THE LOCKHEED OIL RECOVERY DEVICE.

As previously indicated in the summary of test commentary presented in Table 8, both units cleared a clean swath of heavy crude oil from the surface of the basin in the open water tests. The appearance of the surface of the model basin after the devices had passed resembled what would be left if someone had cut a swath in a carpet and rolled it up. Figure 20 is a photograph of the clean swath left on the surface following passage of the Lockheed device in an open water test with crude oil. Clearly, nearly all of the oil had been removed from the water surface across the full width of the disc drum unit. The data obtained from the Lockheed tests in crude however, as summarized in Table 10, showed throughput efficiencies for these two tests of only 23 and 63 percent. After analyzing the data from Test 2, it was realized that a substantial amount of the oil remained on the disc drum unit as a very thick coating of oil on the vanes. This oil had been removed from the surface of the water but had not penetrated through the vanes of the unit to the discs from which it could be recovered. The coating on the vanes was not so severe so as to preclude the entrance of oil between the vanes, however, the amount was substantial. For this reason, the data of Test 2 is considered to be of questionable value and the procedure for further testing of the Lockheed unit in crude oil was modified as a result of this inconsistency between observations and measured data. For subsequent Lockheed tests the unit was primed over a distance of 15 to 20 feet prior to the start of data collection, with the objective being to saturate the unit to an equilibrium level prior to the start of data collection in the same manner that the unit would be saturated by the end of a test run. The procedure used prior to this was the same procedure that was used in Phase I testing where the unit was rotated in air prior to each test and similarly raised free from the oil/water surface and rotated again in air at the conclusion of the test, such that the discs of the unit were wiped clean at the start and end of a test. The new priming procedure was used for Test 5, the second test of the Lockheed unit in crude oil and open water conditions. Again, test observations indicated that the unit had removed everything in its path over the length of the run, however the calculated throughput efficiency is 63%, indicating that even with the new priming procedure in this case, it is likely there was still a greater build-up of oil on the vanes of the unit at the completion of the test than there was at the start of the test. Carrying this line of thought to its limit, the question arises as to whether or not the Lockheed unit, when operated in great thicknesses of extremely viscous oil such as the crude oil used in the Phase II program, would build-up a great enough thickness of oil on the vanes of the unit such that oil would no longer penetrate through the openings between the vanes to the discs from which the oil is recovered. Unfortunately, the limitation of the model basin precluded any further evaluation of this possibility with the crude oil tested. Certainly, in the extreme case of sufficiently viscous oil, one can envision such an occurrence.

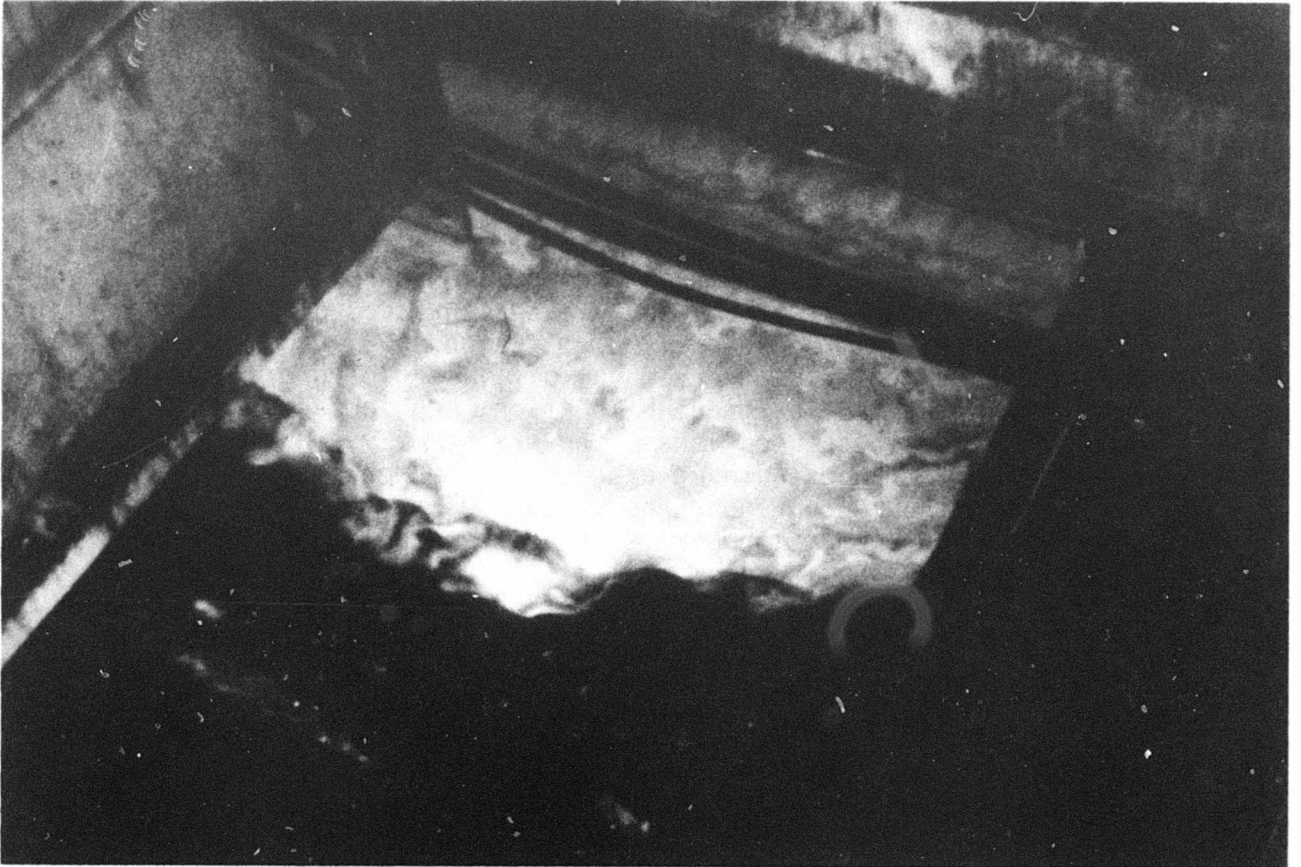
FIGURE 23. PHOTOGRAPH OF THE SEQUENTIAL OIL SPILLAGE THROUGH THE BACK SIDE OF THE LOCKHEED UNIT TAKEN DURING A STATIONARY TEST IN OPEN WATER WITH THE BARRIER IN PLACE.

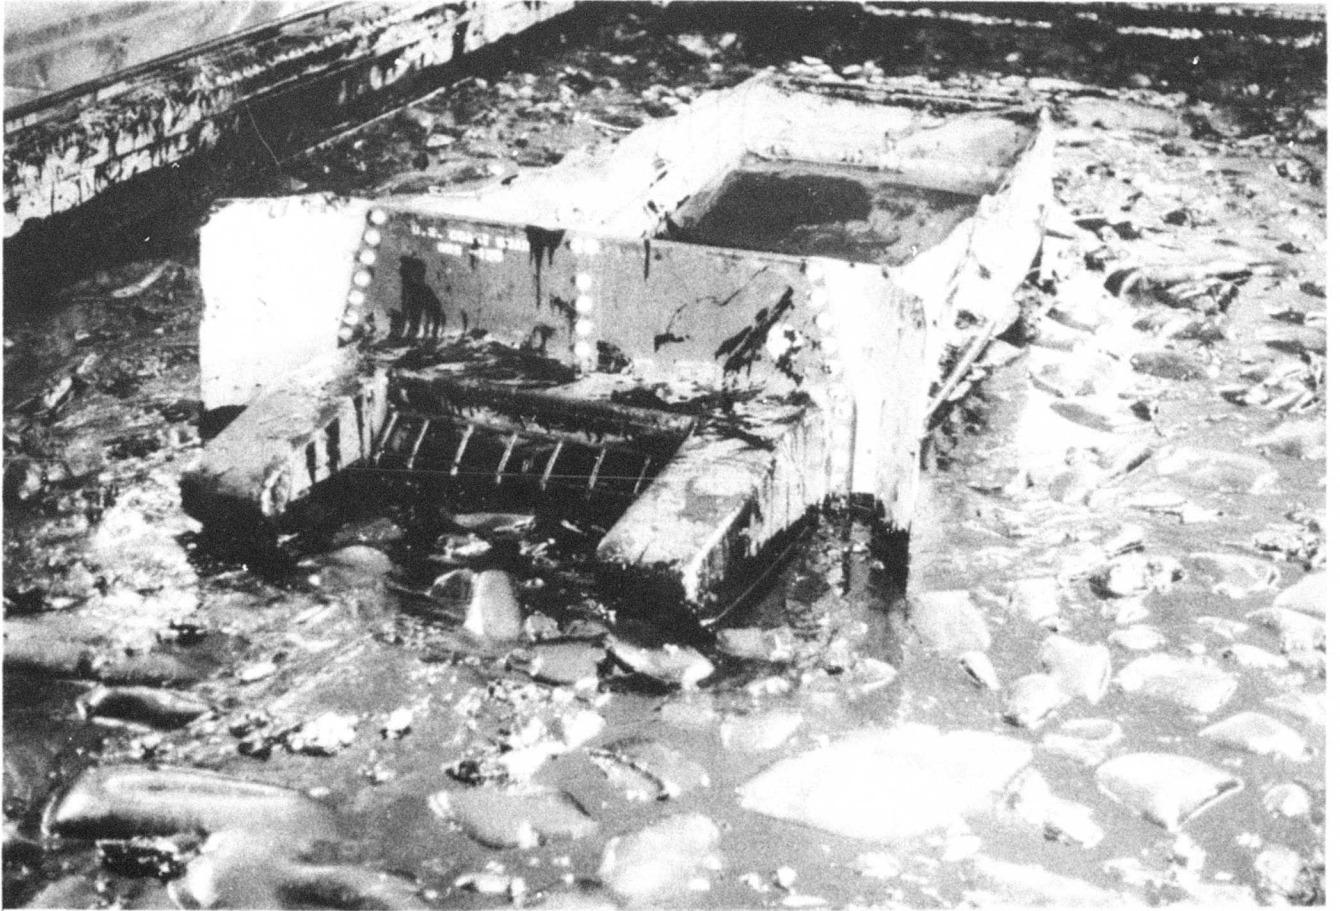
FIGURE 32. PHOTOGRAPH OF THE OSI SKIMMER READIED FOR TESTING IN ICE INFESTED WATER AND CRUDE OIL.

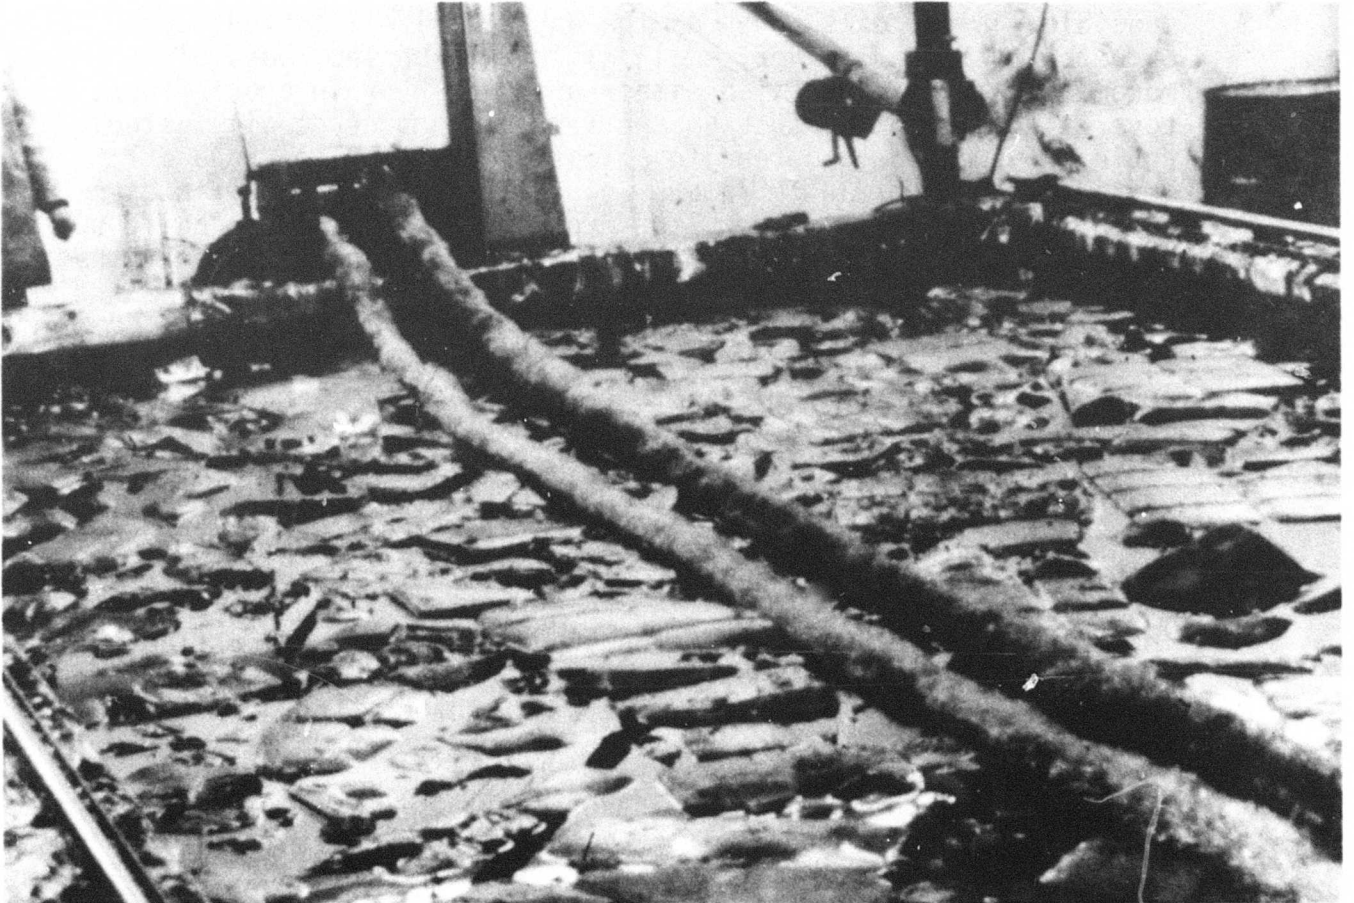
FIGURE 36. PHOTOGRAPH OF THE OIL MOP OPERATING IN NO. 2 FUEL OIL.

lift was about 1 to 1.5 feet in this test program and, as the belt moved at an angle from the water surface up to the squeeze rollers, most of the surface coating of water on the rope material and on the collected oil had a tendency to drain free. Figure 36 is a photograph of the Oil Mop unit undergoing testing in No. 2 fuel oil in the model basin.

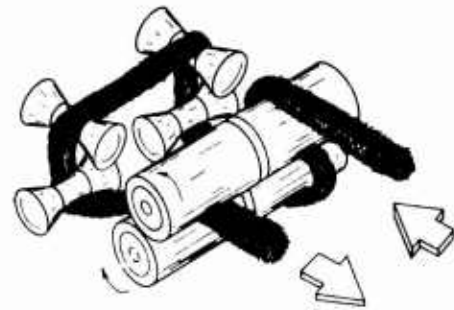
FIGURE A-9. GENERAL CONFIGURATION, OVERALL DIMENSIONS AND ROPE THREADING DETAILS FOR THE OIL MOP UNIT TESTED.
