FA-TN-75003

DEVELOPMENT OF A FLEXIBLE INTERNAL ELEMENT (FIE)
FOR ALUMINUM CASED AMMUNITION

January 1975

Munitions Development and Engineering Directorate

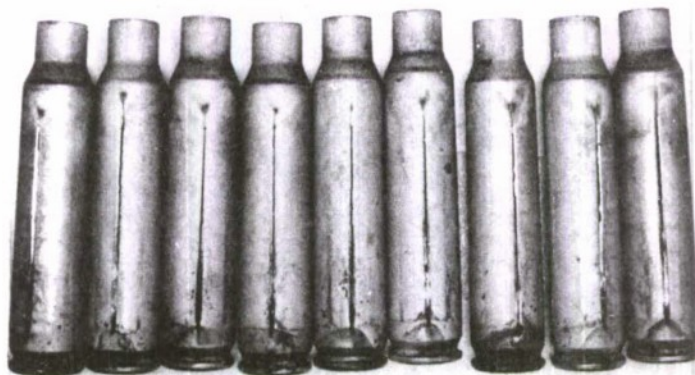
X-ray view showing cups after insertion

X-ray view showing cups after firing

External view of cases after firing
