A STUDY OF THE FAILURE OF JOINTS
IN COMPOSITE MATERIAL FUEL CELLS DUE TO
HYDRAULIC RAM LOADING

THESIS

June 1976

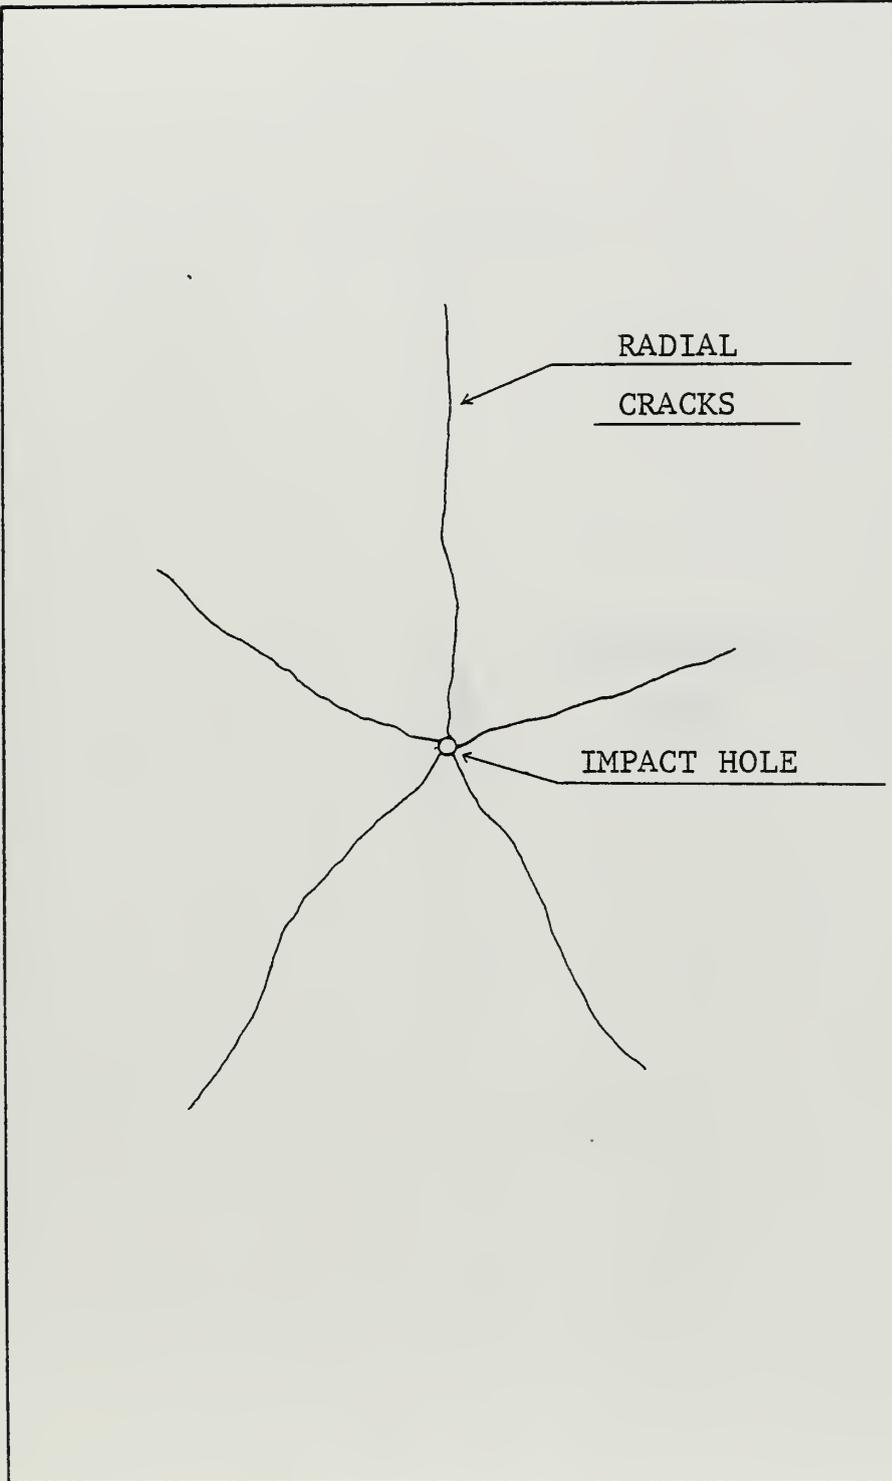
Figure II.1 RADIAL CRACK FAILURE

At present, five main types of fracture of the composite fuel tank wall have been identified. Although there is always some form of hole in the wall due to the penetration of the projectile, different crack types may occur. First, there is the possibility of radial cracks extending out

from the hole, as illustrated in Figure II.1. Second, there is the possibility of a lengthwise crack with extensive delamination of the material around the hole, as seen in Figure II.2.

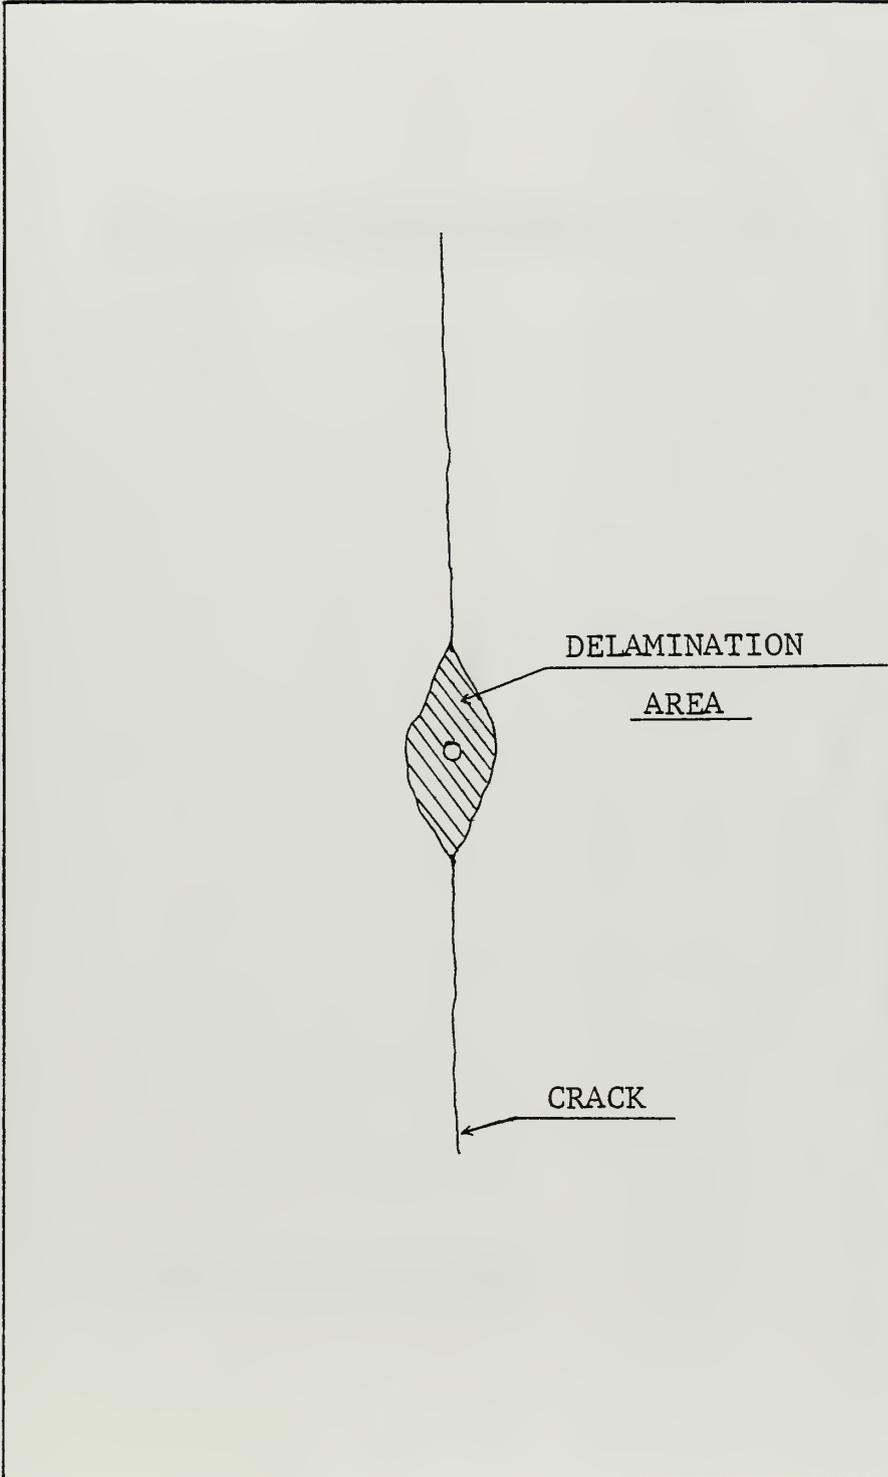
Figure II.2 LENGTHWISE CRACK FAILURE

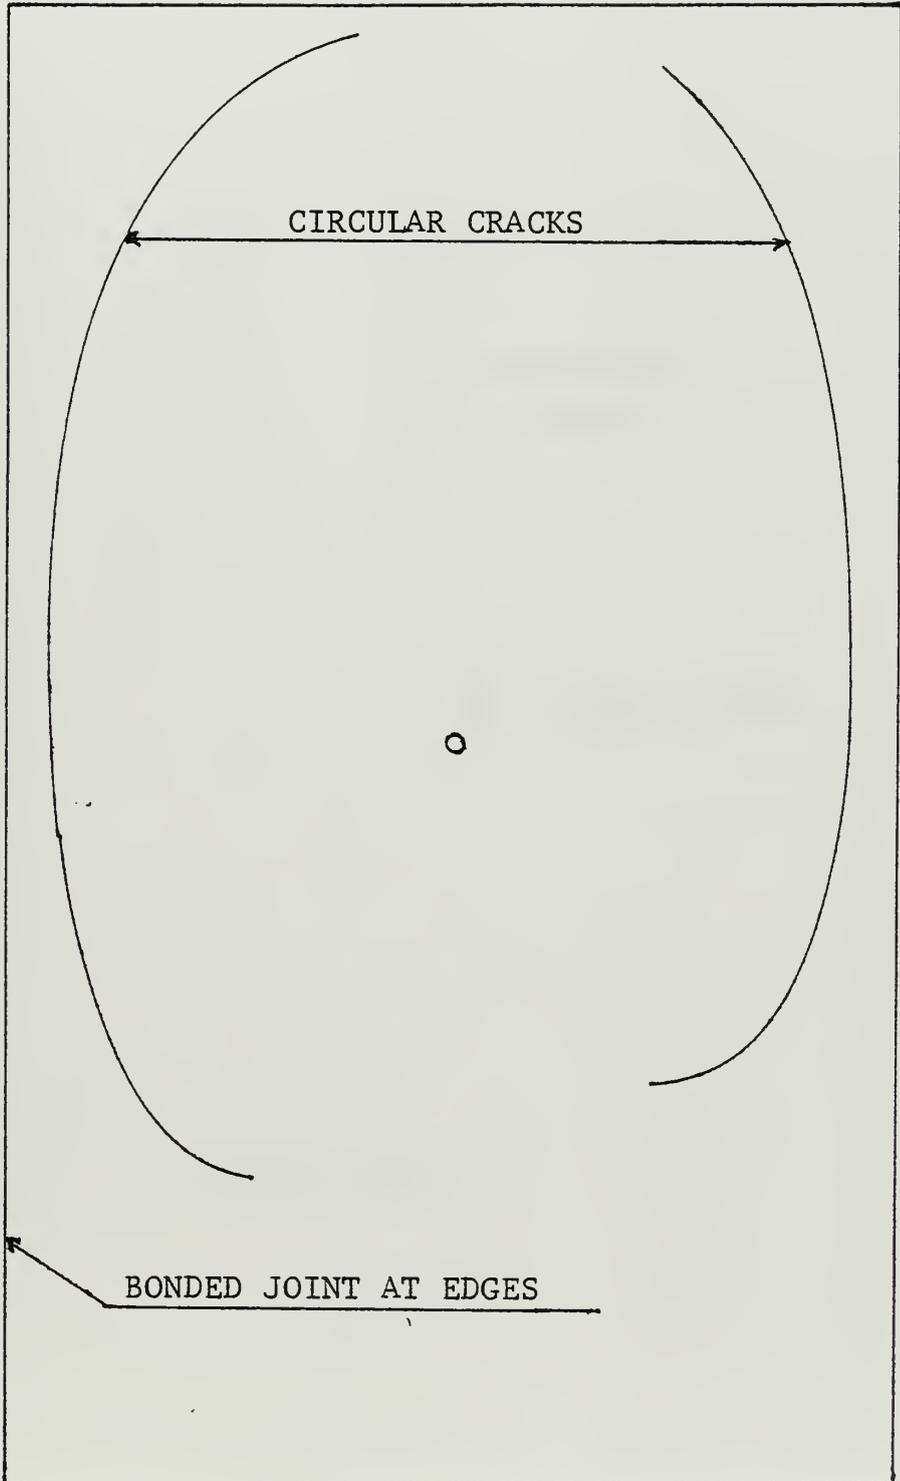
Figure II.3 CIRCULAR CRACK FAILURE

The remaining modes of fracture do not occur around the hole, are significantly influenced by the hydraulic ram loading, and indicate a more serious loss of structural integrity than the first two modes of fracture. The third fracture type has long circular cracks near the edges or attachments of the plate, where a bonded attachment technique was used. It is illustrated in Figure II.3. The fracture in the fourth case is very similar to that of the third case. This type also has long cracks along the edges of the plate, where the attachment to the supporting members is made, but the attachment technique used here was one of clamped edges, and the fracture has almost led to a breakout of the entire plate, as illustrated in Figure II.4. The main difference between the third and fourth types of fracture is a difference in the method of attachment of the plate. In the third case, the attachment was a built up, interlaminarly bonded joint. The attachment in the fourth case was a clamped edge.

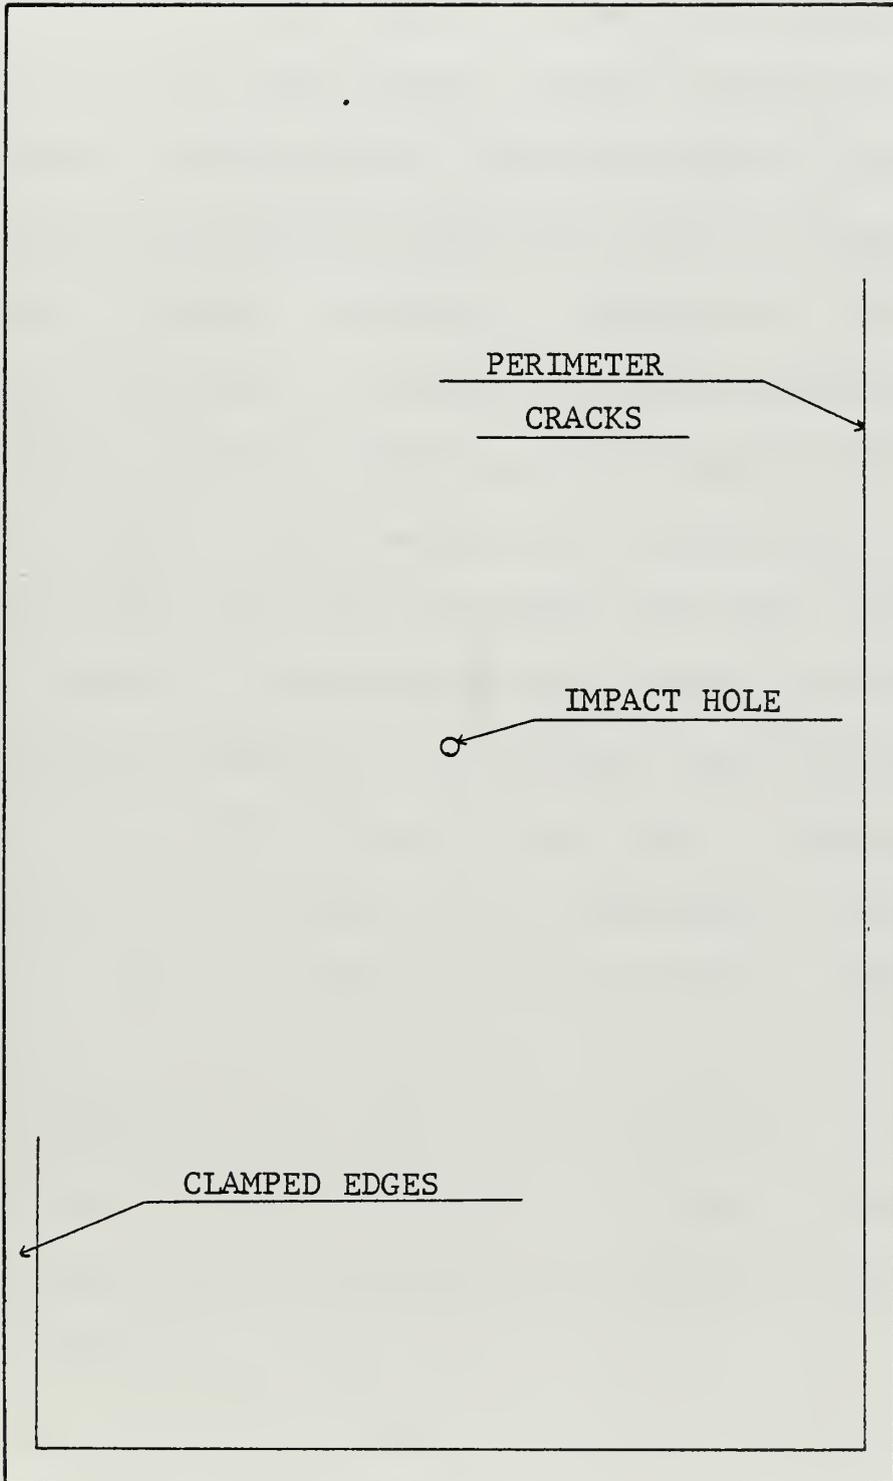
Figure II.4 EDGE LENGTH CRACK FAILURE

A crack or fracture, such as the one along the clamped edge of a composite plate, shown in Figure II.4, is transverse in some layers, and longitudinal in others. For cracks and fractures in composites due to the hydraulic ram loading, where the plate failed at the attachments, the stresses in the material are dependent upon N, M, and Q, and the combination of the three makes the prediction of a particular failure mode very difficult.

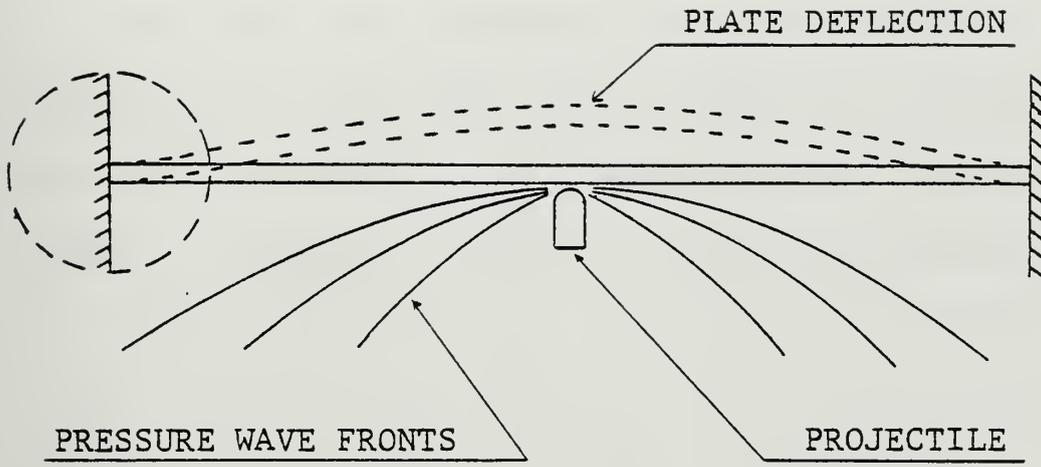
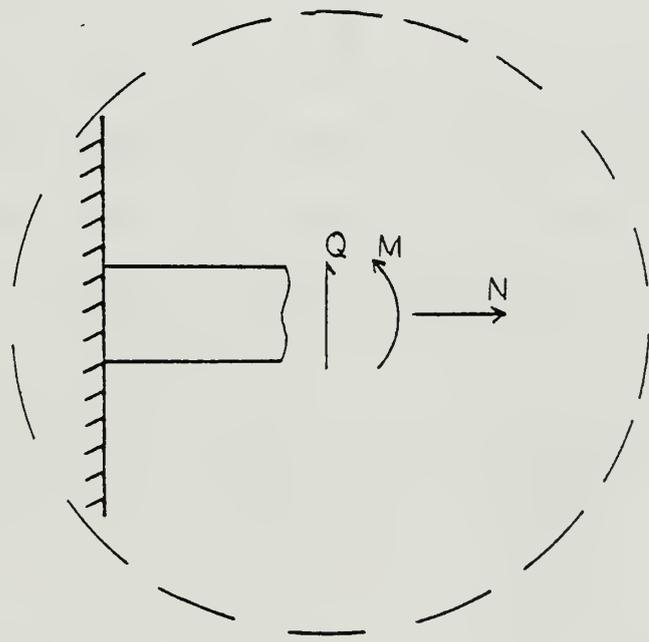
Figure II.5 HYDRAULIC RAM LOADING ON A PLATE

of the plate, the attachments are one of the critical areas of failure for a fuel tank of composite construction. An examination of the loading on the plate by the hydraulic ram also reveals that the attachment areas of the plate will be critical failure areas. The fluid pressures on the plate, created by the penetrating projectile, will produce three types of internal loads in the plate, membrane tensile and shearing forces, (N), thickness shearing forces, (Q), and bending and twisting moments, (M). This type of pressure loading, as seen in Figure II.5, can create high stress levels at the edges of the plate where the plate is restrained.

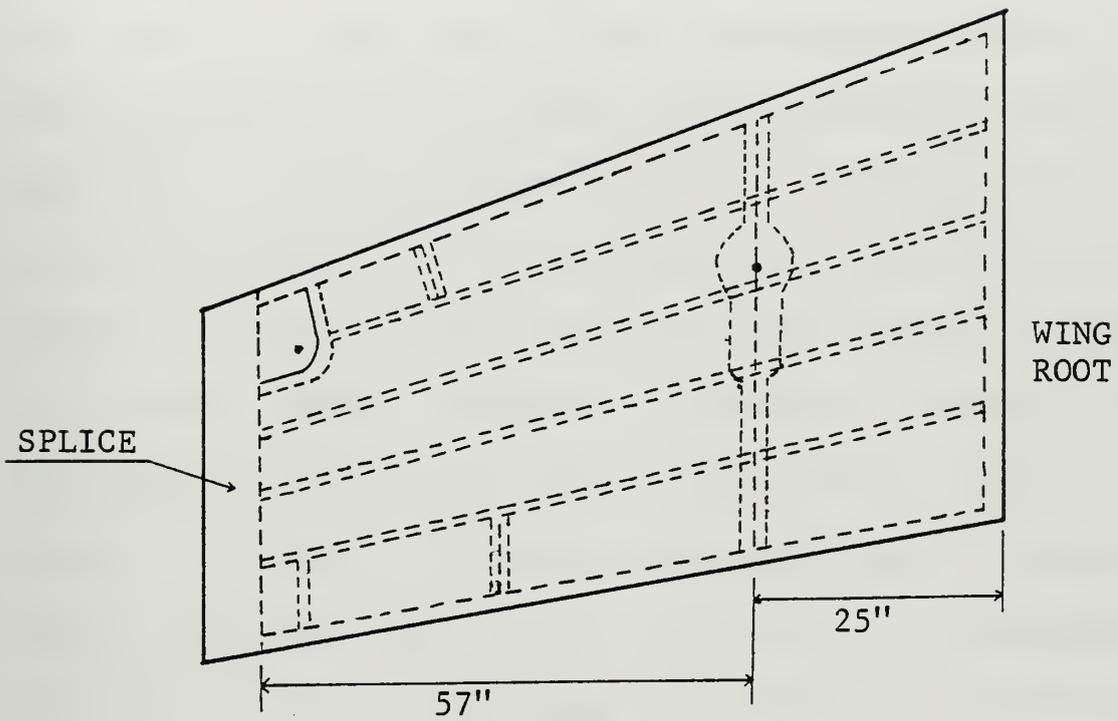
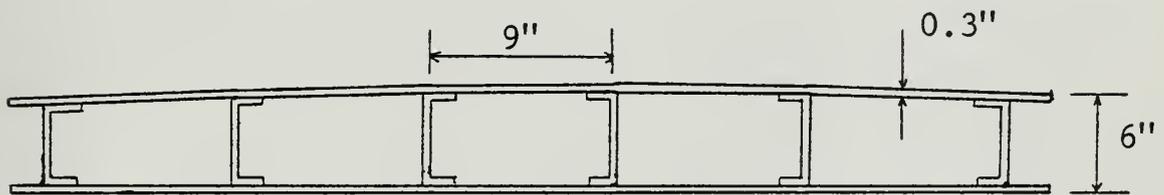
Figure III.A.2 F-18 WING CONCEPT

The F-18 wing [Ref. 1], shown in Figure III.A.2, is also a beam-like, straight wing design. A graphite-epoxy laminate of low modulus/high strength is being considered for the skins. Only one large composite panel is used as the skin on each surface of the wing over the fuel tank section. The thickness of the wing tank varies from 9 inches to 5.5 inches, and it has aluminum spars and ribs, with no stiffeners. The spars are approximately 9 inches apart from each other, and the ribs are approximately 25 inches and 57 inches apart. At the present time, the McDonnell-Douglas Aircraft Corporation [Ref. 1] is not planning on using either softening strips or a honeycomb type of skin for the F-18.

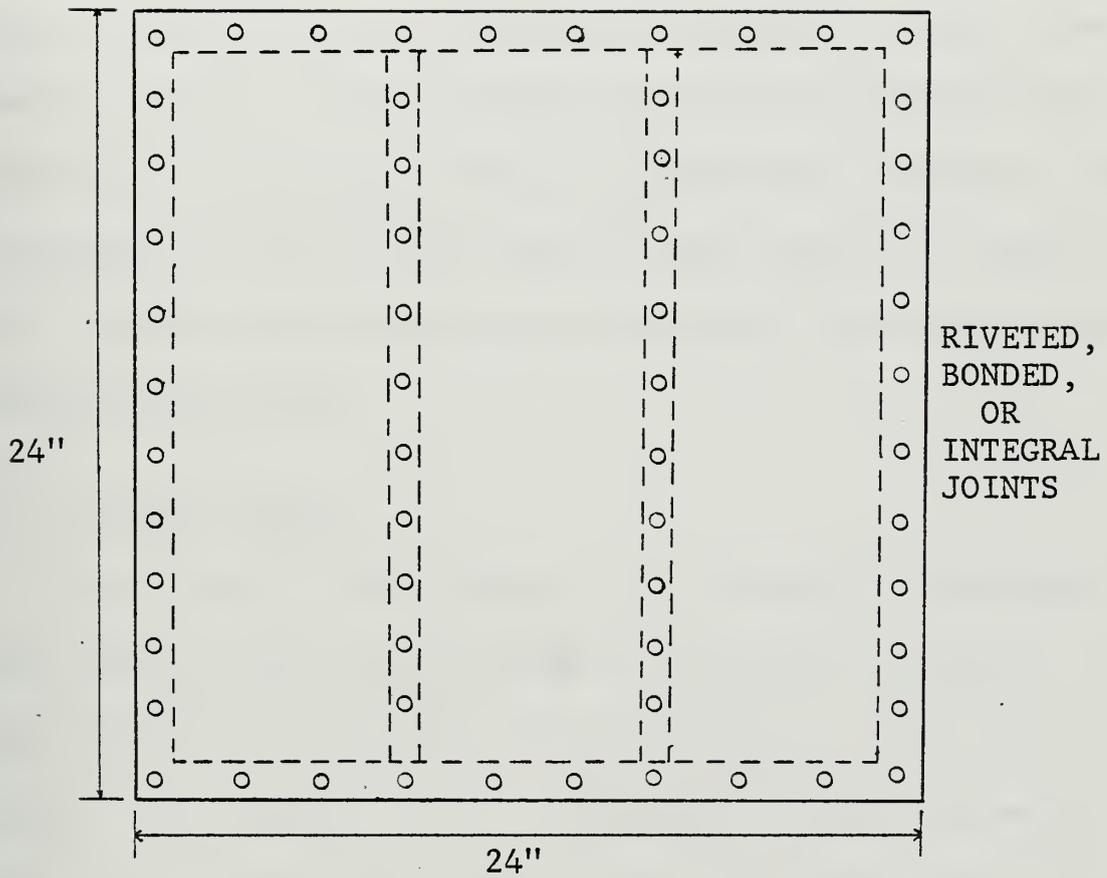
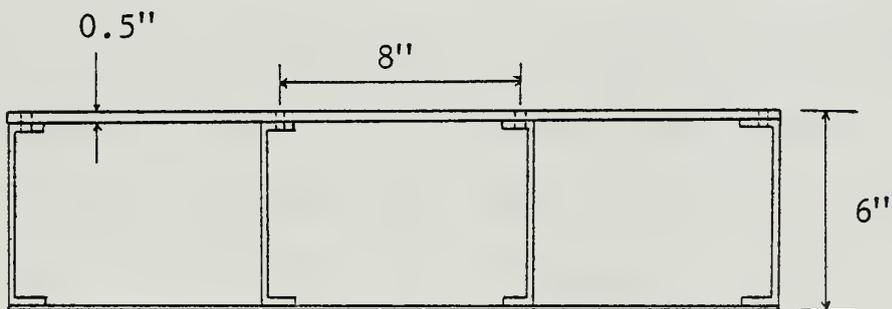
Figure III.A.3 WING TANK TEST SECTION

of a typical wing fuel tank. This permits hydraulic ram testing with a tank that not only approximates actual wing tank concepts, but also allows for consistencies that are necessary in any experimental analysis. A typical section proposed for hydraulic ram testing is one that is approximately 24 inches between ribs and 8 inches between spars, or 4 inches between stiffeners. Therefore, by using plates 24 inches by 24 inches in size, a test section that is similar in size to the proposed aircraft wing fuel tanks can be developed. The section should also be approximately six inches thick to approximate the thickness of actual wings and thus present a similar liquid volume. This typical section is illustrated in Figure III.A.3. One disadvantage of this size of test tank is that it may not give an indication of the total amount of unzipping that might occur because of hydraulic ram loading.

A problem that has severely restricted the testing of this type of section at the Naval Postgraduate School is cost. A graphite-epoxy composite laminate that is 24 inches square and $\frac{1}{2}$ inch thick would cost between \$1500 and \$2500 to produce. It would require outside contracting for its construction since there are only limited composite manufacturing capabilities at the Naval Postgraduate School.

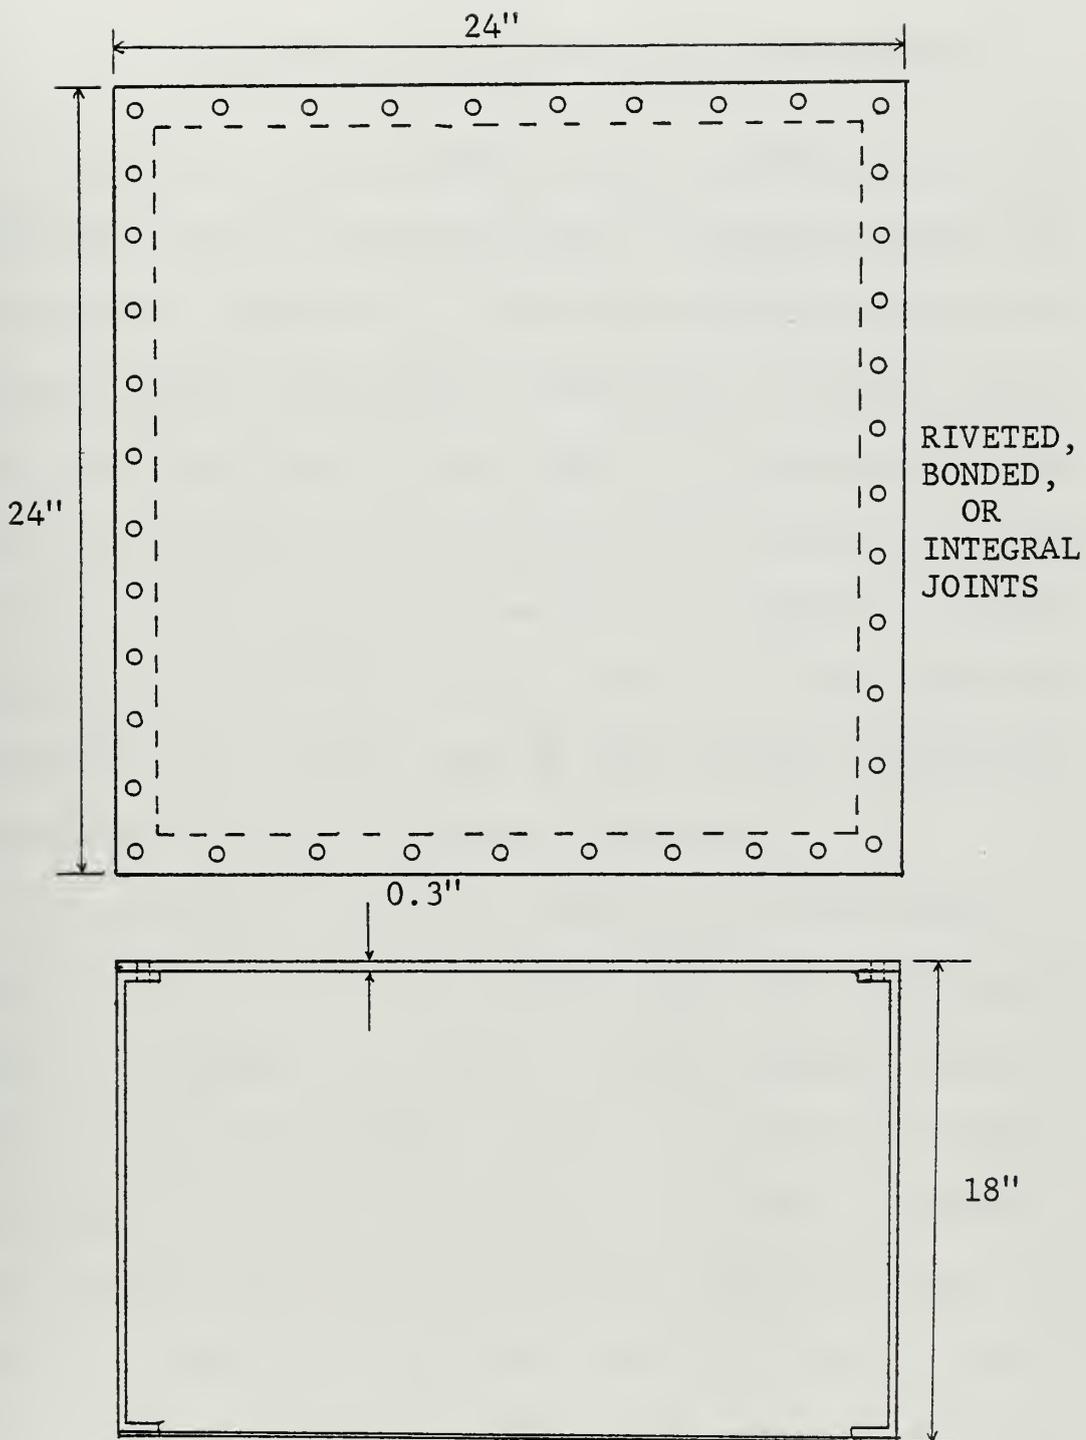
Figure III.B.1 FUSELAGE TANK TEST SECTION

For hydraulic ram testing of a fuselage fuel tank, a 24-inch by 24-inch by 18-inch cube could be expected to closely approximate an actual fuselage fuel tank. It allows for a realistic representation of volume and depth characteristics in an actual tank. In much the same way as with a wing tank testing section, the fuselage tank testing section should permit experimentation with different methods of attachment, and different types of skins. An example of the proposed test tank is illustrated in Figure III.B.1. Although the concept is drawn with a flat skin, a test section using curved skins would permit the investigation of the effects of curvature on the failure of composite walled fuselage fuel tanks. A flat walled tank is sufficient to explain the effects of fluid depth and volume, and also to give a basic idea of the type of fracture to be expected in a fuselage fuel tank. If bonded or integral joining techniques are to be investigated, more than one test tank would need to be built. Construction costs would probably be only slightly lower than the costs of constructing a wing test tank, mainly because of reduced composite material needs, but they would still be relatively inexpensive in comparison with the testing of an actual aircraft's fuselage fuel section.

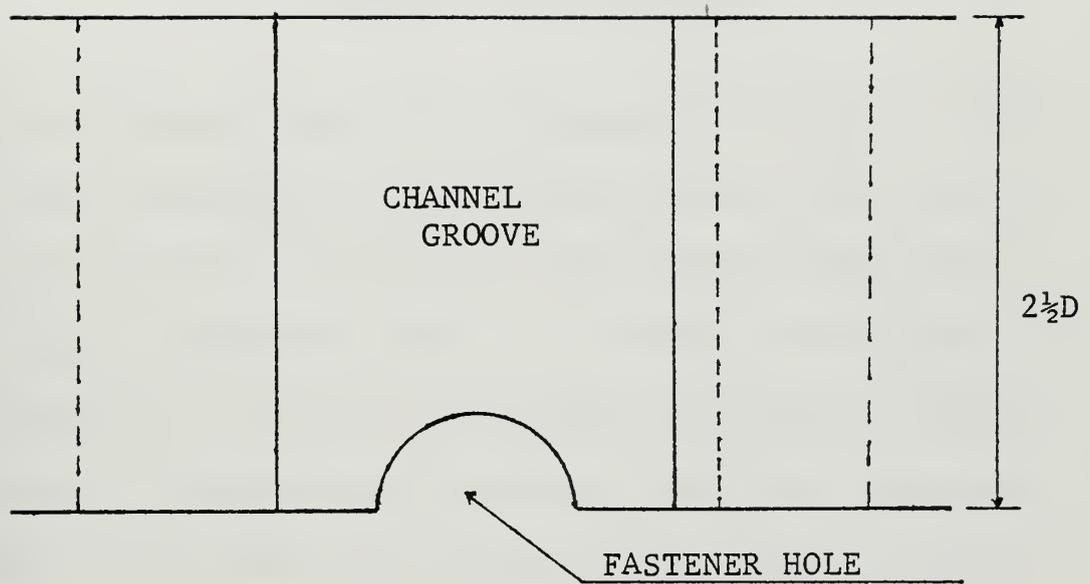
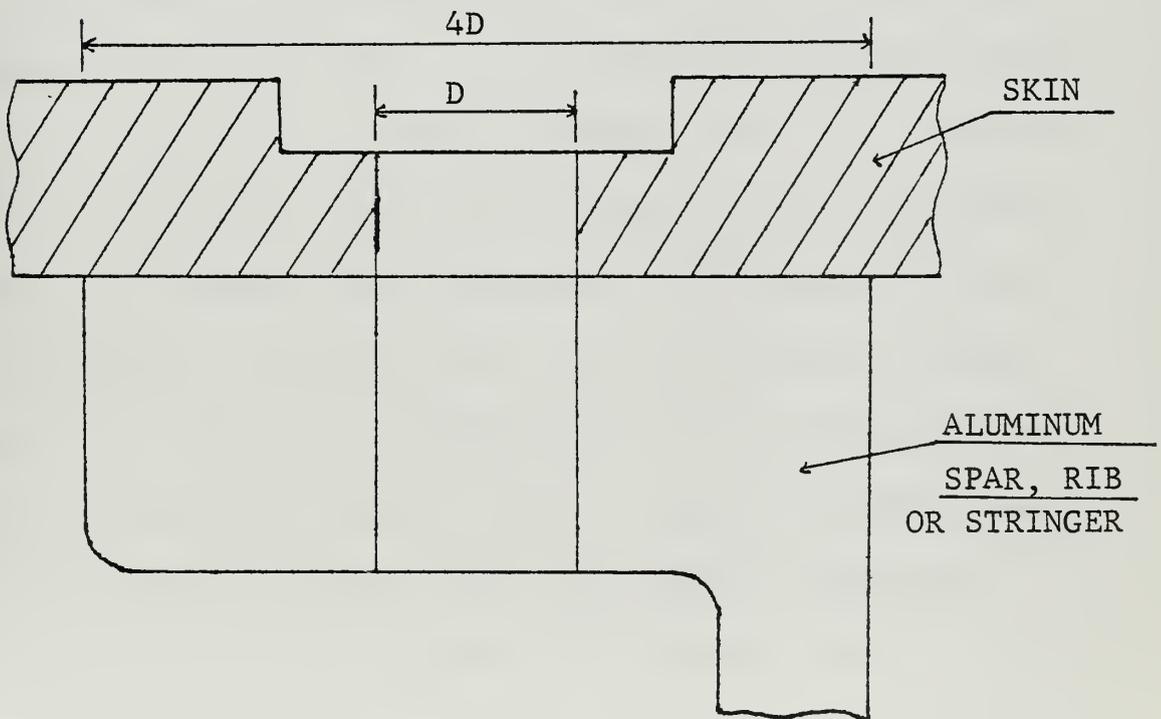
Figure IV.1 TYPICAL MECHANICALLY FASTENED JOINT (HALF SECTION)

Since the use of mechanically fastened joints is the most widespread among the types of fasteners used by the aircraft manufacturers, this study will restrict itself to their usage. The actual load concentration factors become of primary interest in the study of mechanically fastened joints for composites, since a hole through which to insert the fastener is needed to use it.

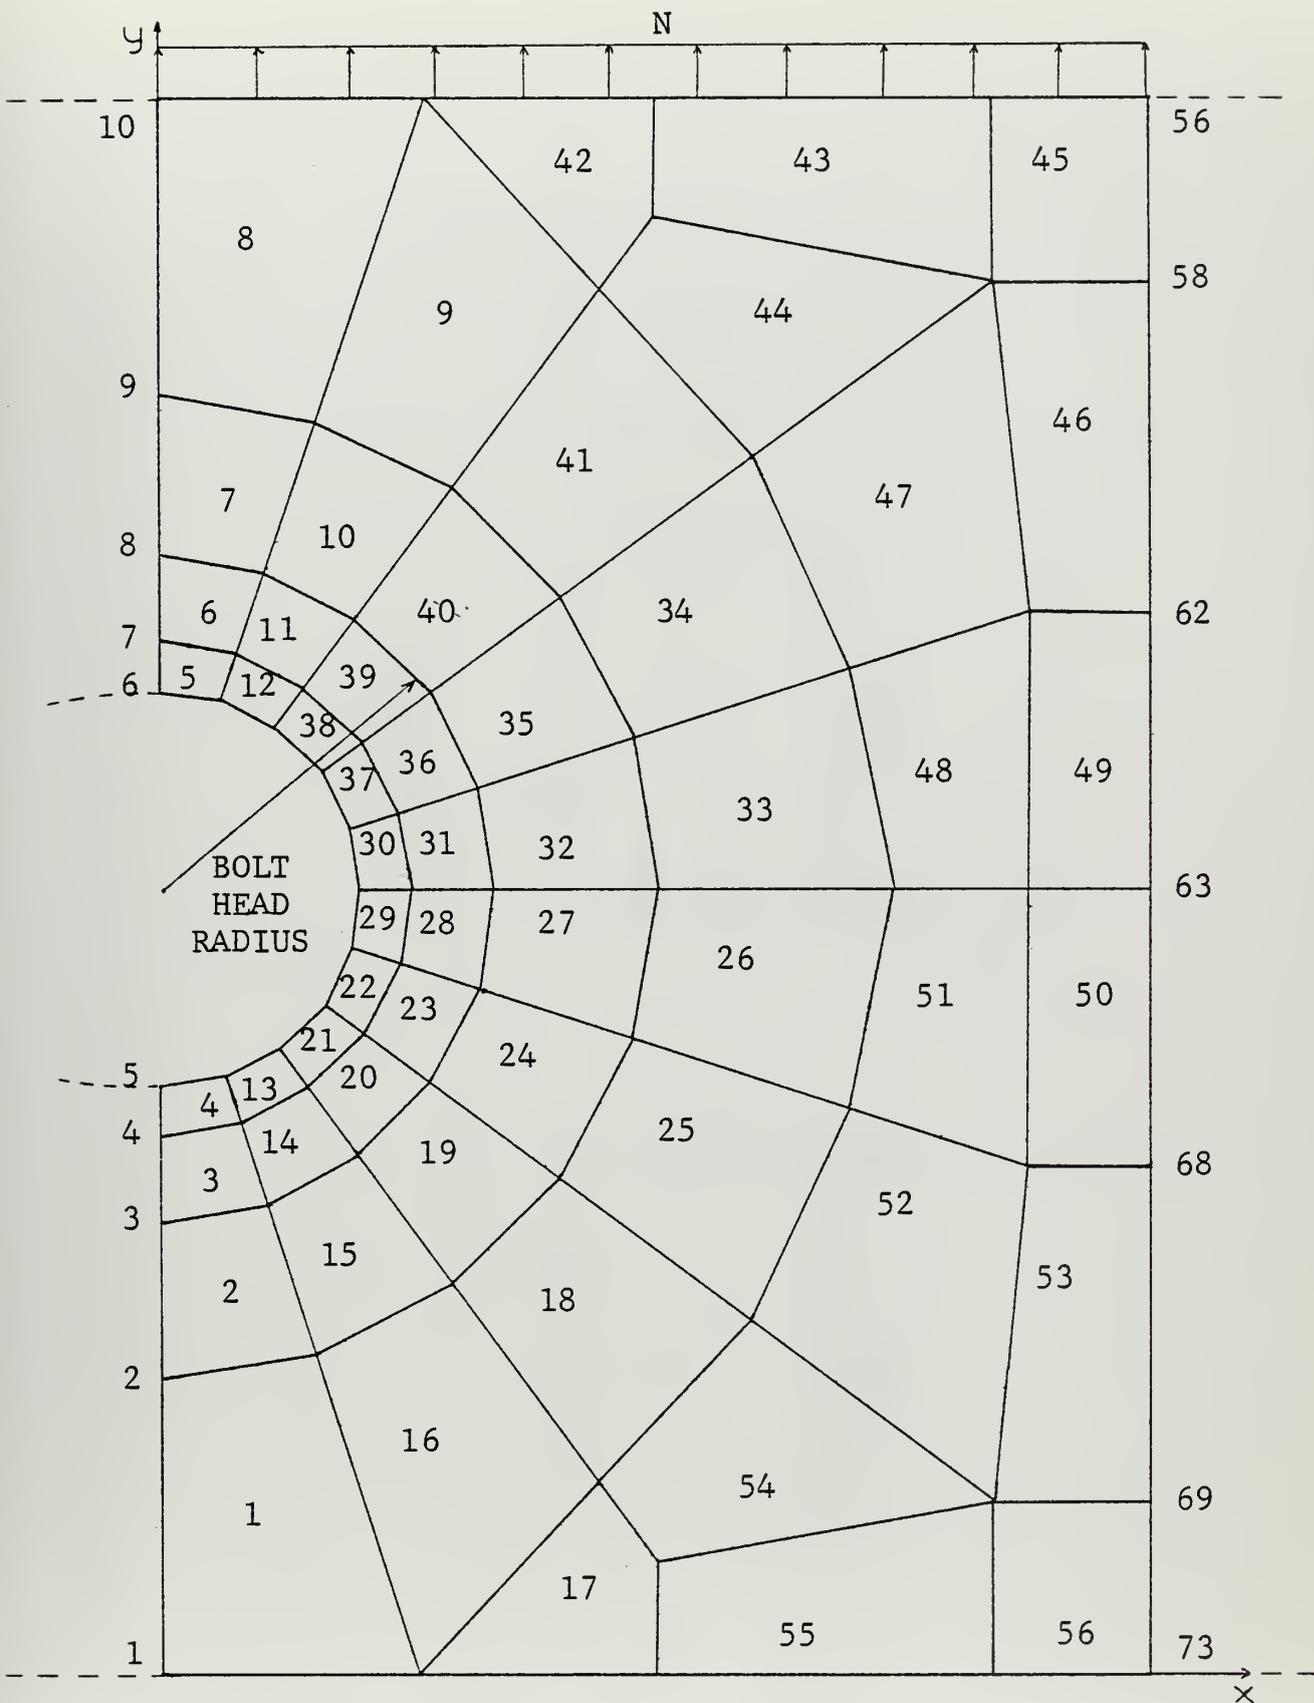
Figure VI.A.1 PLATE MODEL

Since the area of the joint is small, and since it is symmetrical, only 56 plate elements and 73 nodes were used to model one-half of the joint. Figure VI.A.1 shows the joint model with the layout of the nodes and the numbering

of the elements. Unit loads/unit length were used so that actual stress resultant concentration factors around the hole would be found. A two-dimensional thickness model is analyzed in the following section to determine the stress concentration due to the stress resultant concentration.

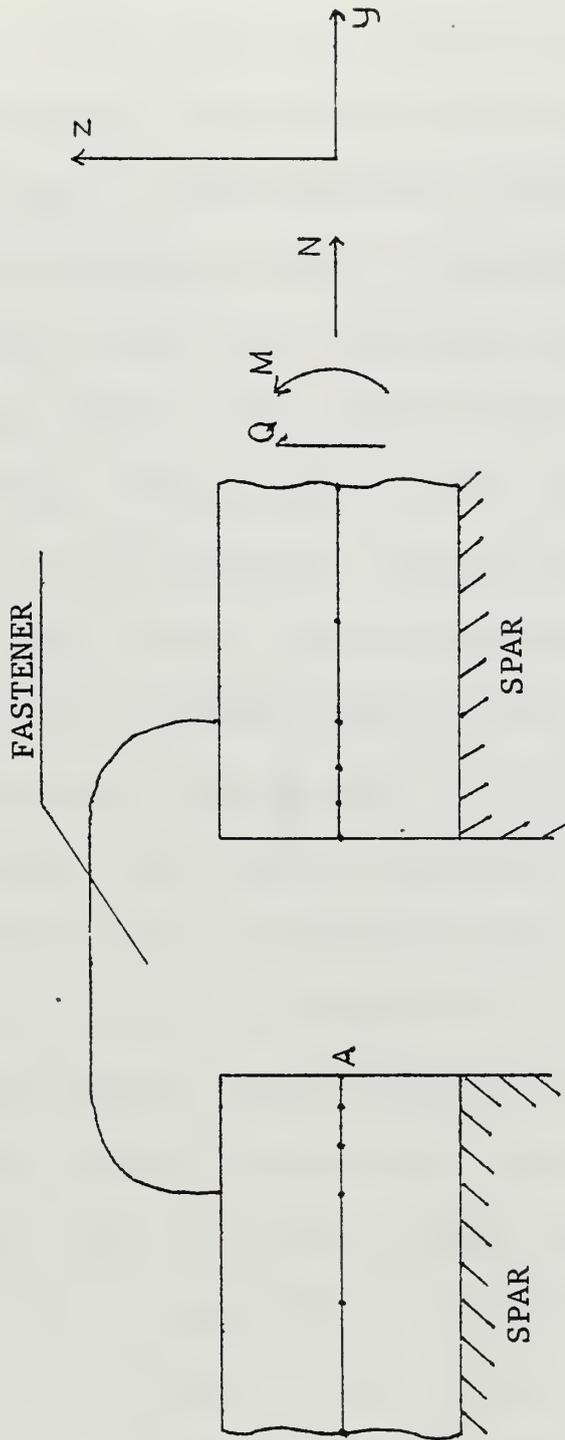
Figure VI.A.2 JOINT LOADING

It was assumed that the fastener would not fail, but would remain rigid. The skin was permitted to move in the y-direction except where the fastener would restrict such movement, such as at point A, Figure VI.A.2. It was also assumed that the fastener would restrain the movement of the plate in the z-direction where the fastener head overlapped the plate, and it was also assumed that the fastener did not permit any rotations where it overlapped the plate. The boundaries of the model, nodes 1 through 10, and nodes 56, 58, 62, 63, 68, 69 and 73 were not permitted displacements in the x-direction or rotations about the y-axis, due to the symmetry of the problem. The edge between nodes 10 and 56 was where the unit loads/unit length were applied,

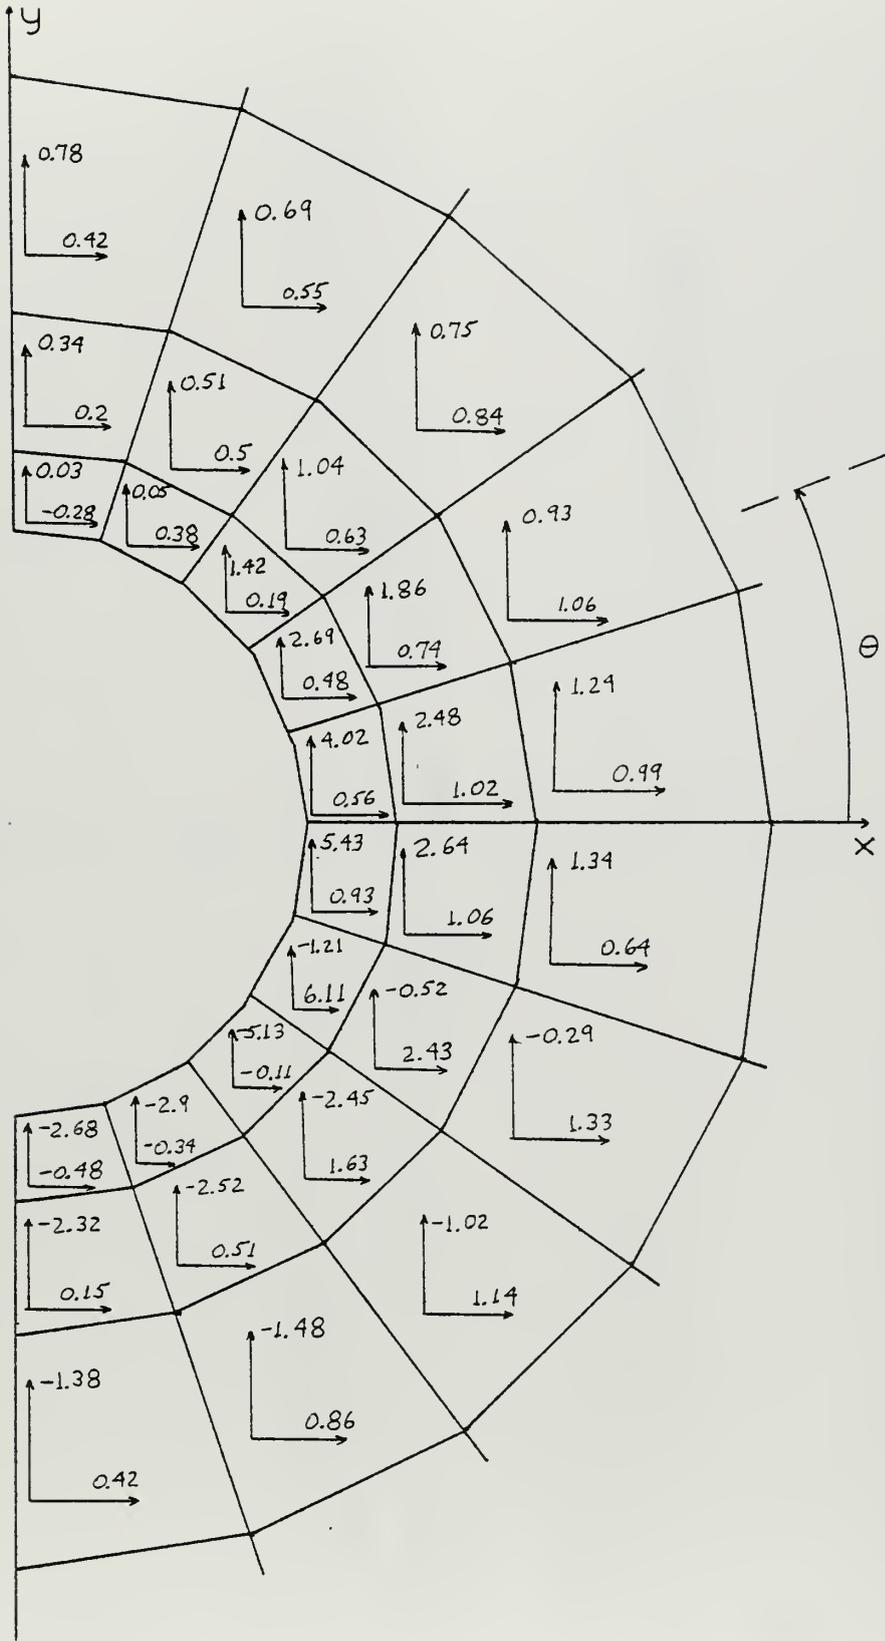
Figure VI.A.3 STRESS FIELD AROUND HOLE DUE TO N

Figures VI.A.3, VI.A.4, and VI.A.5 show how the stresses in the plate, S_{xx} and S_{yy} , varied around the hole for a unit tensile force/unit length. Although the joint is somewhat similar to a plate with a hole, the fastener was available to resist the tensile forces put on the plate; hence, higher stress concentrations than those of a plate with a hole in it were the result. Since only the fastener restricts deflection in the y-direction, all of the tensile force is picked up at the fastener, causing stress concentrations near five in compression in the plate.

Not only were there large stress concentrations in compression where the fastener picked up the load, but there were also large stress concentrations in tension in the y-direction of approximately 5.5. Since there is a hole, and the loads will not be picked up until they get around the hole, large stress concentrations will exist even where the fastener has no effect in restricting deflections in the y-direction. Results of the analytical studies of Howland and Theocaris [Ref. 2] indicate that stress concentrations near five or five and a half are quite close to

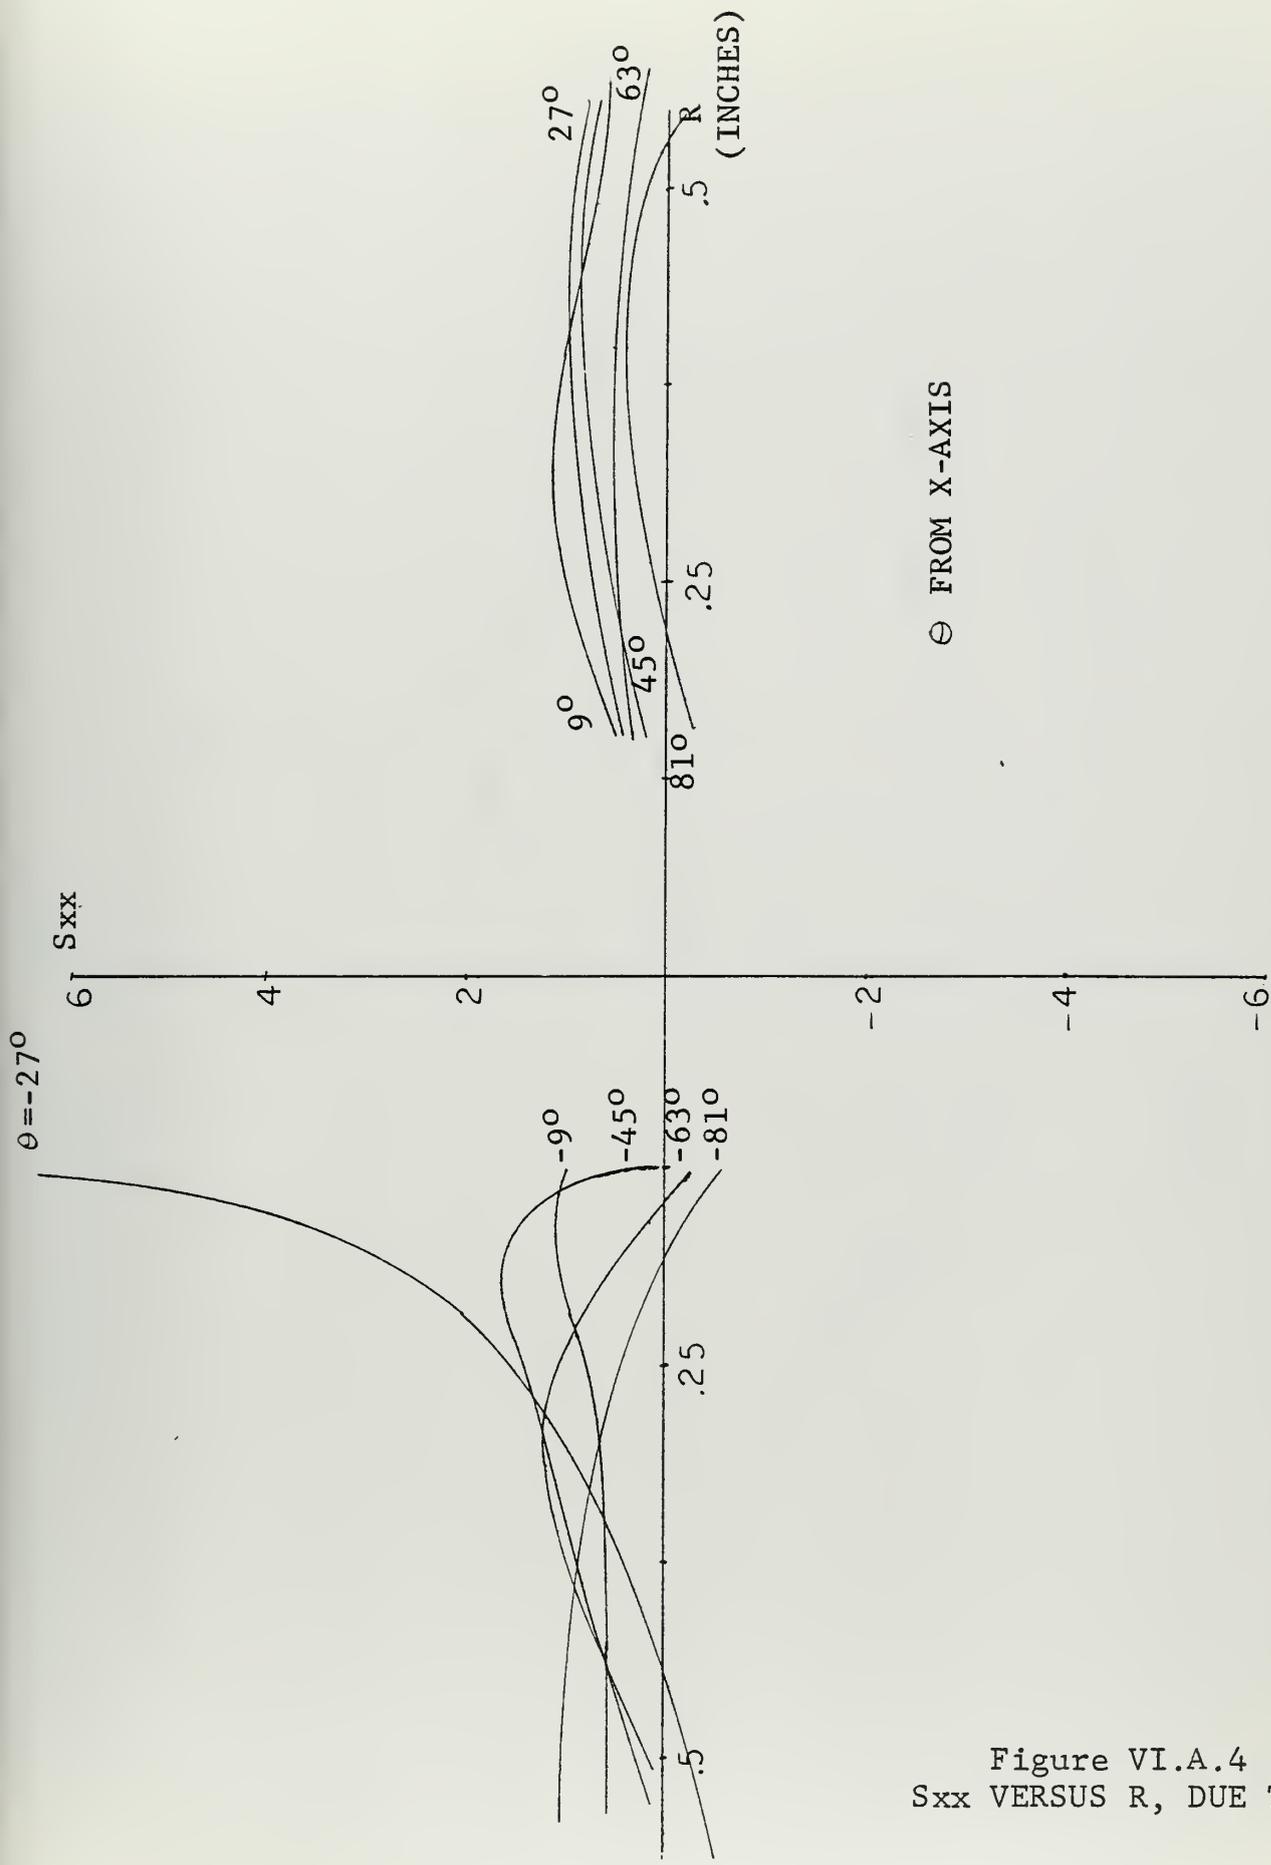
Figure VI.A.4
 S_{xx} VERSUS R , DUE TO N
