A STUDY OF THE FAILURE OF JOINTS
IN COMPOSITE MATERIAL FUEL CELLS DUE TO
HYDRAULIC RAM LOADING

THESIS

June 1976

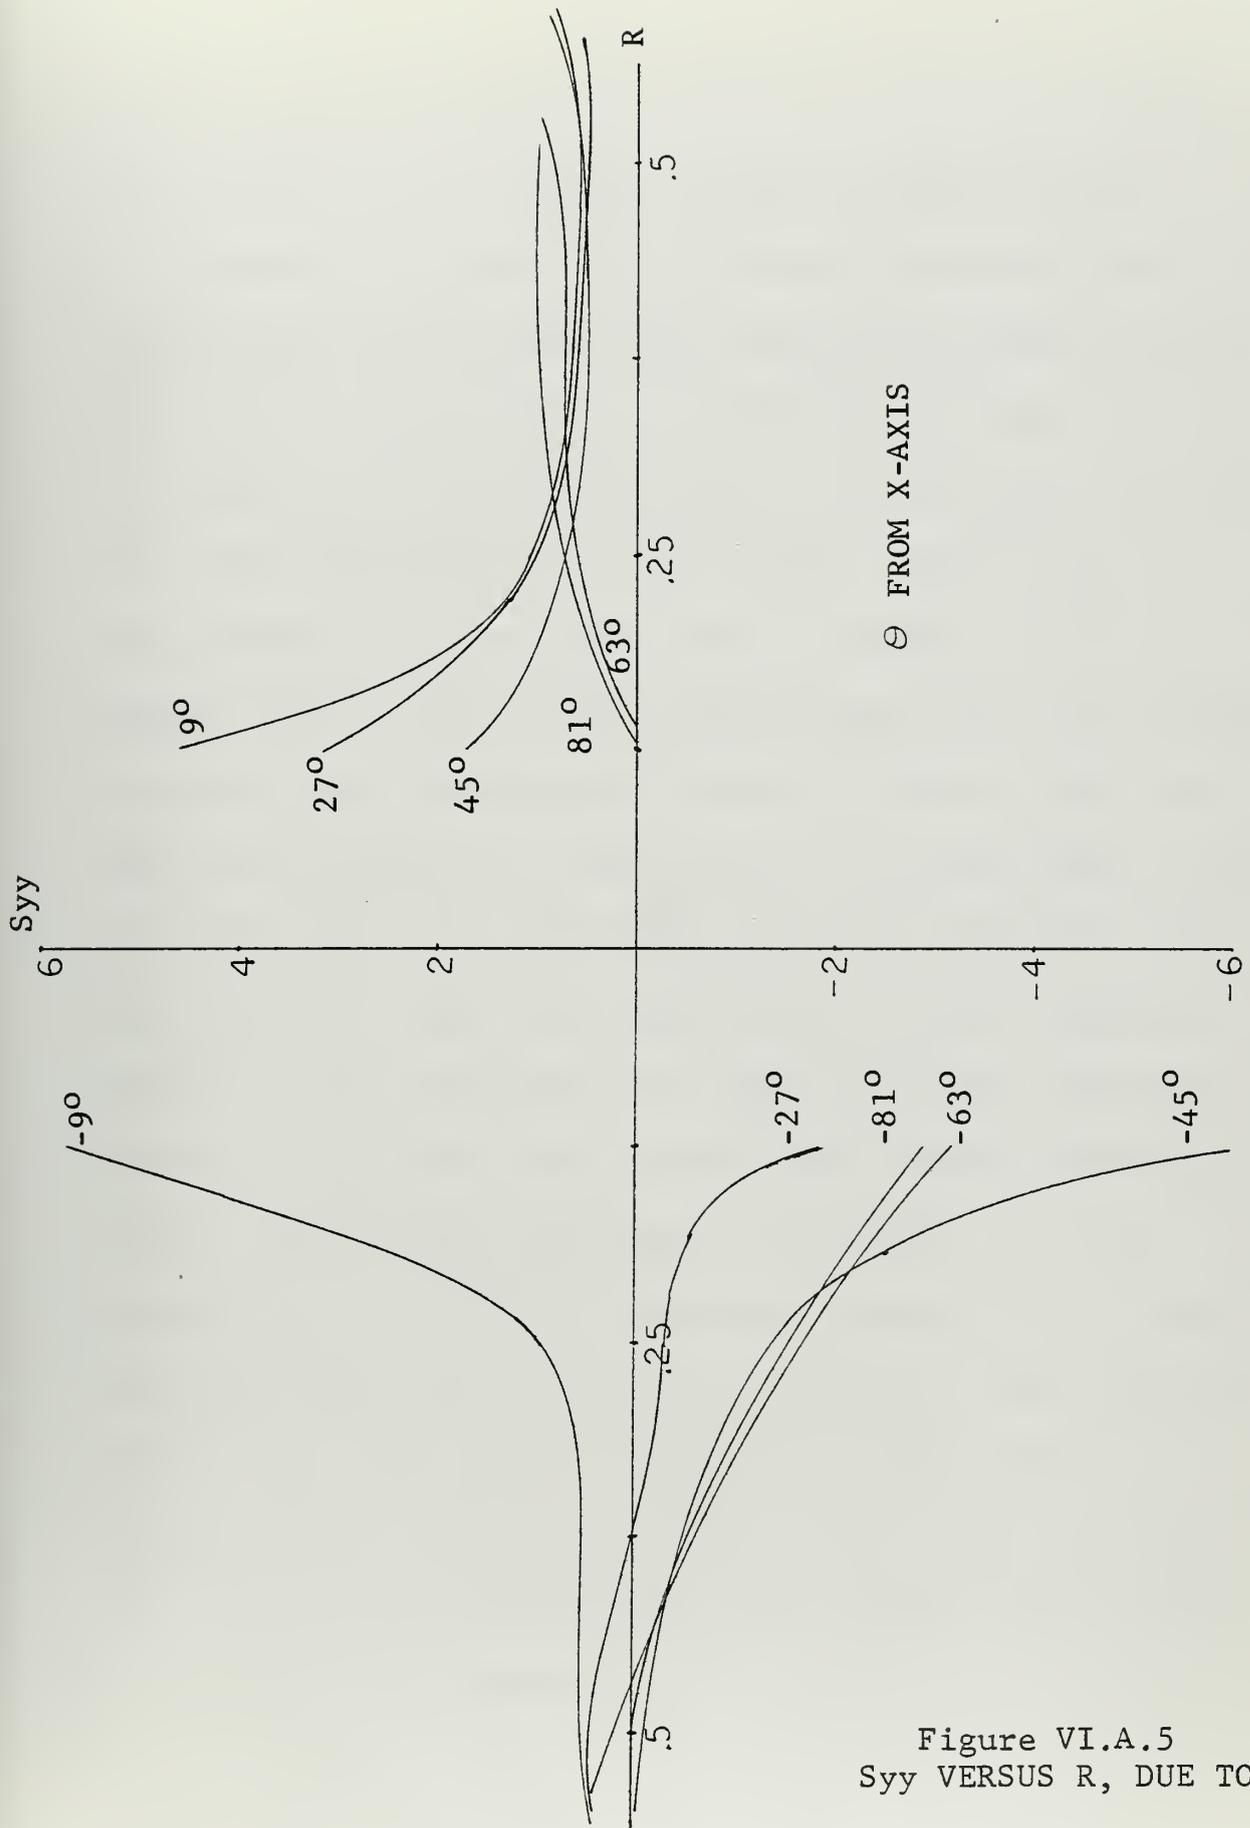
Figure VI.A.5
 S_{yy} VERSUS R , DUE TO N

Figures VI.A.3, VI.A.4, and VI.A.5 show how the stresses in the plate, S_{xx} and S_{yy} , varied around the hole for a unit tensile force/unit length. Although the joint is somewhat similar to a plate with a hole, the fastener was available to resist the tensile forces put on the plate; hence, higher stress concentrations than those of a plate with a hole in it were the result. Since only the fastener restricts deflection in the y-direction, all of the tensile force is picked up at the fastener, causing stress concentrations near five in compression in the plate.

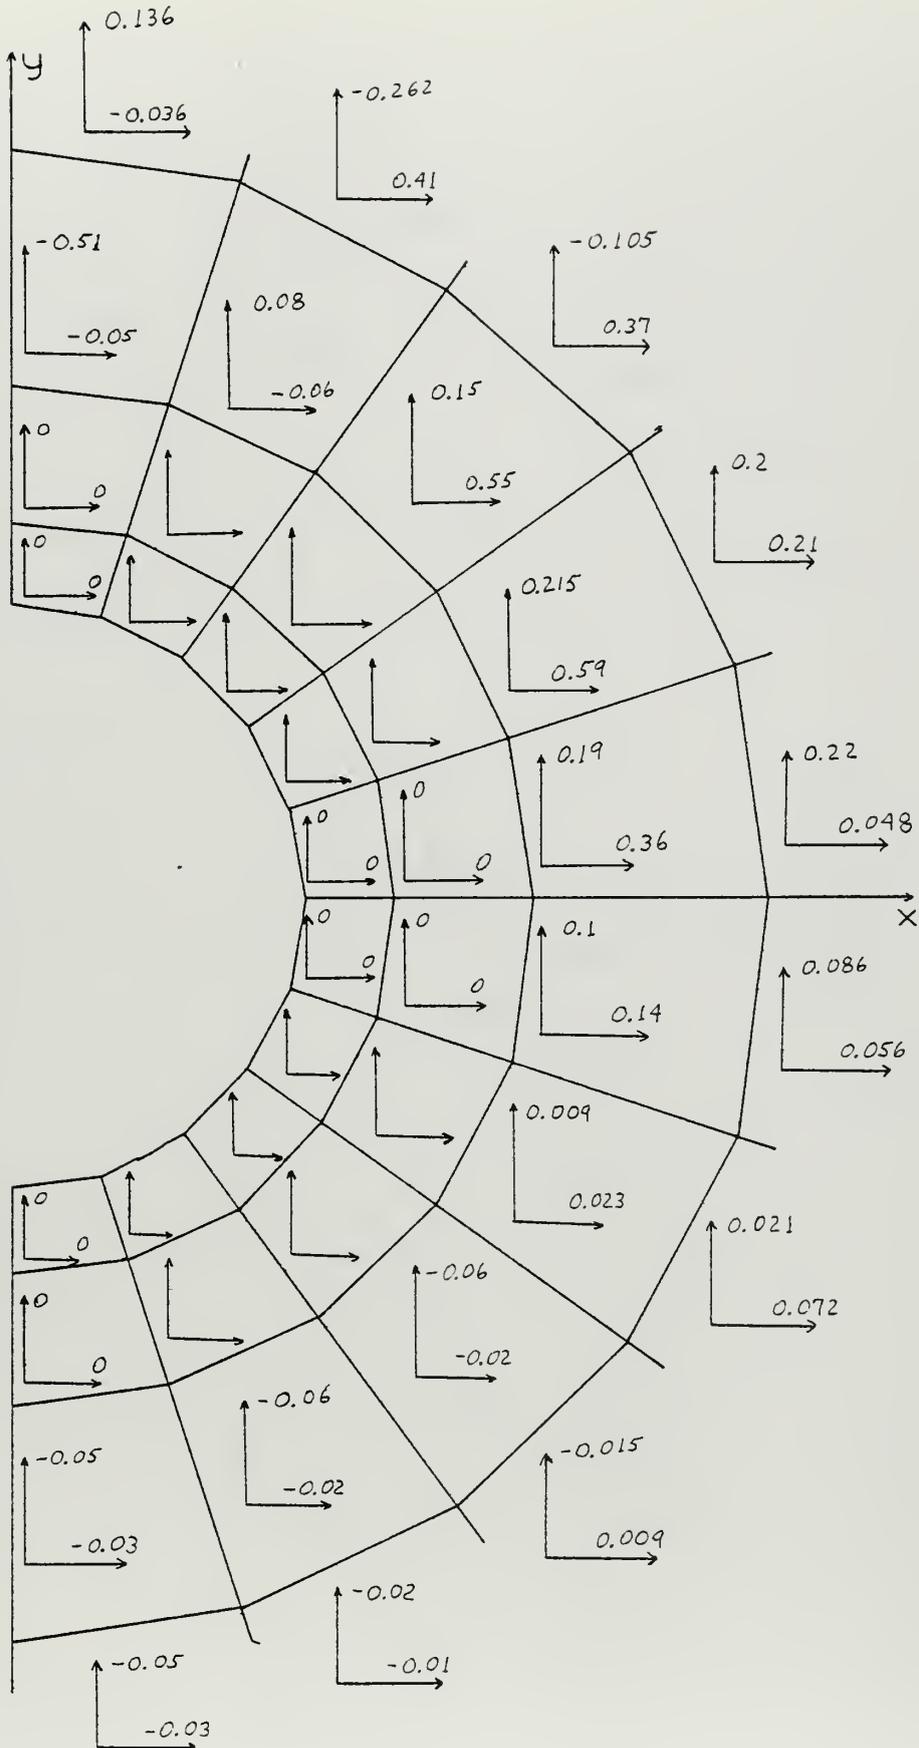
Figure VI.A.6 BENDING MOMENT FIELD DUE TO BENDING MOMENT

Figures VI.A.6 and VI.A.7 show how the moments due to the applied bending moment and the applied transverse shearing forces, respectively, are distributed through the plate. No moments were found in the section of the plate where the bolt head was influencing the material rotation, as one would expect. The important idea to remember about the moment field is that if the bending moment and the thickness shearing forces are the most critical loads in the joint, then these figures will give only a very basic idea of what one would expect for the bending stresses around the hole. Unfortunately, since the program does not give thickness shearing stress resultants for either the unit transverse shearing force/unit length or the unit bending moment/unit length (only moment resultants are printed) it is not possible to determine the thickness shearing force concentrations around the bolt hole for these two loads using the plate model. The way one can determine the transverse shearing stress state around the hole for these two loads is to use a three-dimensional finite element model of the joint using brick elements.

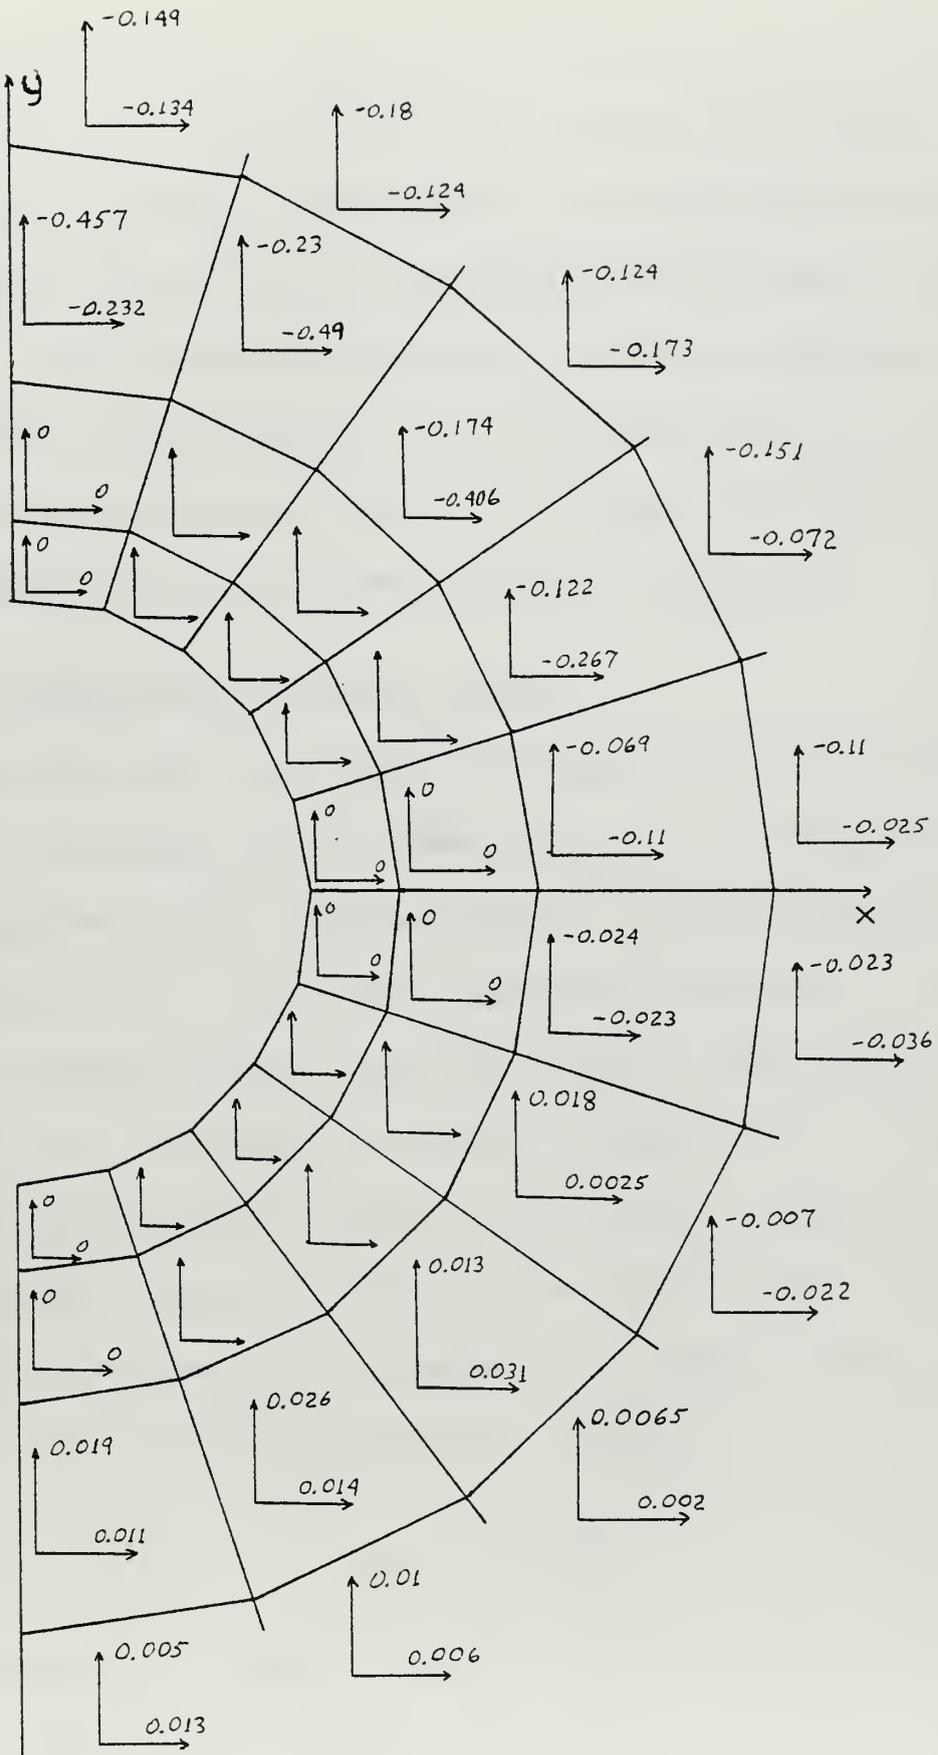
Figure VI.A.7 BENDING MOMENT FIELD DUE TO TRANSVERSE SHEAR

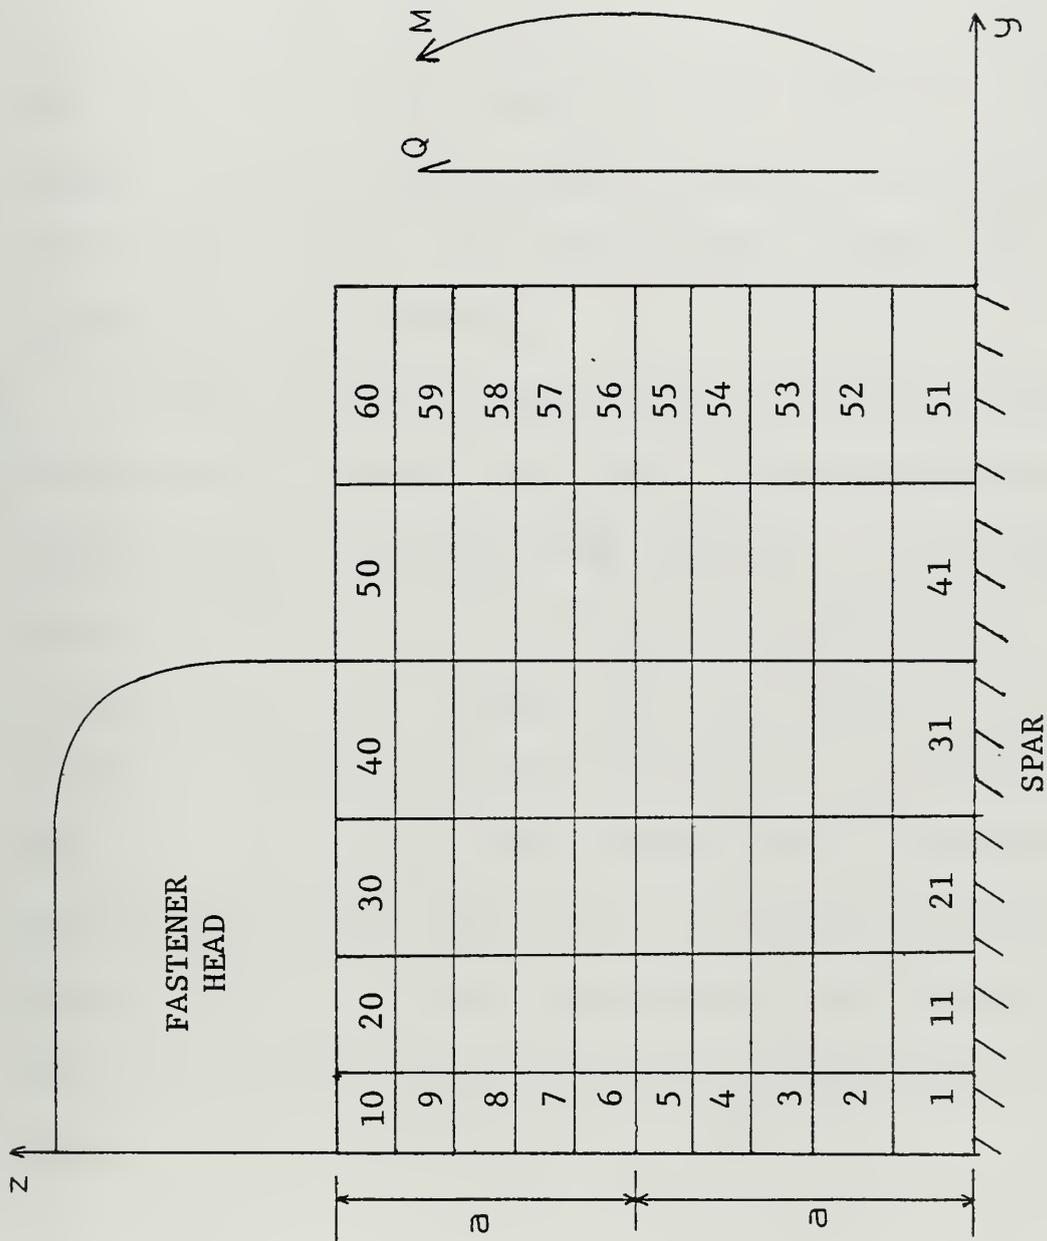
Figure VI.B.1 THICKNESS MODEL

it acts upon on the membrane, gives the force to be applied at each node. The thickness shearing forces were assumed to vary parabolically through the thickness, where;

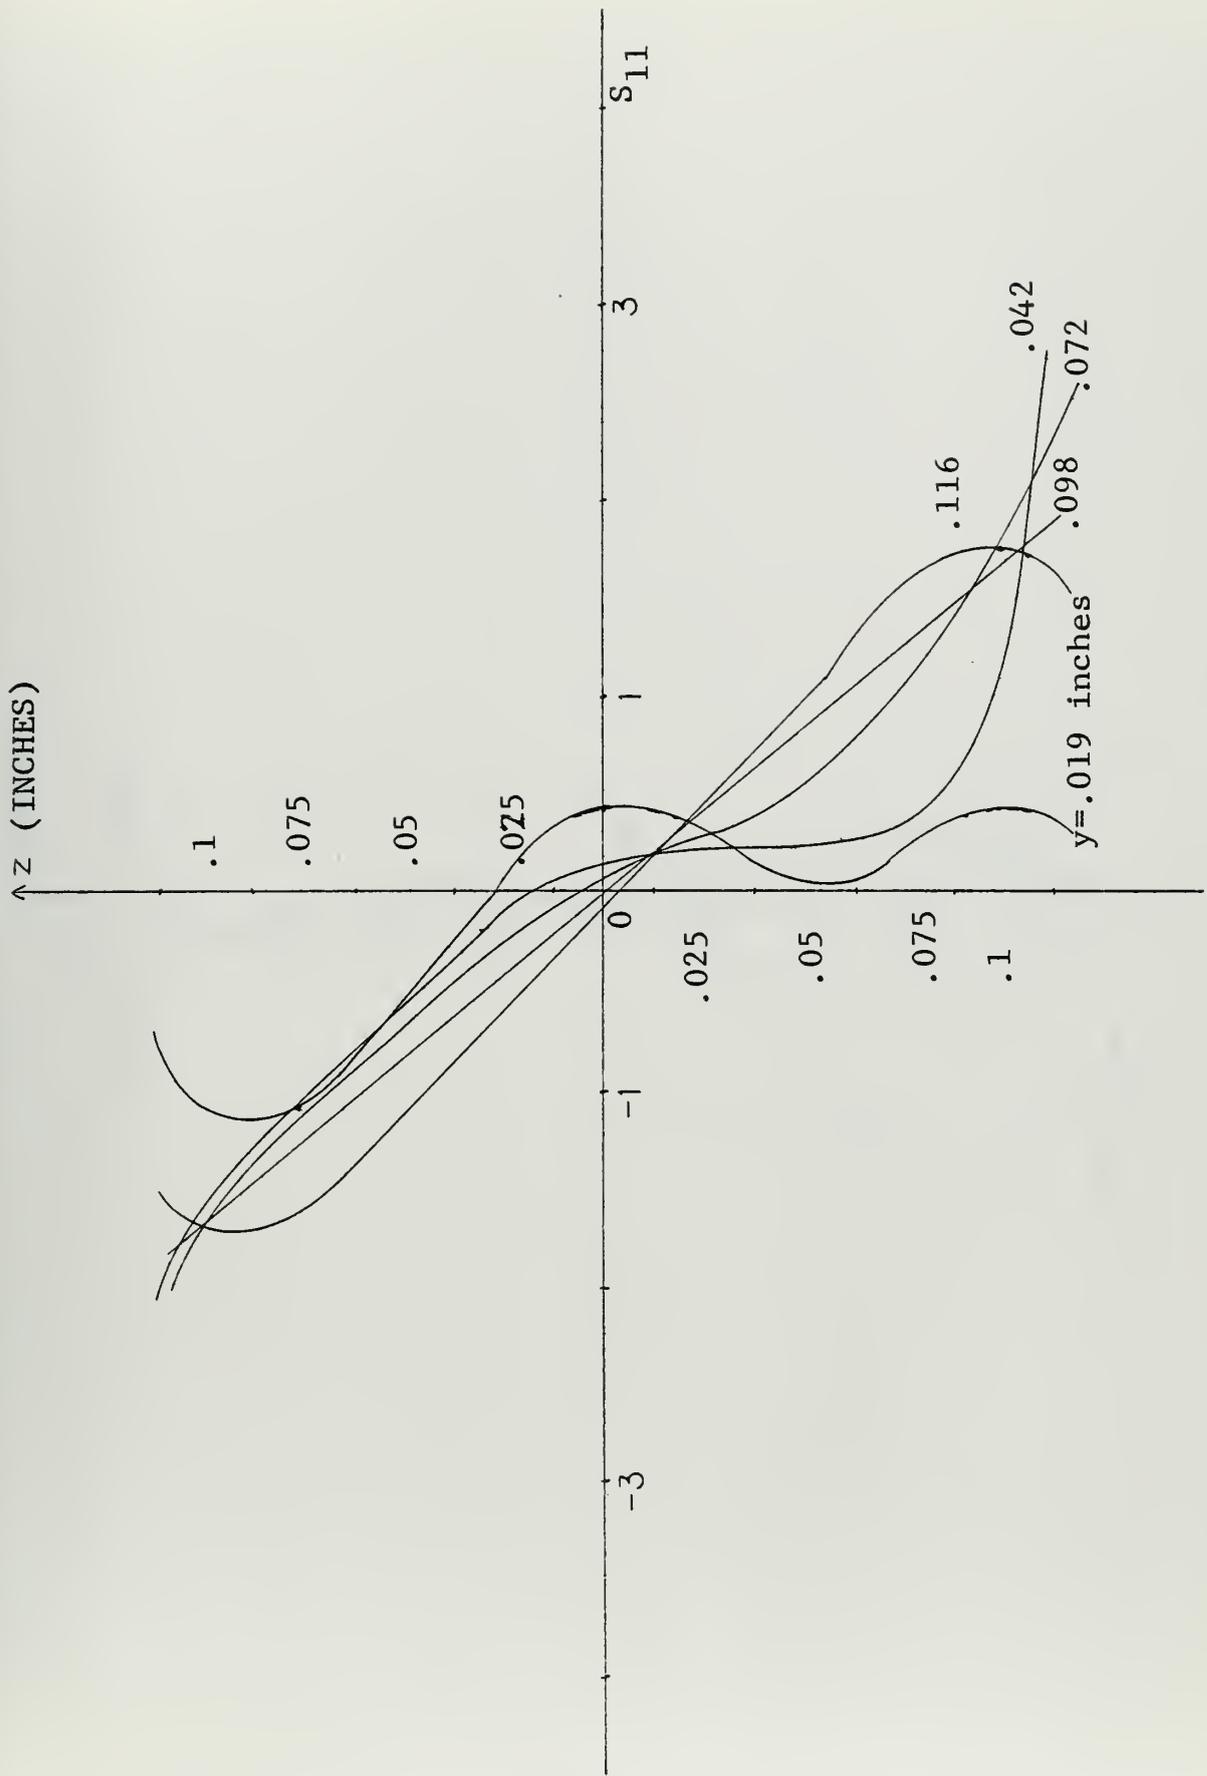
Figure VI.B.2 S₁₁ VERSUS Z DUE TO UNIT BENDING MOMENT

Figures VI.B.2 and VI.B.3 show the stress distribution through the thickness and along the y-axis for a unit bending moment/unit length. The results indicate that the bending moment is not going to be the most critical load on the

joint. The maximum stress concentrations produced by the bending moment are only about Z , insignificant even in comparison with those produced by a unit tensile force/unit length on the plate. This maximum stress concentration is in compression at the edge of the fastener head, where the fastener can first pick up the load. One would expect these stresses in the z -direction, due to the bending moment, to be zero. Although the computer analysis does not show that they are zero, the values up to the fastener head are very close to zero. Once the fastener starts to restrict the deflections, though, there is a gradual increase in the stresses near the fastener body. The stresses in the y -direction, due to the bending moment, would be linear in a normal plate analysis. Since there is a fastener, though, the stress changes from what is essentially a linear distribution in z , to an odd distribution which is caused by the fastener re-straining the deflections of the plate. The majority of the load is picked up at the edge of the fastener head and then decreases towards the fastener body.

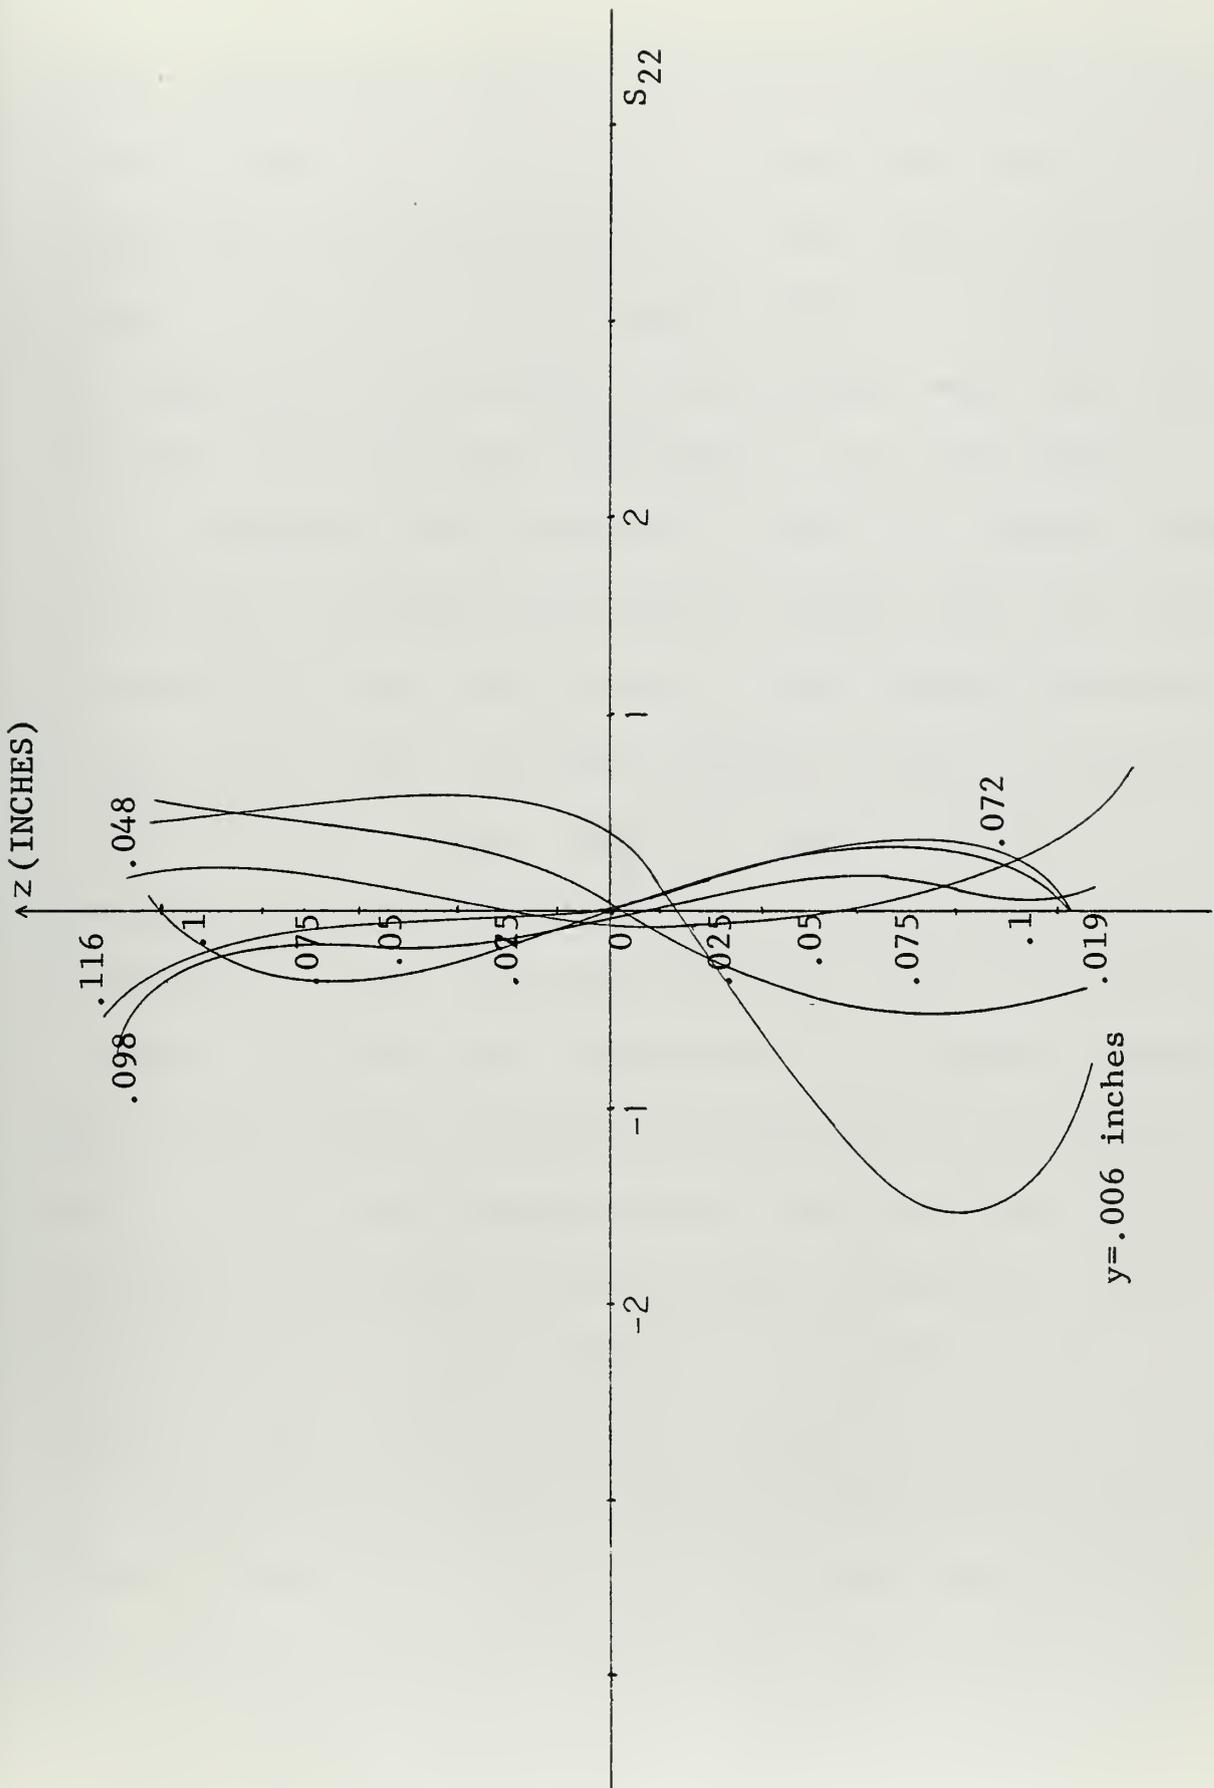
Figure VI.B.3 S_{22} VERSUS Z DUE TO UNIT BENDING MOMENT

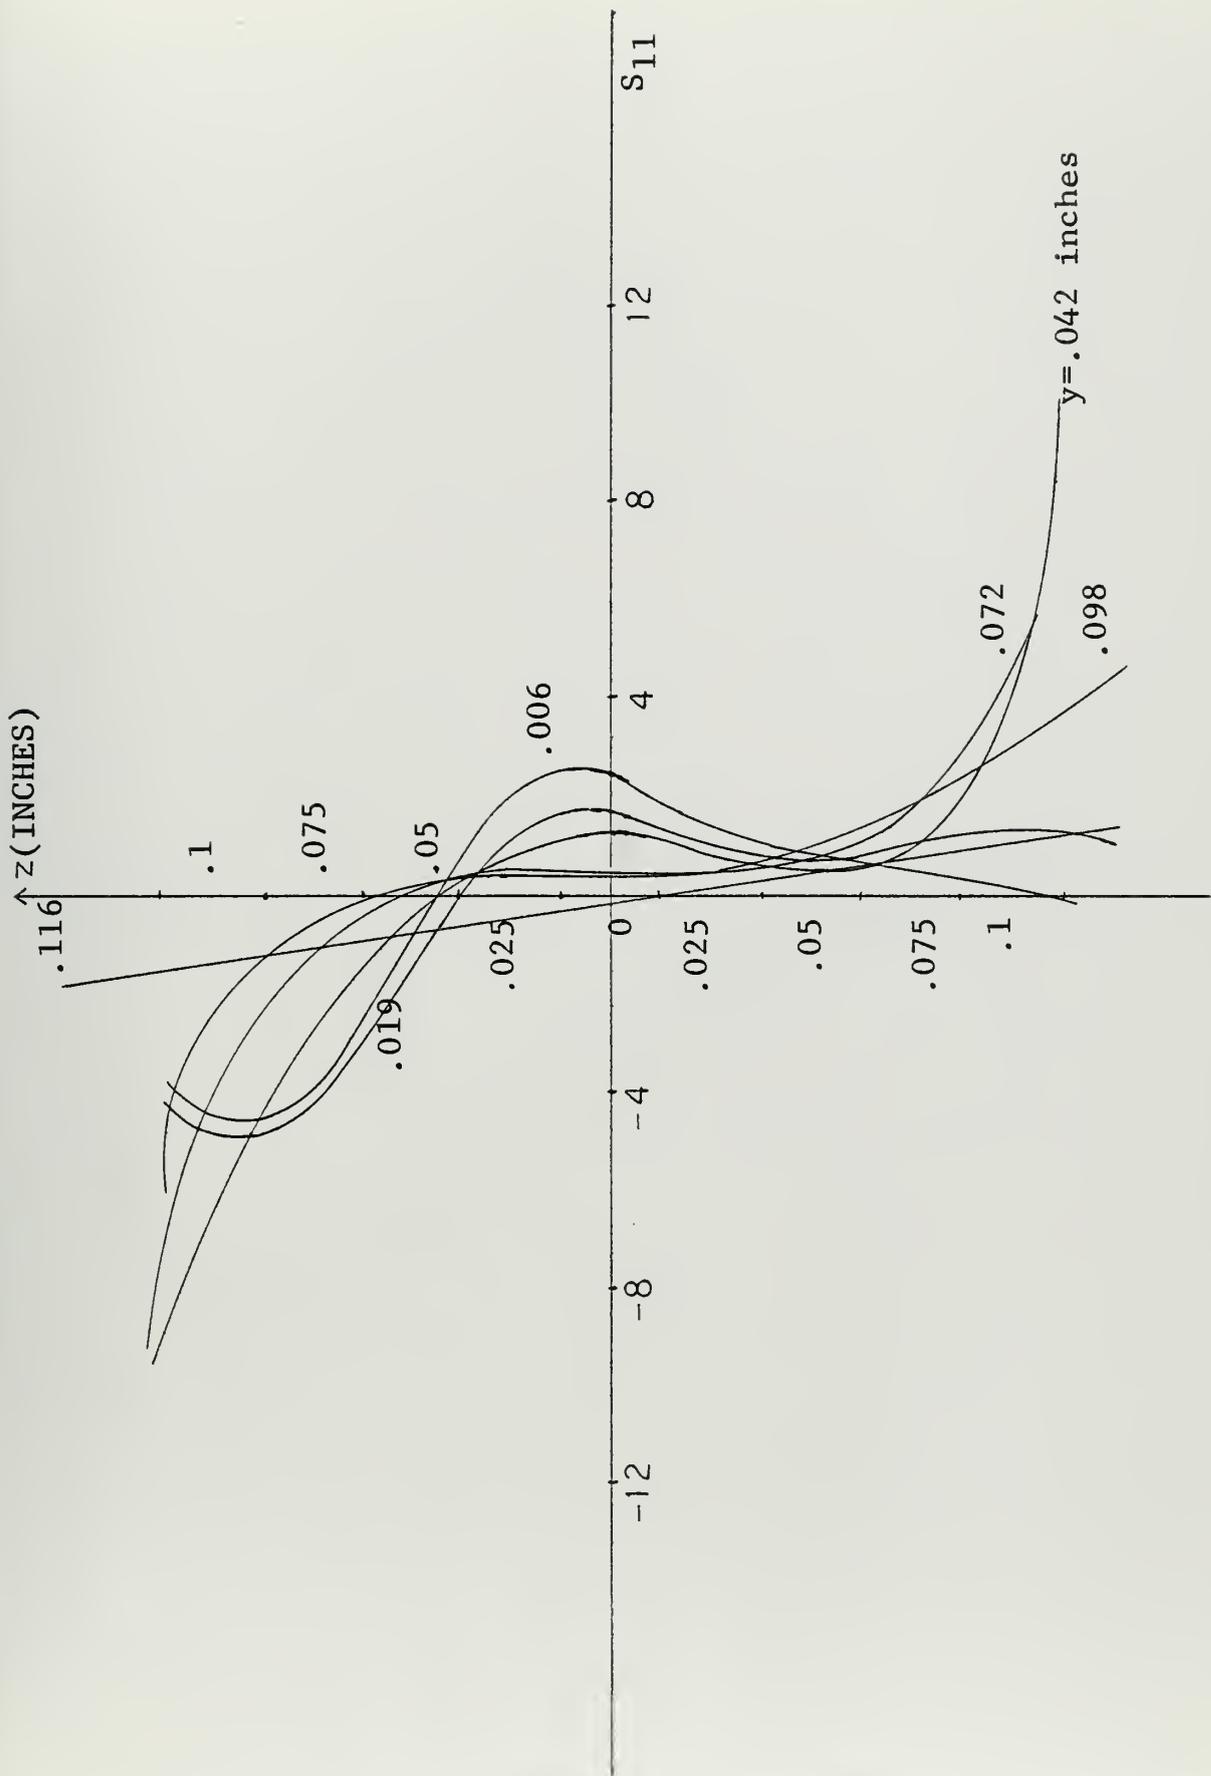
Figure VI.B.4 S_{11} VERSUS Z DUE TO UNIT THICKNESS SHEAR

Figures VI.B.4, VI.B.5, and VI.B.6 show how the stress varies through the thickness and along the y -axis for the thickness shearing force/unit length. The results indicate that the thickness shear may be significant in the failure

of the joint due to hydraulic ram loading. As one would expect, the stress in the material in the z-direction is essentially zero where there is no restraint at the bottom of the plate, but it increases almost linearly to its maximum where the fastener head restricts the displacements and picks up the transverse shearing loads. The stresses in the y-direction due to the transverse shearing force start off in a linear distribution through the thickness, but rapidly change from linear due to the re-straining effect of the fastener.

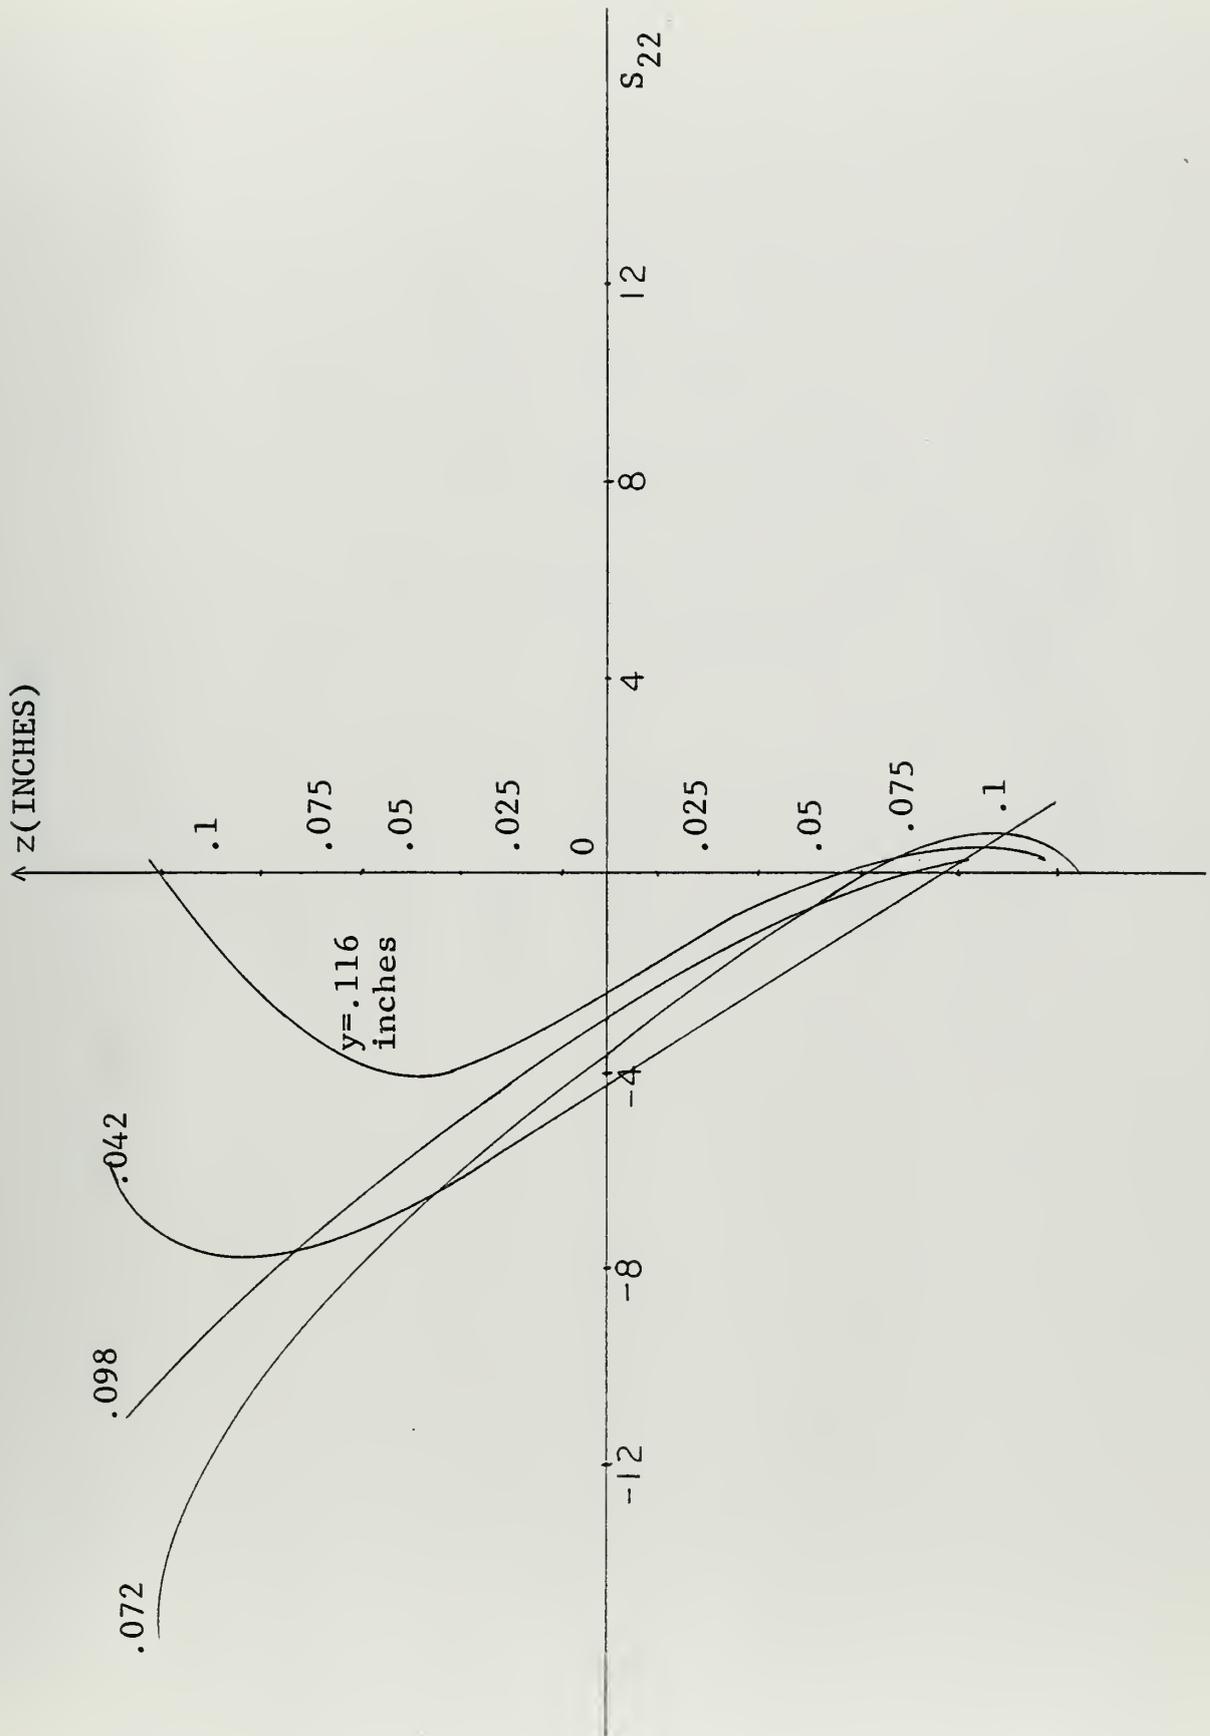
Figure VI.B.5 S₂₂ VERSUS Z DUE TO UNIT THICKNESS SHEAR

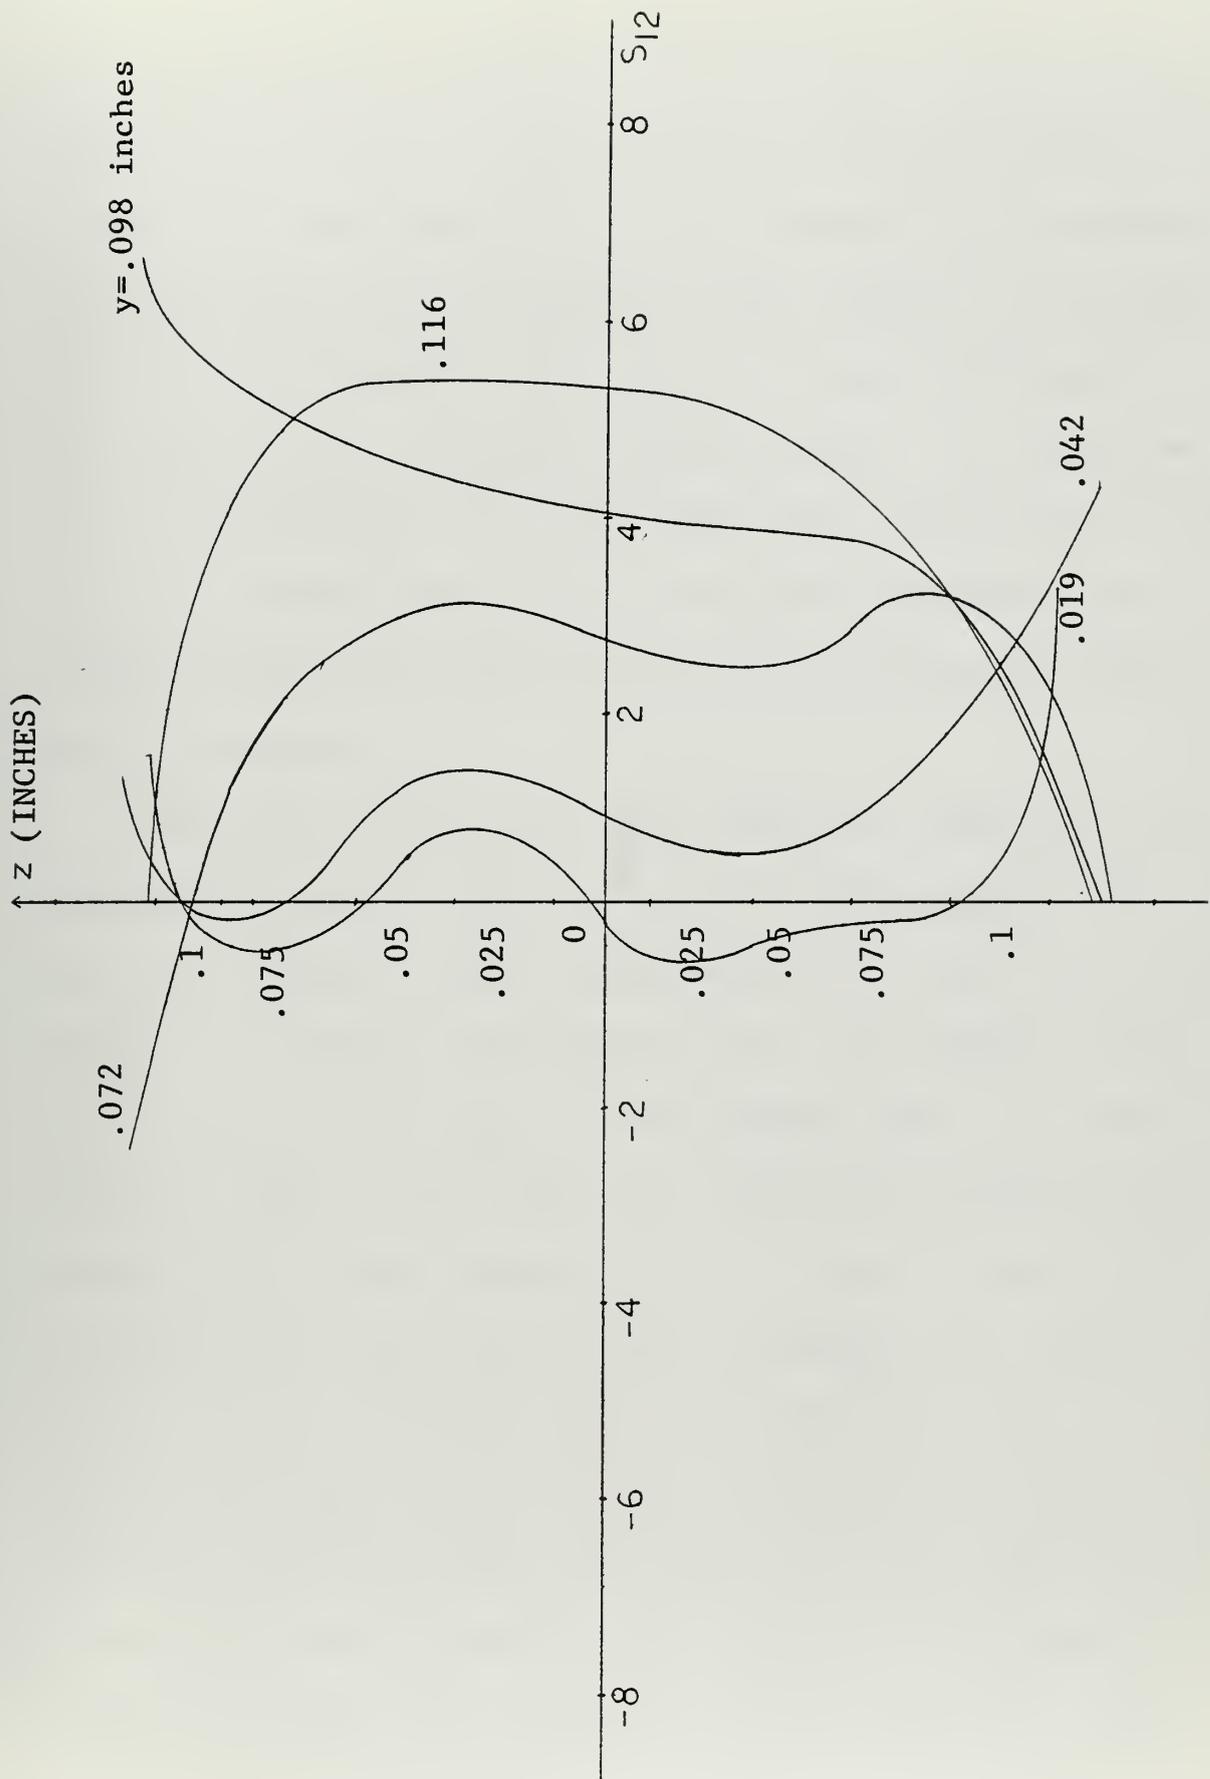
Figure VI.B.6 S_{12} VERSUS Z DUE TO UNIT THICKNESS SHEAR
